Re: Work Plan Report
Emerald PWU 20 #1H
API No. 30-015-38338
GPS: Latitude 32.6525154 Longitude -104.1045456
UL "D", Sec. 20, T19S, R29E
Eddy County, NM
NMOCD Ref. No. 2RP-779; 2RP-4281; 2RP-5167; 2RP-5377

Pima Environmental Services, LLC (Pima) has been contracted by Devon Energy Production Company (Devon) to perform a spill assessment and to submit a work plan for approved remediation activities on the open releases that occurred at the Emerald PWU 20 Fed #1H (Emerald). There are currently four open spills at this site. 2RP-779 release, the initial C-141, has been submitted and was assigned Incident ID nMLR1113050834, by the New Mexico Oil Conservation Division (NMOCD). 2RP-4281 release, the initial C-141 was submitted on June 29, 2017, and was assigned Incident ID nAB1718733399. A work plan was submitted and approved for this incident. The work plan will be followed as approved. The third release, 2RP-5167, the C-141, was submitted on November 20, 2018, and assigned Incident ID NAB1900959144. The fourth release, 2RP-5377, the initial C-141, was submitted on November 21, 2018, and assigned Incident ID NAB1912031219.

Emerald PWU 20 #1H
API 30-015-38338
Eddy County, NM
Location M

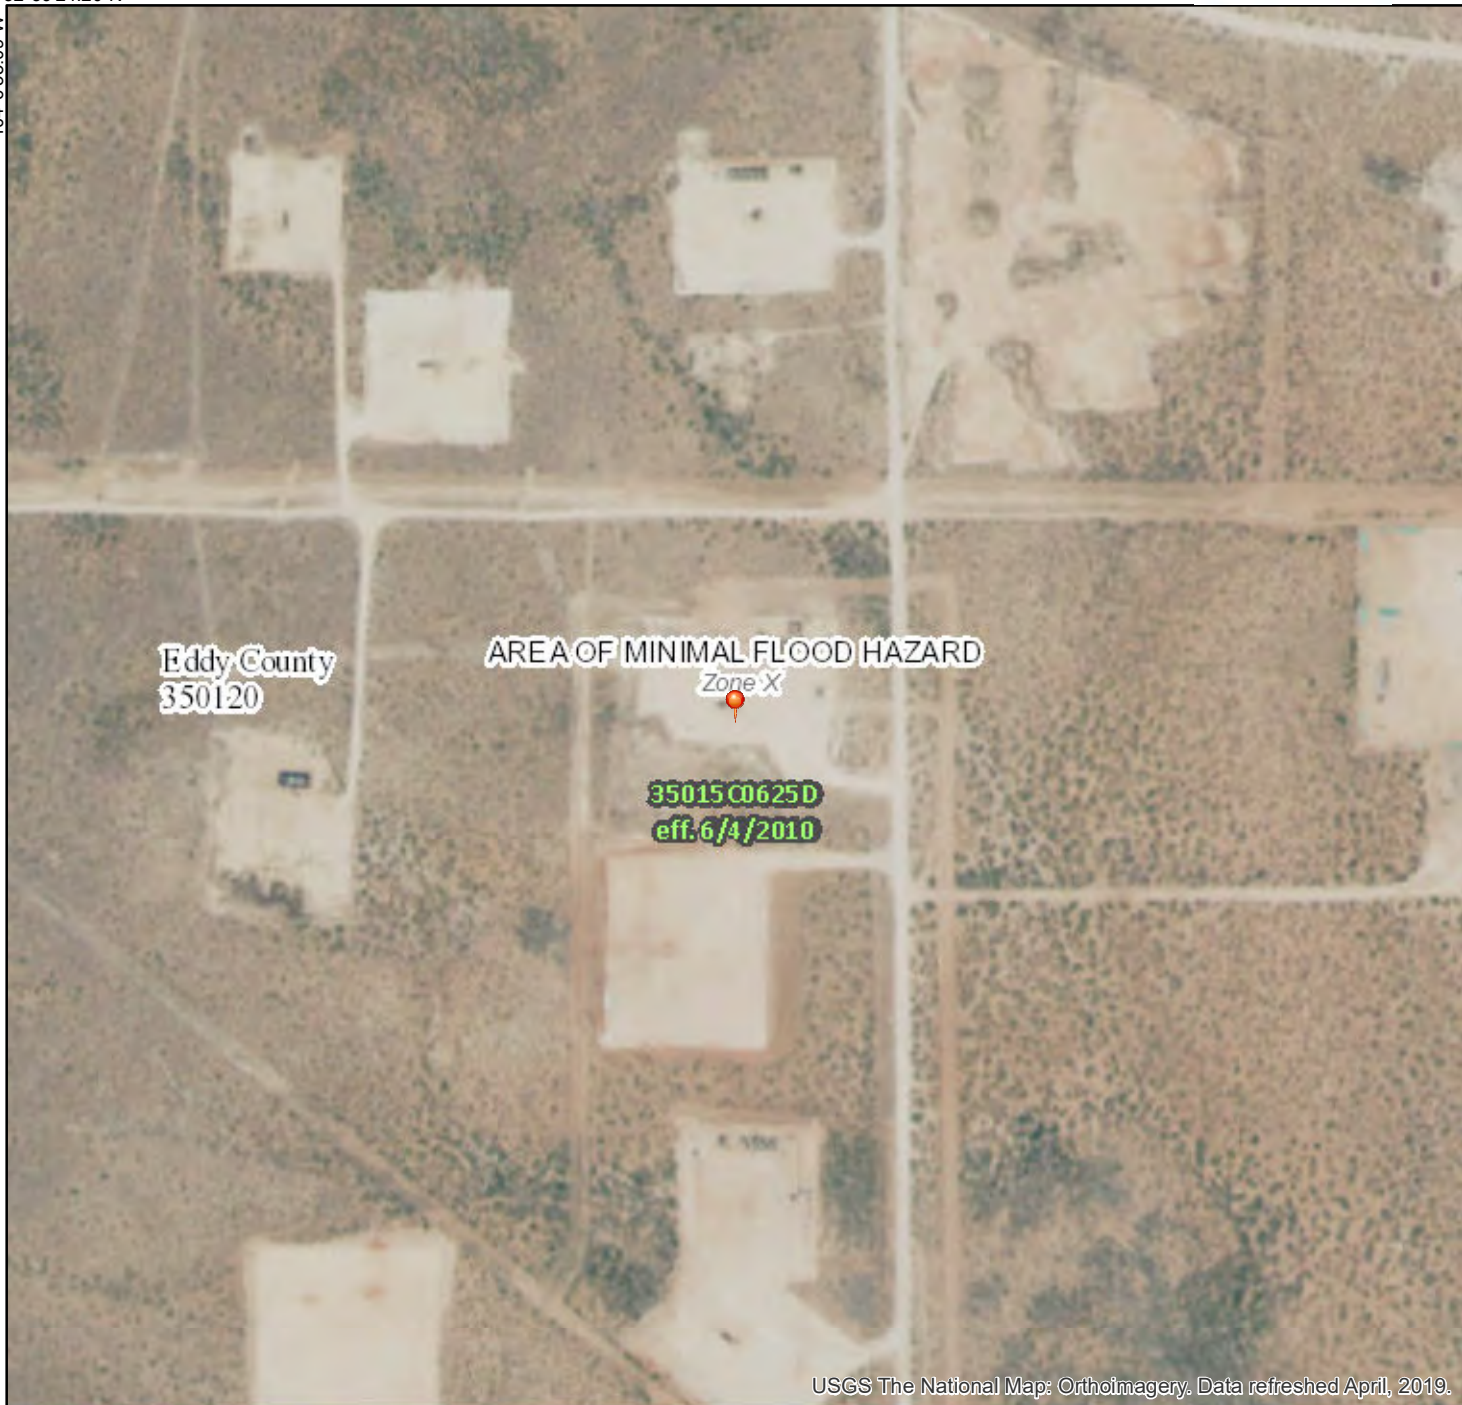
National Flood Hazard Layer FIRMette

The pin displayed on the map is an approximate point selected by the user and does not represent an authoritative property location.

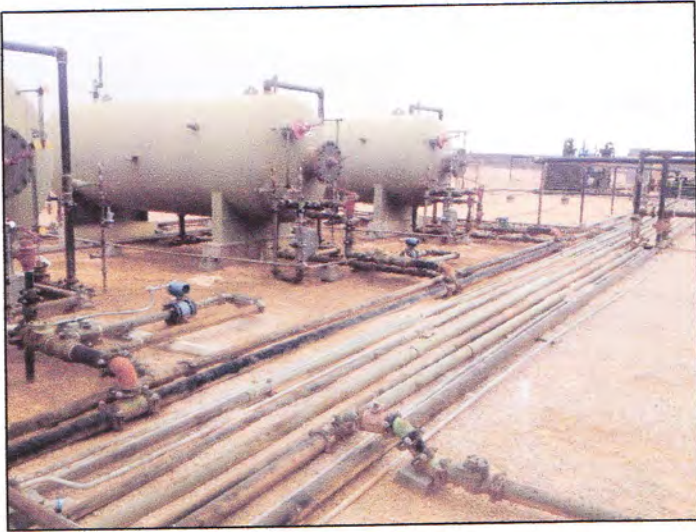
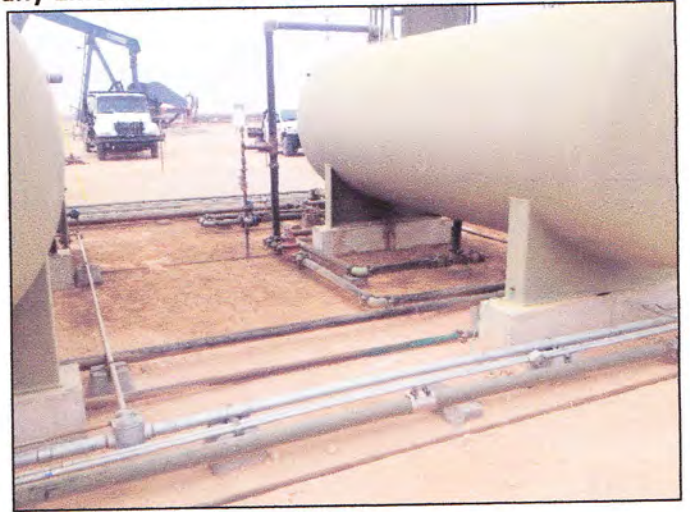
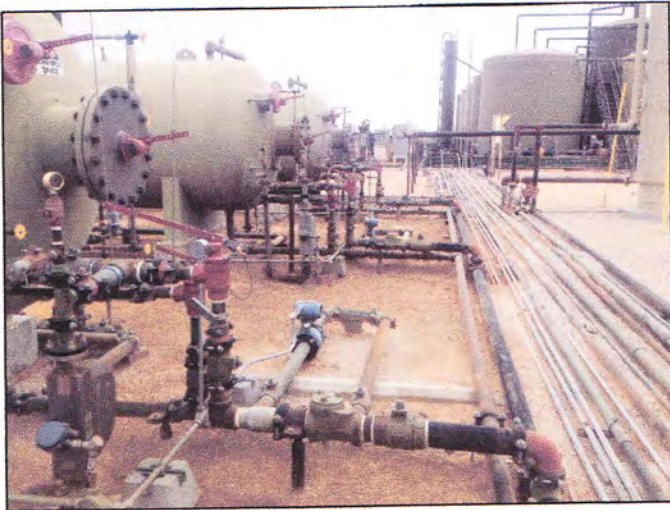
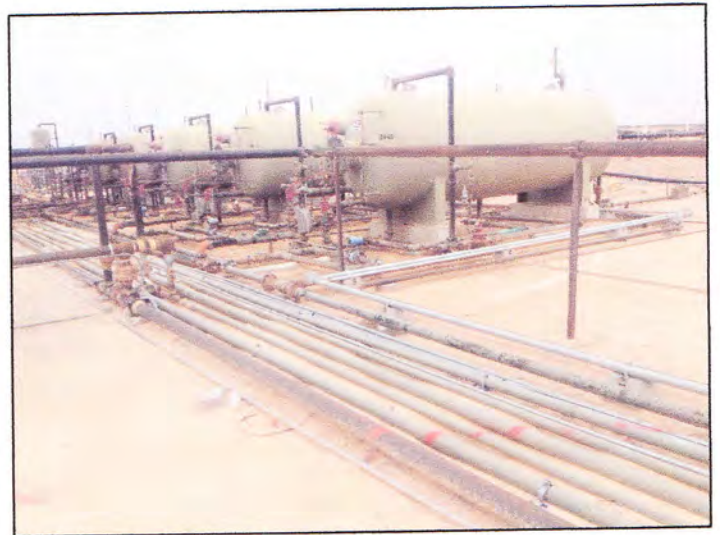
Devon Energy Production Company-Emerald PWU 20 1H

At the time of discovery, wells flowing to the battery were shut in and the repairs made to the three-phase separator. All released fluids remained on the caliche pad and no area off the pad was impacted. The impacted area is in a highly congested area of surface equipment and is approximately 20' x 20'. Two sample points were selected for soil sampling by use of a hand auger. (See attached chloride field test and lab analysis.)

Due to hazards associated with working around the above ground piping/vessels and the sheer congestion of the area, the excavation of the impacted soil will have to be done with hand tools. I propose to hand excavate the impacted soil around the surface equipment to a depth of 1' BGS. The hand excavated soil will be stockpiled on plastic and disposed of at a division permitted facility. Fresh base course will be used for back fill with the area being brought back to grade, leveled, and raked.
