Remediation Plan

Re: NEDU 2A
Case # 1RP-5591

Apache Corporation: NEDU Sat 2A Release Date: June 26, 2019	RP No. 1RP-5591 API No. 30-025-34651
--	---

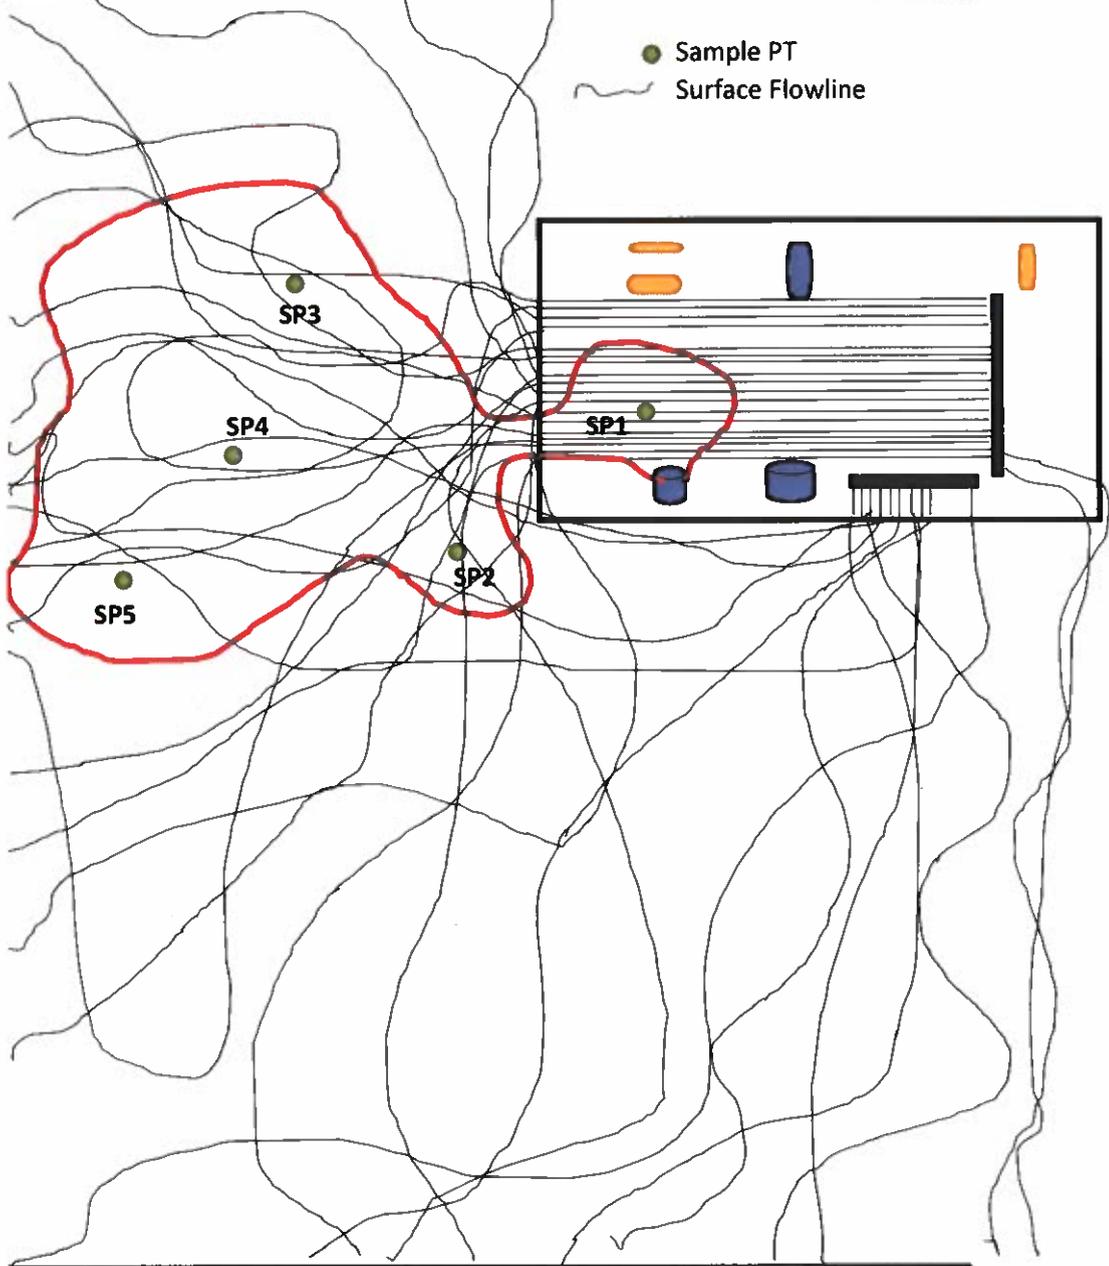
Sample ID	Depth	BTEX	Chloride	TPH	Ext DRO	Description
SP1	Surface	<0.300	2960	18900	4690	
SP1	1'	<0.300	1340	237	44.9	
SP2	Surface	<0.300	736	426	161	
SP2	1'	<0.300	576	33.3	<10	
SP3	Surface	<0.300	496	7680	3090	Impervious
SP4	Surface	<0.300	32	<10	<10	Impervious
SP5	Surface	<0.300	<16	<10	<10	Impervious

Apache Corporation purposes that the area around SP 2 be hand excavated to a depth of 1 foot to remove the chloride contamination to below 600 mg/kg. Once excavation is complete 5 point bottom and wall composite samples be collected and submitted to a commercial laboratory for analysis of chloride. Once SP 2 meets the chloride threshold in the pasture of less than 600 mg/kg the entire pasture area will be tilled to loosen the soil and micro-blaze will be applied to the area to address the hydrocarbon contamination. Once treatment is complete final bottom samples will be collected not to exceed 500 square feet and submitted to a commercial laboratory for analysis of chloride, TPH, and BTEX. If the pasture area is above the threshold for the pasture reclamation standards in rule 19.15.29 then those areas will be treated until the standards are met. Since the plan calls for no excavating then the horizontal samples already obtained will be used for final wall samples in the closure report. The battery area will be hand excavated to a depth 6 inches to 1 foot. Once excavation is complete than 5 point bottom and wall samples will be collected not to exceed 500 square feet and submitted to a commercial laboratory for analysis of chloride, TPH, BTEX.

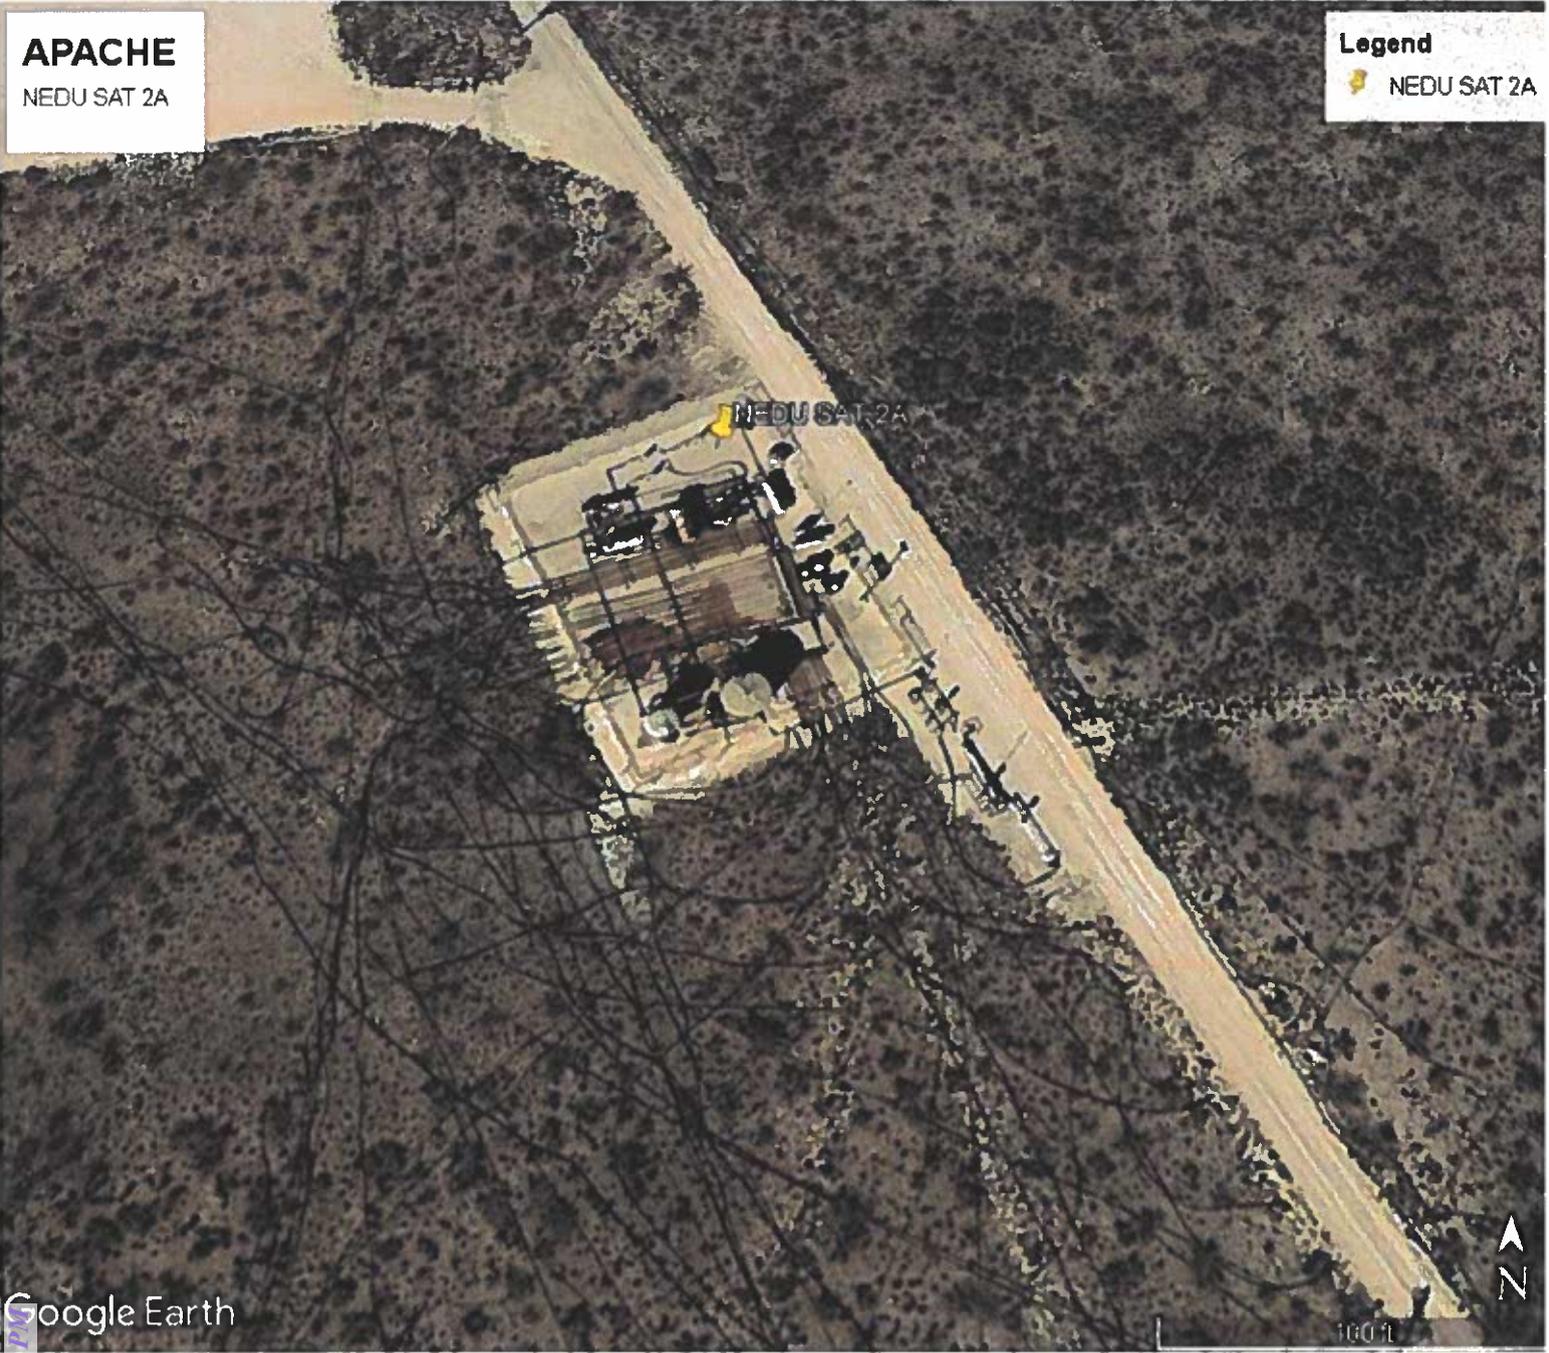
Apache Corporation request a variance to further delineation vertically at SP 3. The release area is situated on top of a hill and hard rock is encounter at 1 foot. The area is not accessible to drive equipment such as backhoes, hydro-vac, or a soil bore rig. The pasture has multiple poly flow lines and the battery has limited space to enter the area through the battery. There is representation of vertical delineation at SP 2 at 1 foot.
