Re: Closure Report
N-Line Leak 3
GPS: Latitude 32.734912 Longitude -103.772112
UL "F", Sec. 21, T18S, R32E
Lea County, NM
NMOCD Ref. No.

Tasman Geosciences (Tasman), on behalf of DCP Midstream (DCP), has prepared this Closure Report for the historical Release Site known as the N-Line Leak 3. Details of the release are summarized below:

Attachment #1- Figure 1 – Site Characteristics Map

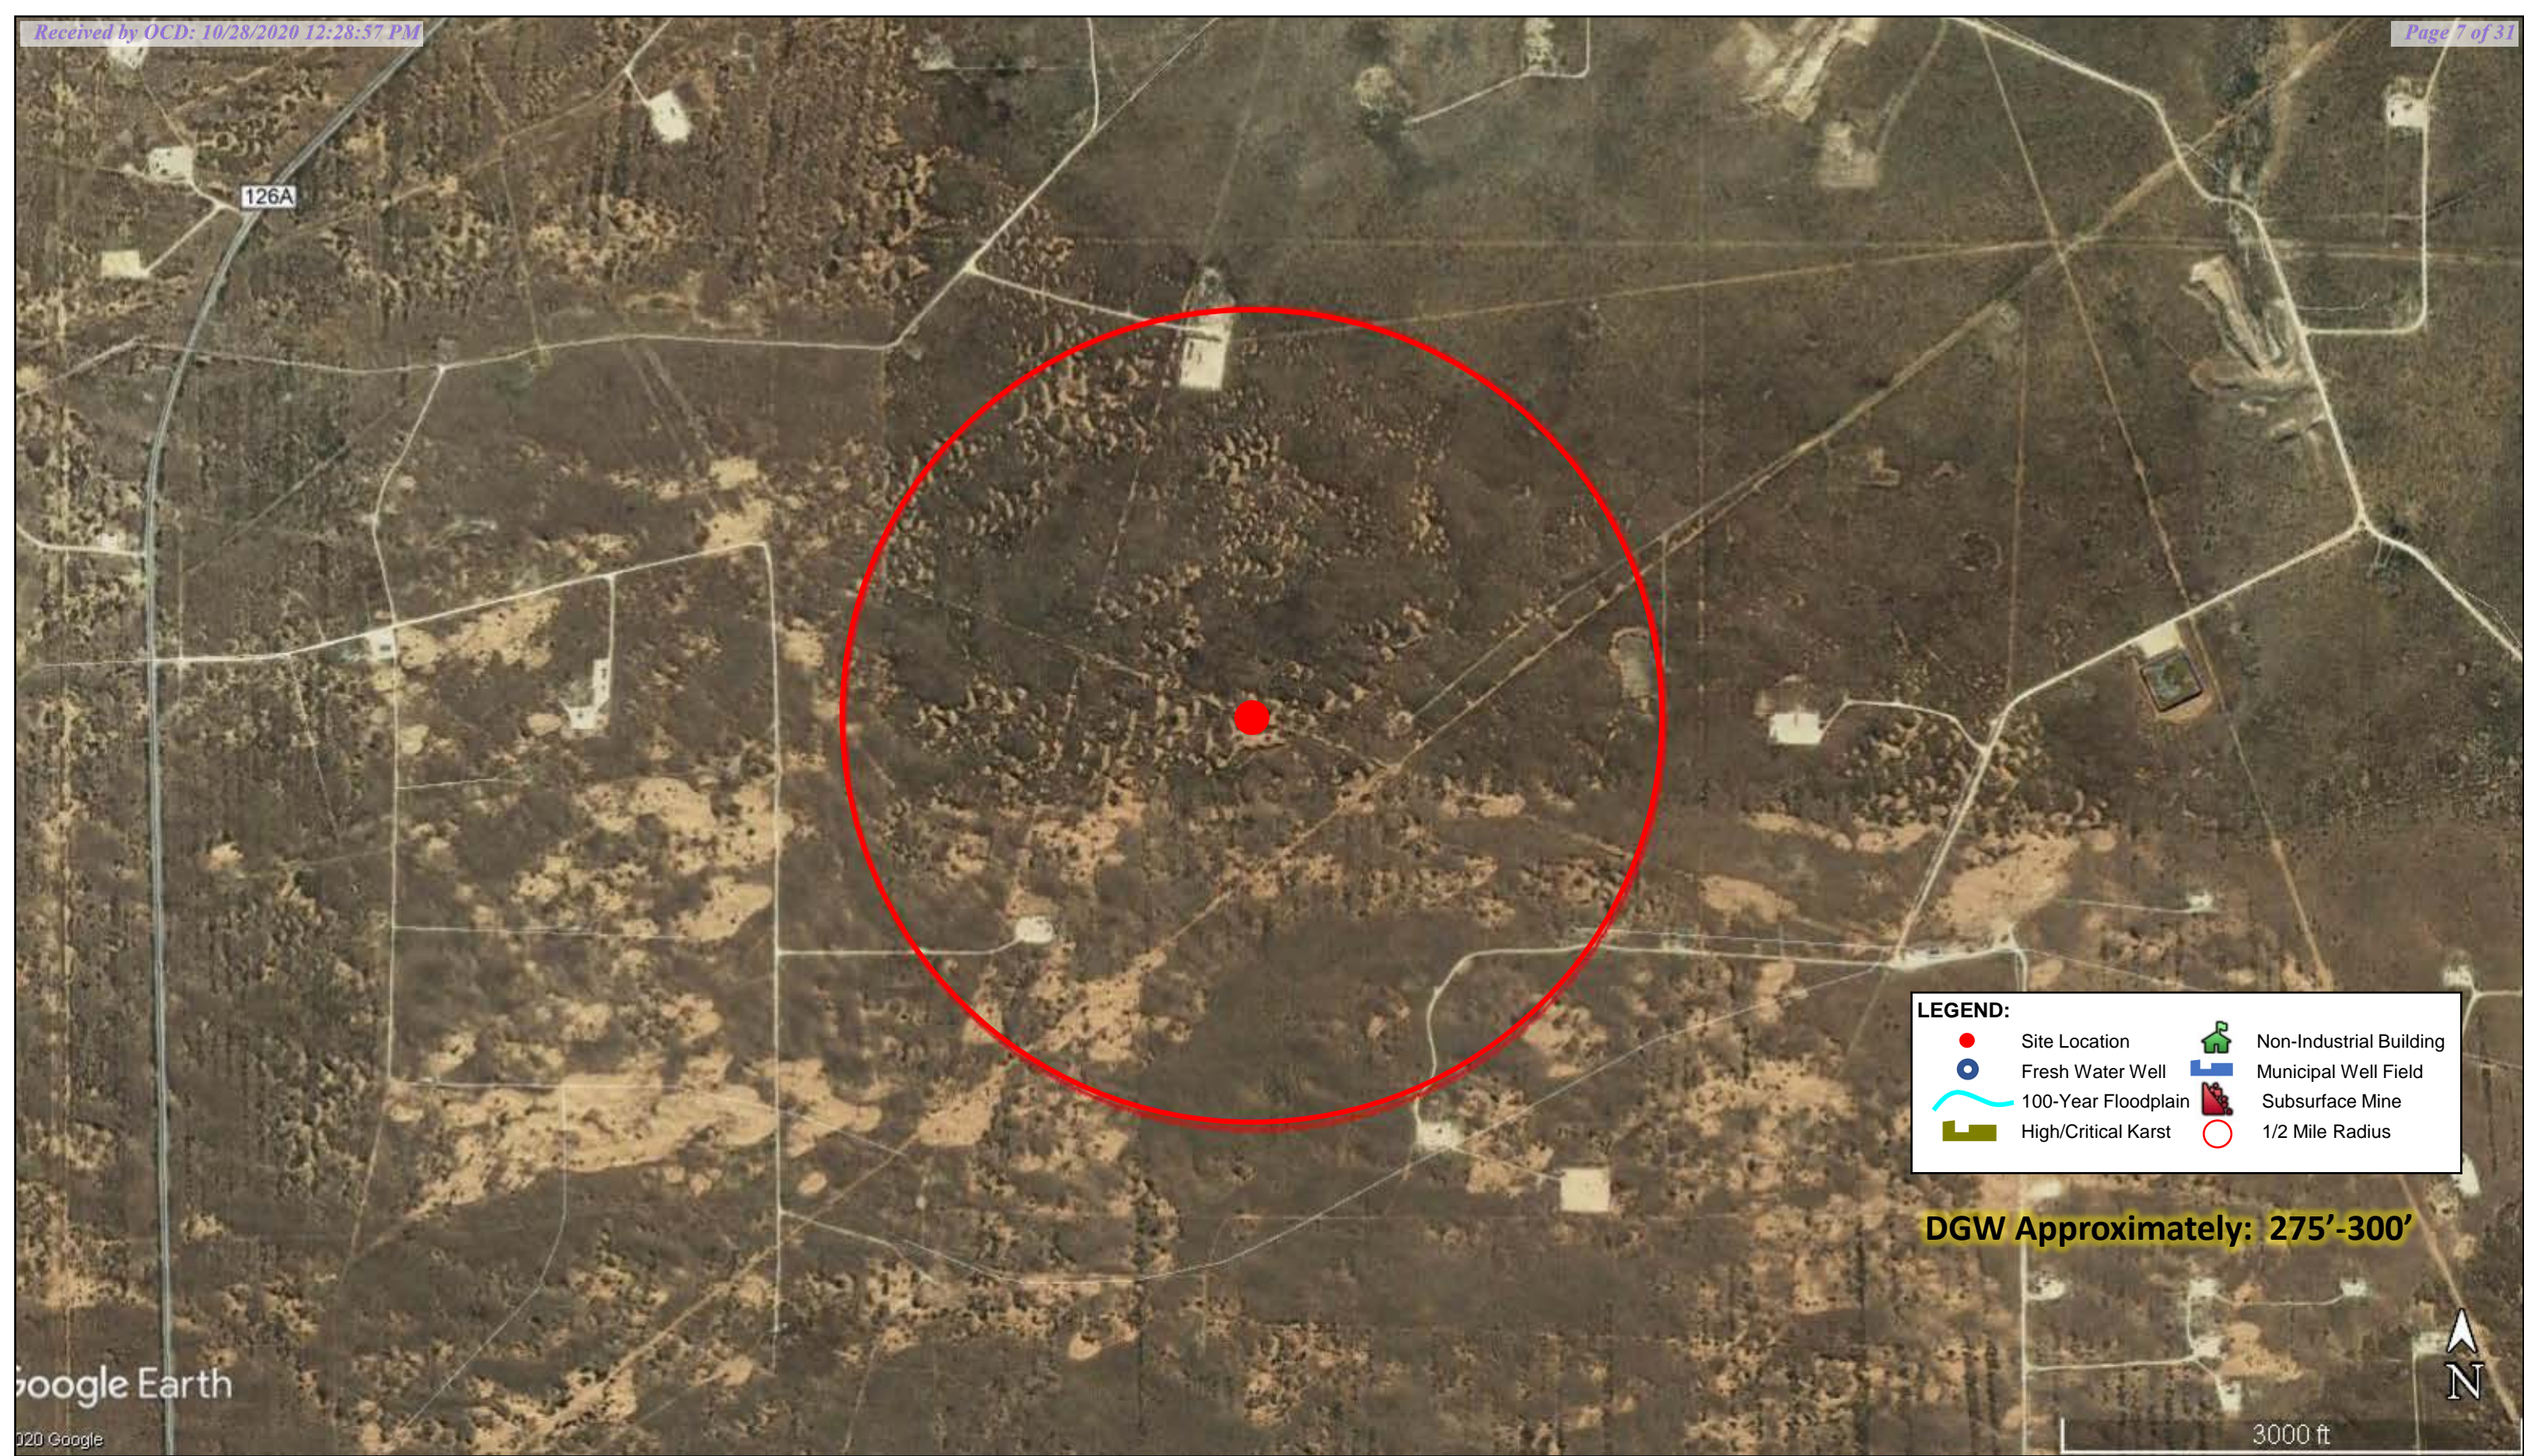
| DATE: June 2020 | TASMAN GEOSCIENCES | <i>Tasman Geosciences, Inc.</i> <i>2620 W. Marland Blvd.</i> <i>Hobbs, NM 88240</i> | DCP Midstream N Line Leak #3 (3.3.2020) GPS: 32.734912, -103.772112 UL "F", Section 21, Township 18 South, Range 32 East Lea County, New Mexico | Site Characteristics Map | Figure 1 |

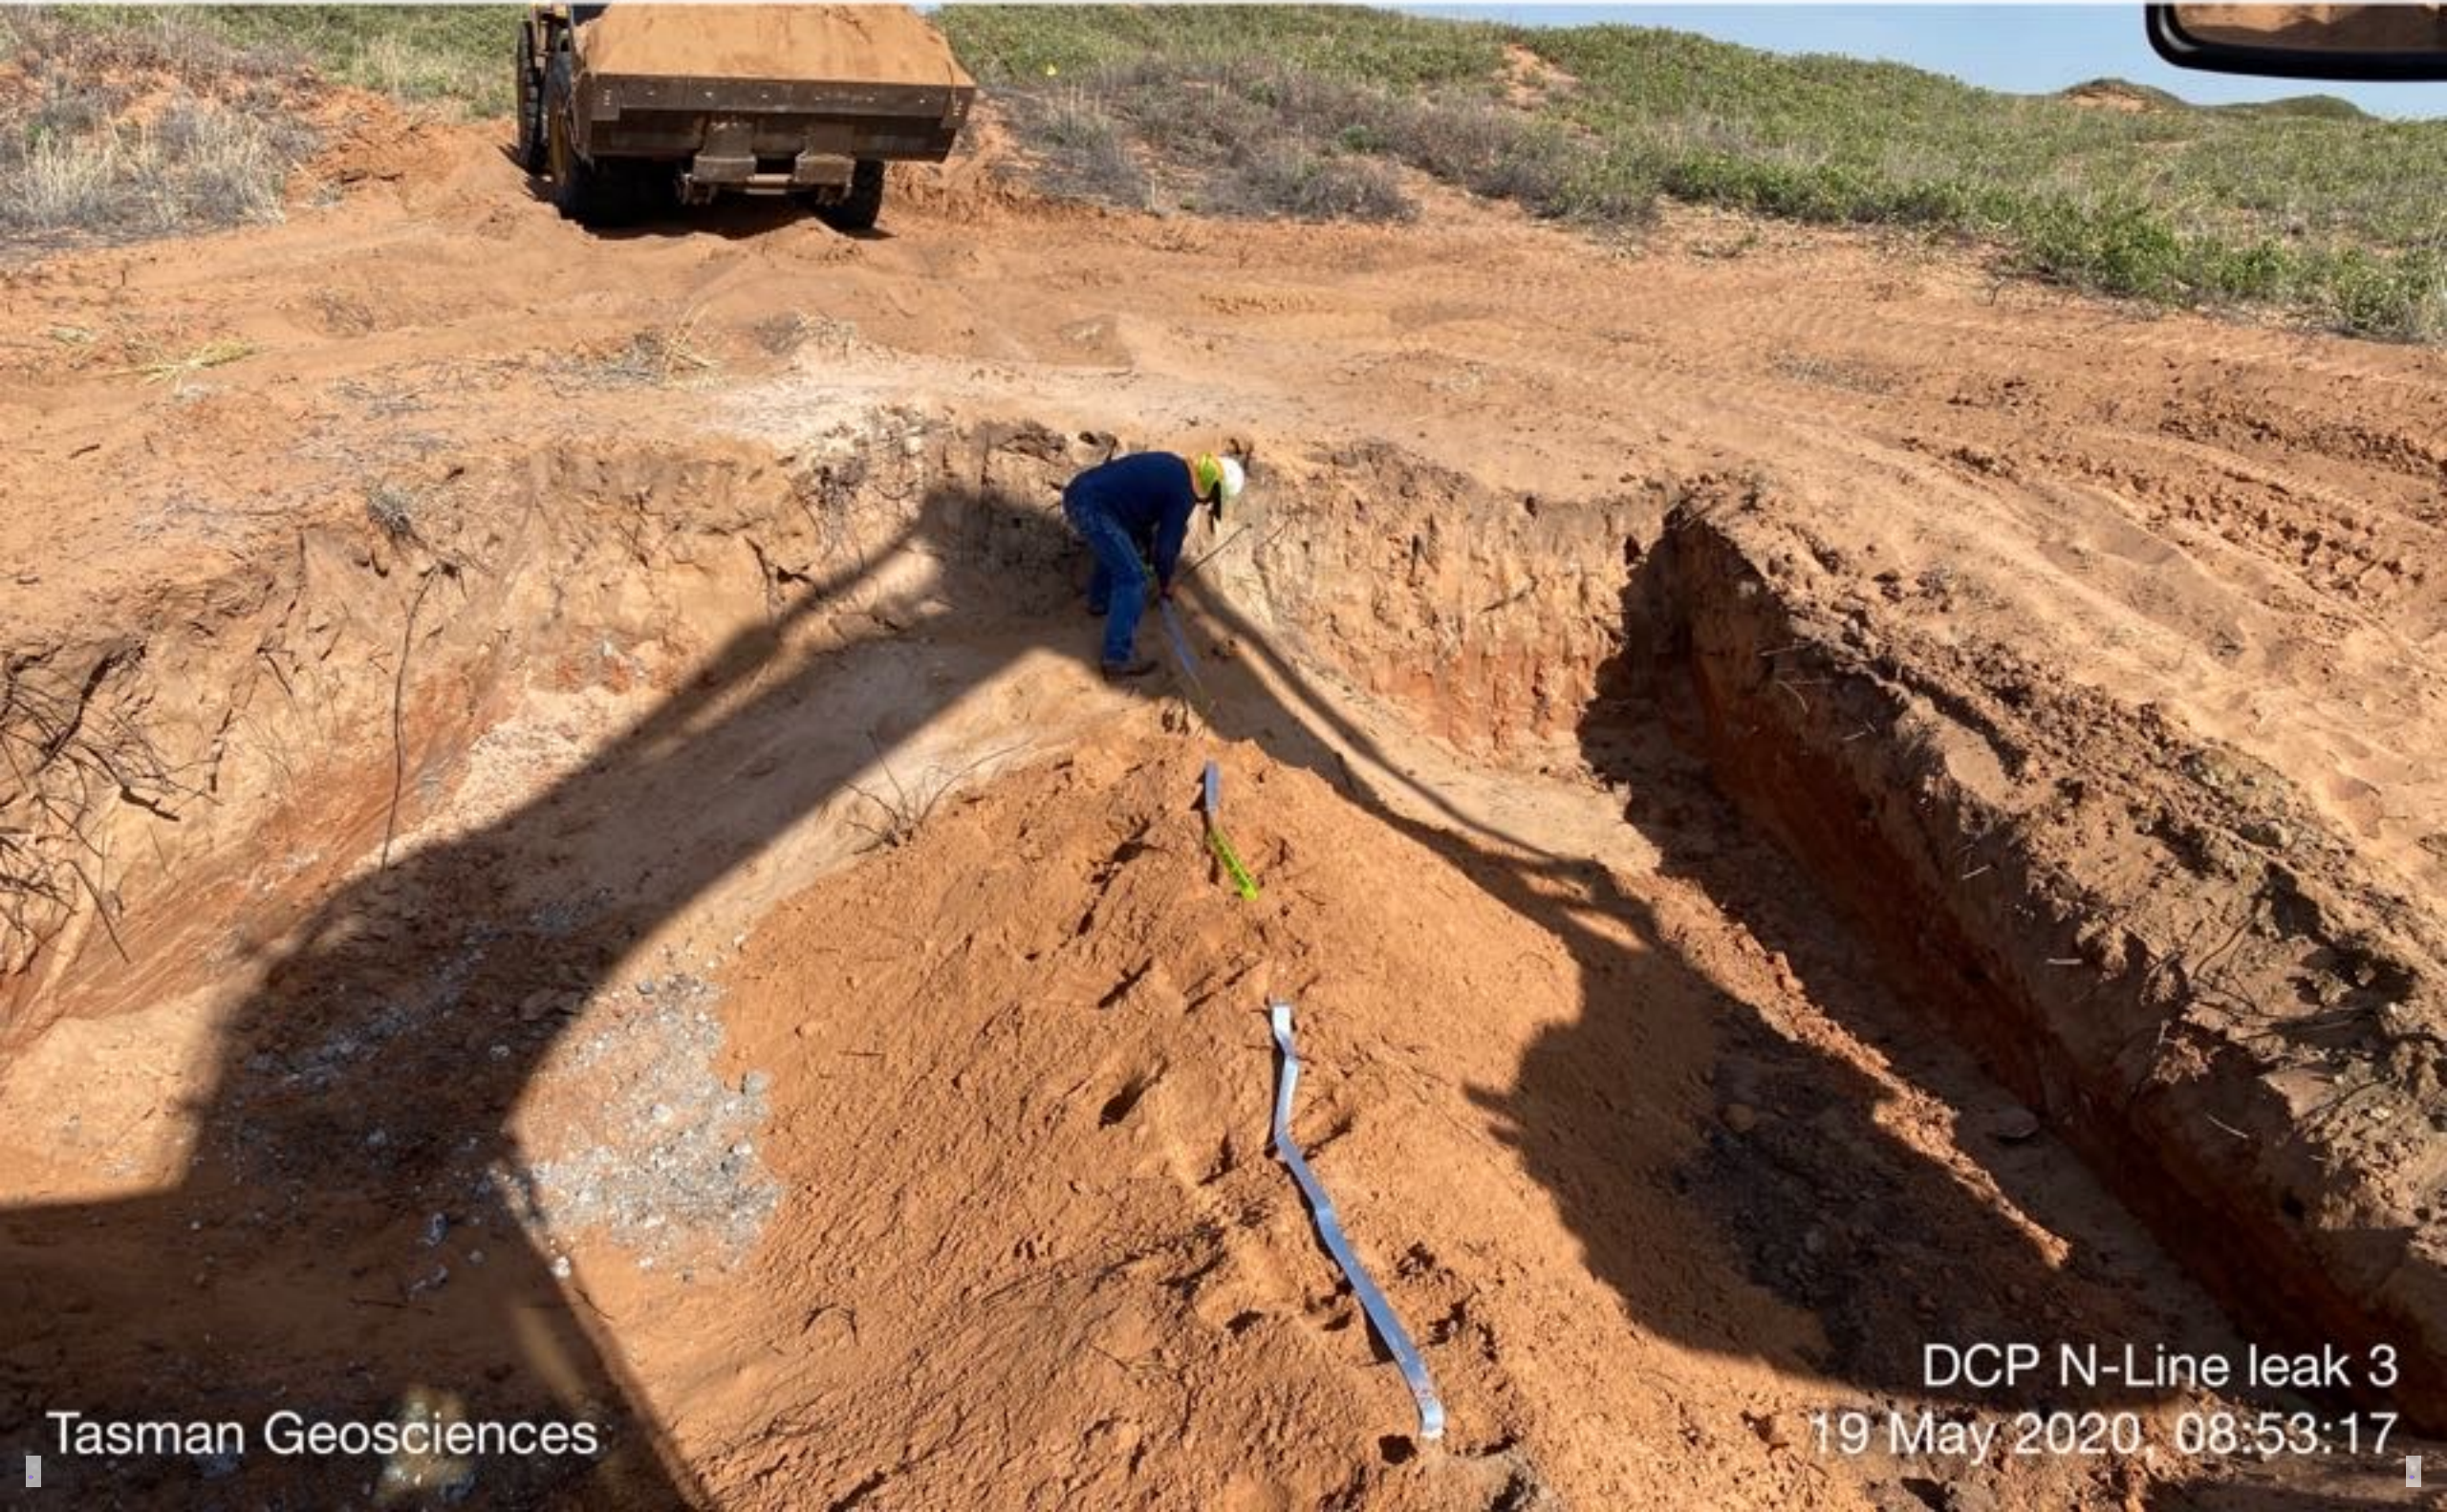
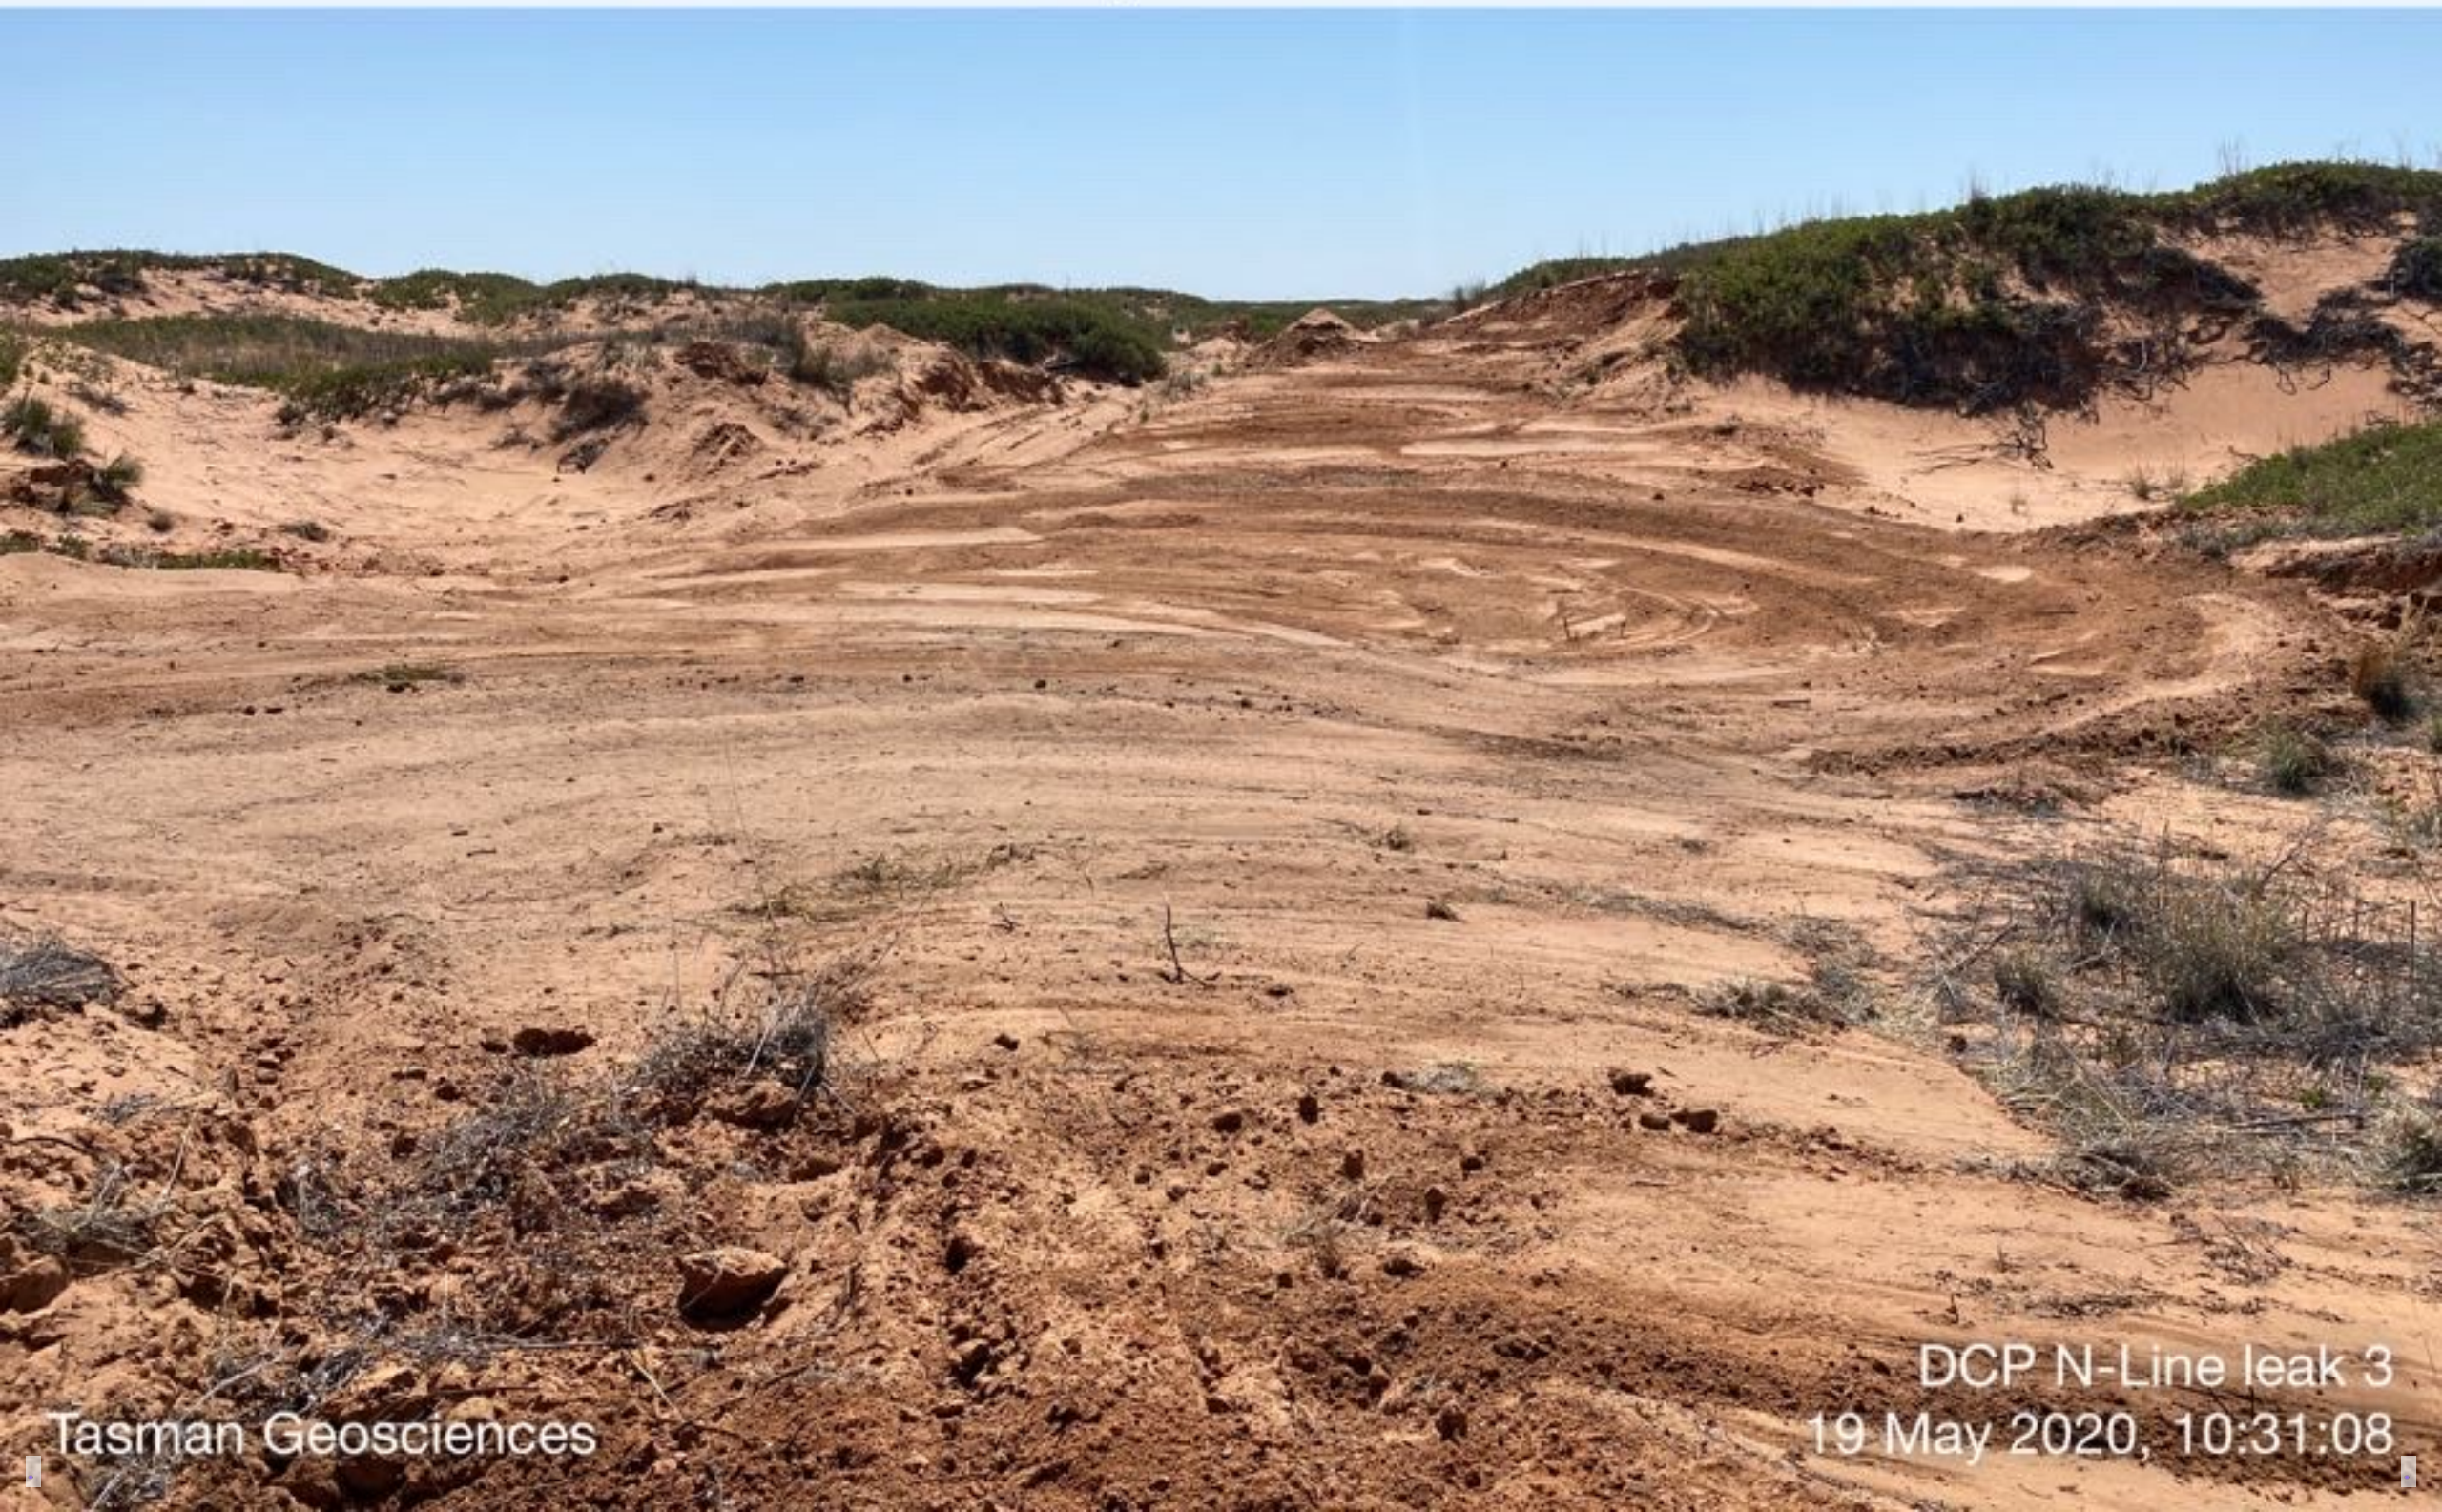
Attachment #4- General Site Photographs

● 32.734882°, -103.772127° ±22ft

● 32.734921°, -103.772298° ±36ft
