Site Characterization Report and Deferral Request

COG Operating, LLC Wild Ride Federal #001H

Eddy County, New Mexico
Unit Letter E, Section 29, Township 26 South, Range 25 East
Latitude 32.01648 North, Longitude 104.42426 West
NMOCD Reference No. nAB1922539866

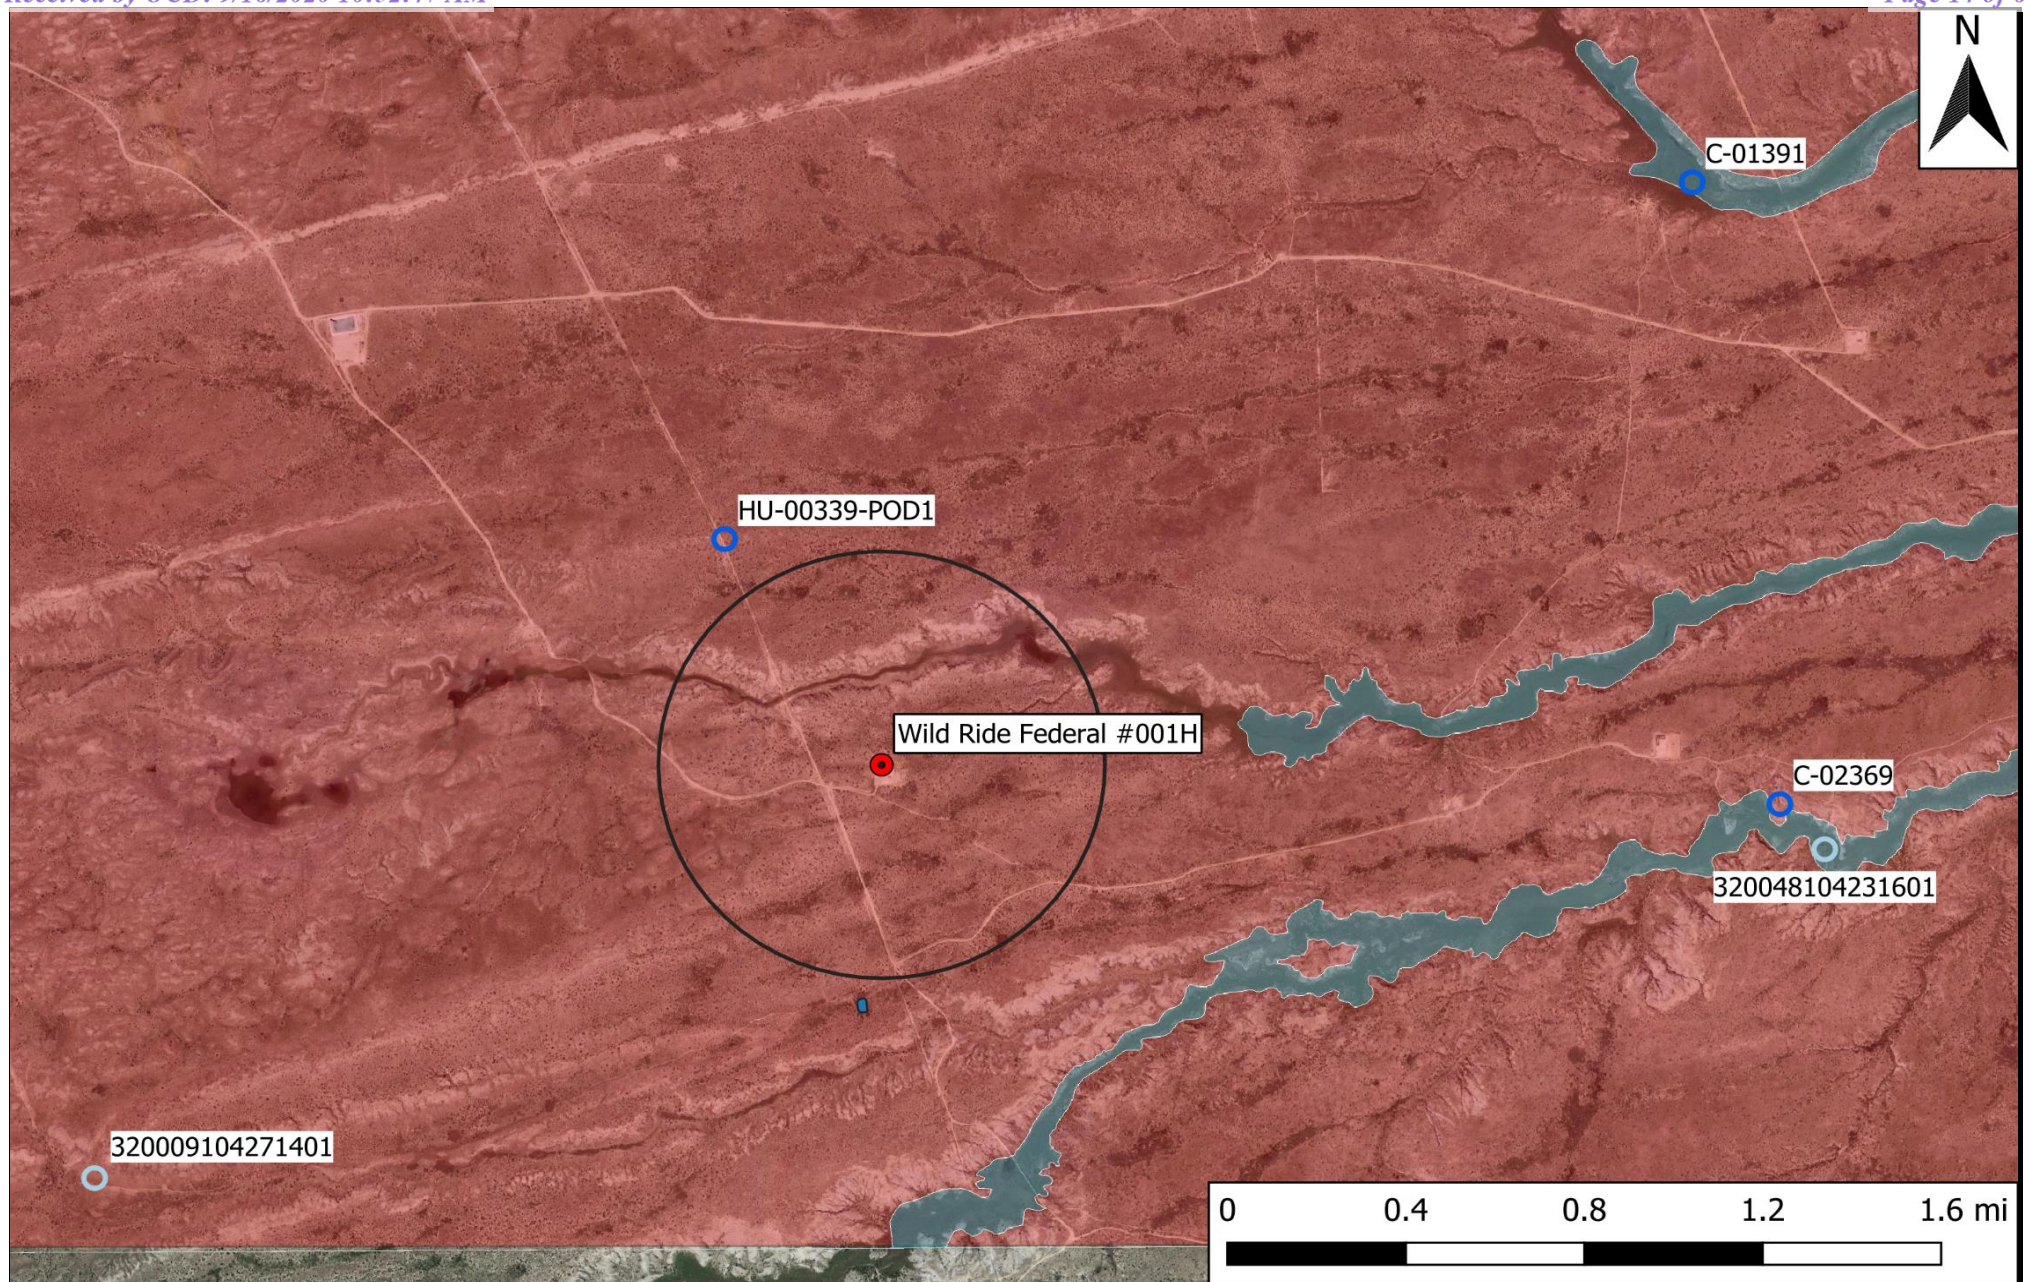
Aerial Proximity Map

- Legend**
- Site Location
 - Well - USGS
 - Well - NMOSE
 - 0.5 Mi Radius
 - 1% Annual Flood Chance
 - Surface Water
 - Potash Mine Workings
 - High Karst
 - Medium Karst

Figure 2
 Aerial Map
 COG Operating, LLC
 Wild Ride Federal #001H
 GPS: 32.01648, -104.42426
 Eddy County

NMOCD Siting Criteria data was gathered from available resources including Bureau of Land Management (BLM) shapefiles; topographic maps; NMOSE and USGS databases; and aerial imagery. The results are depicted on Figures 1 & 2.

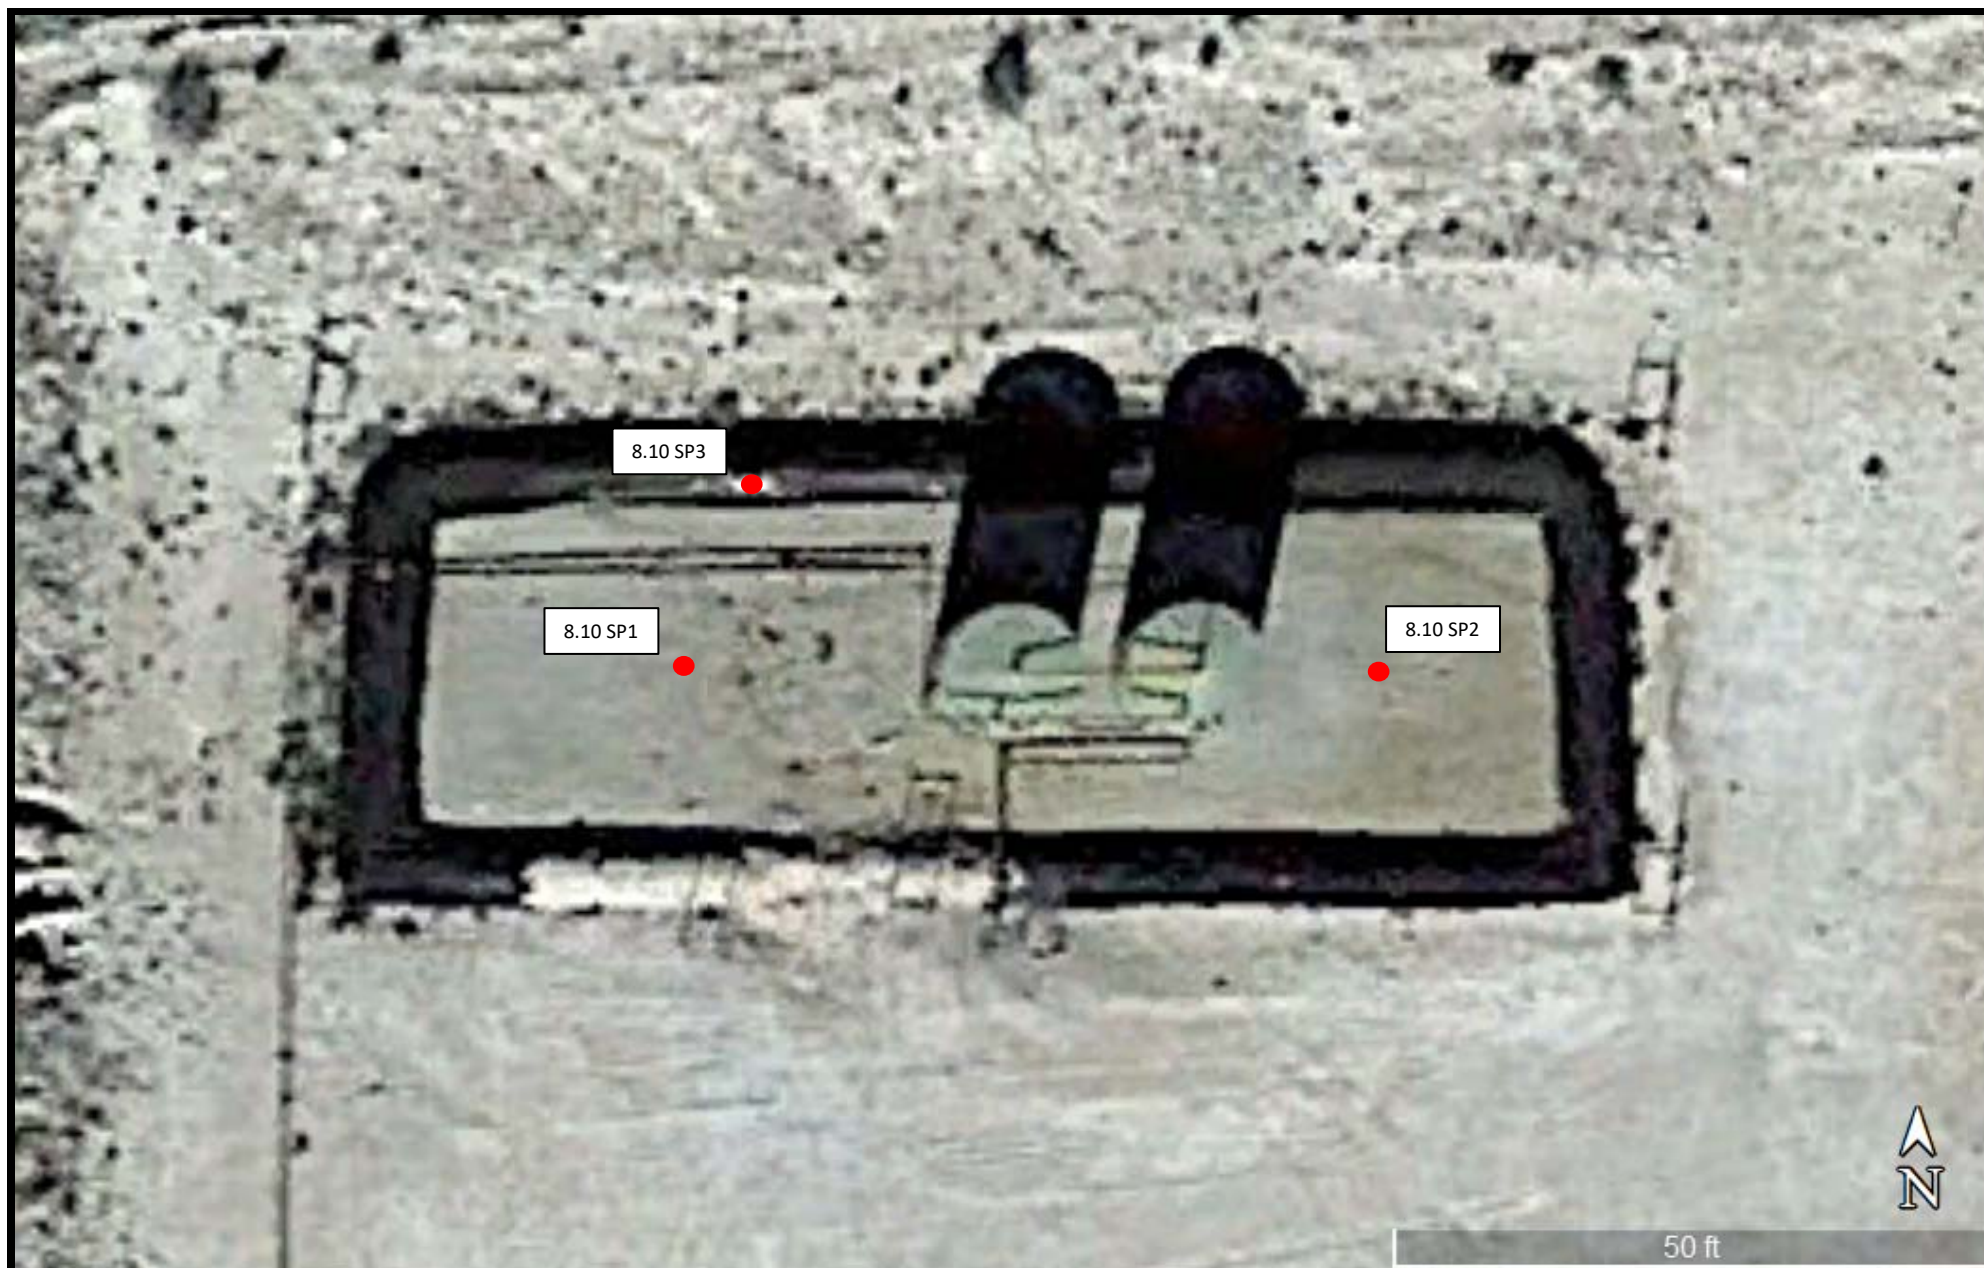
Figure 3

Site and Sample Location Map

Site and Sample Location Map
COG Operating, LLC
Wild Ride Federal #001H
GPS: 32.01648, -104.42426
Eddy County

On August 10, 2020, eTech revisited the Site. During the site visit, access holes were cut into the liner to allow for the advancement of hand-augered soil bores on the west and east sides of the lined tank battery containment. During the advancement of the hand-augered soil bores, four (4) soil samples (8.10 SP1 @ Surface, 8.10 SP1 @ 1', 8.10 SP2 @ Surface, and 8.10 SP2 @ 1') were collected. In addition, a hand-augered soil bore (8.10 SP3) was advanced within the lined containment in an area that was inferred to have been melted by the subject fire. During the advancement of the hand-augered soil bore, two (2) soil samples (8.10 SP3 @ Surface and 8.10 SP3 @ 1') were collected. The collected soil samples were submitted to the laboratory for analysis of BTEX, TPH and chloride concentrations. Laboratory analytical results indicated BTEX, TPH and chloride concentrations were below the NMOCD Closure Criteria in each of the submitted soil samples with the exception of soil samples 8.10 SP1 @ Surface and 8.10 SP3 @ Surface, which exhibited chloride concentrations of 1,170 mg/kg and 1,450 mg/kg, respectively. Laboratory analytical results indicated soil was not impacted above the NMOCD Closure Criteria for chloride beyond 1 Ft. bgs in the areas characterized by sample points 8.10 SP1 and 8.10 SP3.

A "Site & Sample Location Map" is provided as Figure 3. A "Soil Chemistry Table" is provided as Table 1. Laboratory Analytical Reports are provided in Appendix C. Field data and soil profile logs, if applicable, are provided as Appendix B.

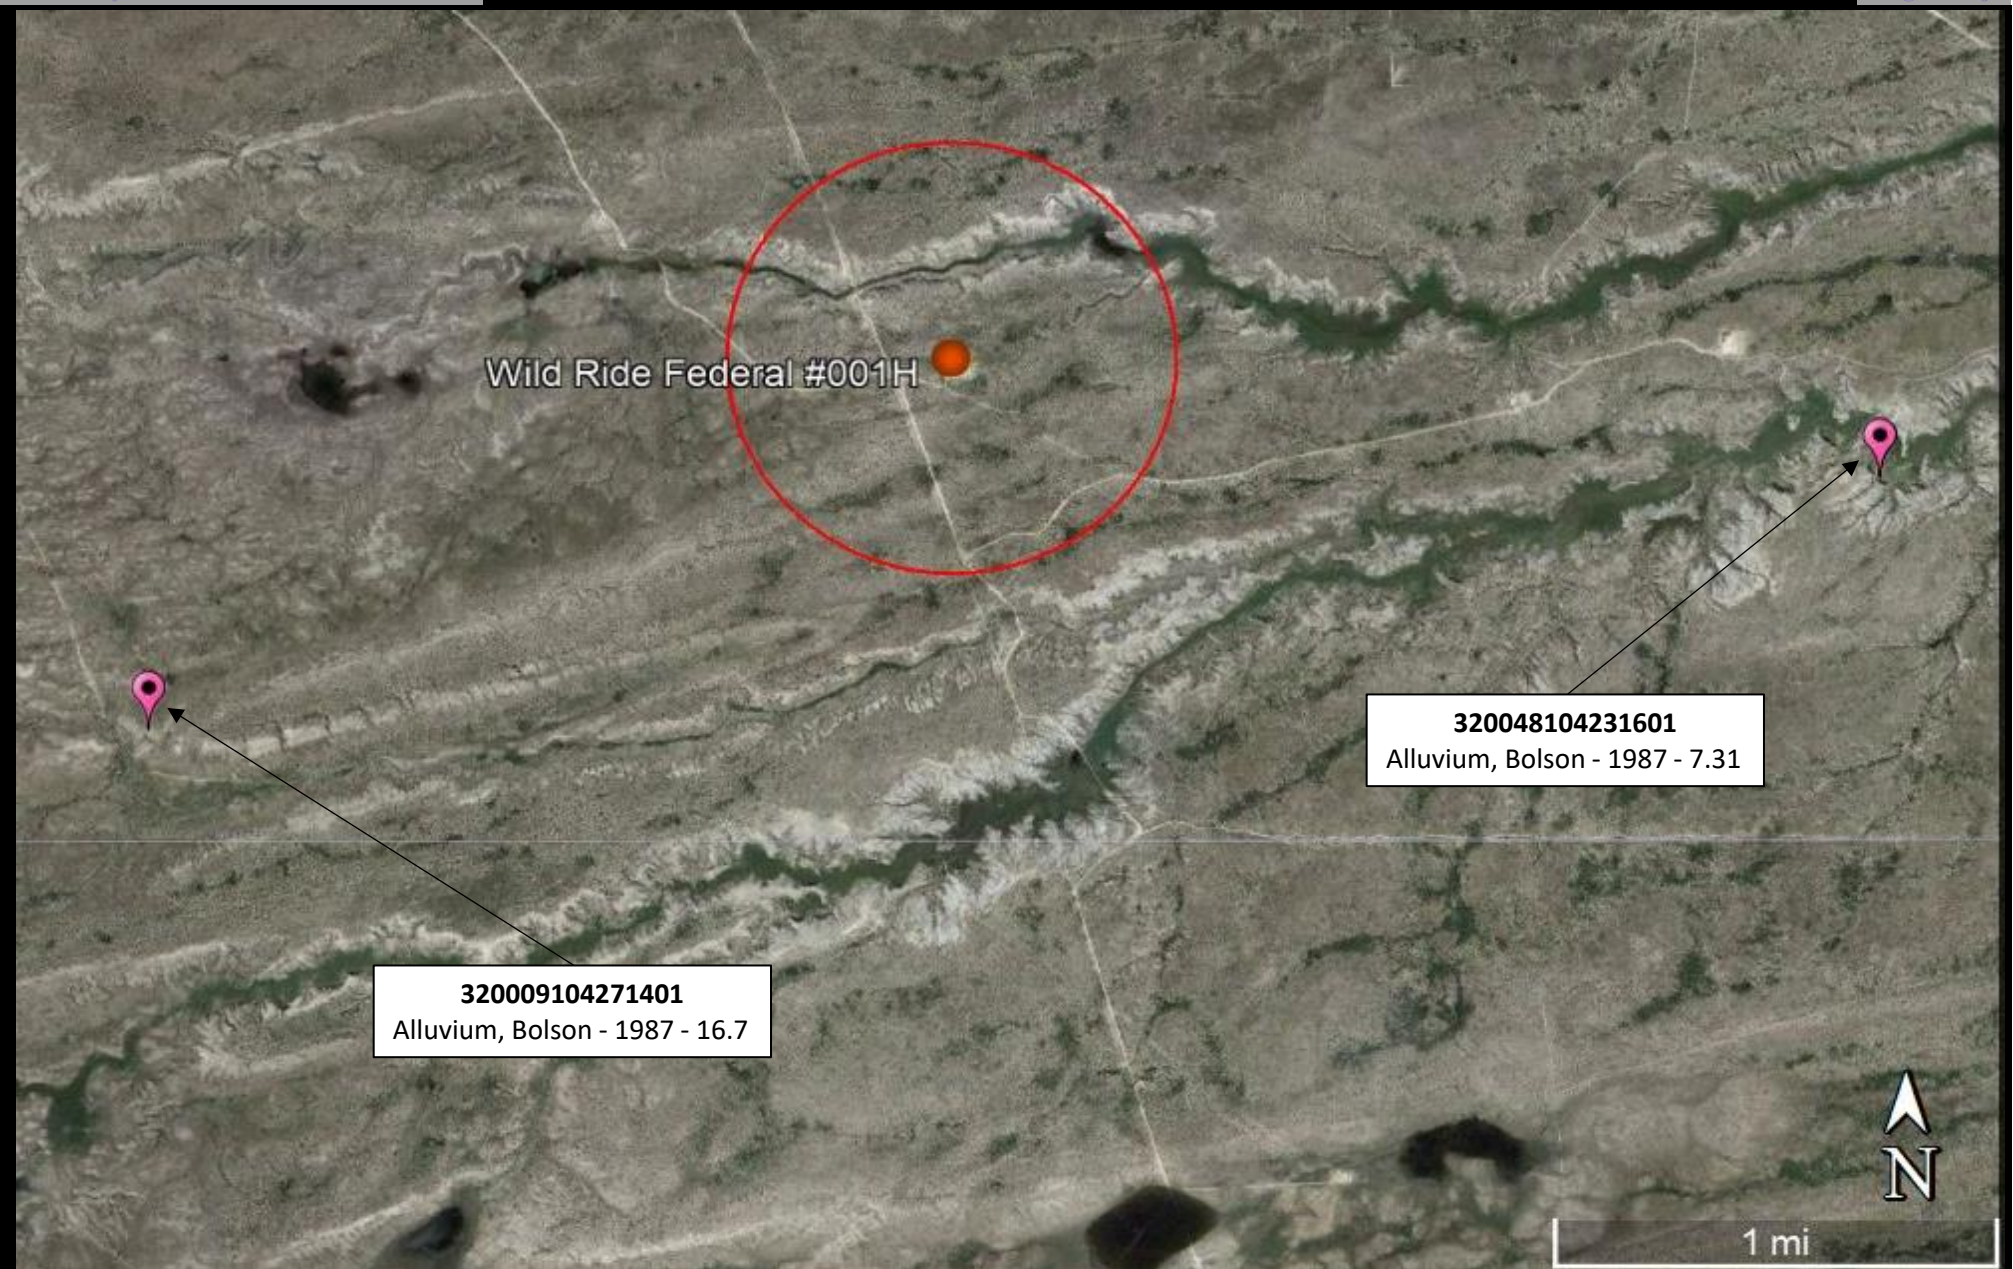
Figure 5

USGS Well Proximity Map
COG Operating, LLC
Wild Ride Federal #001H
GPS: 32.01648, -104.42426
Eddy County

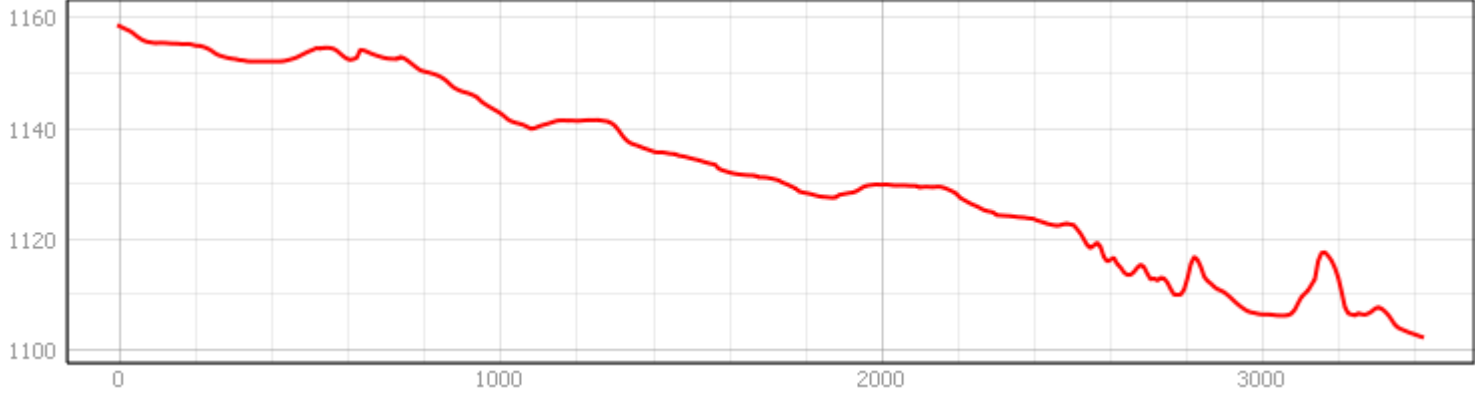
Wild Ride Federal #1H – Elevation Profile Graphs

| Start | Elevation (Y - meters) by Distance (X - meters) | End | Delta |
|---|---|---|---|
| Site Location (1159 m) | | East Well (1102 m) | -57 m (-187 ft) |

Probable groundwater depth was determined using data generated by numeric models based on available water well data, published information, geology and topography. The change in elevation between the Site and the nearest USGS well west of the Site and the natural drainage north of the Site where groundwater is not outcropping was considered to assist in the determination. Additionally, the Site is located within the Castille Formation; logs from water wells in the vicinity suggest that they were completed within alluvial deposits. Depth to groundwater information is provided as Appendix A.

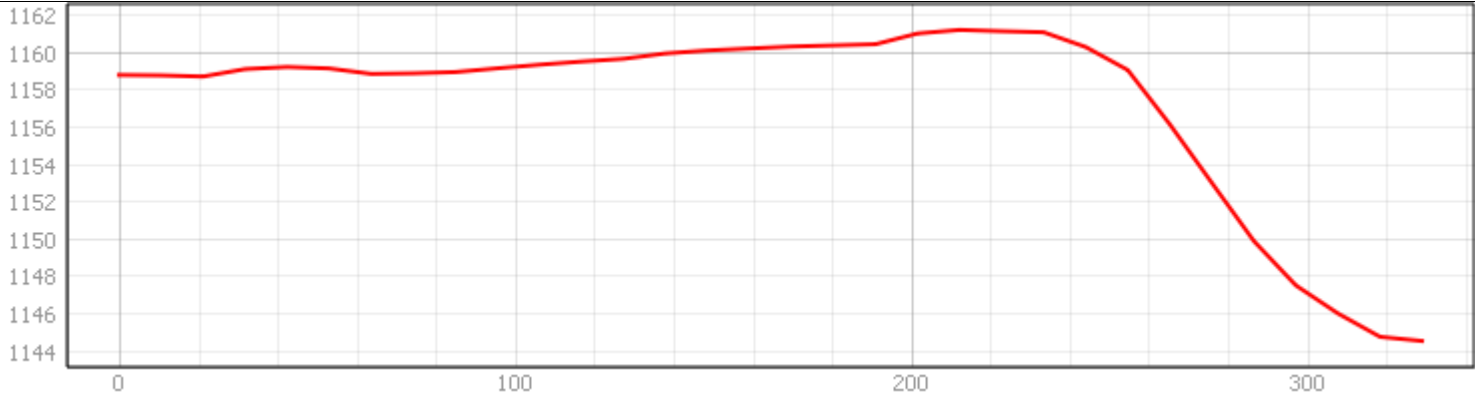
| Start | Elevation (Y - meters) by Distance (X - meters) | End | Delta |
|---|---|---|---|
| Site Location (1159 m) | | North Arroyo (1145 m) | -14 m (-45.9 ft) |
