## Remediation Summary and Soil Closure Request

### Grizzly Energy, LLC Cole State #10

Lea County, New Mexico  
Unit Letter E, Section 16, Township 22 South, Range 37 East  
Latitude 32.39287 North, Longitude 103.17297 West  
NMOCD Reference No. nRM2000635221

**Etech Environmental & Safety Solutions, Inc.**  
3100 Plains Highway  
Lovington, New Mexico 88260

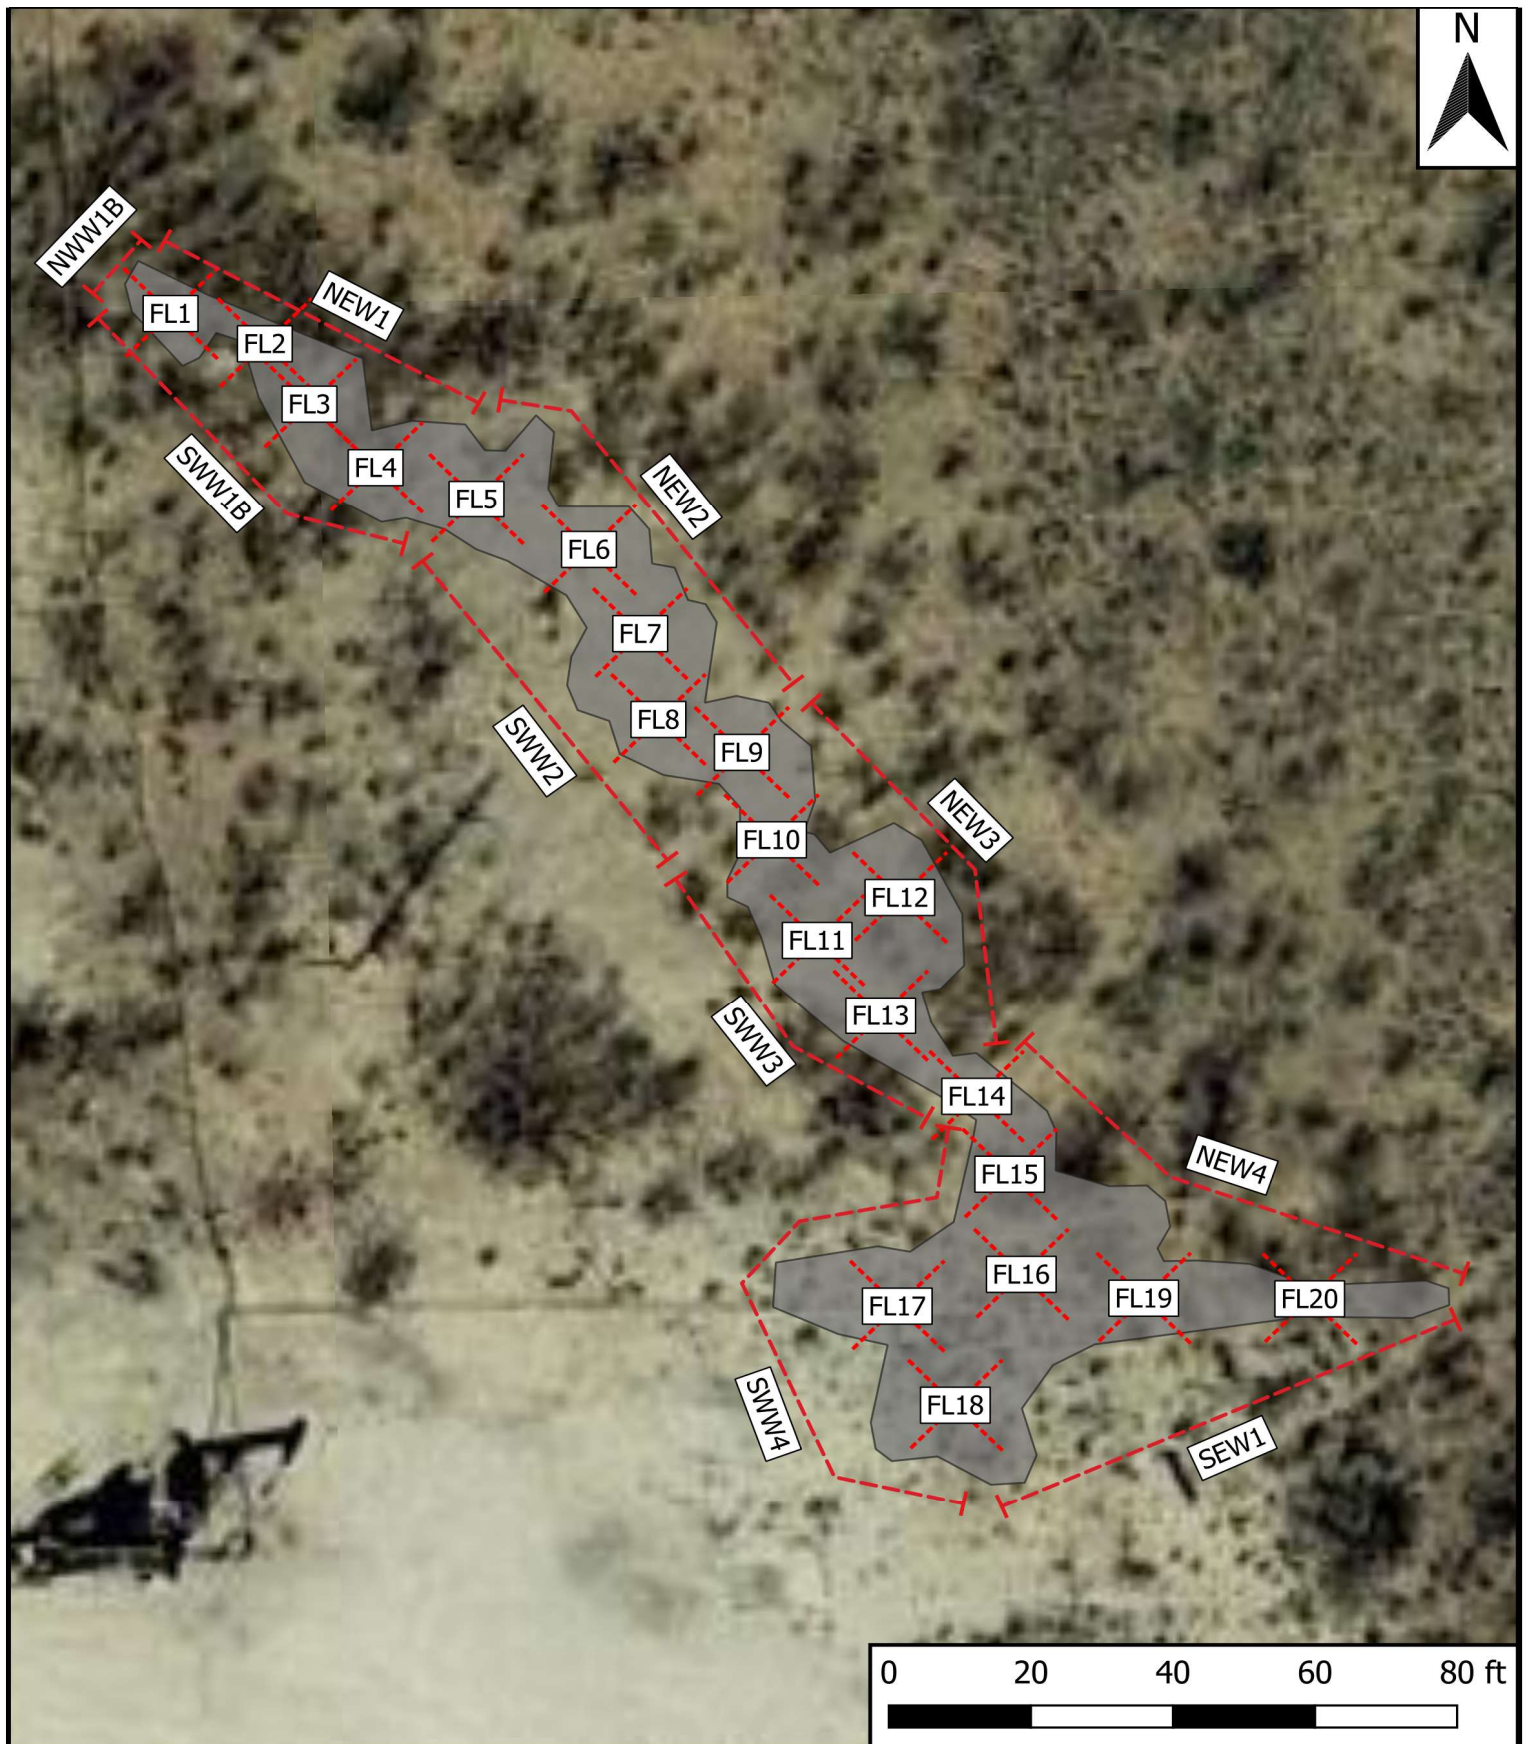
### **Figure 3**

## **Site and Sample Location Map**

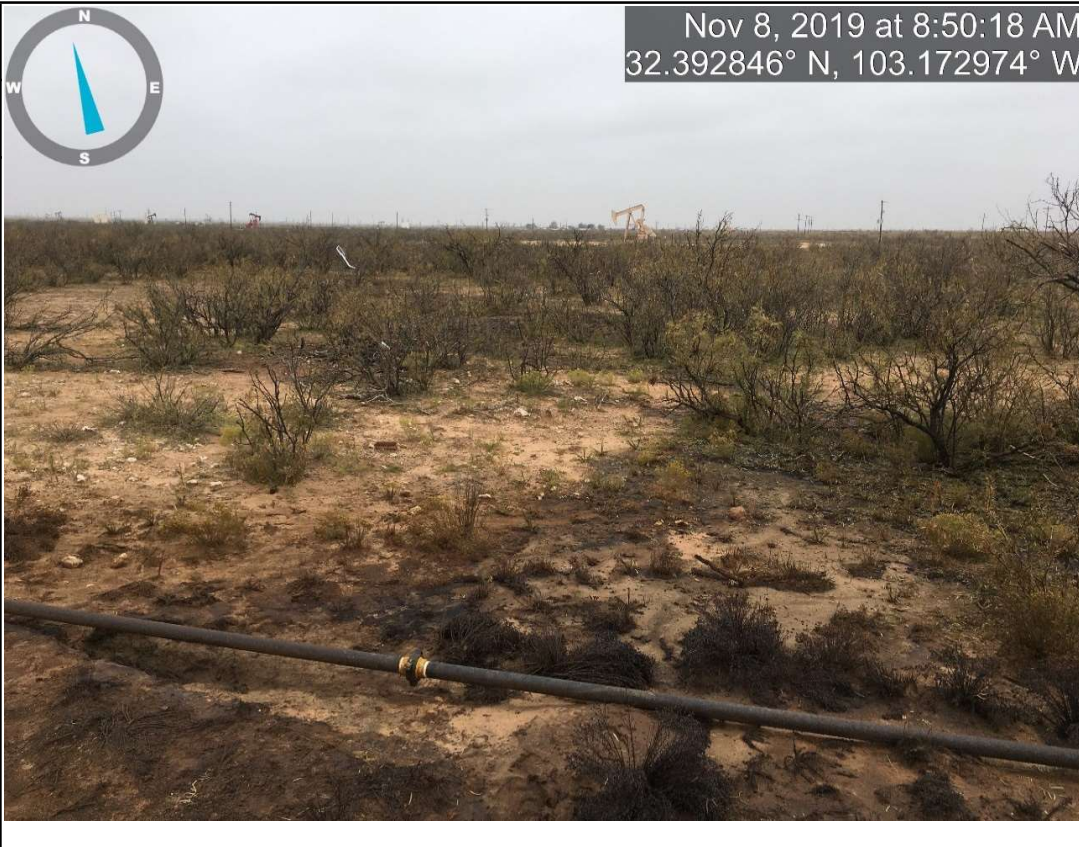
<b>Photo Number:</b> 2

<b>Photo Direction:</b> North	
<b>Photo Description:</b>  South of spill area looking north toward the rest of the spill.

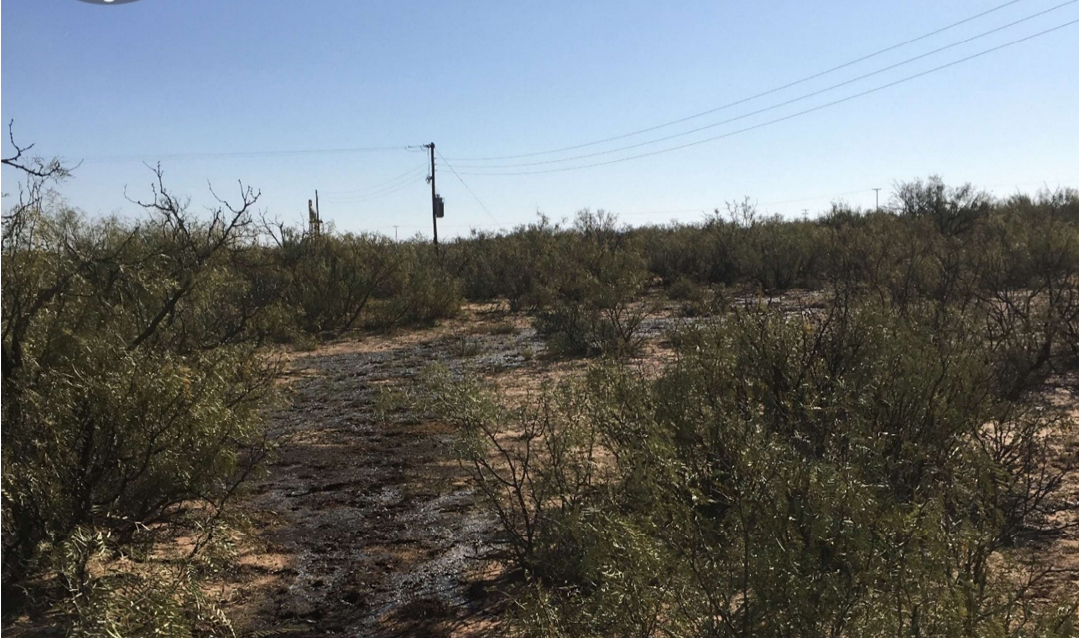
<b>Photo Number:</b> 4

<div>Nov 5, 2019 at 9:21:19 AM 32.393226° N, 103.173279° W</div>
<b>Photo Direction:</b> East	
<b>Photo Description:</b>  Northern section of the spill area.

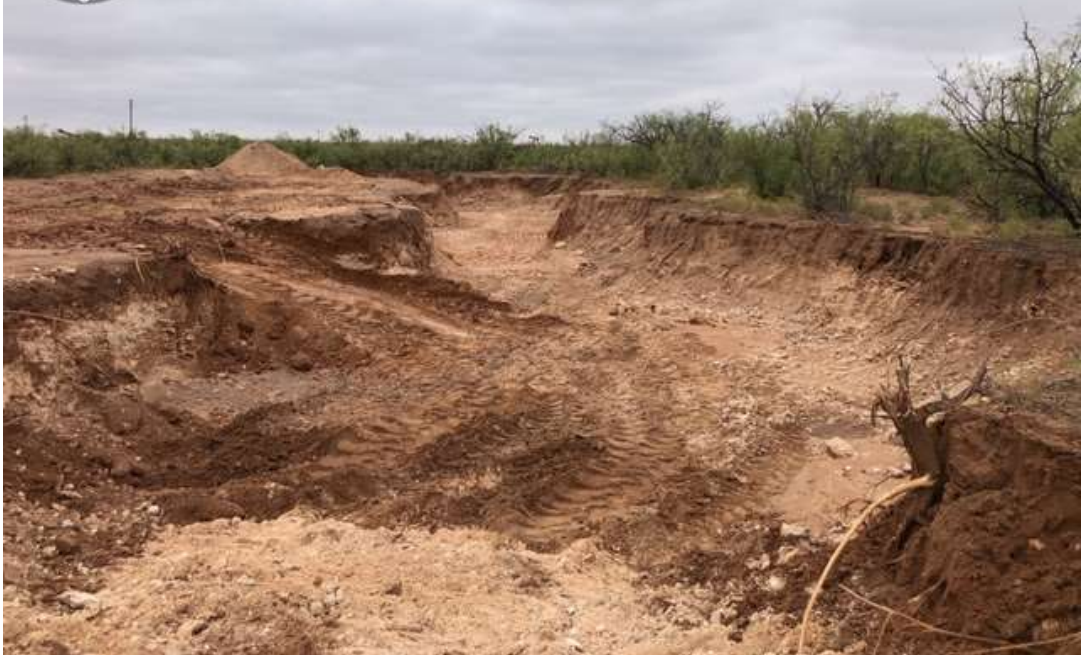
<b>Photo Number:</b> 6

<p>Sep 10, 2020 at 1:44:47 PM +32.392989,-103.173033 ±5.00m 325° NW</p>
<b>Photo Direction:</b> Northwest	
<b>Photo Description:</b>  Open excavation.

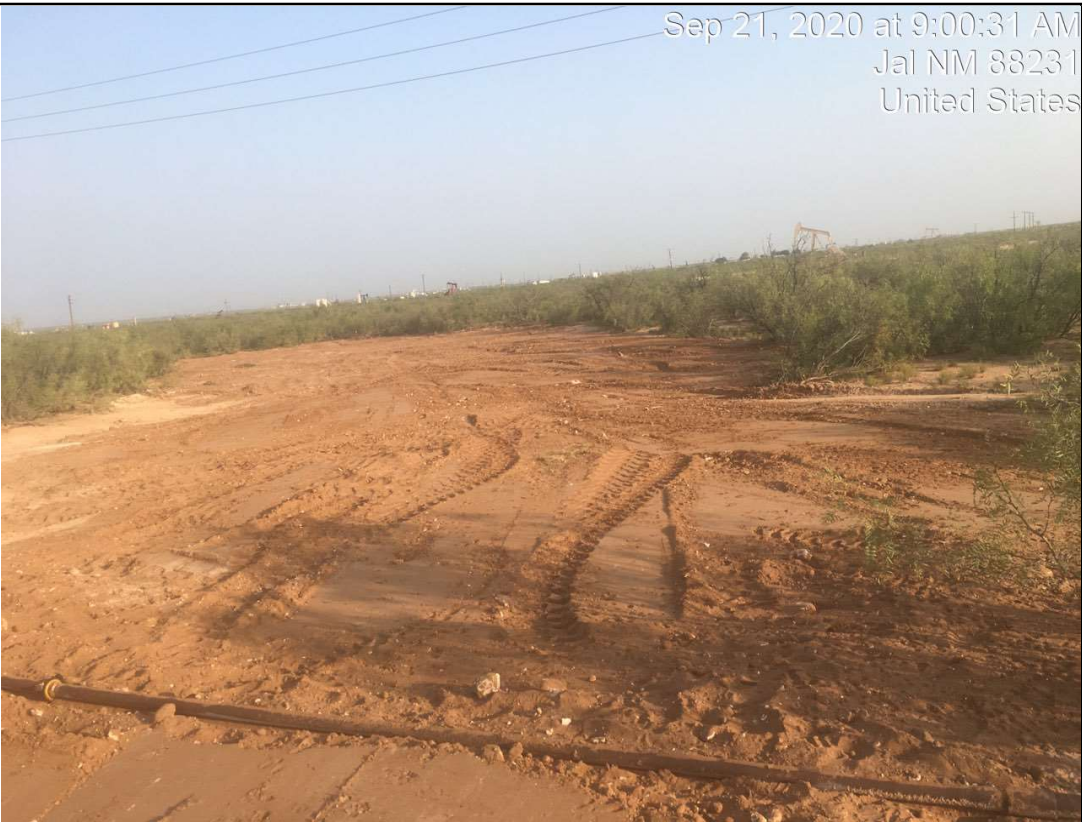
<b>Photo Number:</b> 11

<b>Photo Direction:</b> North	
<b>Photo Description:</b>          Impacted area after backfill and grading.
