Release Notification

Site Name	JRU DII BS2A 7E 211H	Site Type	Well Pad
Date Release Discovered	4/7/2020	API#	(if applicable)

James Ranch Unit Drilling Island - 1
Remediation Work Plan
Incident Numbers NRM2006432204, NRM2011445697,
NRM2011535196, NRM2011559899
Photographs Taken: April 20, 2020 through September 16, 2020

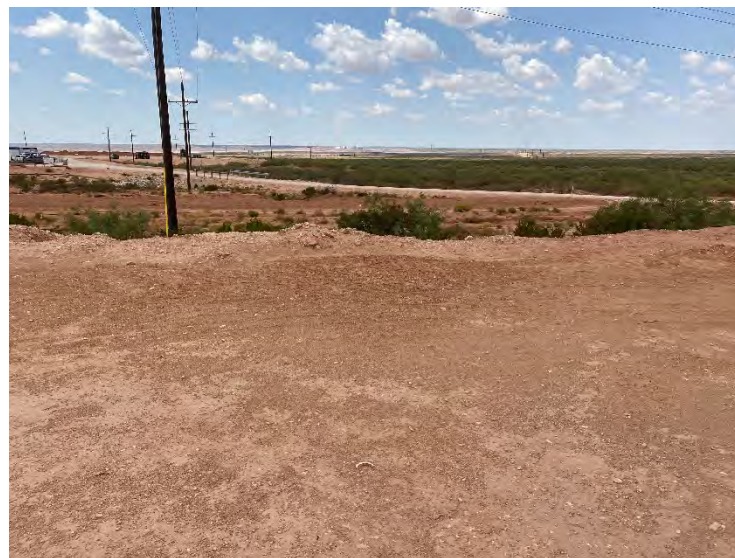
Photograph 6: View of JRU DI1 BS2A 7W 212H release along western edge of pad facing West.
