## **Remediation and Closure Report**

Fairchild 24 #002H  
Eddy County, New Mexico  
30-015-39013  
Incident #nAPP2101841481

Subject: **Remediation and Closure Report**  
Fairchild 24 #002H  
Eddy County, NM  
API 30-15-39013  
**Incident # nAPP2101841481**

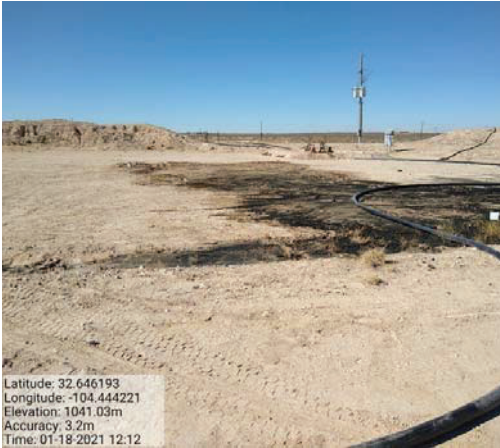
Impacted area at Flowline source

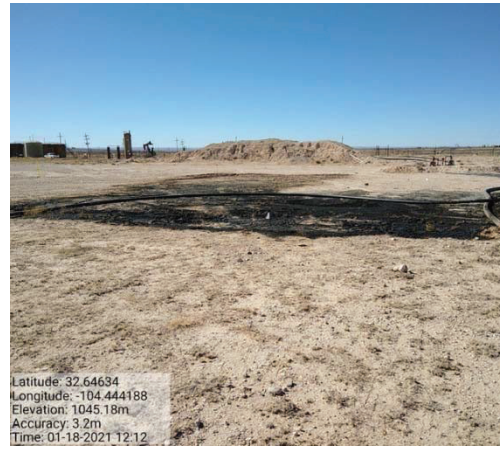
View looking North

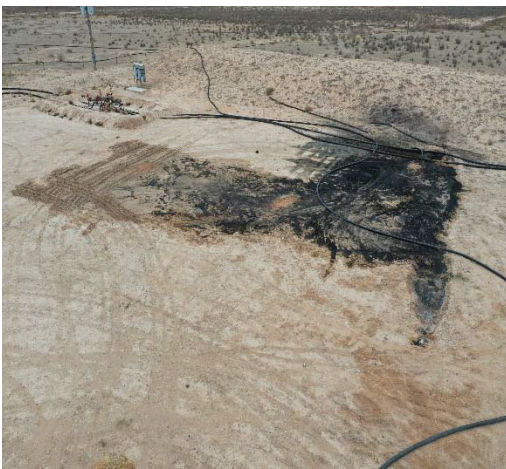
Aerial

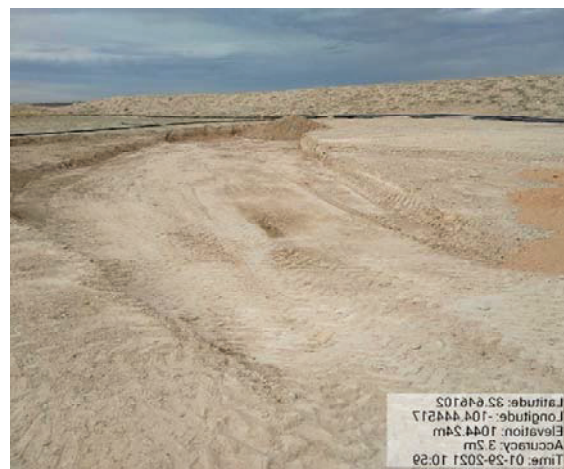
2' Excavation S7-S8

- The impacted areas around S-2,S-4 thru S-6 were excavated to a depth of 0.5', while the areas of S-3, and S-7 thru S-9 were excavated to depths of 1' to 2' bgs.
- All surface impacted soil and visual staining was excavated and disposed of at Lea Land, LLC, a NMOCD approved solid waste disposal facility.
- Confirmation composite soil samples were collected in order to verify analyte levels were below NMOCD remediation guidelines,
- Fresh caliche, similar in grade was used to backfill the location. The pad area was machine compacted and restored to surrounding grade.

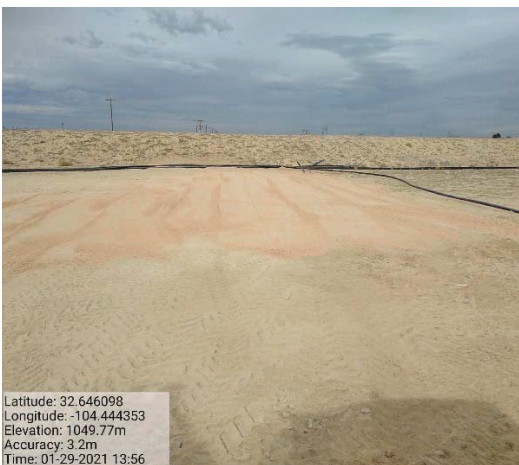
Excavation at S4-S5

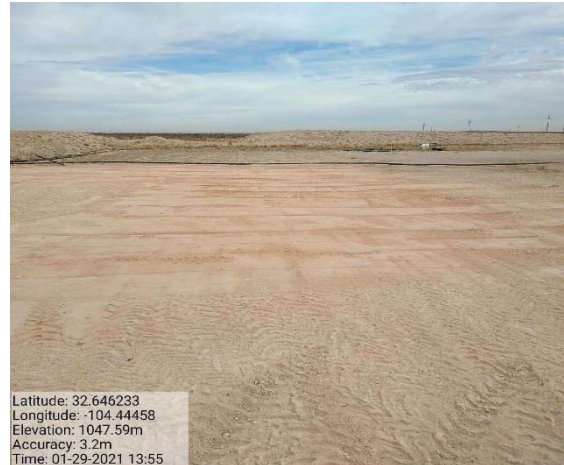
Backfilled to Grade
