Request For Incident Closure

Re: Liner Inspection and Closure Report
Pere Marquette 18 Federal #1
API No. 30-015-38951
GPS: Latitude 32.8410149 Longitude -104.1203232
UL "D", Sec. 18, T17S, R29E
Eddy County, NM
NMOCD Incident ID NAPP2106961705

Liner Inspection Form

SITE PHOTOGRAPHS
SPUR ENERGY PARTNERS
PERE MARQUETTE 18 Federal #1 BATTERY

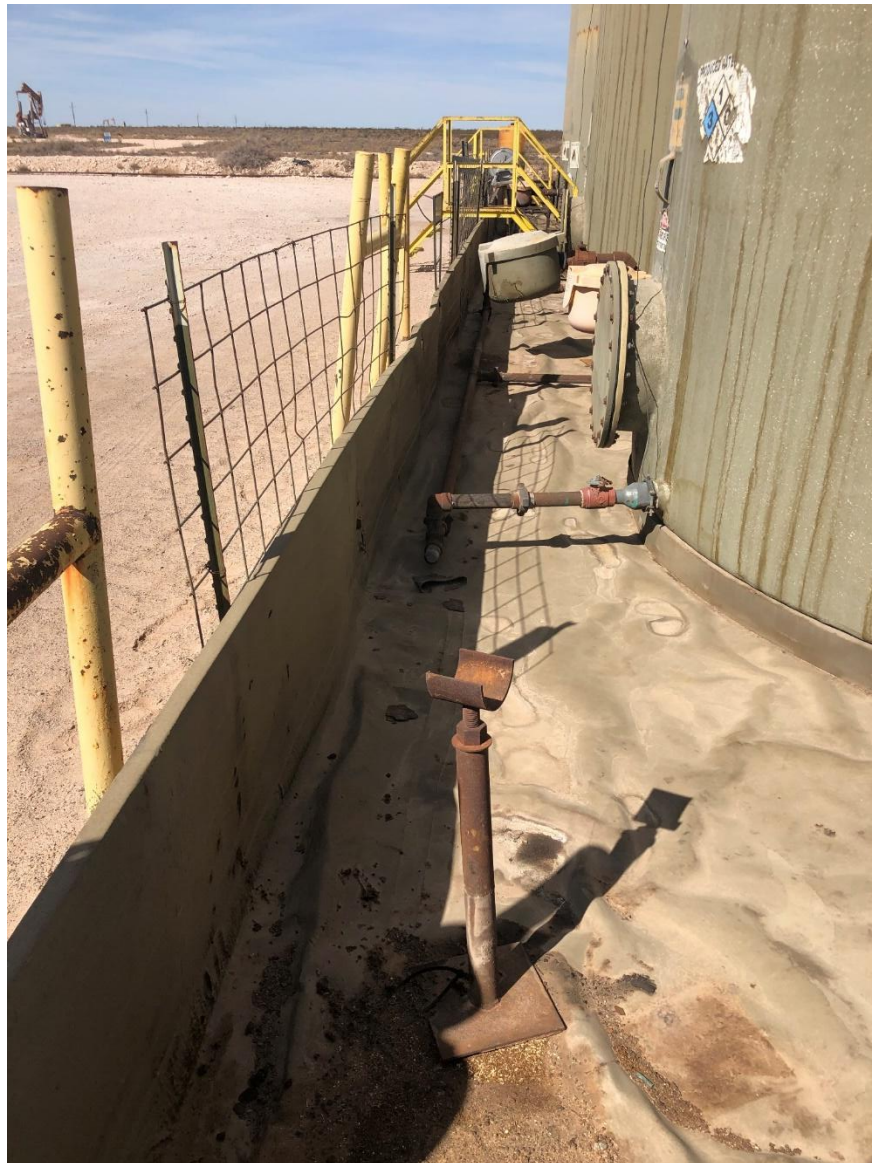
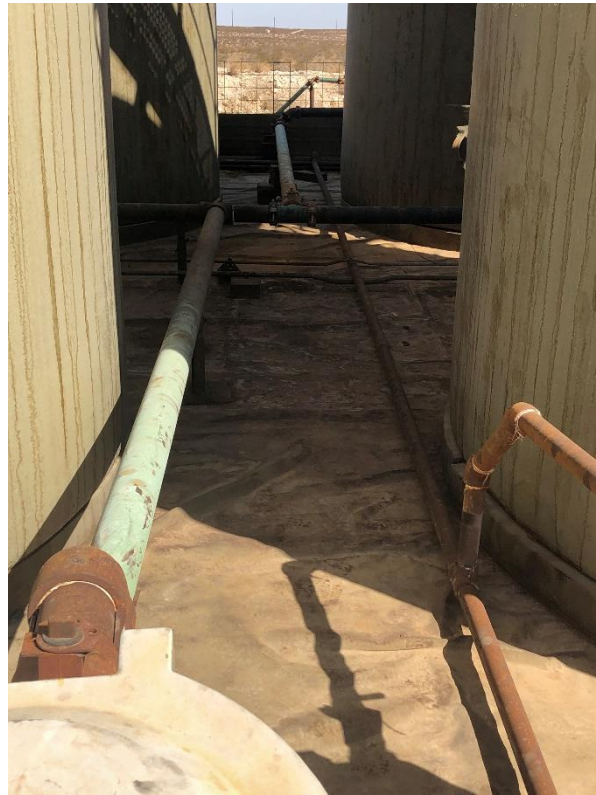
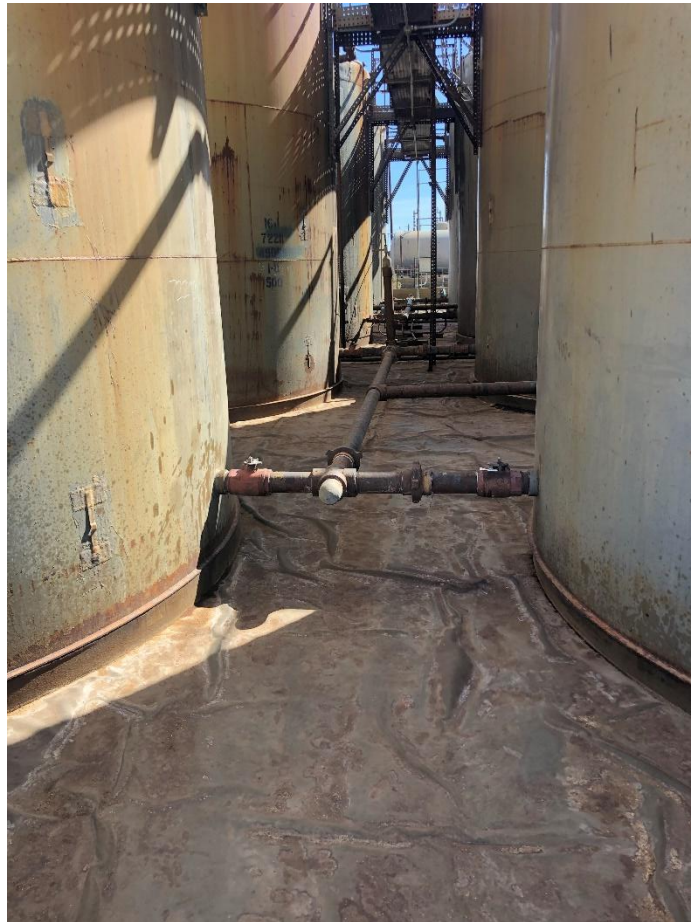
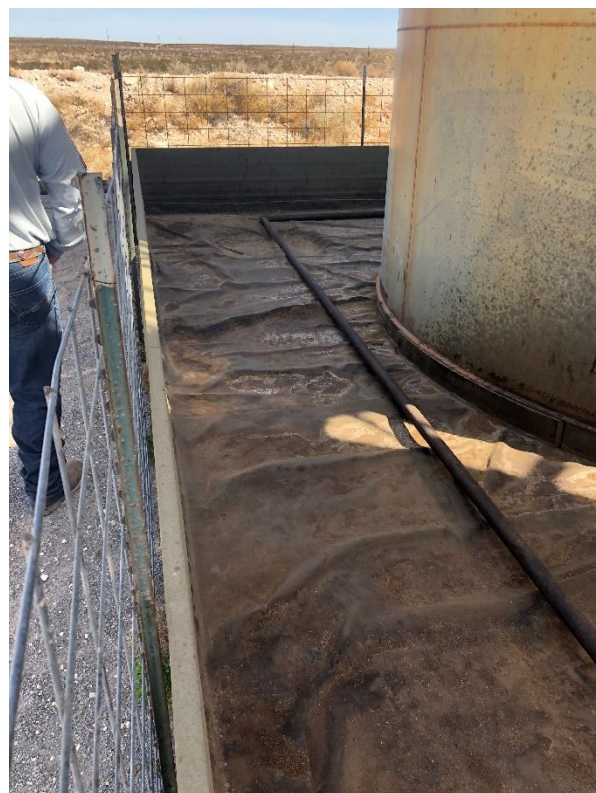
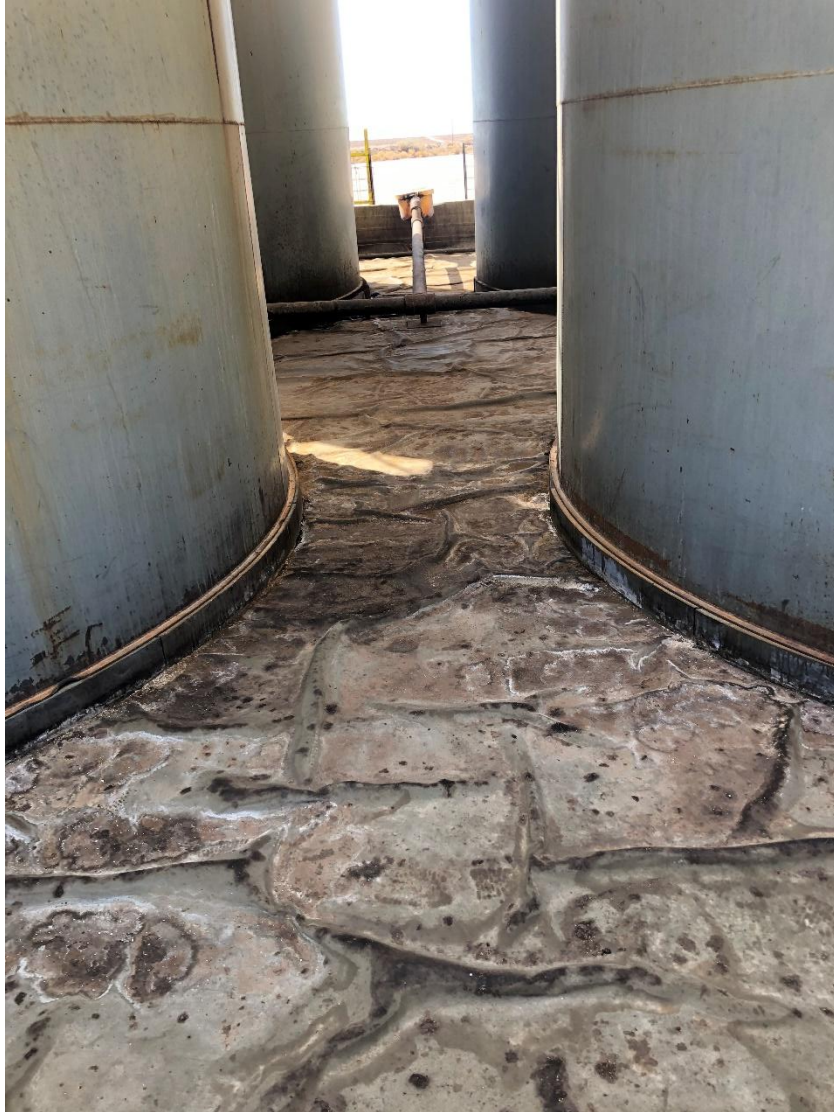
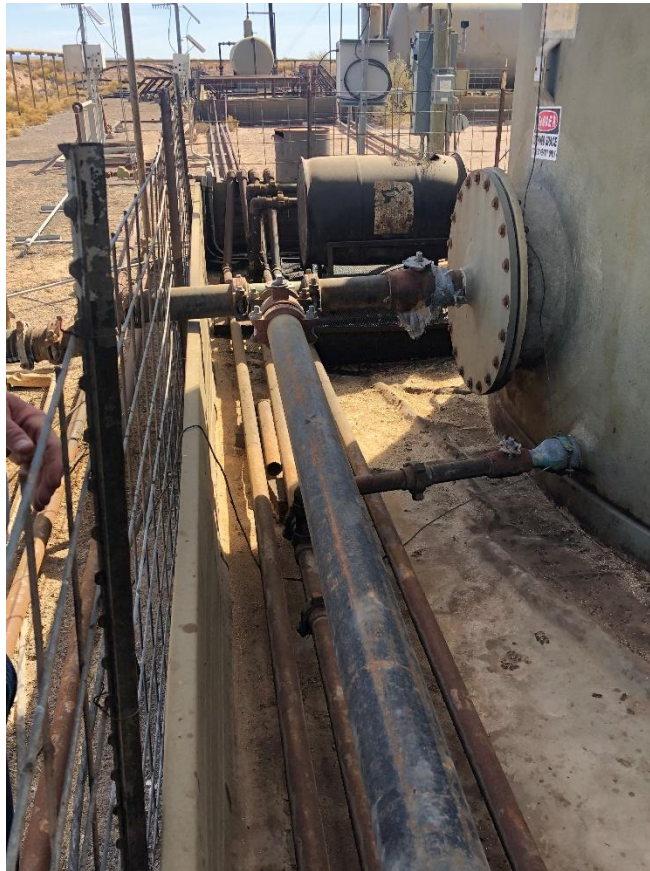
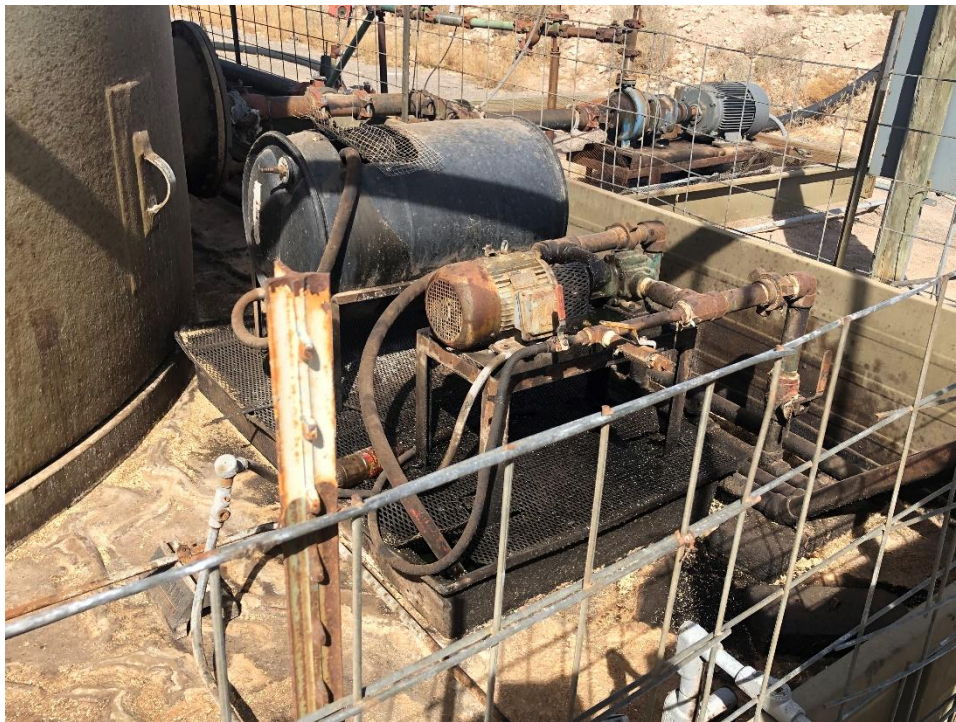
Lined Containment Photos

On March 15, 2021, Pima Environmental conducted a liner inspection. The liners integrity showed no evidence of being compromised and appeared to have contained all released fluids. The liner Inspection Form with photographs is attached with our findings in Appendix C along with a 48-hour email notification.

Visualization	Yes	No	Comments
Is there a tear in the liner?		x	
Are there holes in the liner?		x	
Is the liner retaining any fluids?		x	Some oil staining from the leak
Does the liner have integrity to contain a leak?	x

Comments: No visible tears or leaks in the liner.
