## **REMEDIATION SUMMARY AND PROPOSED SOIL CLOSURE STRATEGY**

**PLAINS PIPELINE, L.P. (231735)  
14 Inch Vac to Jal Legacy  
Lea County, New Mexico  
Plains SRS # 2009-092**

**UNIT LTR "F" (SE ¼ /NW ¼ ), Section 25, Township 25 South, Range 37 East  
Latitude 32° 06' 10.7" North, Longitude 103° 07' 10.3" West  
NMOCD Reference # 1RP-2162**

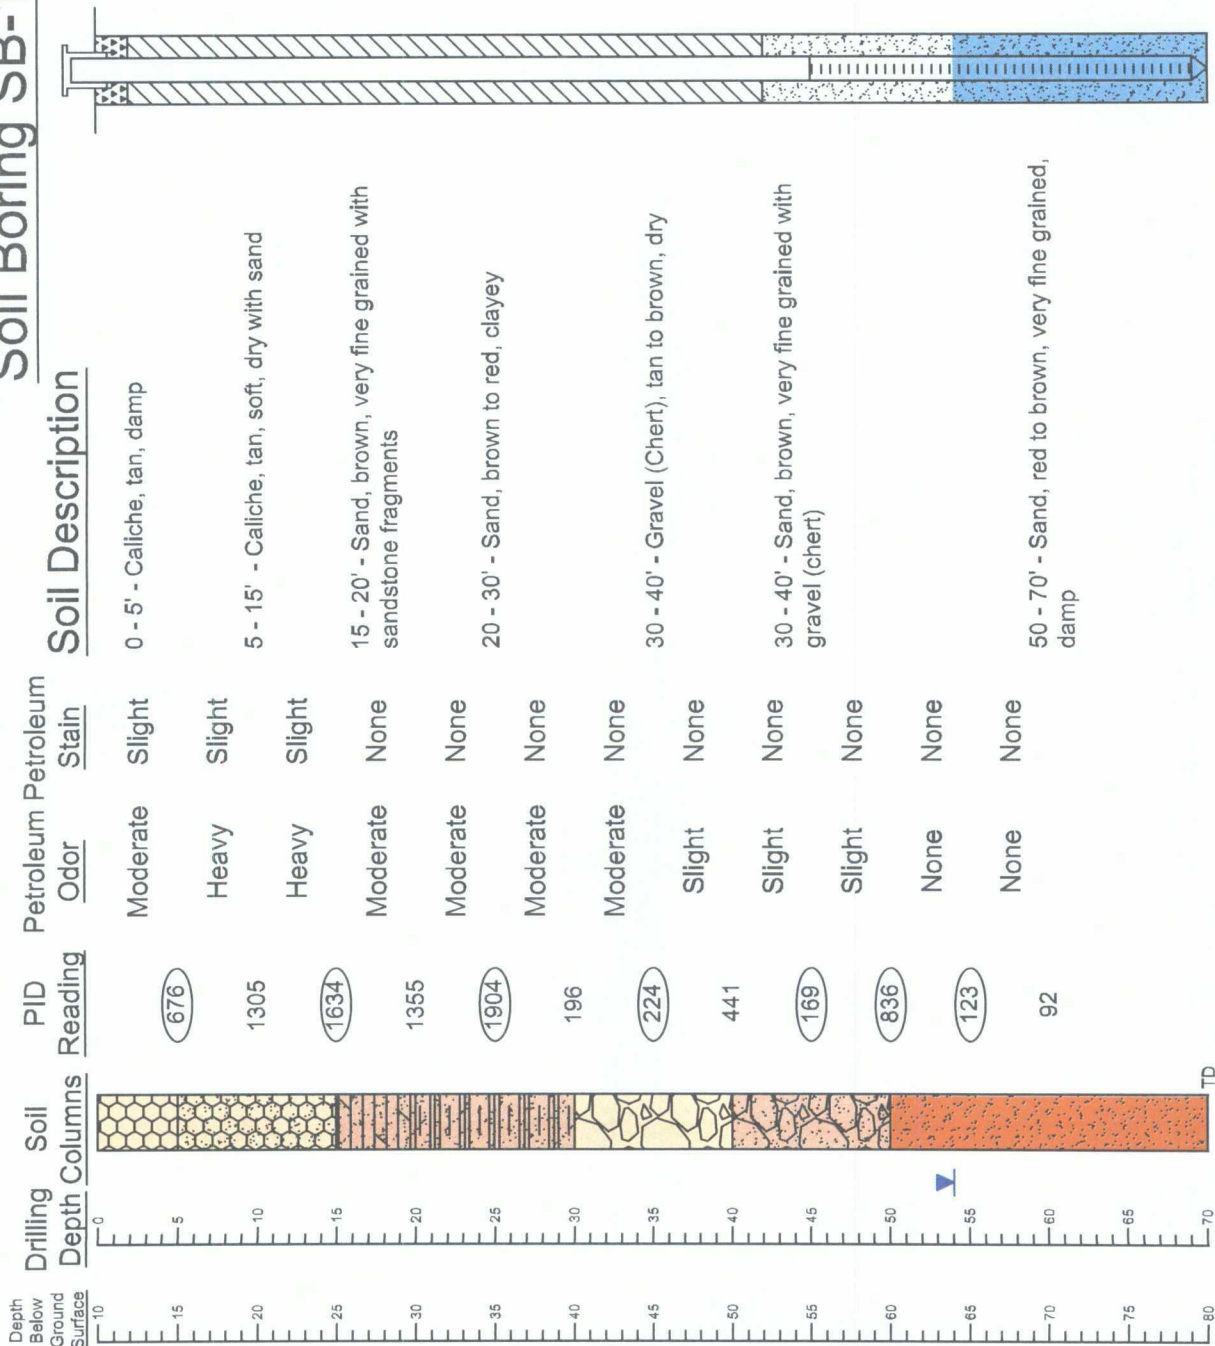
# Soil Boring SB-1 / Monitor Well MW-1

Date Drilled July 1, 2009  
 Thickness of Bentonite Seal 42 Ft  
 Depth of Exploratory Boring 70 Ft  
 Depth to Groundwater Approximately 64 Ft bgs  
 Ground Water Elevation

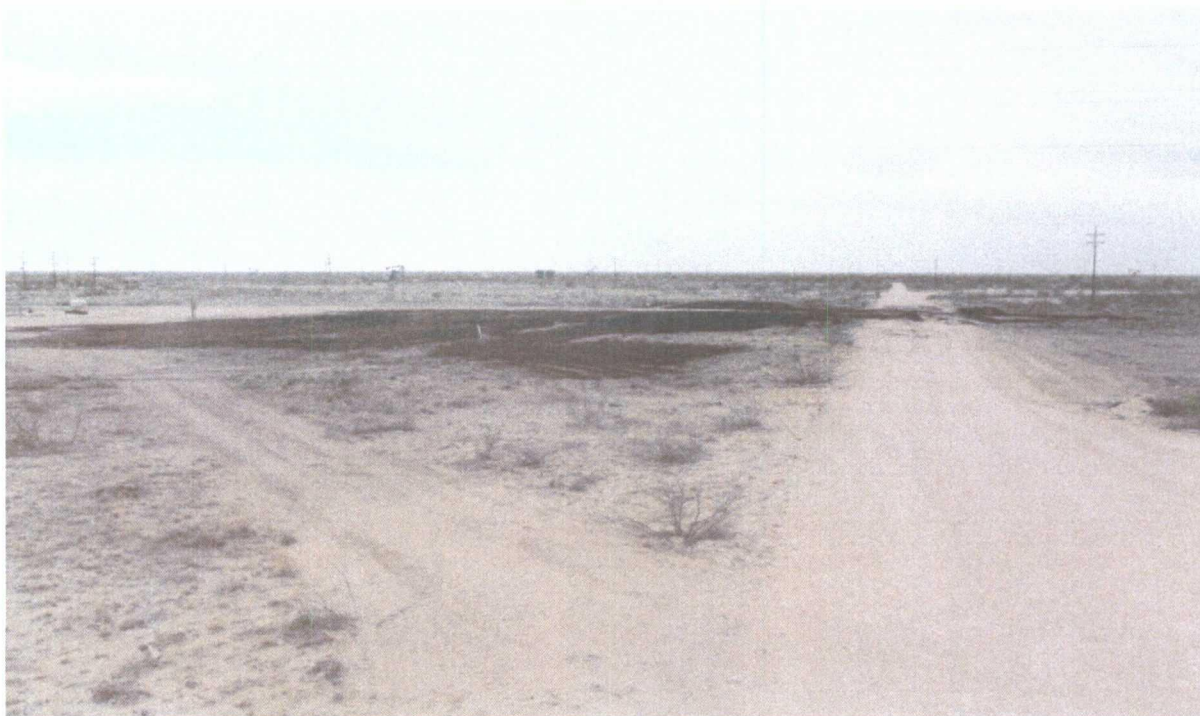
14 Inch Vac to Jal Legacy Initial Release

On April 9, 2009, Plains discovered a crude oil release from a fourteen (14)-inch steel pipeline. The cause of the release was attributed to external corrosion of the pipeline and was reported to the New Mexico Oil Conservation Division (NMOCD) on April 9, 2009. During initial response activities, Plains installed a temporary pipeline clamp on the pipeline to mitigate the release. Approximately two hundred fifty (250) barrels of crude oil was released from the pipeline, with no recovery. General photographs of the site are provided as Appendix C.

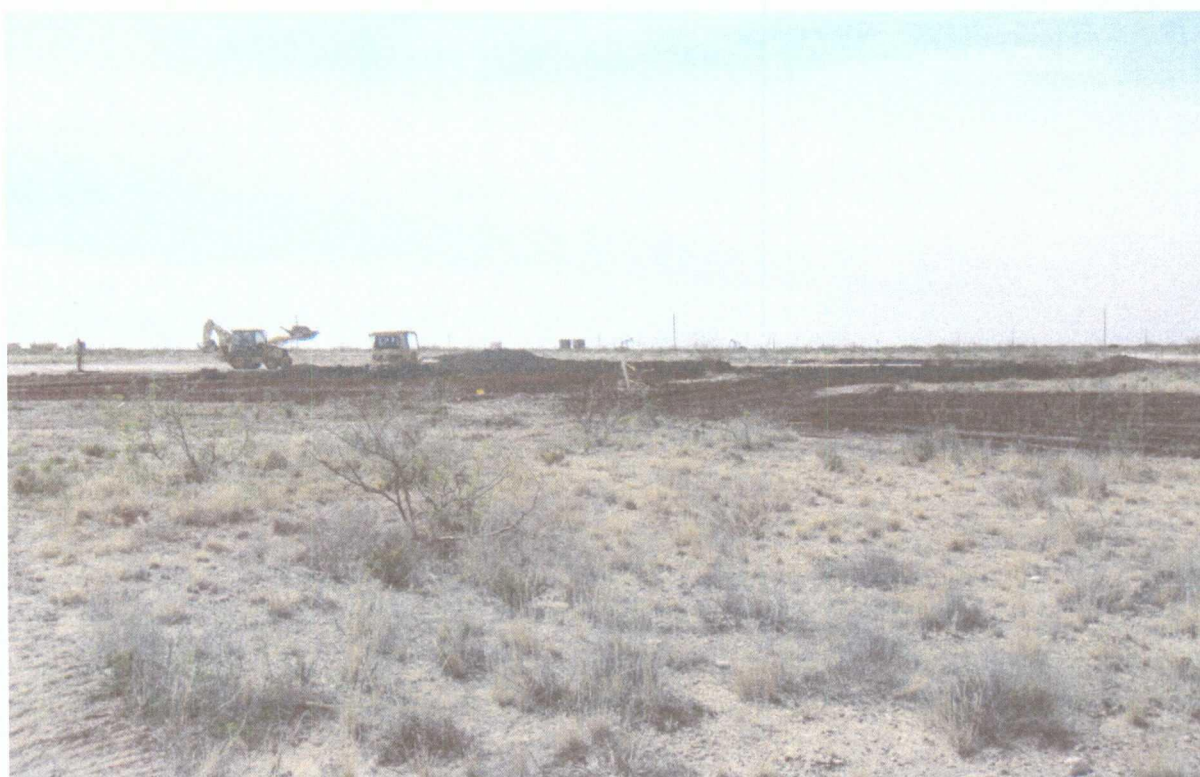
Excavation Activities at the 14 Inch Vac to Jal Legacy Release Site

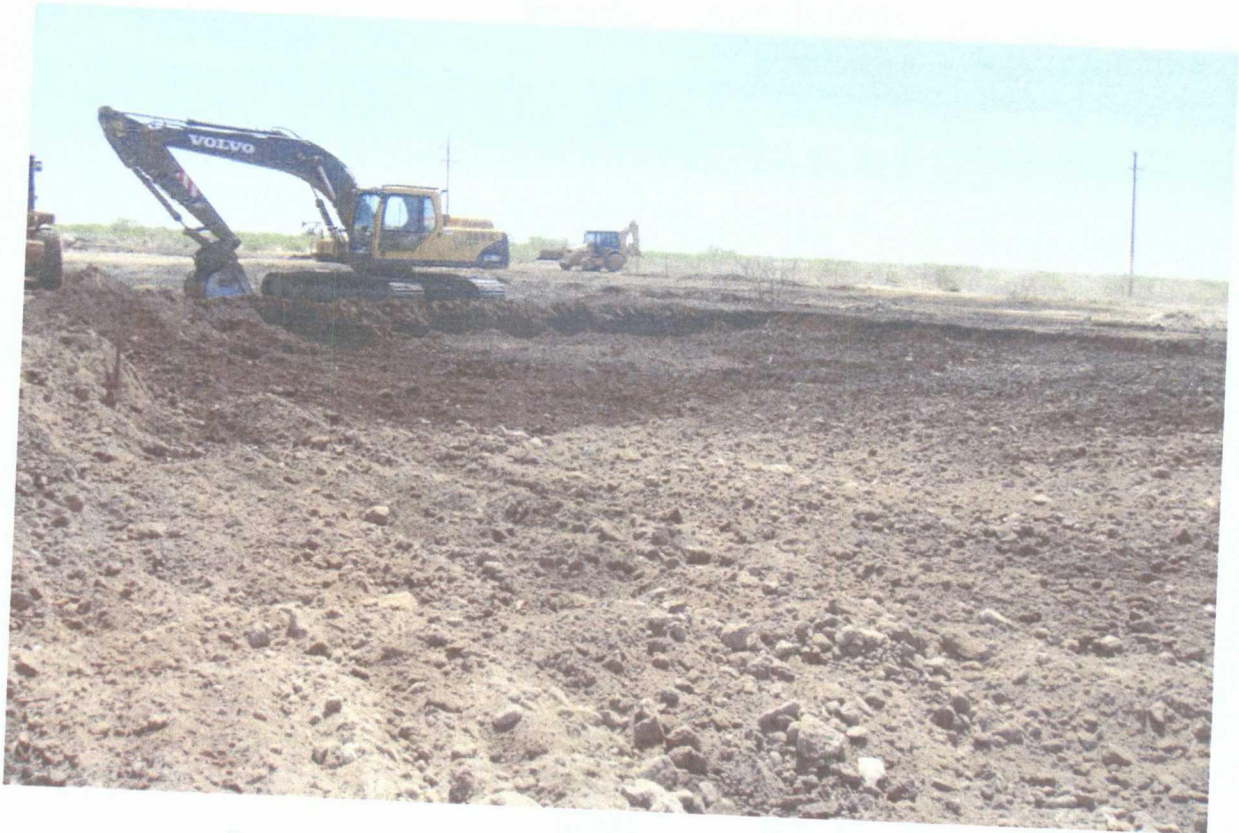
Excavation Activities at the 14 Inch Vac to Jal Legacy Release Site

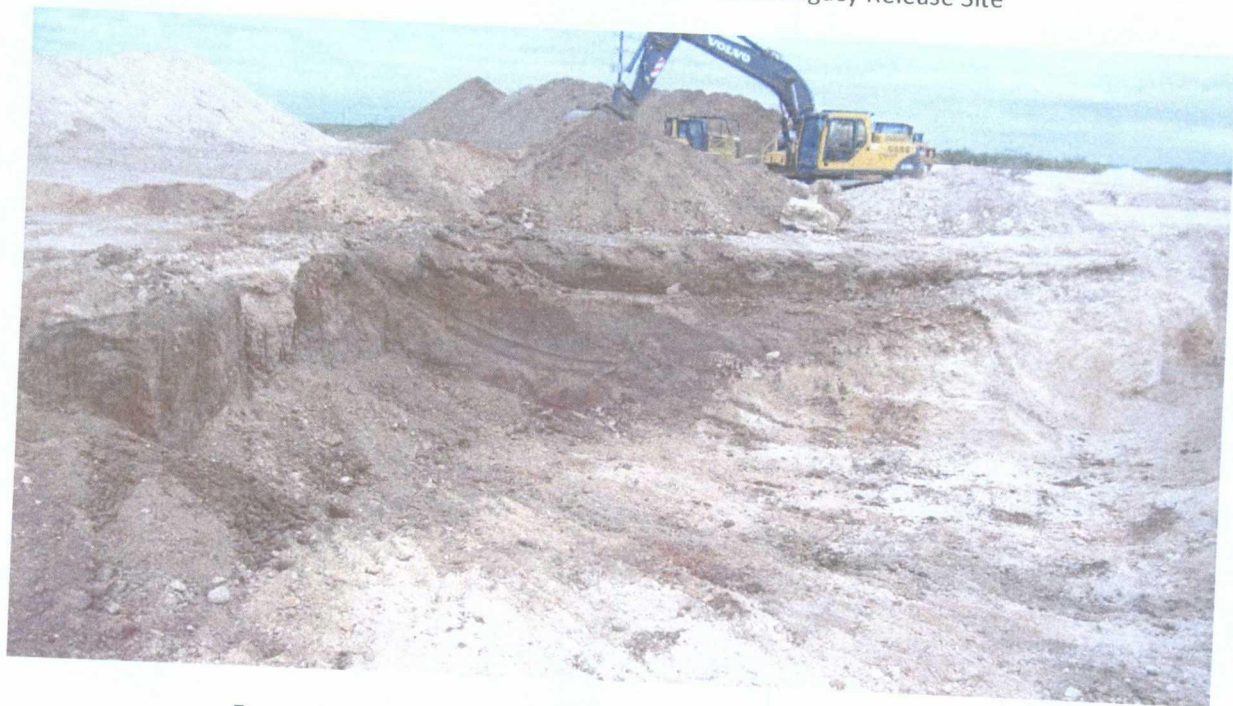
Excavation Activities at the 14 Inch Vac to Jal Legacy Release Site
