RE: Pulliam 27-P #001 Closure Report, Alta Mesa Services LP.
API Number 30-009-20025

RE: Pulliam 27-P #001 Closure Report, Alta Mesa Services LP.

Burial Trench Location at Pulliam 27-P Site
Unit P, Section 27, T8N, R 35E.

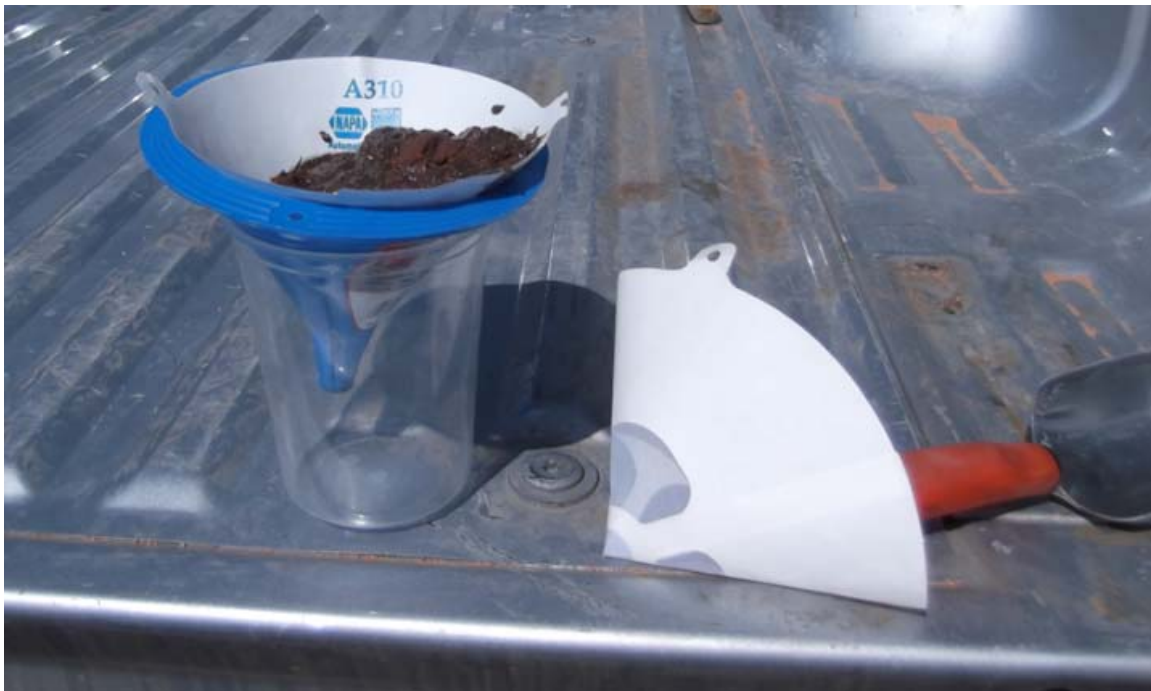
Figure 1: *Paint Filter Test at Pulliam 27-P #001, March 13, 2015. The photo was taken five minutes after the completion of the test.*

4. The burial trench was dug and lined with a 30 Mil. string reinforced LLDPE liner in accordance with paragraph D of 19.15.17.13 NMAC.
5. Stabilization of the pit contents was achieved by mixing the pit contents with dry soil beneath the liner and with material forming the berms of the pit. The material was mixed at a ratio of not more than 2 parts of soil with 1 part of waste material. A paint filter test was performed by R.T. Hicks Consultants that confirmed that the process was in accordance with Paragraph D of 19.15.17.13 NMAC (Figure 1).
6. The stabilized materials were moved to the burial trench (Figure 2).
7. Based upon visual inspection and soil moisture content, an additional one to three feet of the soil beneath the discharge areas of the inner and outer horseshoes was removed and placed in the lined burial trench.

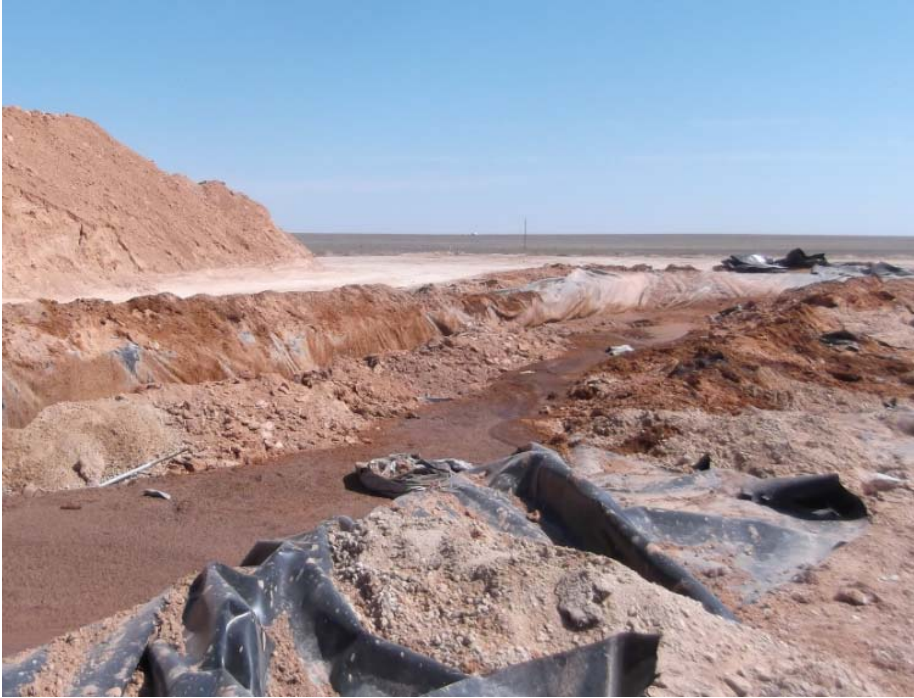
Figure 2: *View to northeast during placement of stabilized material from the temporary pit into the burial trench. The material was later shaped to have a slightly domed top before placement of the upper liner*

8. Materials in the burial trench were smoothed and shaped to shed infiltrating water from the center outwards.
9. On March 13 2015, Hicks Consultants collected a 10-point representative composite sample of materials from the floor of the former temporary drilling pit. Attachment 3 presents the laboratory analysis demonstrating that the bottom of the temporary drilling pit met closure standards.
10. A 30 Mil. string reinforced LLDPE liner was installed to completely cover the stabilized cuttings.

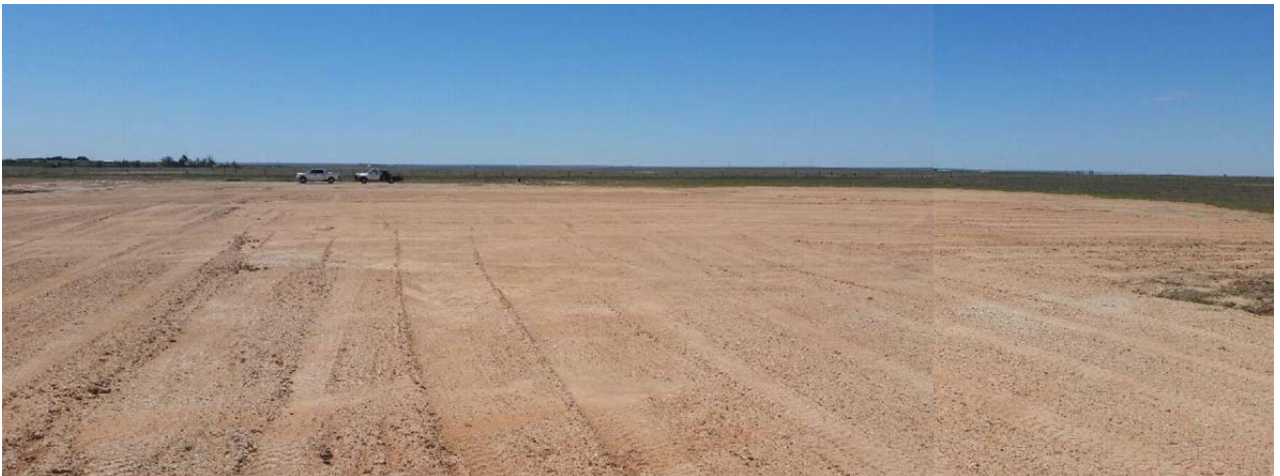
Figure 3: *View to south and southwest of completed top soil surface from the northern side of the burial trench (Photo taken on April 2, 2015). The topography was sloped to be higher over the burial trench and slopes down to the location of the former temporary drilling pit, in the left and center middle ground. Soil from the original excavation had been stockpiled on the right middle ground.*

11. After the liner cover had been installed on March 25, 2015, 4 feet of non-waste containing, uncontaminated, earthen material and the reserved topsoil were replaced in their relative positions in accordance with Subsection (3) of Paragraph H of 19.15.17.13 NMAC. The uppermost topsoil of one foot is greater than or equal to the background thickness.
12. The top soil surface was completed by March 30, 2015. Final contours were blended with the surrounding topography to prevent erosion and ponding of surface water (Figure 3).

13. The site is to be reseeded in the summer of 2015 in accordance with the landowner's request to return the land to its previous use. The site was formerly part of an agricultural field. As such, the landowner will specify application rates and schedules. It is expected that vegetative cover will attain 70% of pre-disturbance levels this growing season. If conditions or circumstances are such that the landowner elects not to plant this spring, the operator will inform the division of the delay in seeding. The operator will provide photo-documentation when successful re-vegetation is achieved.
