RE: 1RP-1924 EBDU # 28

Closure Plan

RE: Closure Request for Apache Corporation – EBDU #28  
API No. 30-025-06538  
U/L D, Section 12, Township 21 S, Range 37E

On behalf of Apache Corporation, Hungry Horse LLC has prepared this Closure Report that demonstrates the delineation and remediation for the release associated with the EBDU #28 that occurred on July 23<sup>rd</sup>, 2008, with the RP # of 1RP-1924.

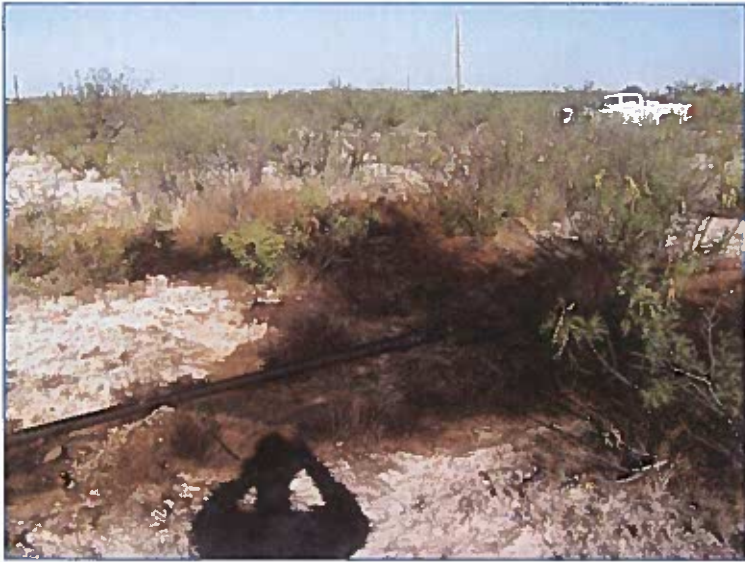
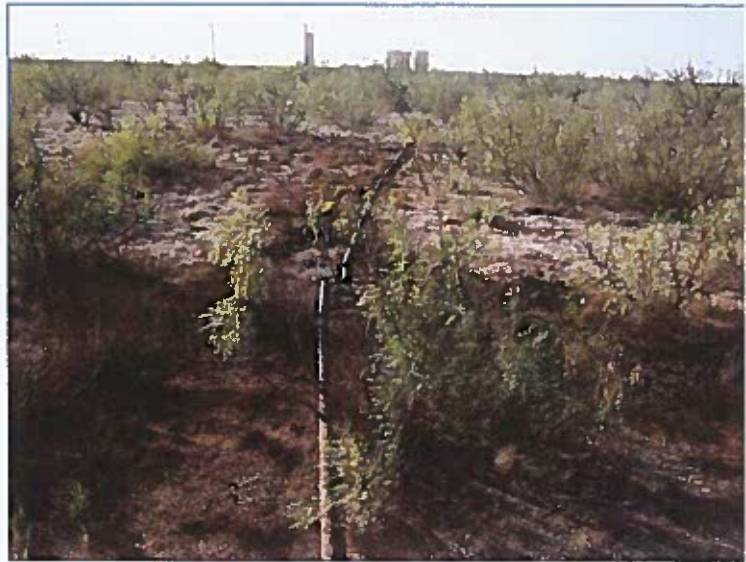
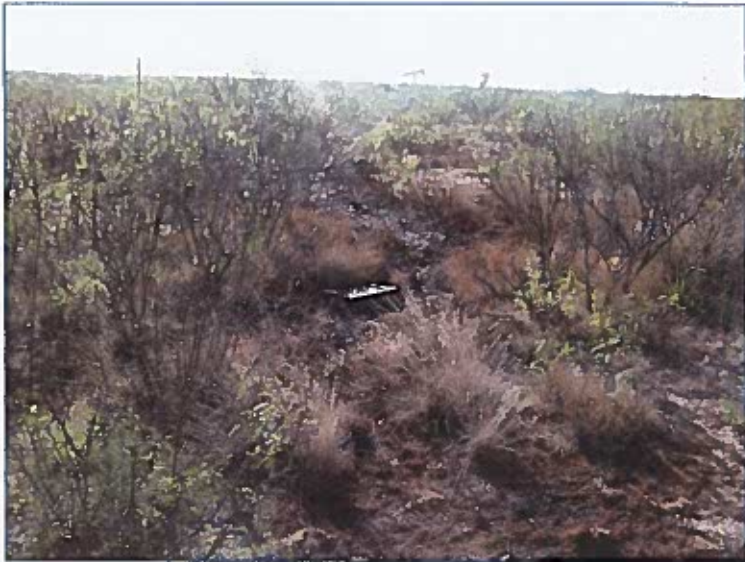
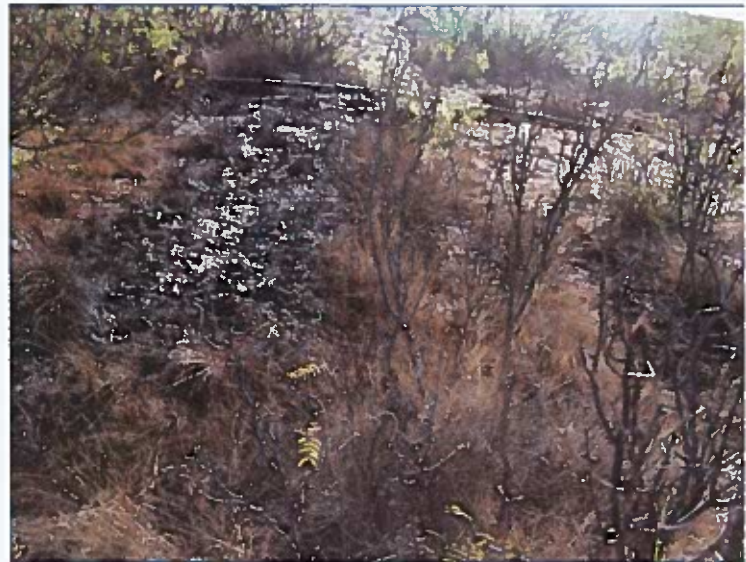
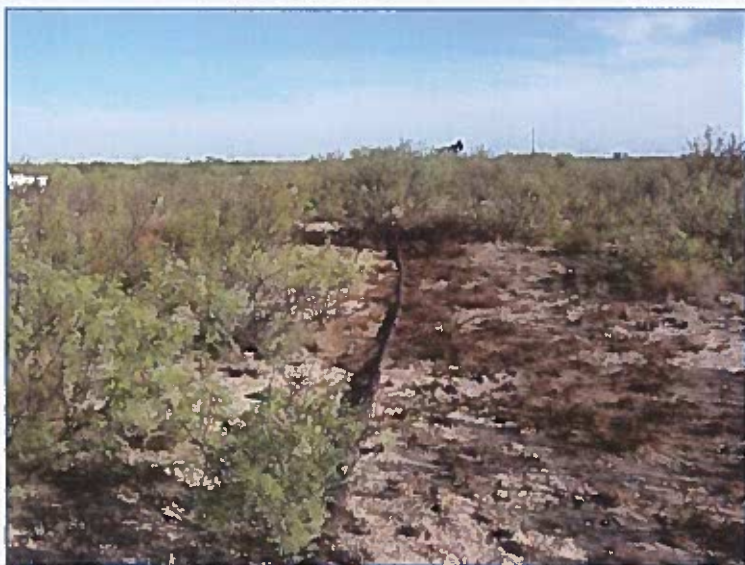
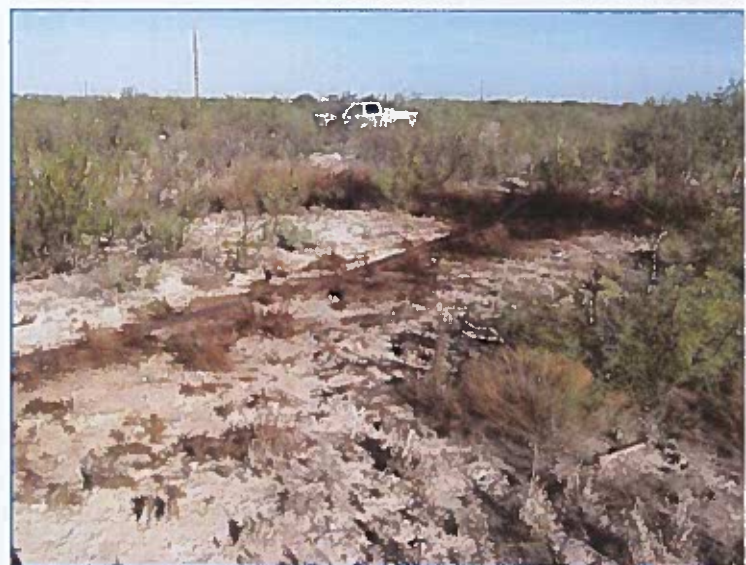
Hungry Horse, LLC began delineation of this site starting on July 25<sup>th</sup> of 2008. Surface and 2'bgs samples were taken as per the landowner. Lab data and photos were available from the remediation and backfill process. They are included in this report. Approximately, 1,914 cubic yards of contaminated soil was hauled to Sundance Disposal. 508 cubic yards of topsoil and 136 yards of fill dirt was hauled in. The remediation was final on August 4<sup>th</sup>, 2008. Please also notice the historical maps attached herein.

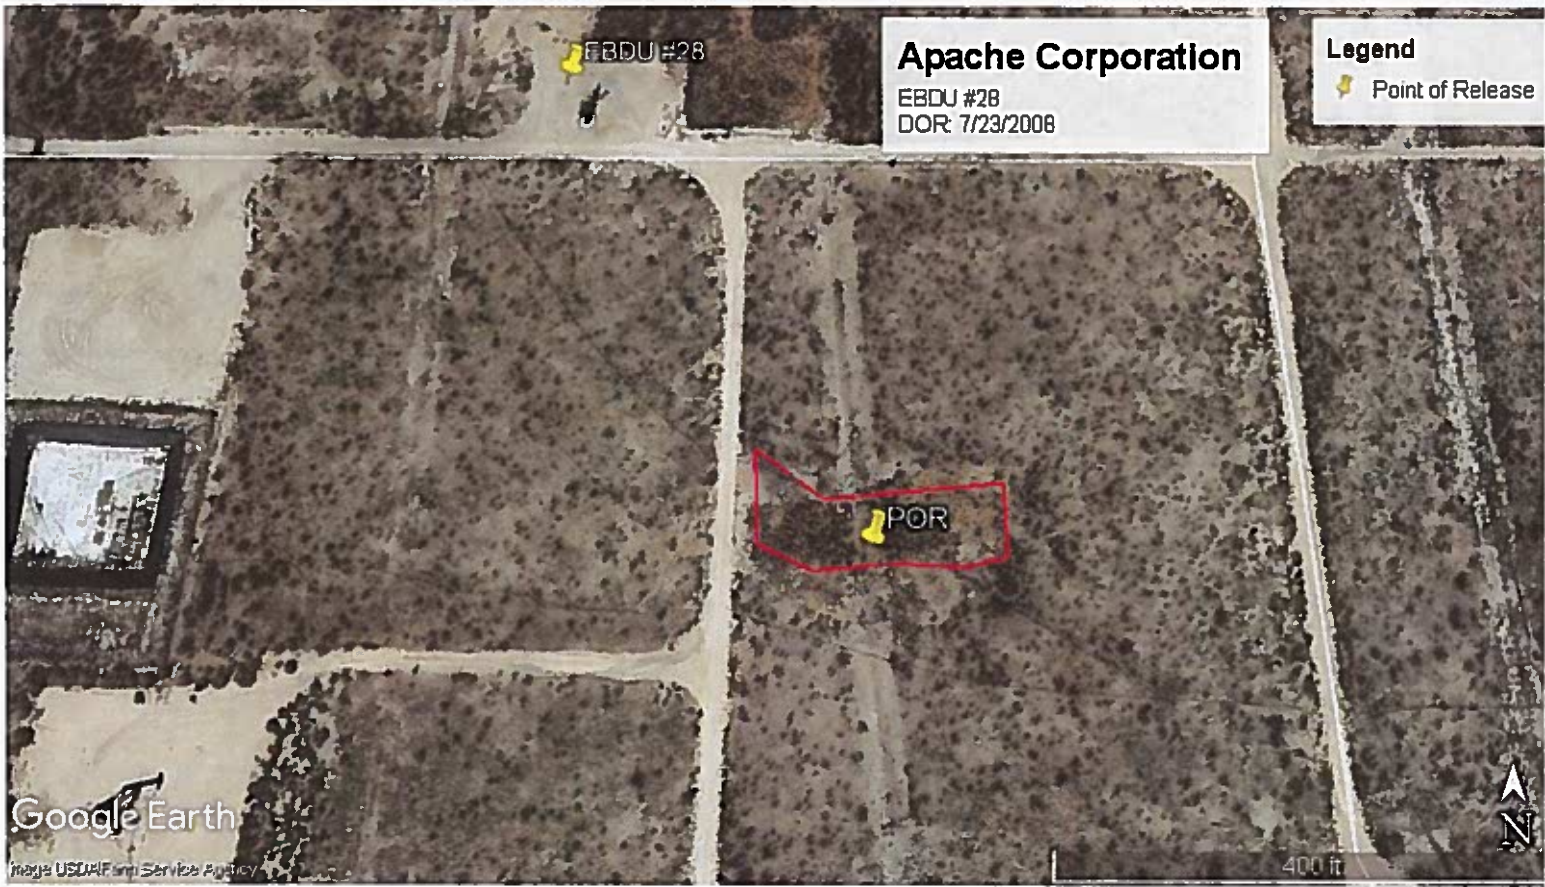
EBDU #28  
DOR: 7/23/2008

Point of Release
