**Jimmy Cooper #5 Closure Report
Duke Energy Field Services
Lea County, New Mexico**

JIMMY COOPER #5 (JC#5)

T20S, R36 E, SECTION 23, UNIT P

Re: Removal of Hydrocarbon-Impacted Soils from the JC #5 site
Township 20 South, Range 36 East, Section 23, Unit P

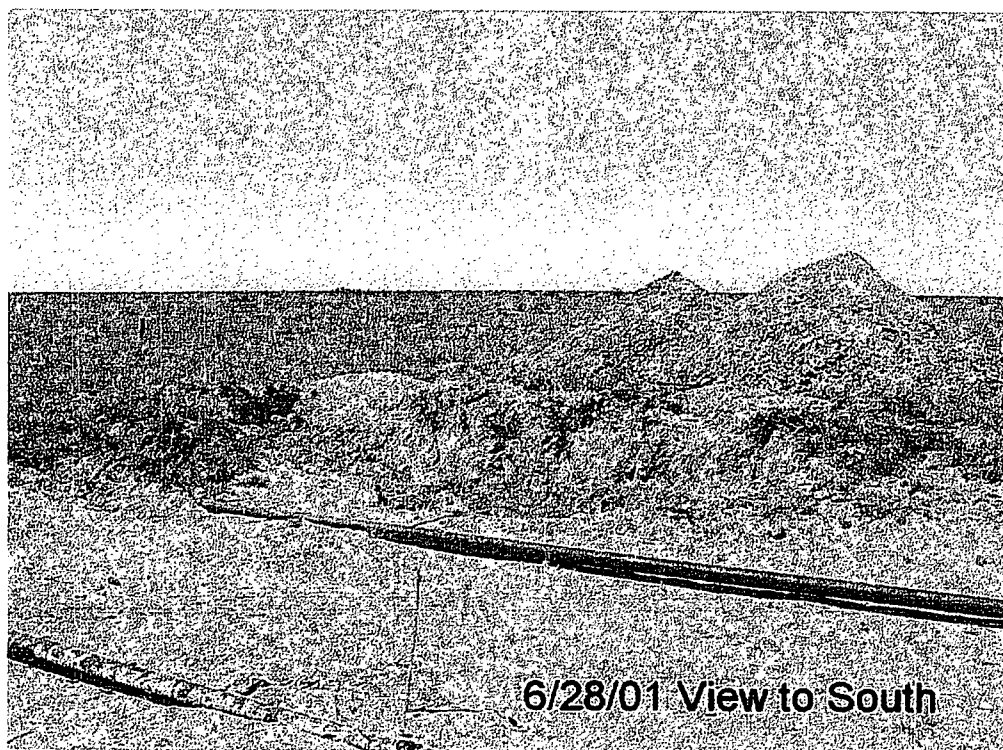
JC5-2 View showing excavation at completion.

Photo 6 and 7 is a view of the completed excavation as of June 28, 2001. The laboratory results (verbal) support the PID readings. All of the samples were below the detection limit (including the stockpile). It is my opinion that the release was associated with the flow line (extremely weathered crude oil) and not condensate from the pipeline. Please call me if you have any further questions.

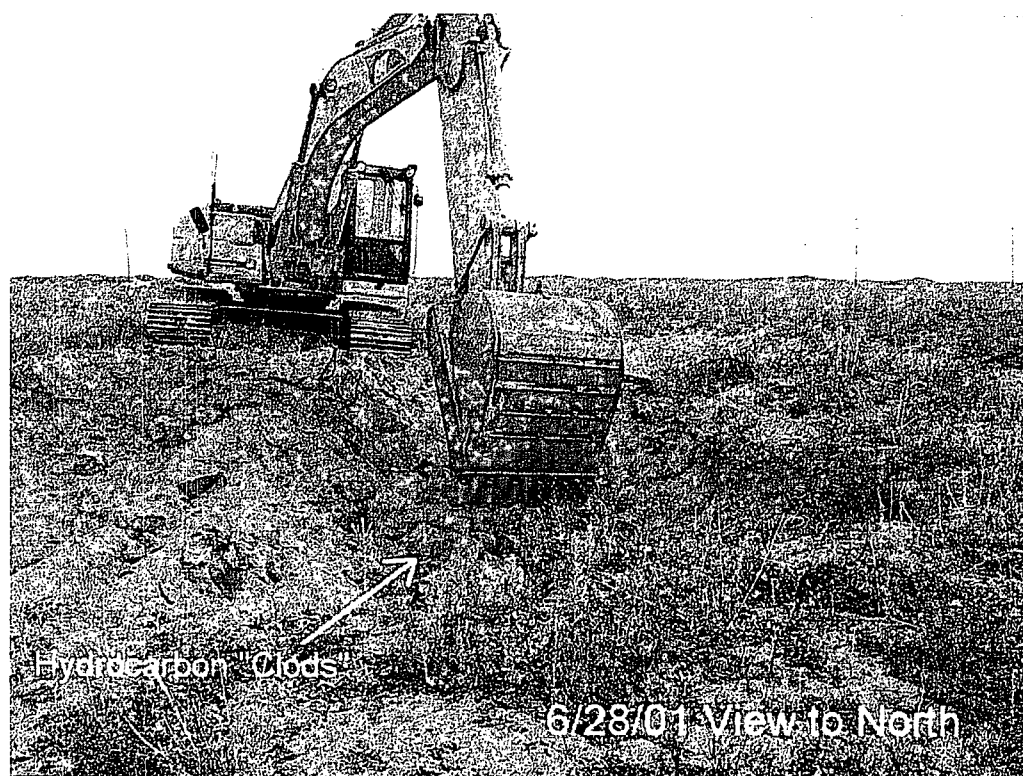
JC5-3 View facing north showing beginning of excavation activities.

Prior to excavating the stained area the area between the pipelines was scraped (approximately 1 foot deep) in an effort to identify impacted soil that may have been covered by blow sand. No discolored soil was observed in this area.
