REMEDIATION SUMMARY & SITE CLOSURE REQUEST

**SOUTHERN UNION GAS SERVICES
DRIP TANK #106 (1RP-1821)
HISTORICAL RELEASE SITE
Lea County, New Mexico
Unit Letter "K", Section 33, Township 21 South, Range 36 East
Latitude 32° 25.933' North, Longitude 103° 16.233' West
NMOCD Reference # 1RP-1821**

June 2013

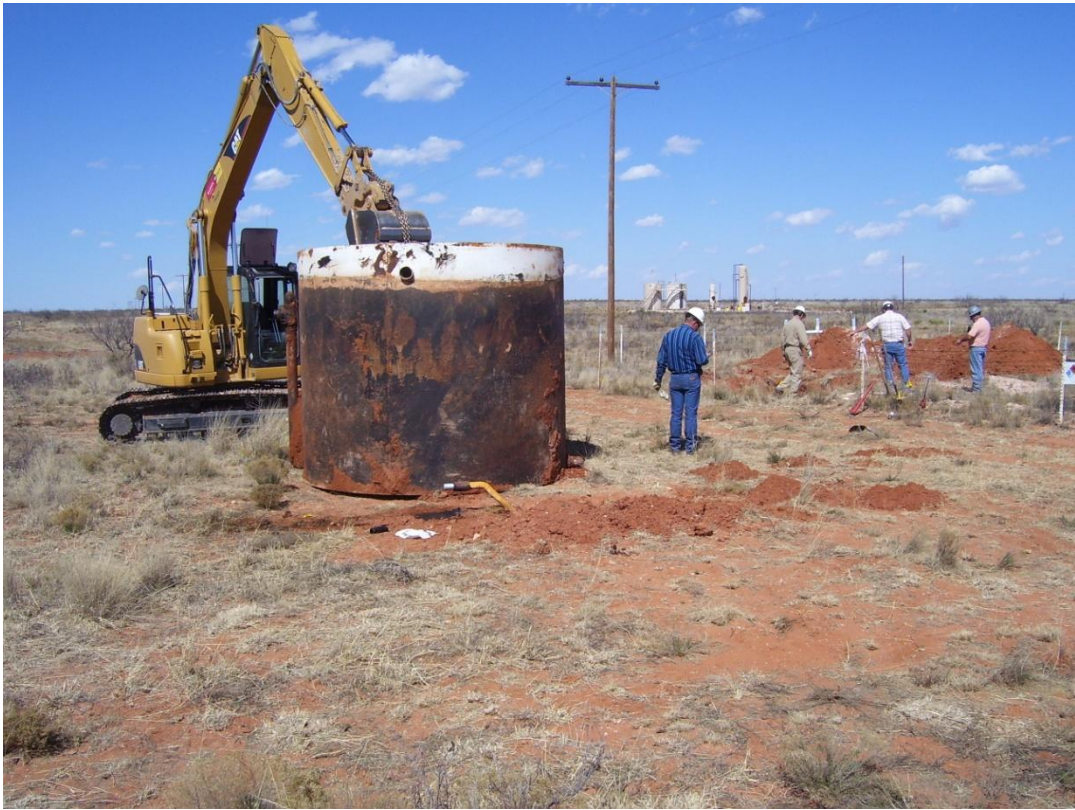
On March 11, 2008, exhumation of the BGT began. Inactive pipelines and plumbing were disconnected, and the BGT was removed and transported to a disposal facility. Upon removing the BGT, five (5) soil samples (Floor, North Wall, East Wall, South Wall and West Wall) were collected from the excavation floor and sidewalls and submitted to the laboratory for analysis of TPH and chloride concentrations. Laboratory analytical results indicated chloride concentrations ranged from less than the appropriate laboratory method detection limit (MDL) for soil samples Floor, North Wall and East Wall to 40 mg/kg for soil sample South Wall. Table 1 summarizes the “Concentrations of Benzene, BTEX, TPH & Chloride in Soil”. Soil sample locations are depicted in Figure 2, “Site & Sample Location Map”. Laboratory analytical reports are provided as Appendix B.

Photograph of the BGT removal at Drip Tank #106.

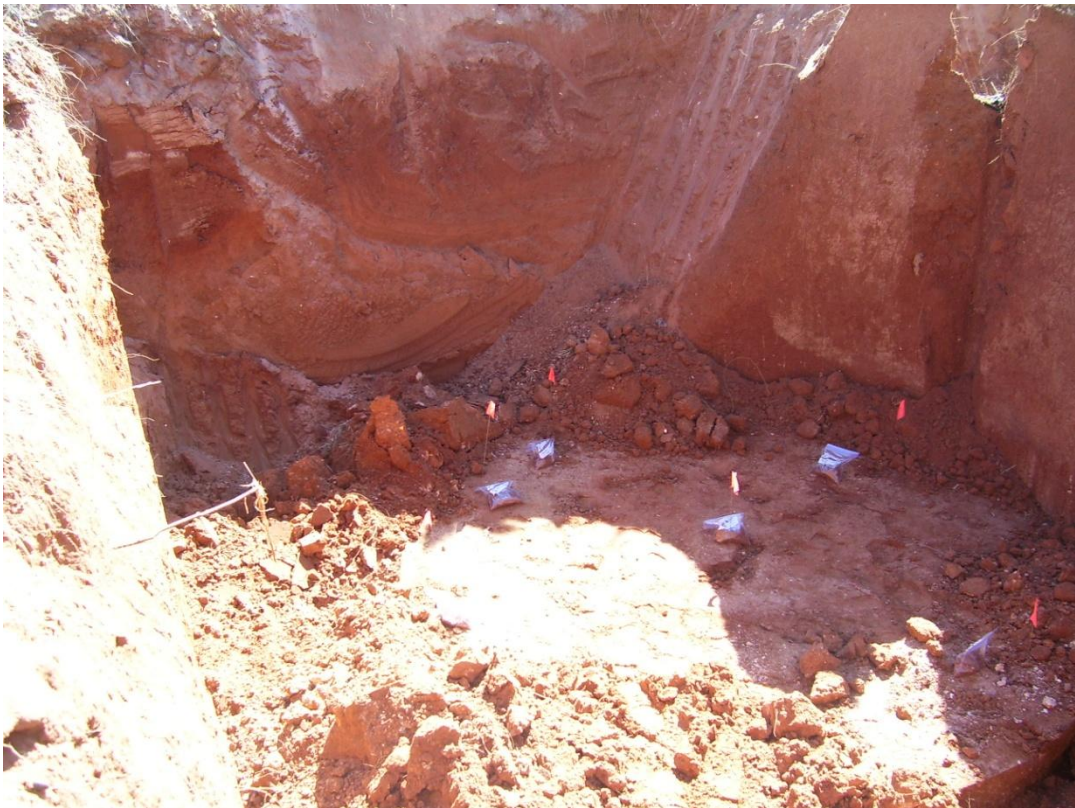
Photograph of the BGT removal and sample locations at Drip Tank #106.

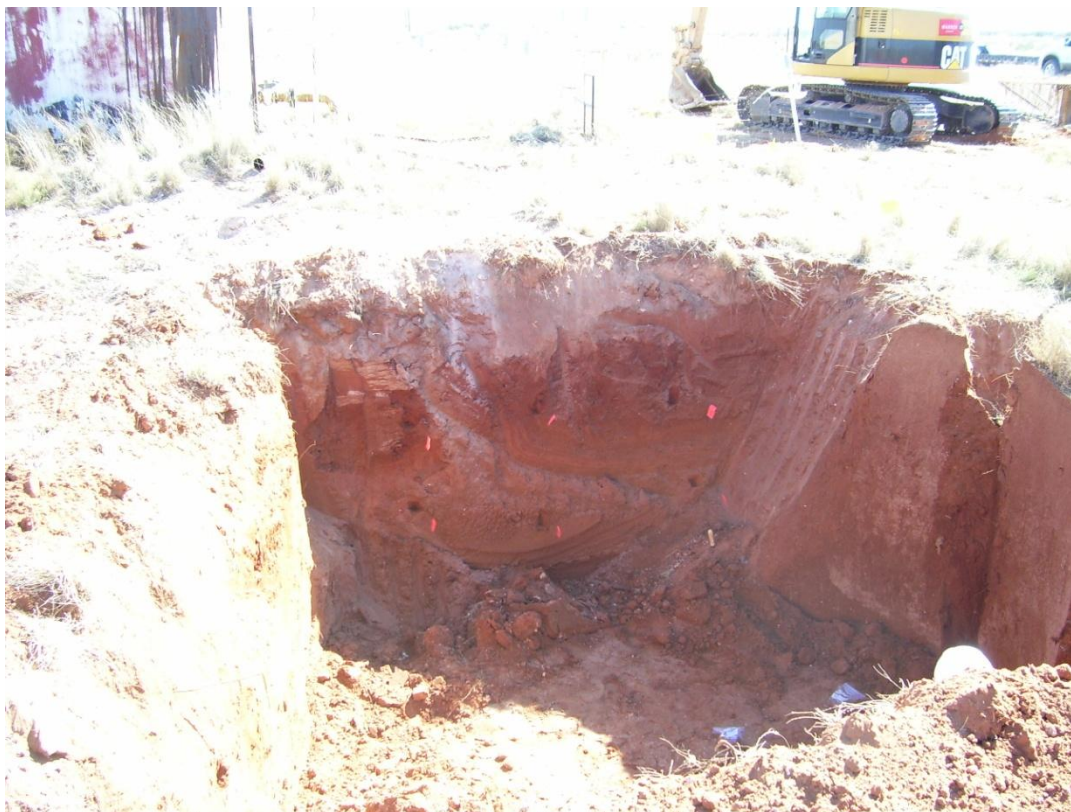
Photograph of the BGT removal and sample locations at Drip Tank #106.

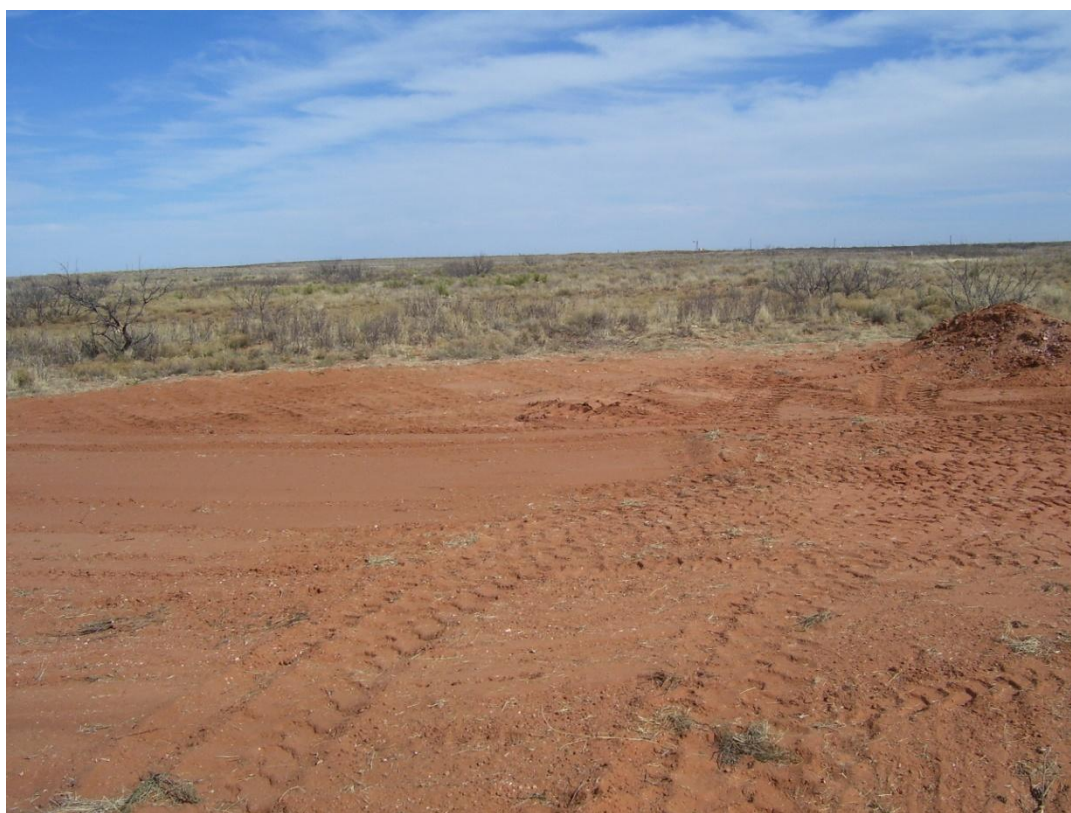
Photograph of the former BGT location after being backfilled.

On March 14, 2008, the excavated area representing the former BGT location was backfilled with locally purchased, non-impacted material. Excavation backfill was water-packed and compacted in eighteen-inch (18”) lifts.

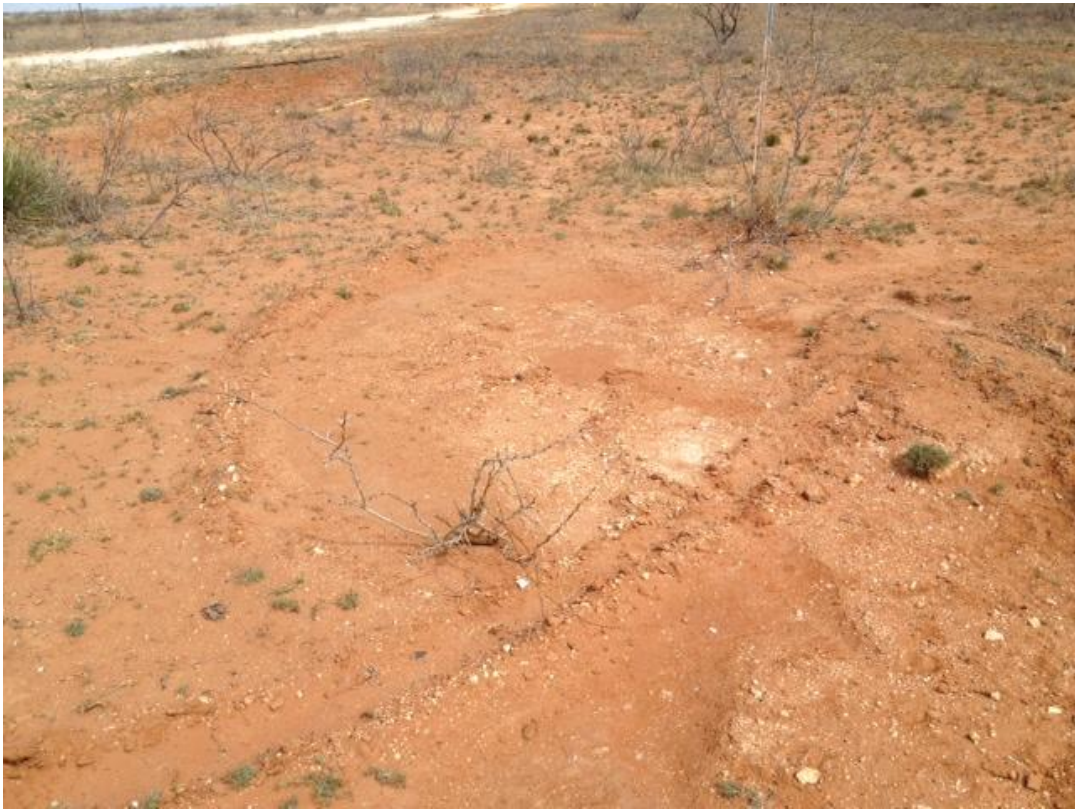
On or around March 13, 2013, two decommissioned above ground storage tanks (ASTs) were removed from the location. During the removal of the ASTs, no holes or visible staining were encountered.

Photograph of the former above ground storage tank location.

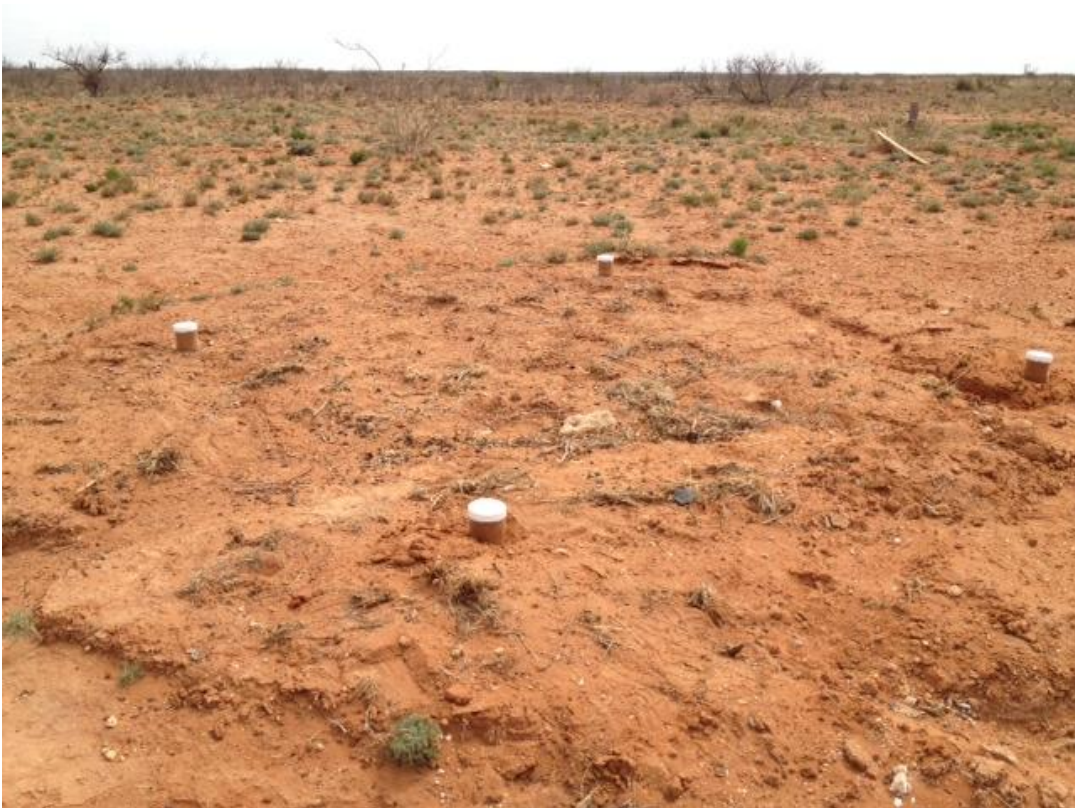
Photograph of the former above ground storage tank location.
