MCA Well #357 (1RP-3025)

Corrective Action Plan

Unit Letter M, Section 28, Township 17S, Range 32E

**RE: Corrective Action Plan
ConocoPhillips MCA Well #357 (1RP-3025)
UL/M sec. 28 T17S R32E
API No. 3002525849**

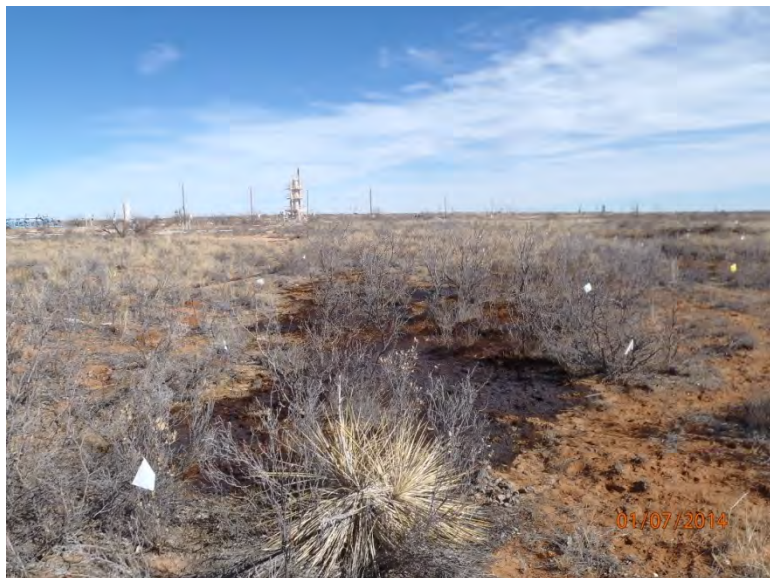
Initial release area, facing east

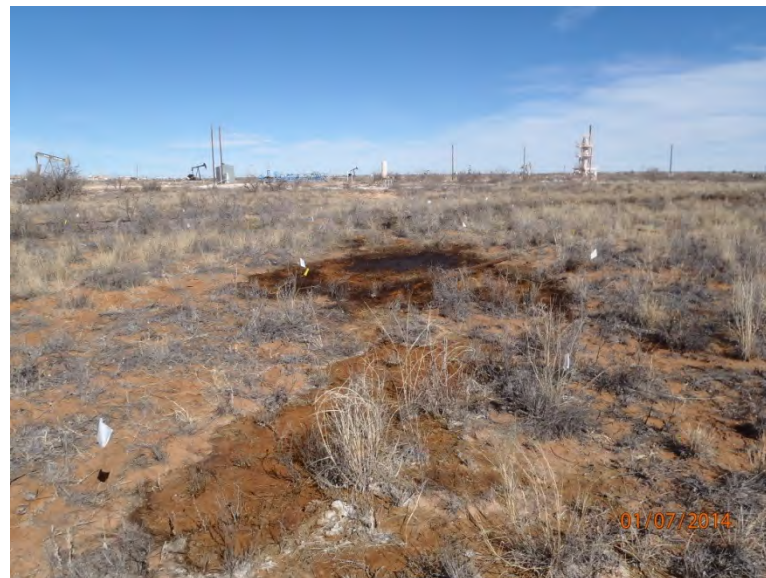
Initial release area, facing northeast

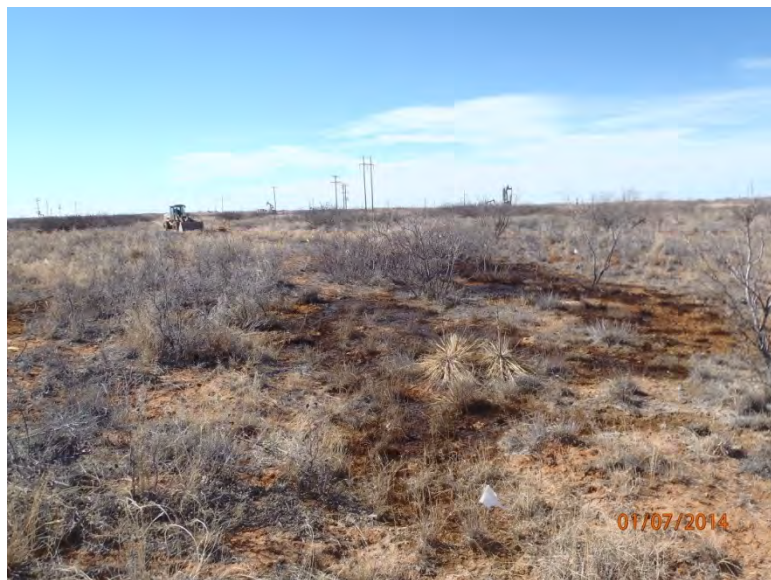
Initial release area, facing west

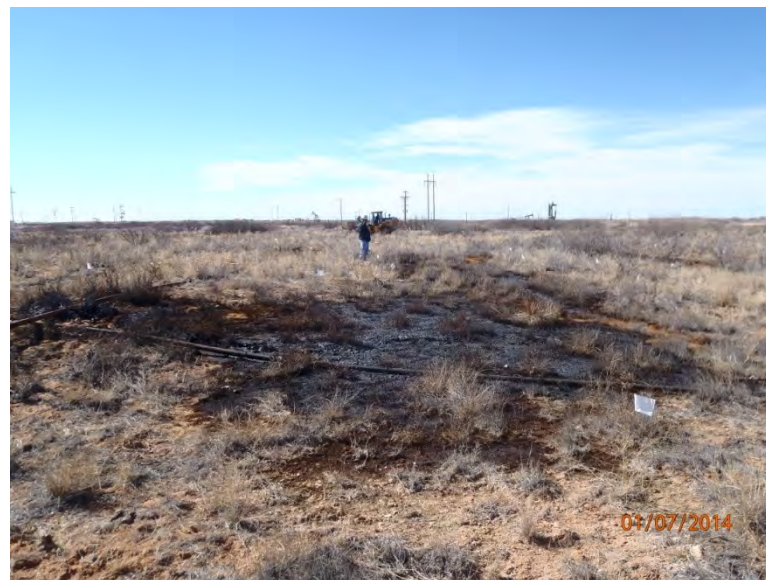
Initial release area, facing west

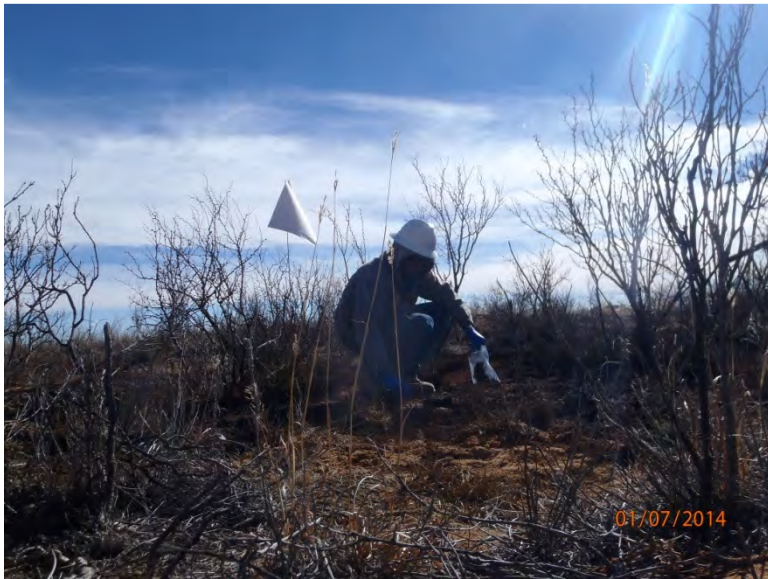
Collecting surface sample, facing south 1/7/14

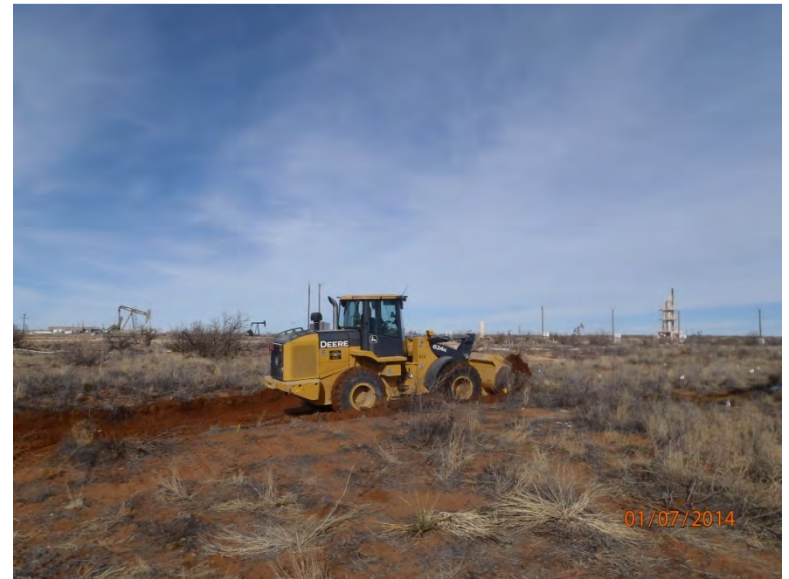
Scraping release, facing northeast 1/7/14

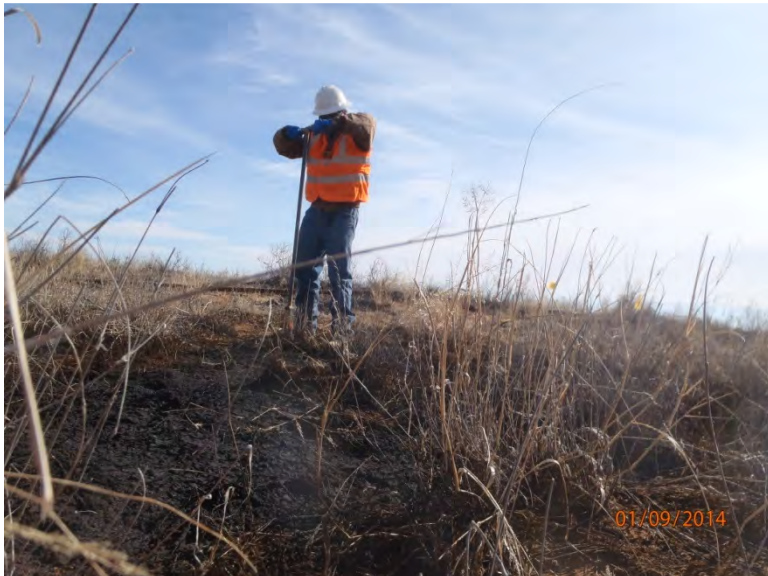
Auguring for depth, facing east 1/9/14

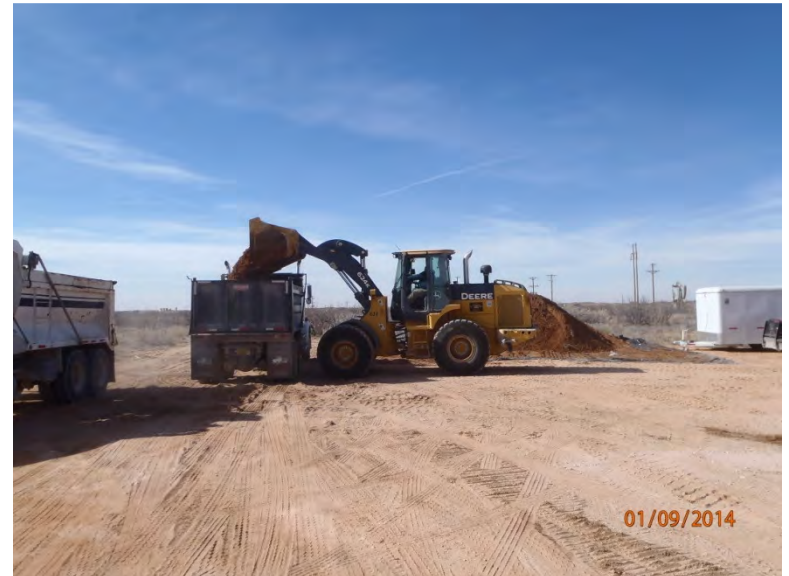
Exporting soil, facing west 1/9/14

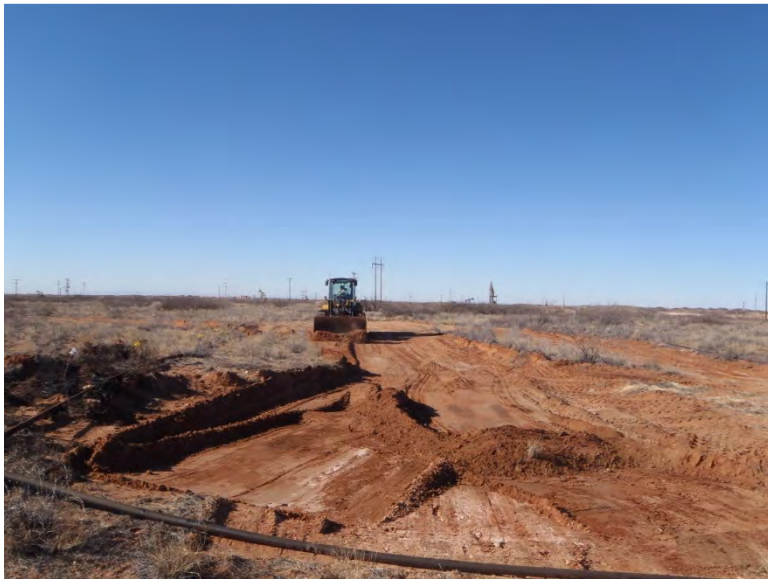
Continue scraping release, facing west 1/13/14

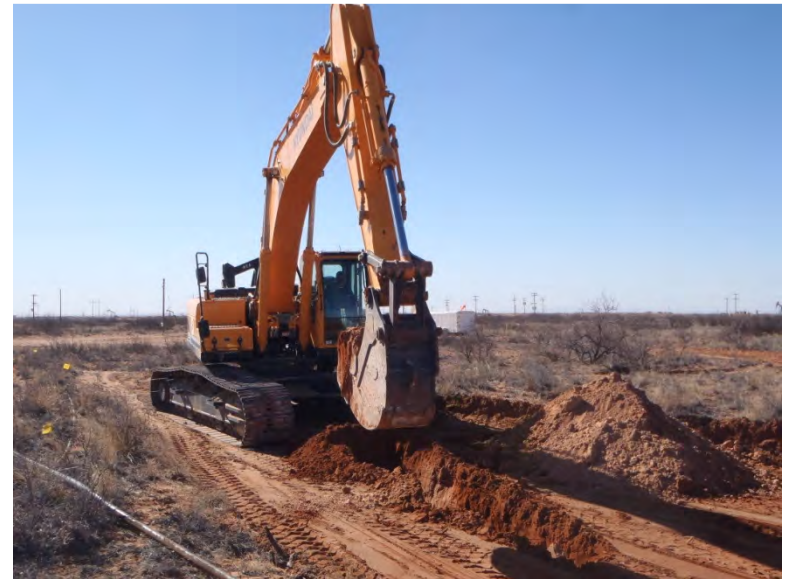
Installing vertical, facing southwest 1/13/14

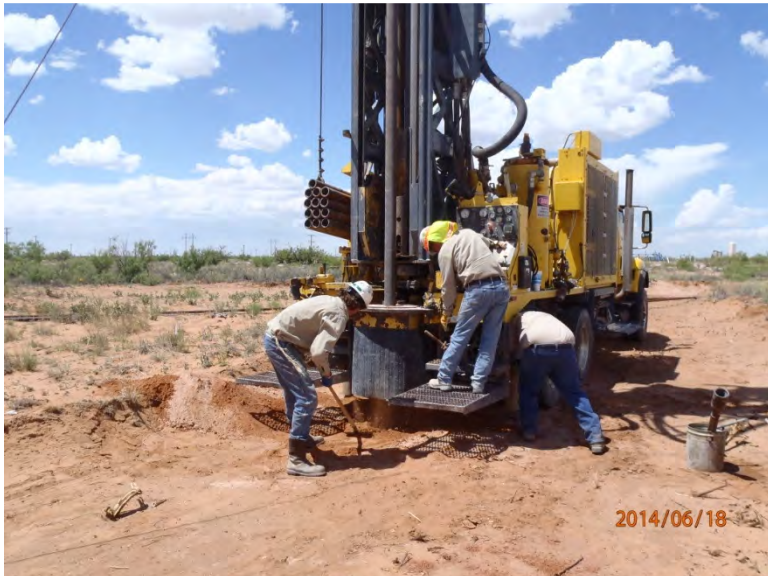
Installing SB-1, facing northwest 6/18/14

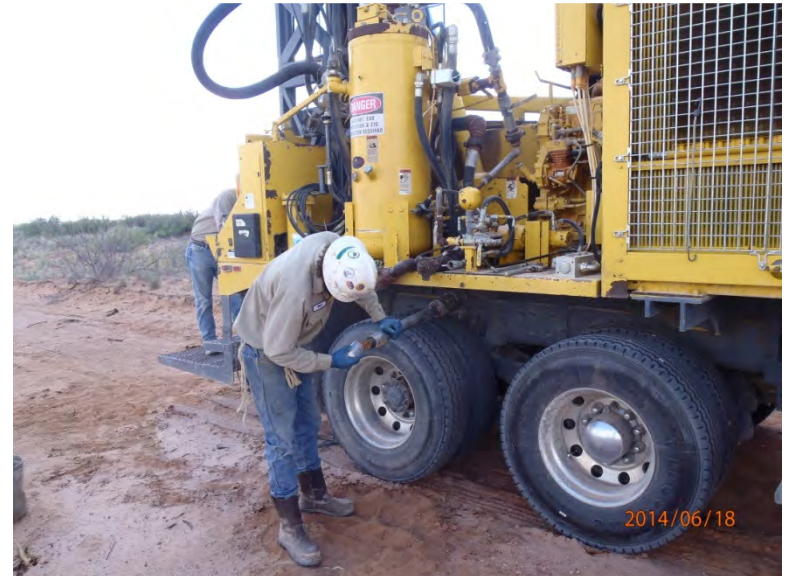
Split spoon sample, facing southwest 6/18/14

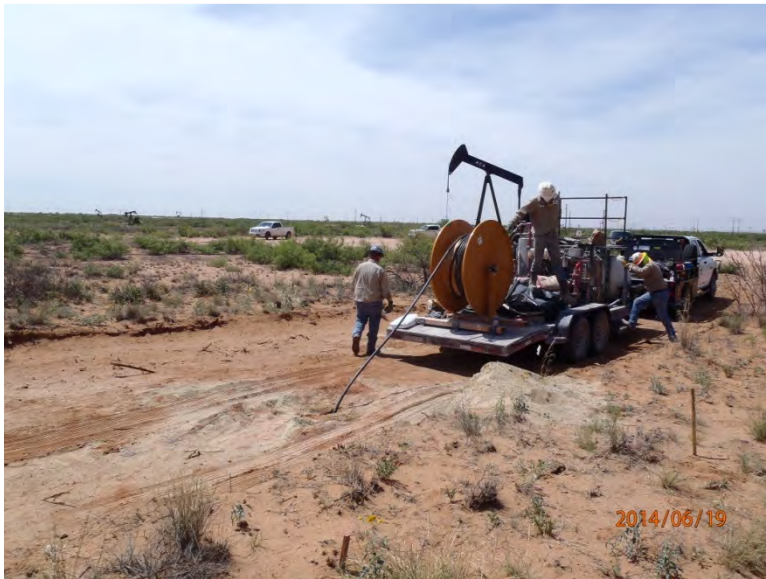
Plugging SB-1 with a cement/bentonite slurry, facing southeast
6/19/14

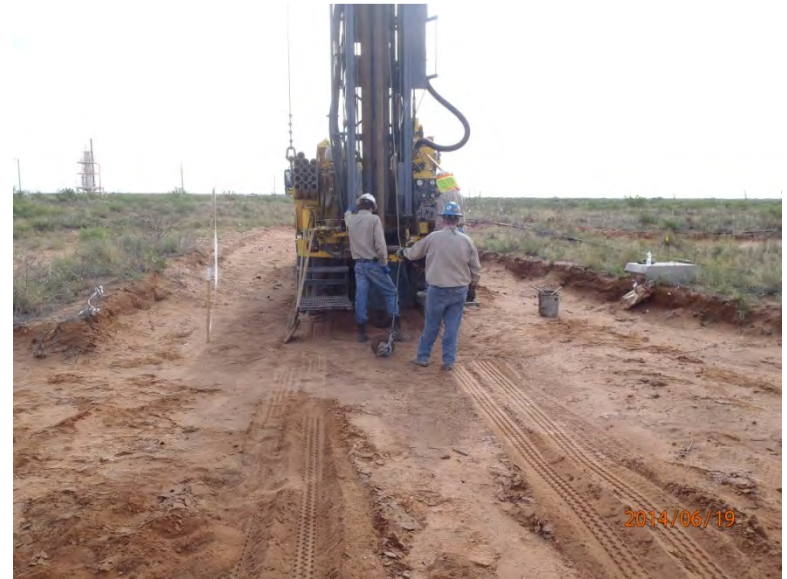
Installing SB-2, facing east
6/19/14

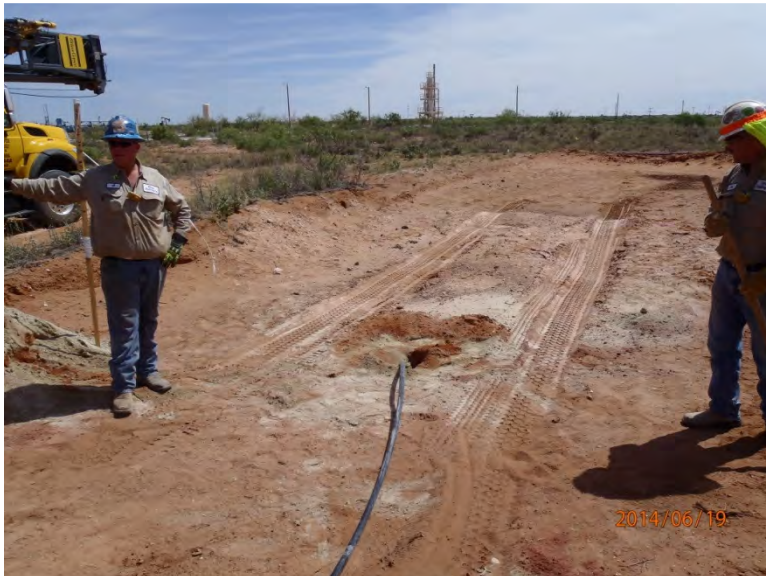
Plugging SB-2 with a cement/bentonite slurry, facing east
6/19/14

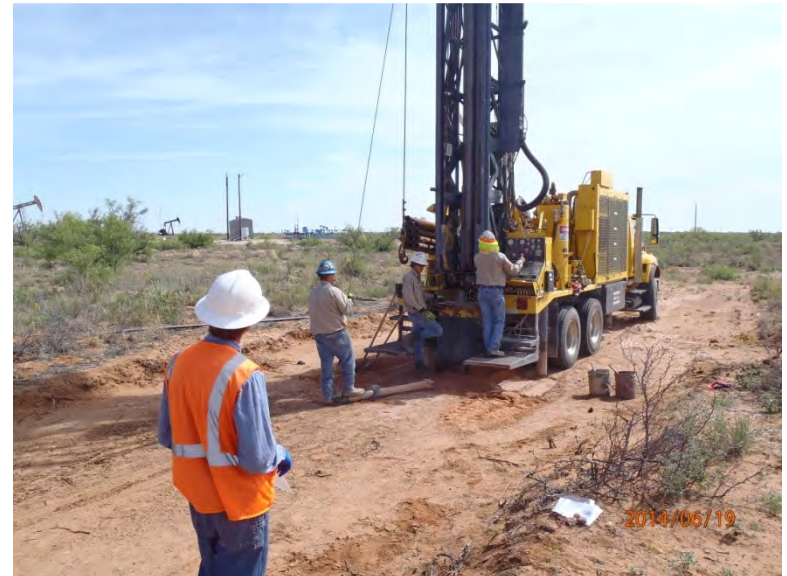
Installing SB-3, facing northeast
6/19/14

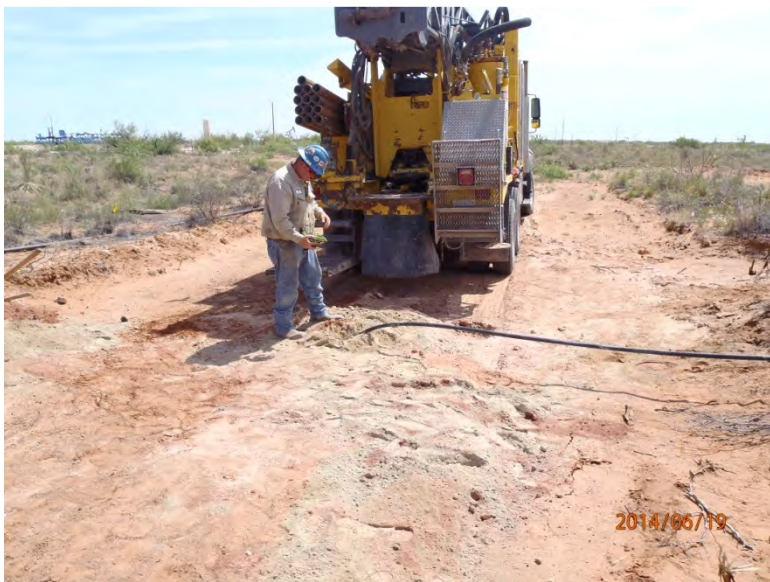
Plugging SB-3 with a cement/bentonite slurry, facing
northeast 6/19/14

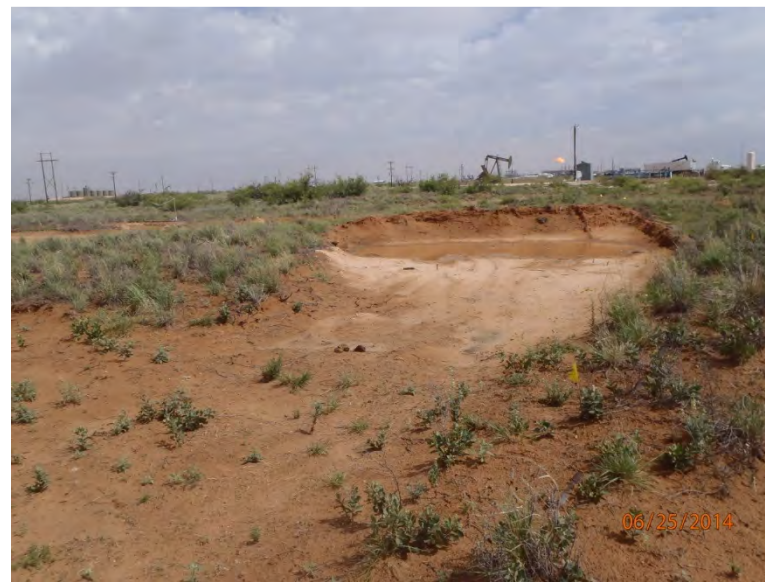
Initial scrape completed, facing north 6/25/14

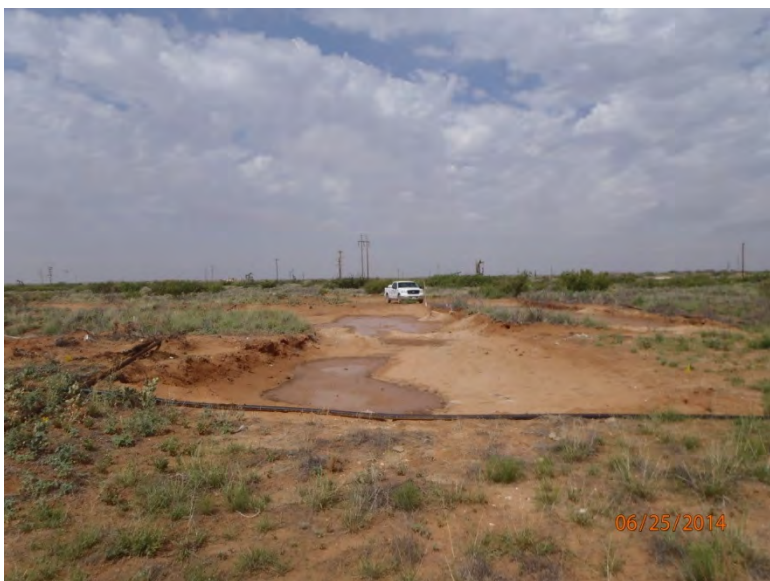
Initial scrape completed, facing west 6/25/14

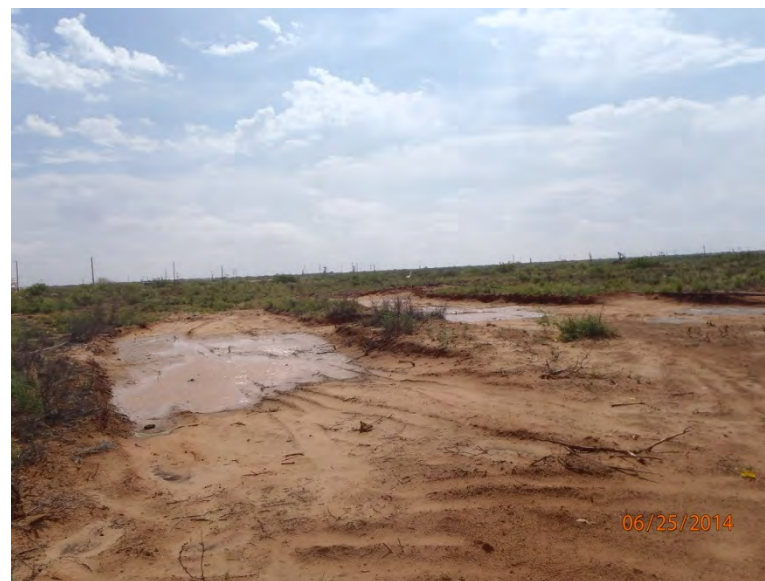
Initial scrape completed, facing southeast 6/25/14
