## **REMEDIATION SUMMARY & SITE CLOSURE REQUEST**

**SOUTHERN UNION GAS SERVICES  
TRUNK "O" 30-INCH (1RP-1817)  
HISTORICAL RELEASE SITE**

**Lea County, New Mexico**

**NMOCD Reference # 1RP-1817**

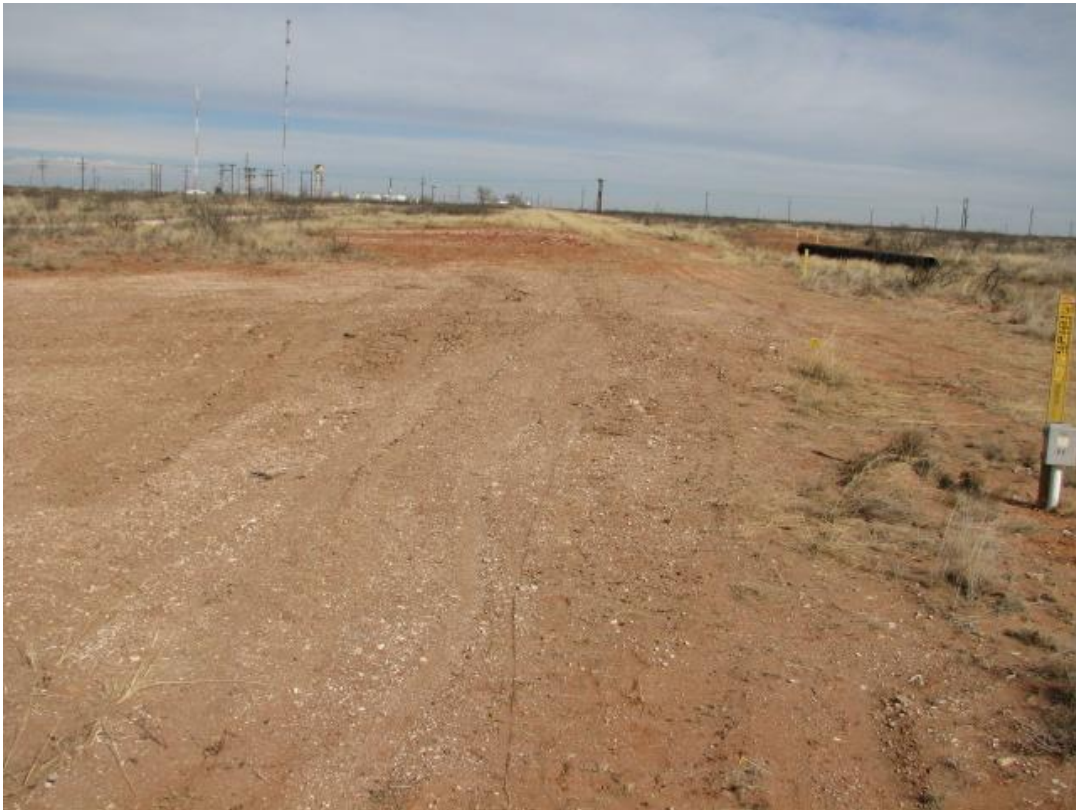
Historical photograph of the Trunk "O" 30" Release Site.

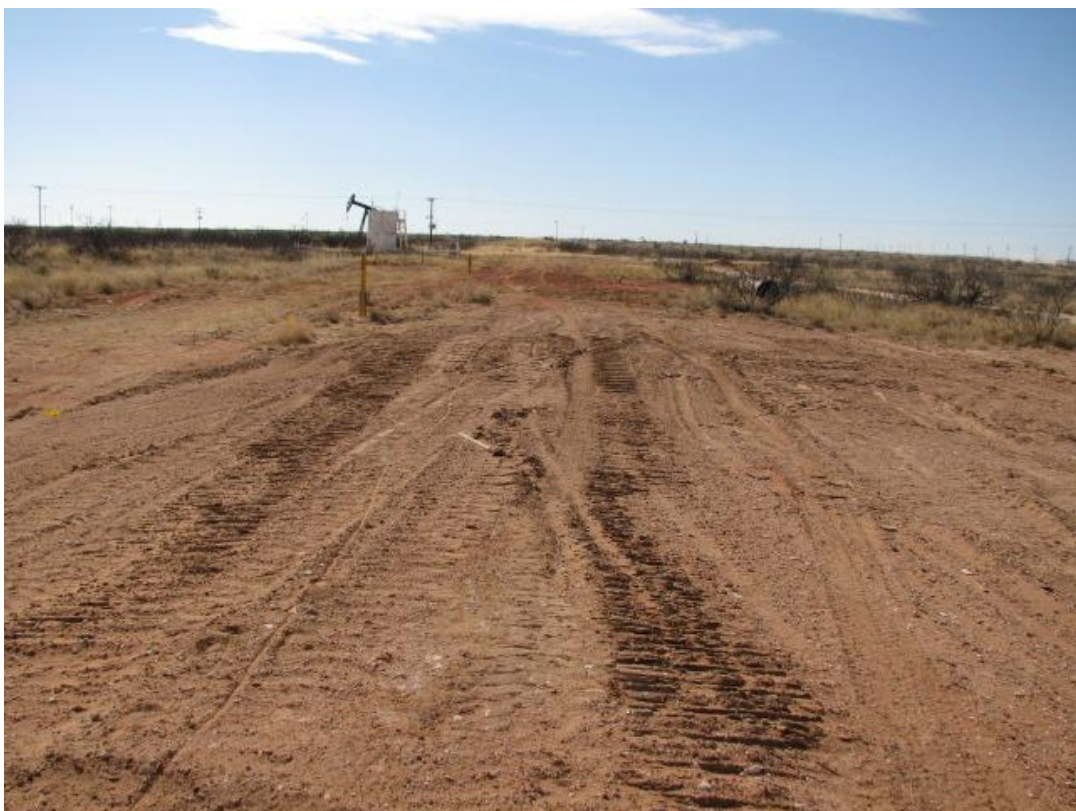
Historical photograph of the Trunk "O" 30" Release Site.

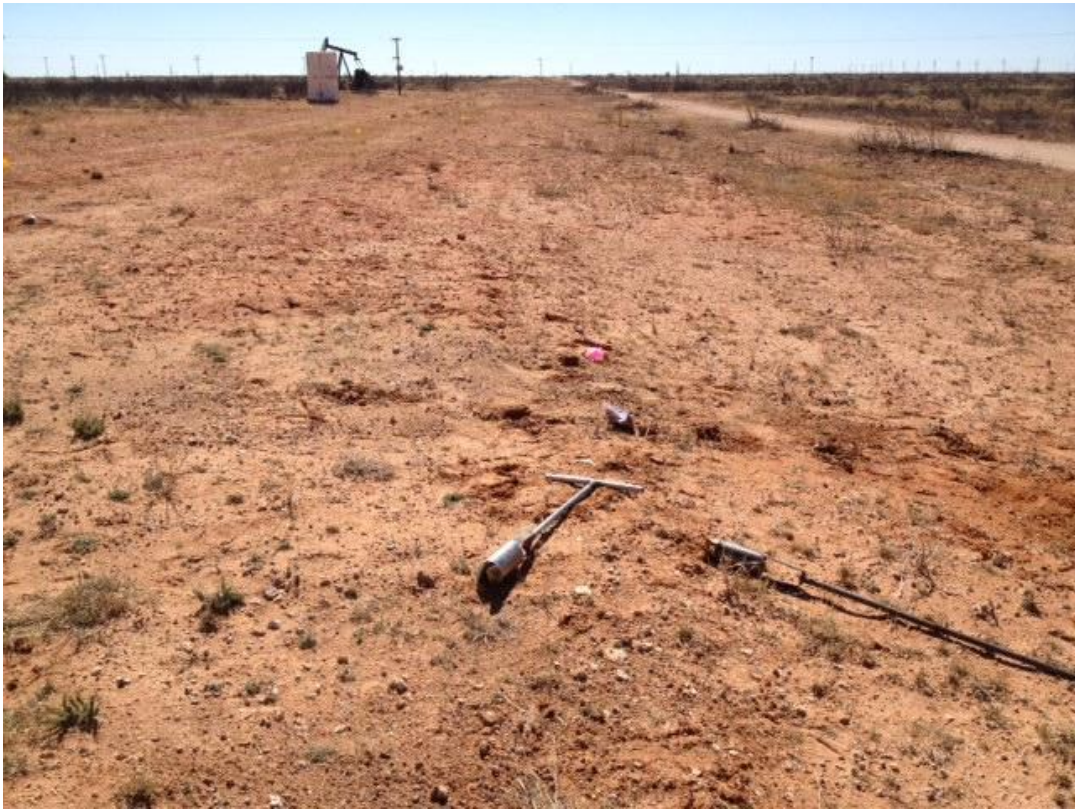
Photograph of the collection of confirmation sidewall soil samples at the Trunk "O" 30" Release Site.

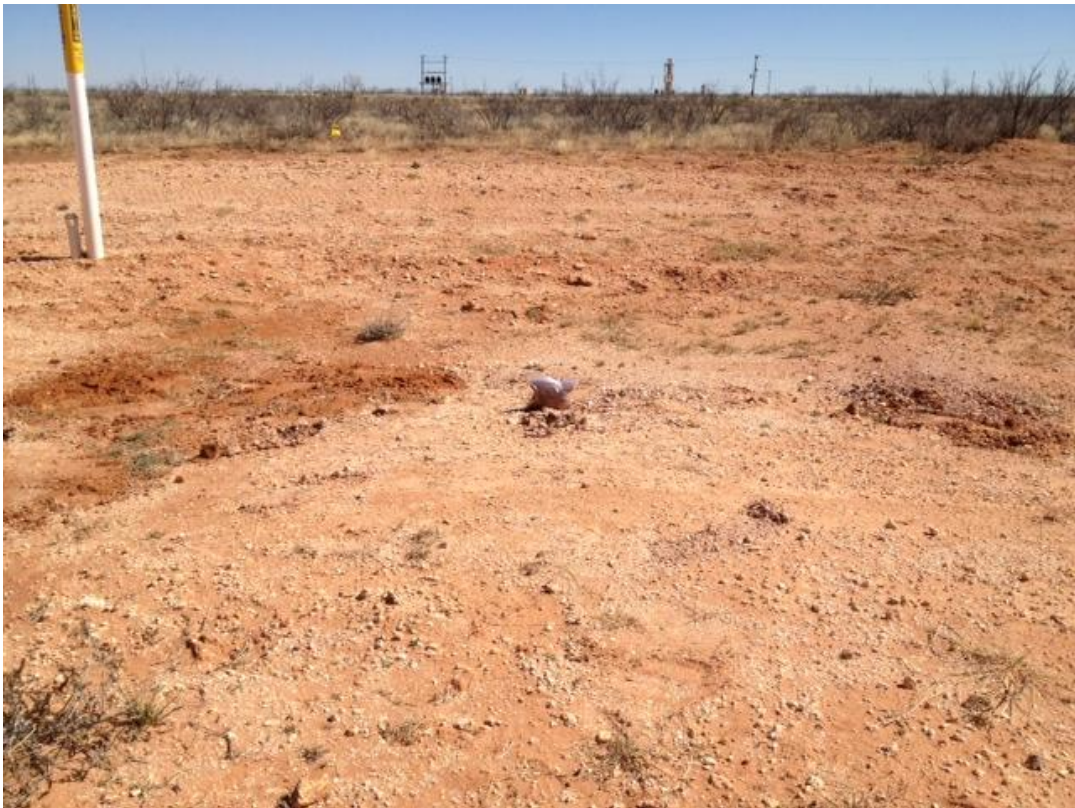
Photograph of the collection of confirmation sidewall soil samples at the Trunk "O" 30" Release Site.

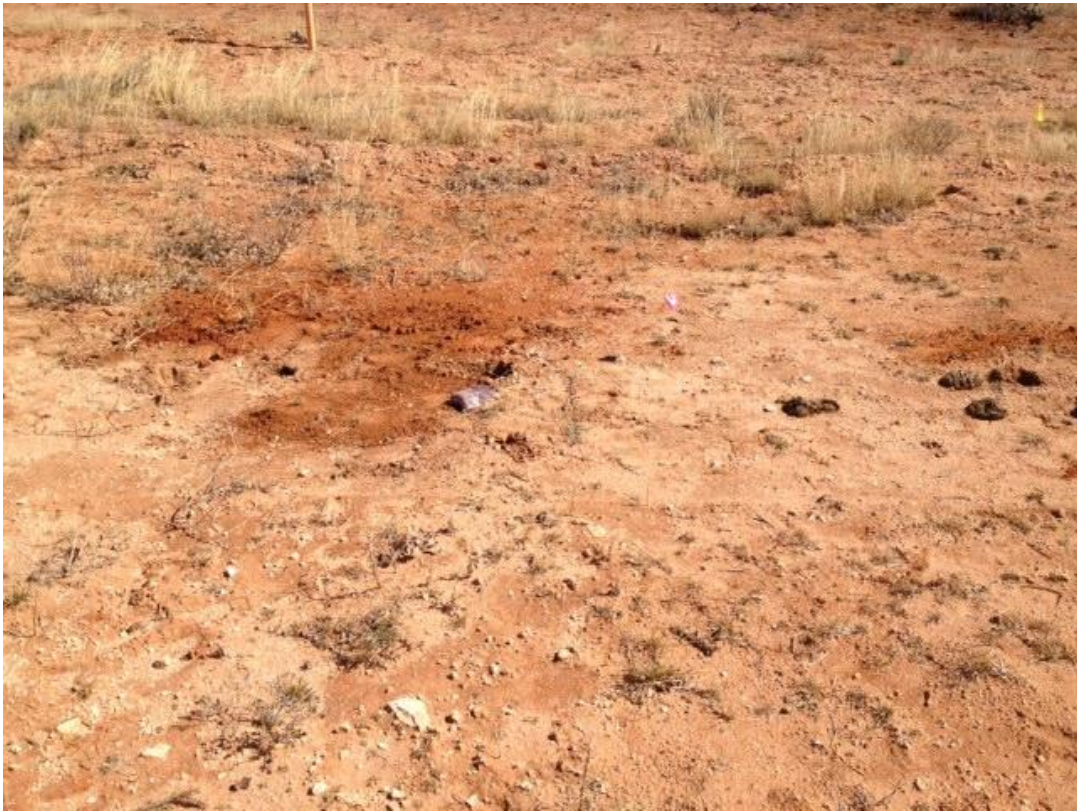
Photograph of the collection of confirmation sidewall soil samples at the Trunk "O" 30" Release Site.

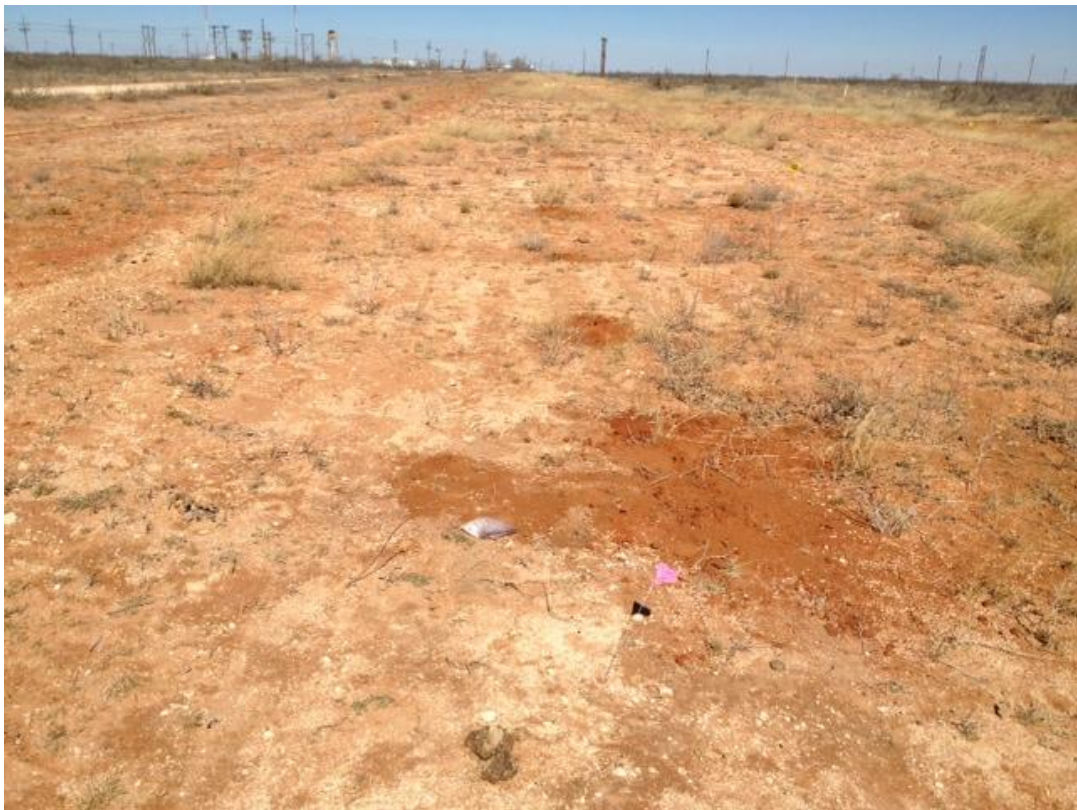
Photograph of the collection of confirmation sidewall soil samples at the Trunk "O" 30" Release Site.
