REMEDIATION SUMMARY & SITE CLOSURE REQUEST

SOUTHERN UNION GAS SERVICES

6" LATERAL (1RP-1877)

NMOCD Reference # 1RP-1877

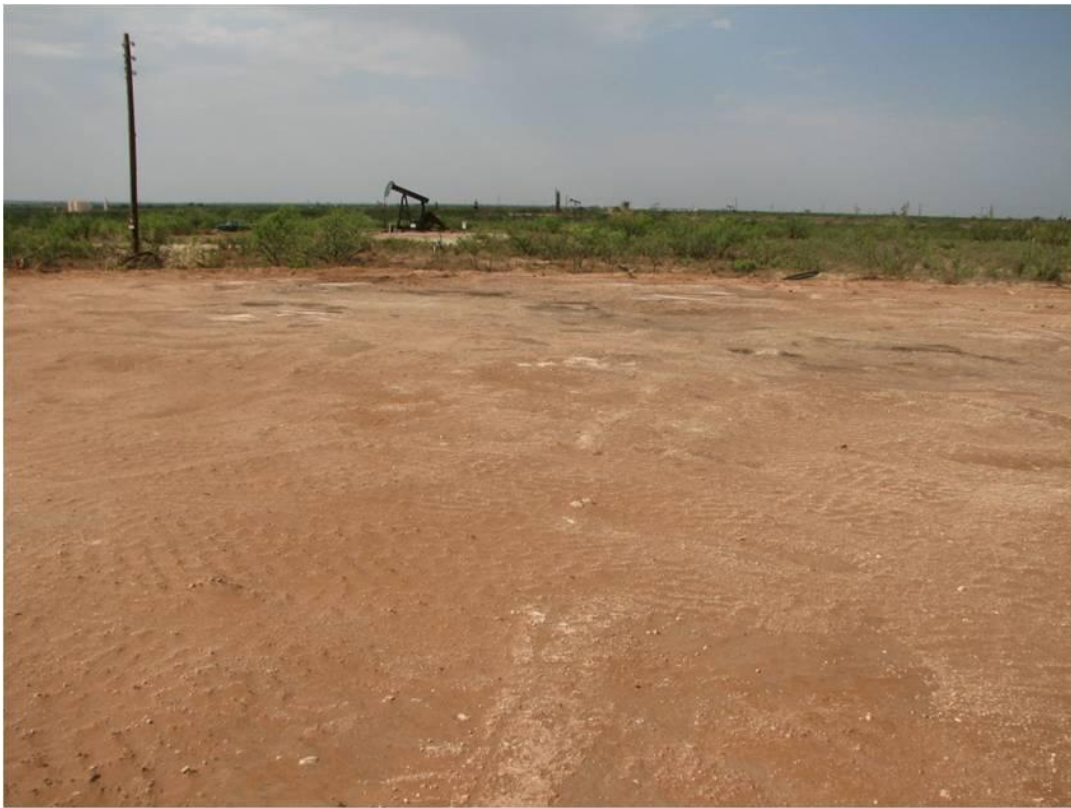
Photograph of the initial release at the 6" Lateral Historical Release Site.

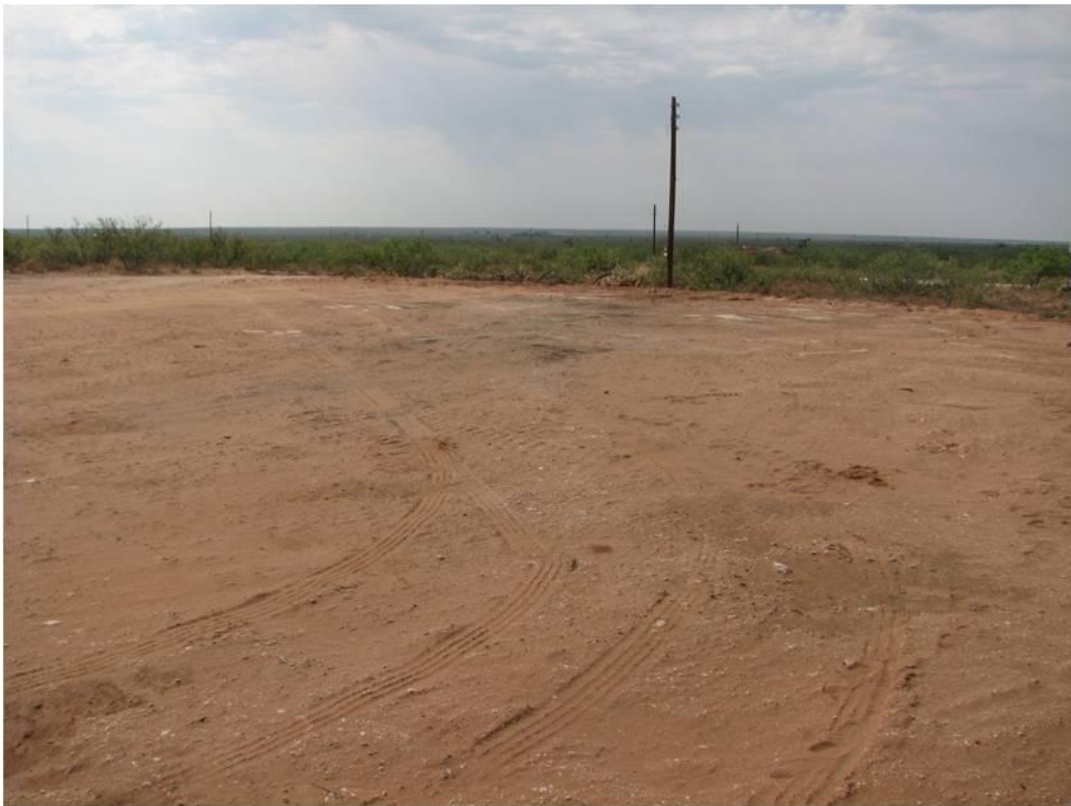
Photograph of the initial release at the 6" Lateral Historical Release Site.

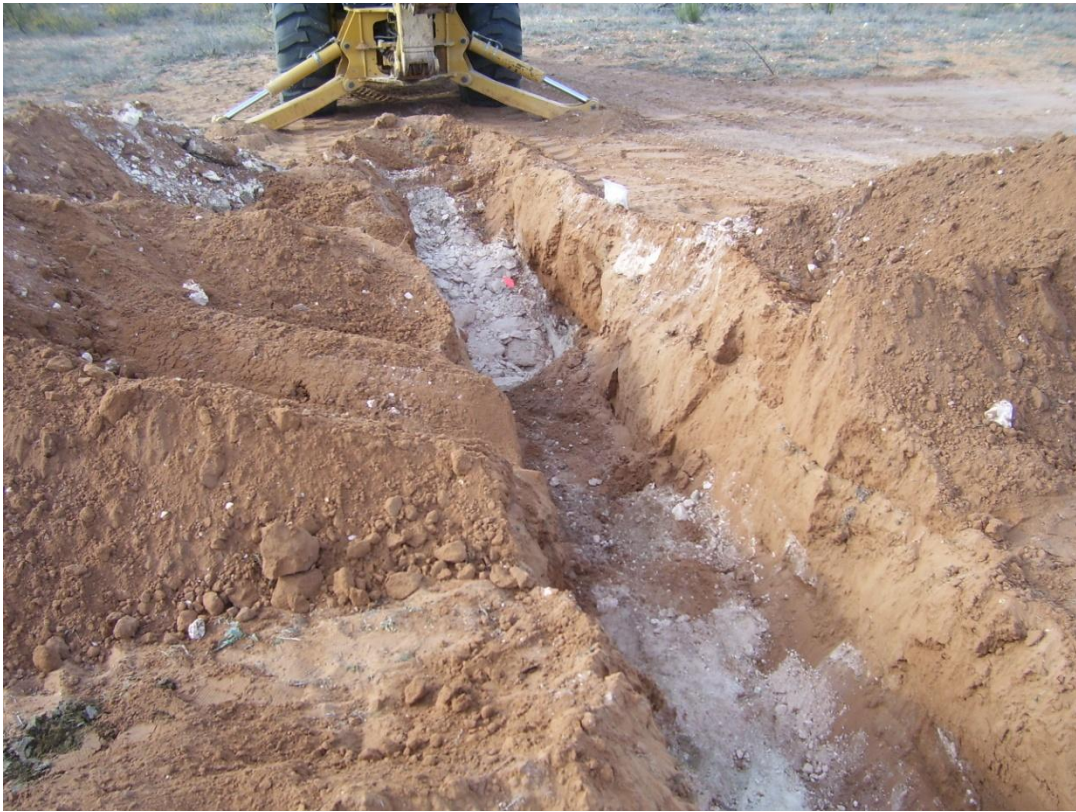
Photograph of delineation activities and confirmation sampling at the 6" Lateral Historical Release Site.

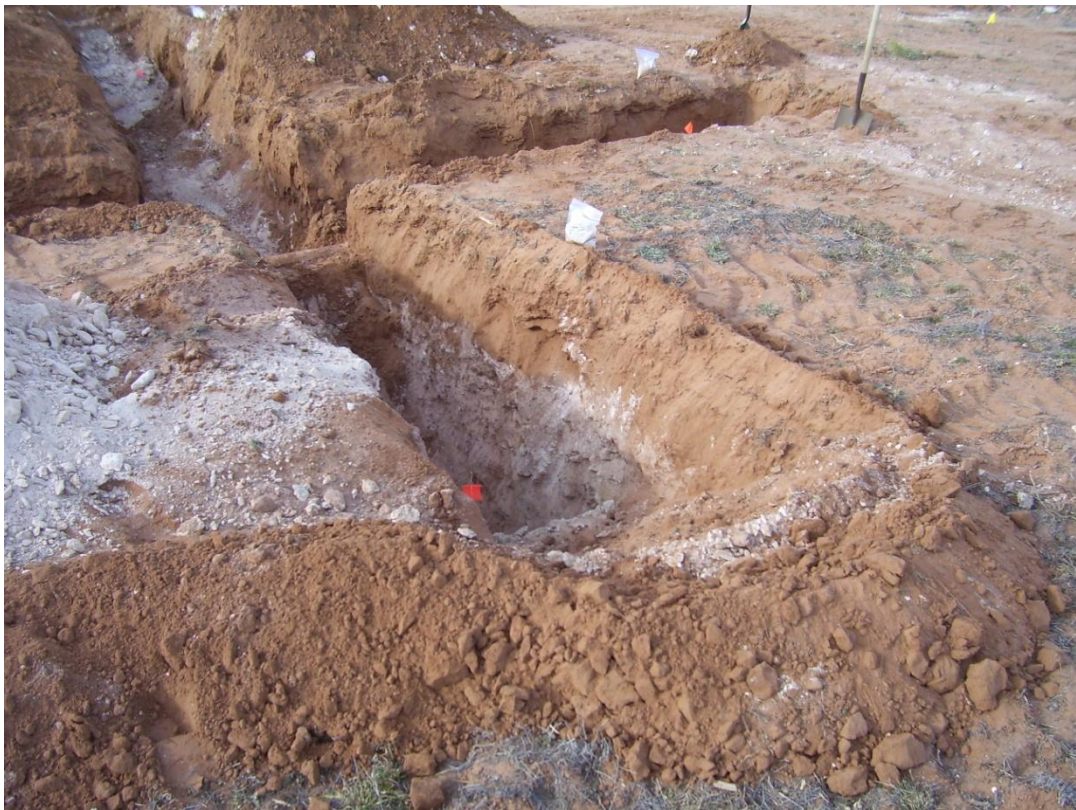
Photograph of delineation activities and confirmation sampling at the 6" Lateral Historical Release Site.

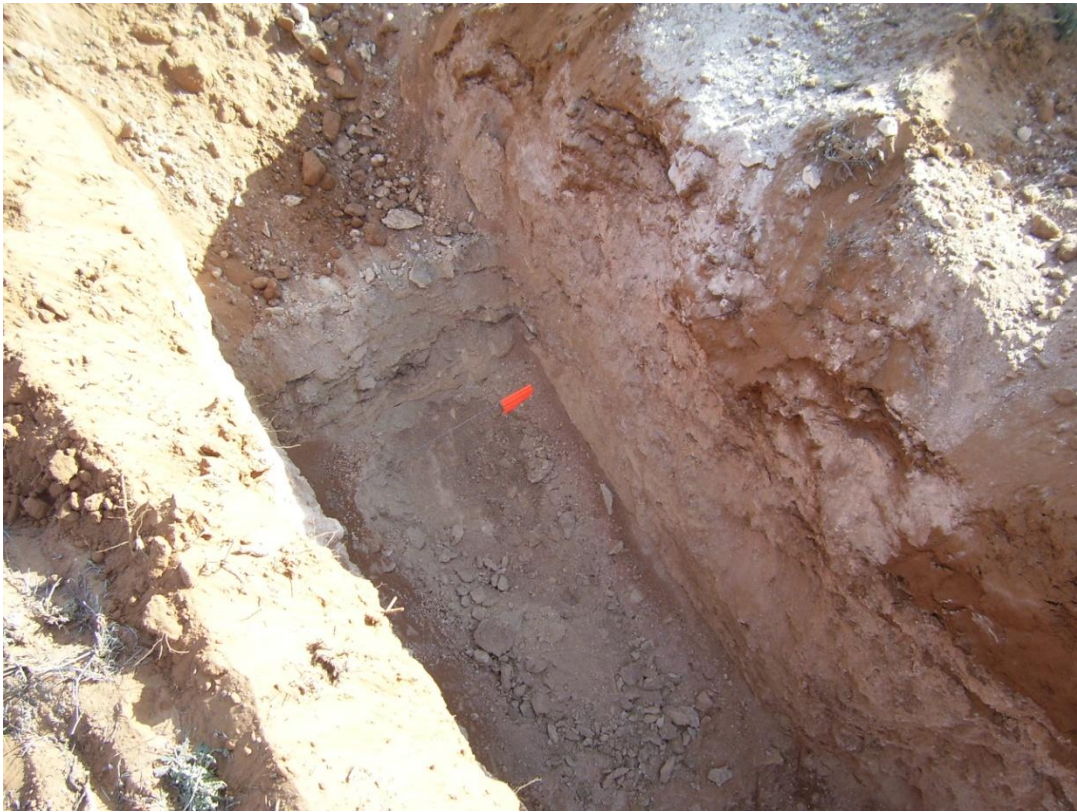
Photograph of delineation activities and confirmation sampling at the 6" Lateral Historical Release Site.

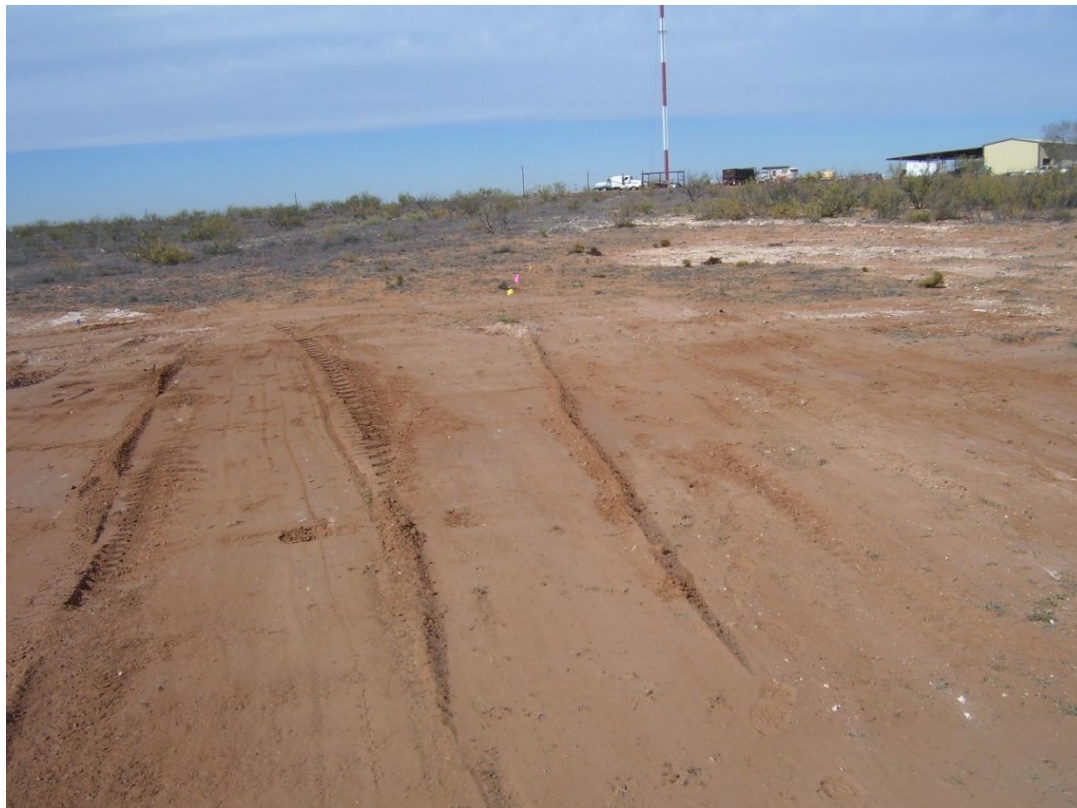
Photograph of 6" Lateral Historical Release Site after delineation activities and confirmation sampling.
