**OXY USA, Inc.
Cotton Draw Unit # 30
Delineation Report and Work Plan**

**Section 21, T25S, R32E
Lea County, New Mexico**

November 11, 2014

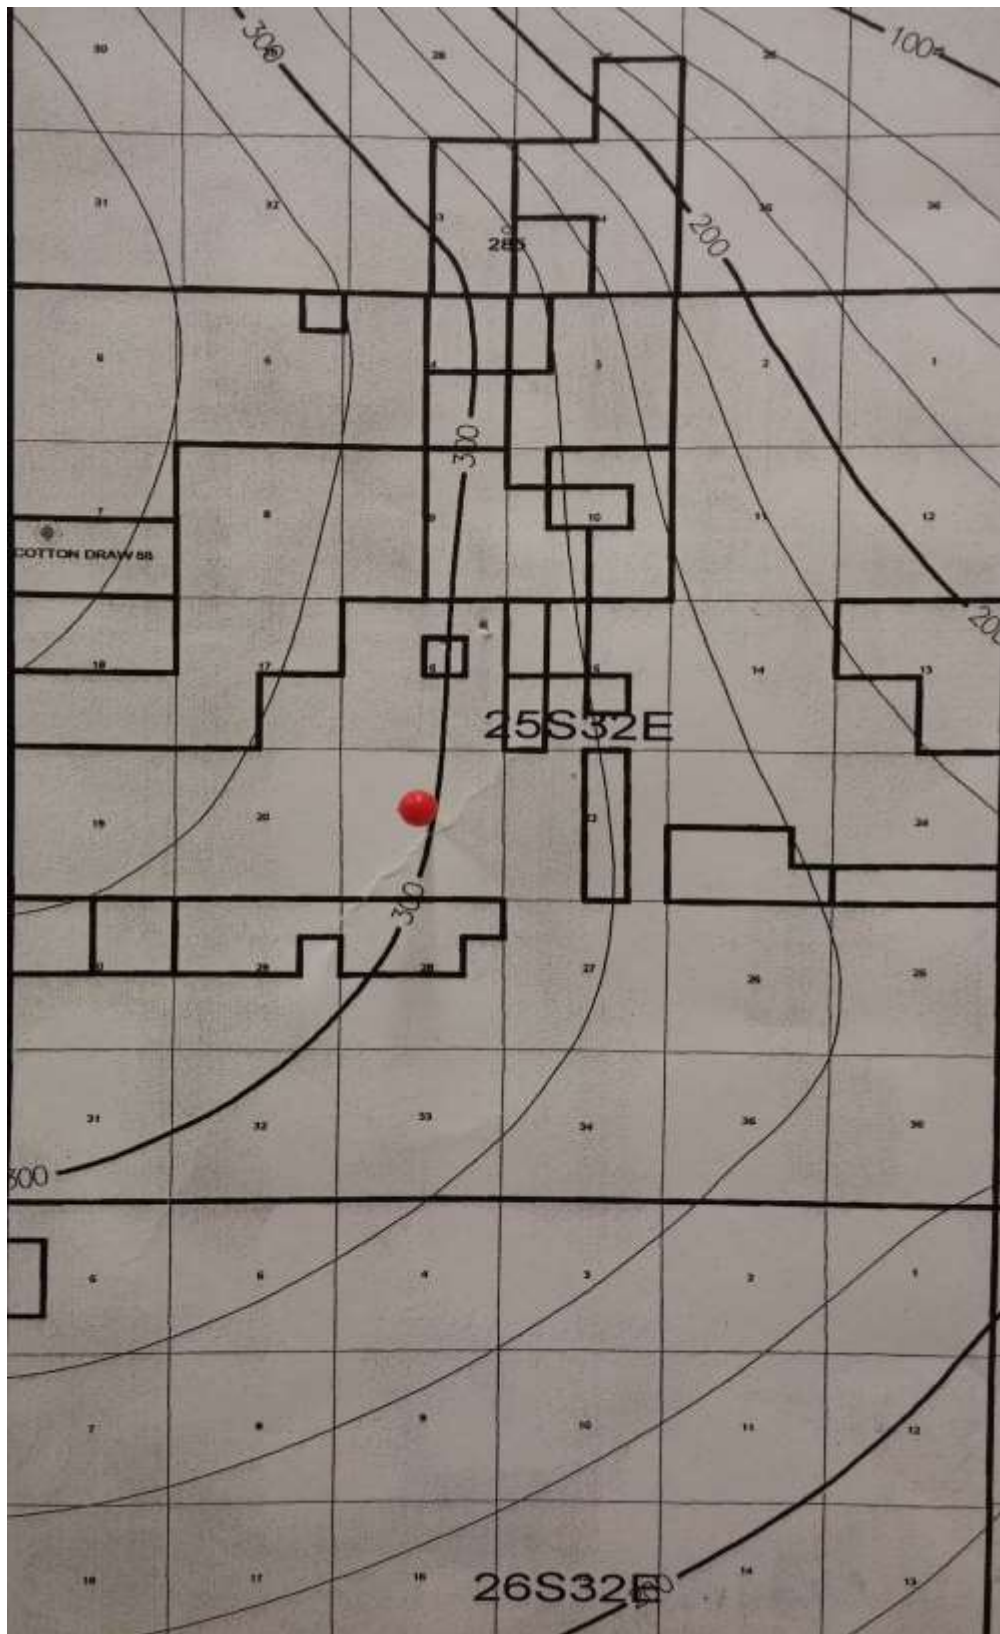
Figure 3
NMOCD Trend Map

The nearest groundwater of record is approximately 3 miles Southeast of the site. The New Mexico Office of State Engineer record is in Section 05 Range 32 East and Township 24 South. The reported depth was 380 feet below ground surface (BGS).
