SEMU DTB Battery 1RP-3233

Termination Request

Unit Letter I, Section 15, Township 20S, Range 37E

**RE: Termination Request
ConocoPhillips SEMU DTB Battery (1RP-3233)
UL/I sec. 15 T20S R37E
API No. 3002506115**

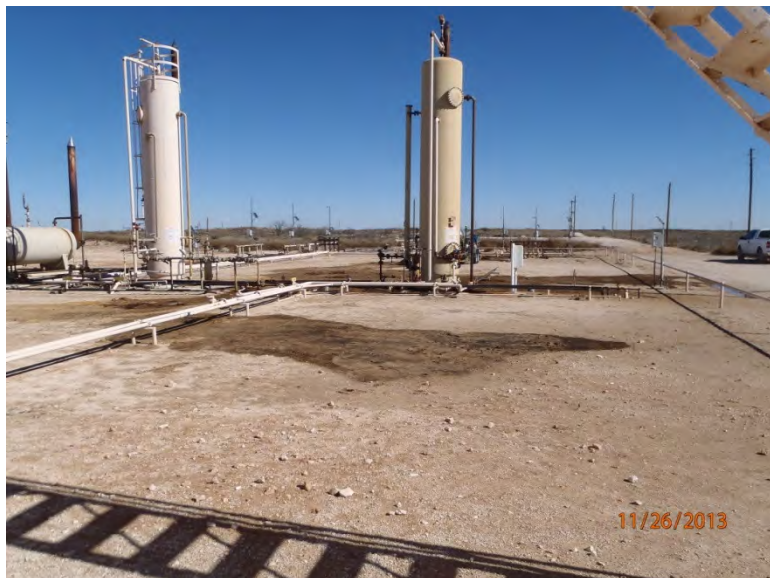
11/26/13

Initial release area, facing east

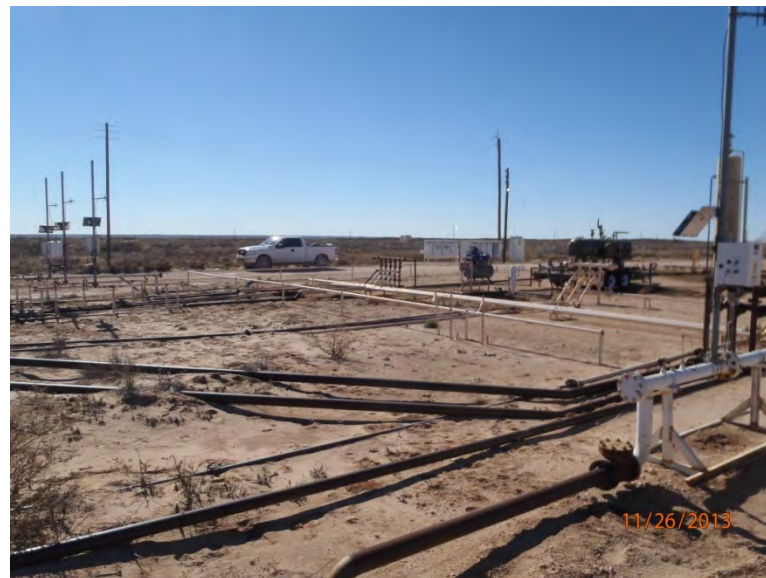
11/26/13

Initial release area, facing southwest

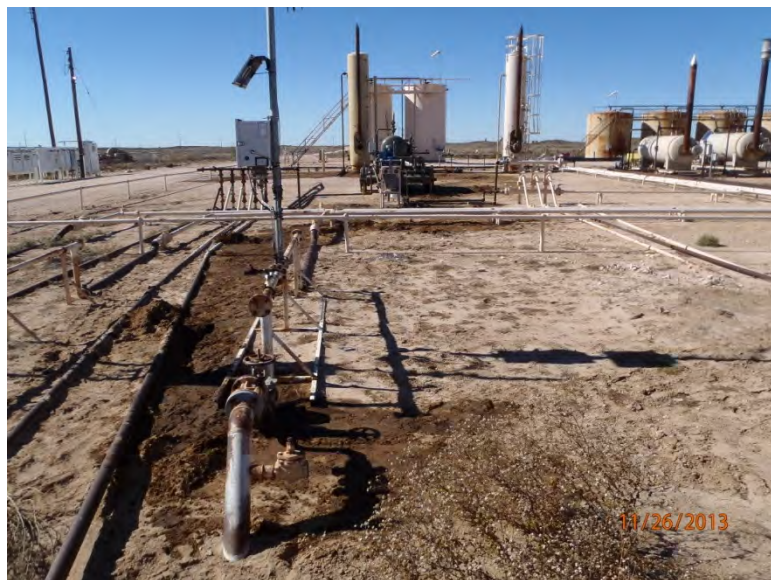
11/26/13

Initial release area, facing west

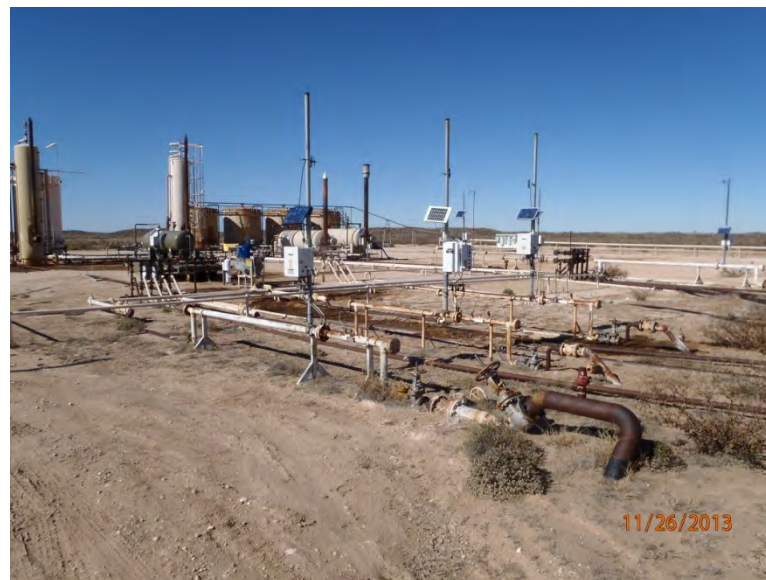
12/26/13

Initial release area, facing northwest

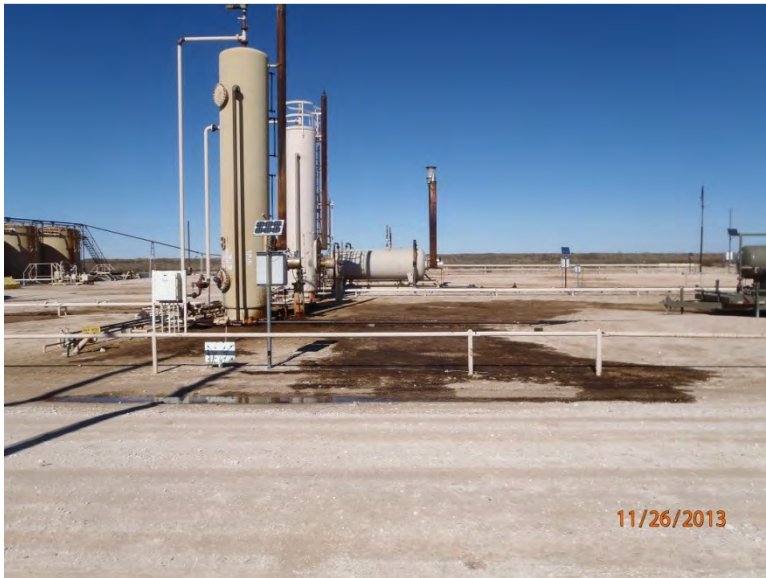
11/26/13

Initial release area, facing north

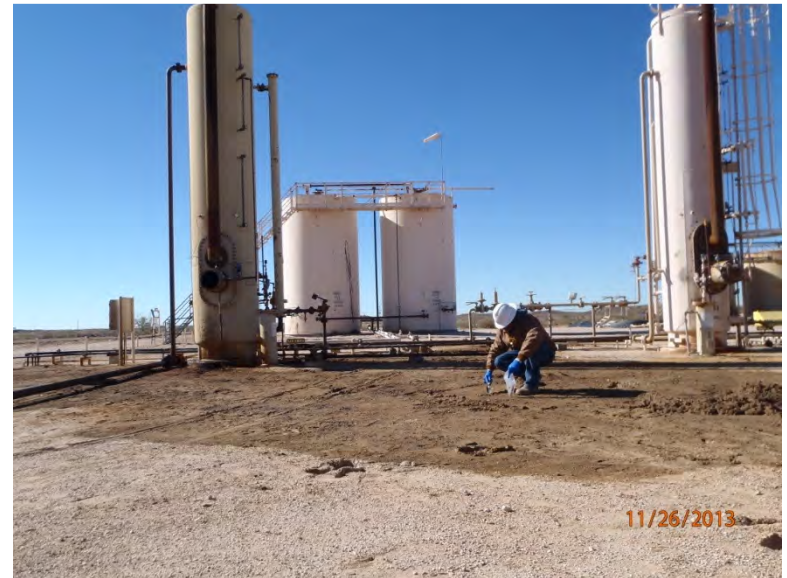
11/26/13

Sample the surface of release, facing west

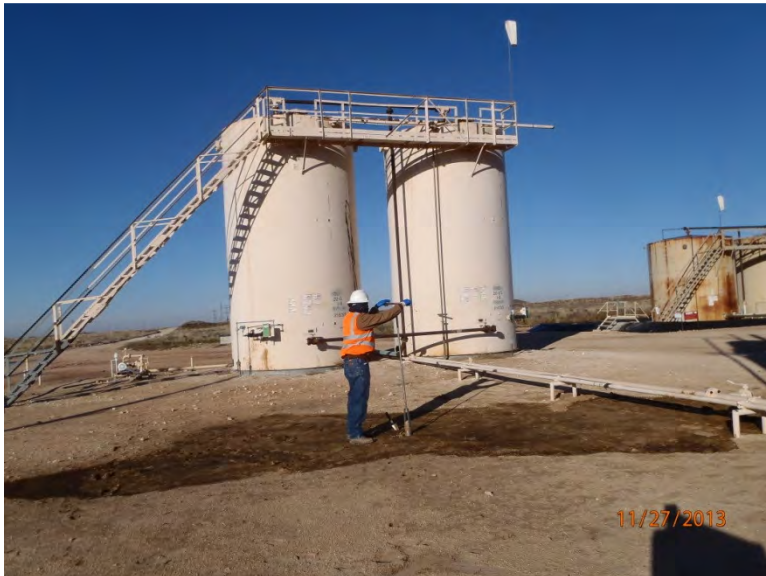
11/27/13

Hand auguring for depth, facing northwest

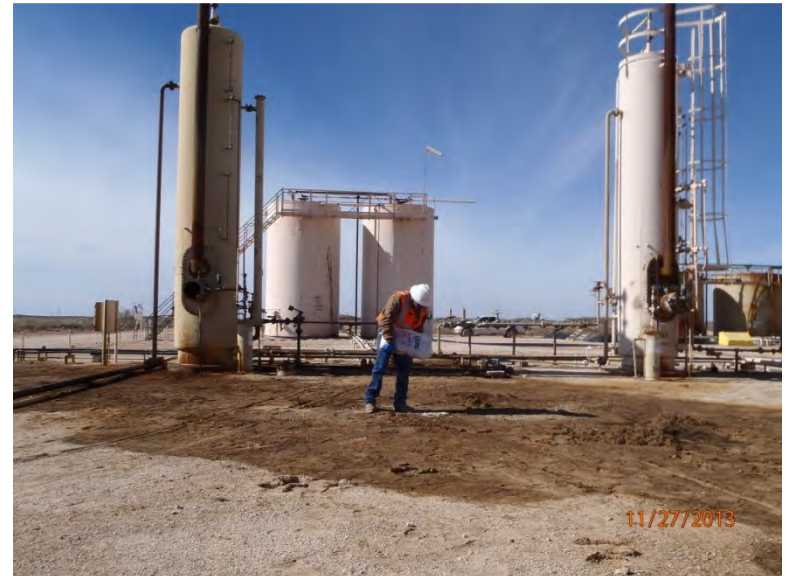
11/27/13

Plugging augur point in total with bentonite, facing west

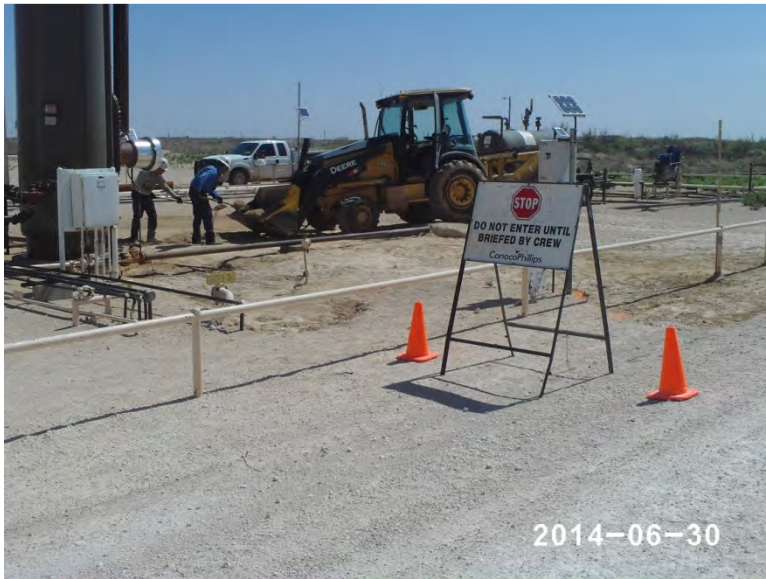
Scraping release by hand, facing southeast 6/30/14

Corrective actions began at the site on June 30th, 2014. The release area was scraped down 6 inches bgs to 1 foot bgs by hand. All excavated soil, for a total of 45 cubic yards, was taken to a NMOCD approved facility for disposal. Once the scrape was completed, a request to backfill the site was sent on July 8th, 2014 to NMOCD and BLM. NMOCD and BLM approved the site to be backfilled on the same day. A total of 20 cubic yards of clay and 45 cubic yards of caliche were imported to the site to serve as backfill. Four inches of clay was backfilled into the scrape and then covered by the imported caliche. A sample of the imported caliche was taken to a commercial laboratory for analysis and returned a chloride result of 64 mg/kg (Appendix B). The backfilled caliche was contoured by hand to the surrounding location.

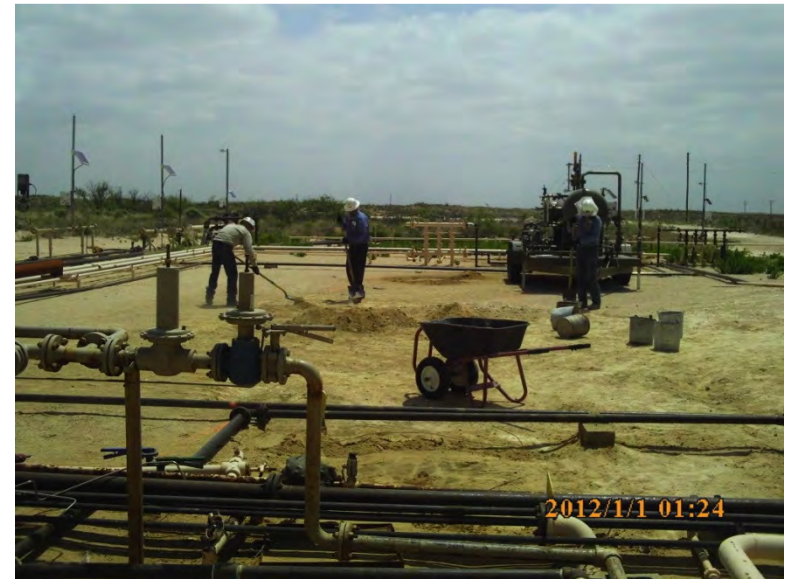
Scraping release by hand, facing east 7/1/14

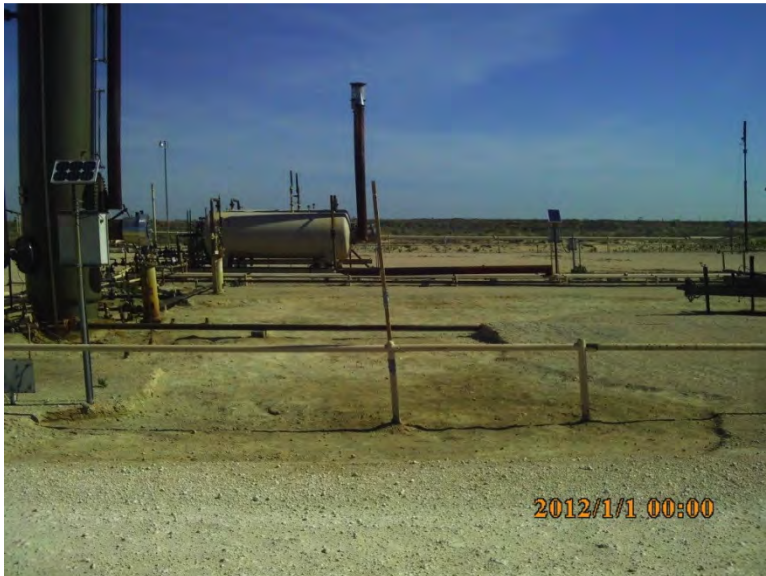
Scrape completed, facing north 7/7/14

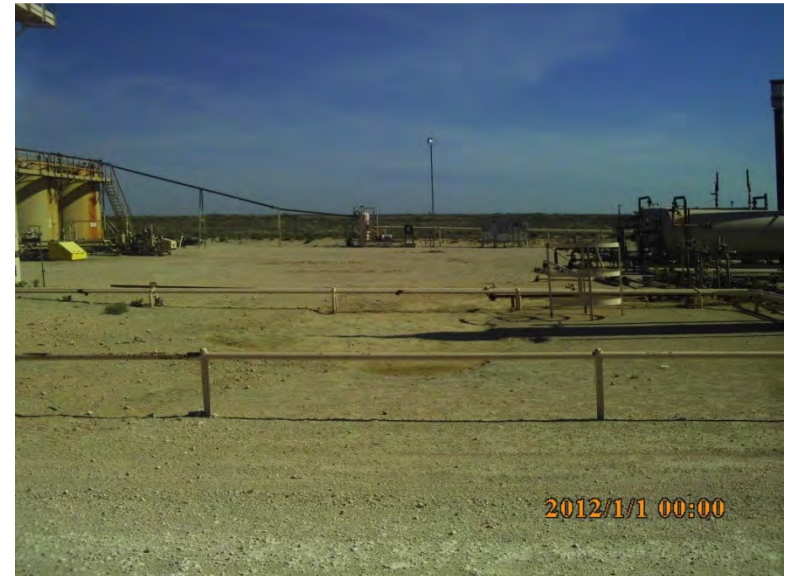
Scrape completed, facing north 7/7/14

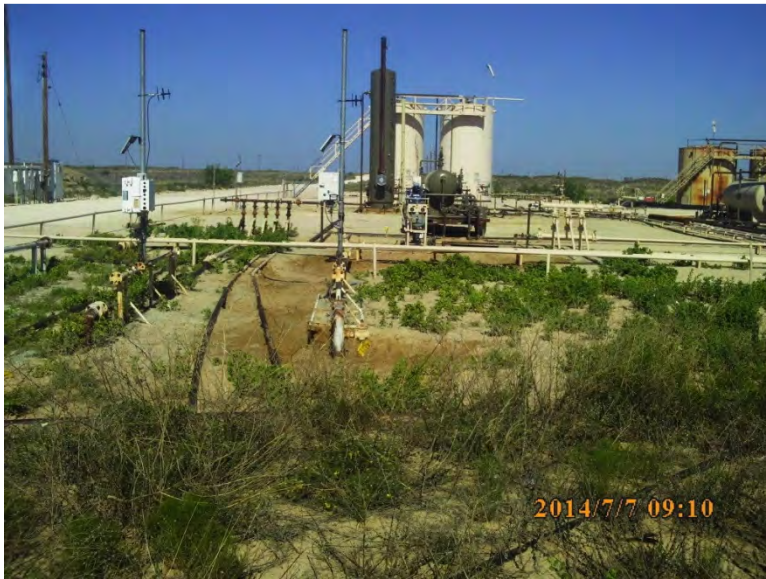
7/7/14

Scrape completed, facing west

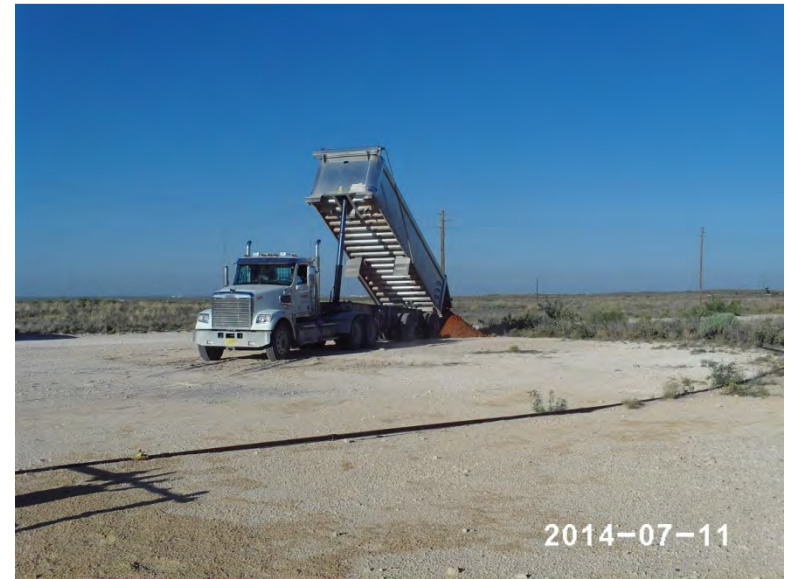
7/11/14

Importing clay, facing southwest

within the tank battery firewall will need to be remediated to below regulatory standards upon final abandonment. On January 3rd, 2014, NMOCD requested clean clay and caliche be imported to the site to serve as backfill. The bottom of the scrape needed to be backfilled with 4 inches of clay covered by 4 inches of caliche, and then the site contoured to the surrounding location.

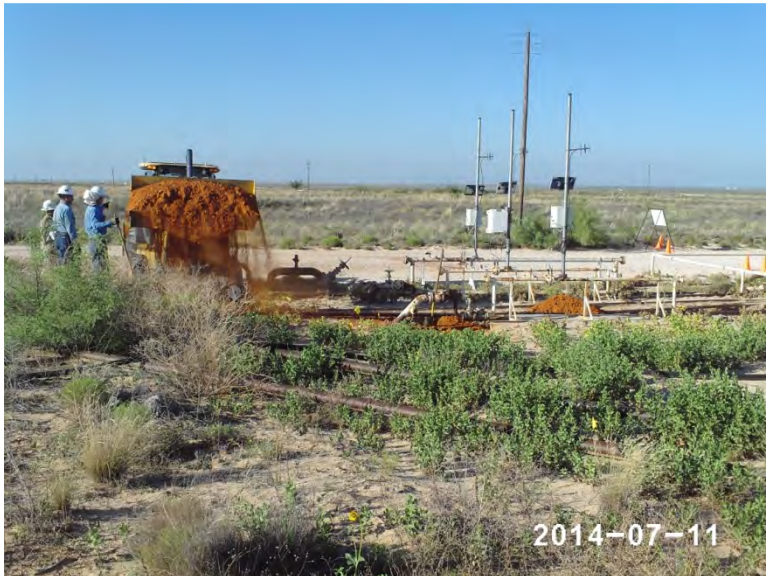
7/11/14

Backfilling site with clay, facing south

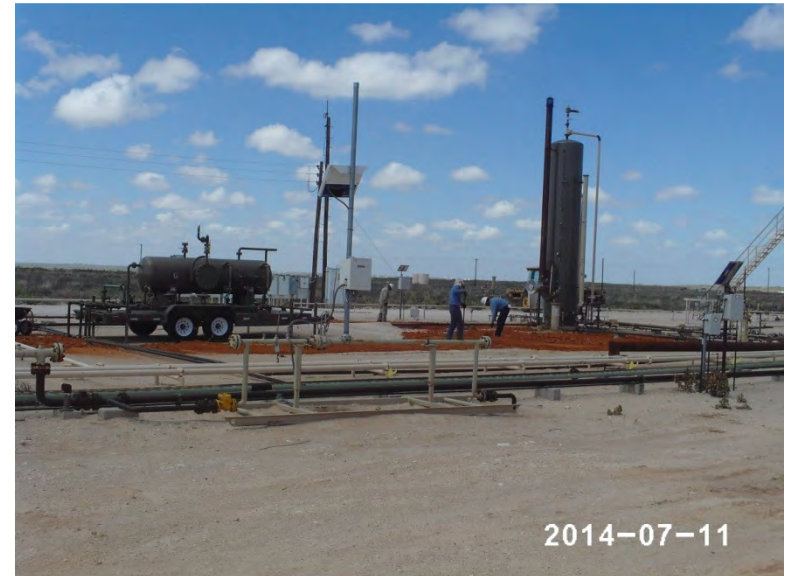
7/11/14

Backfilling site with clay, facing southwest

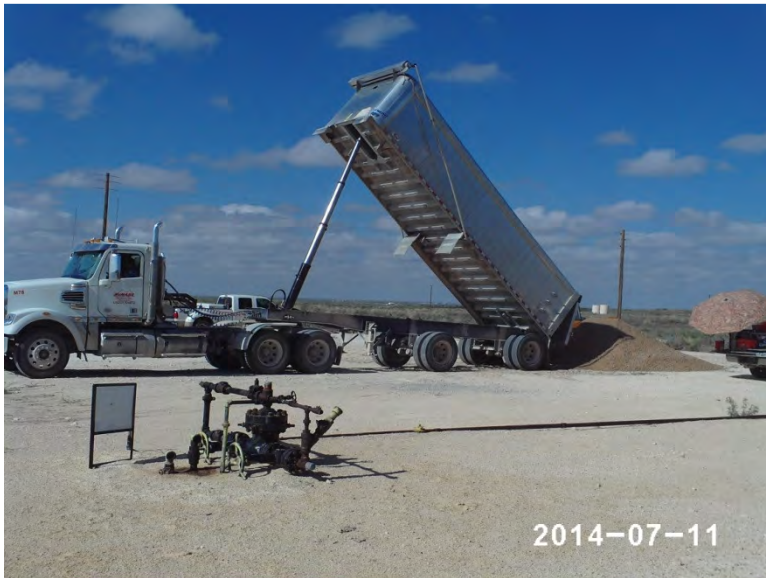
Importing caliche, facing southwest 7/11/14

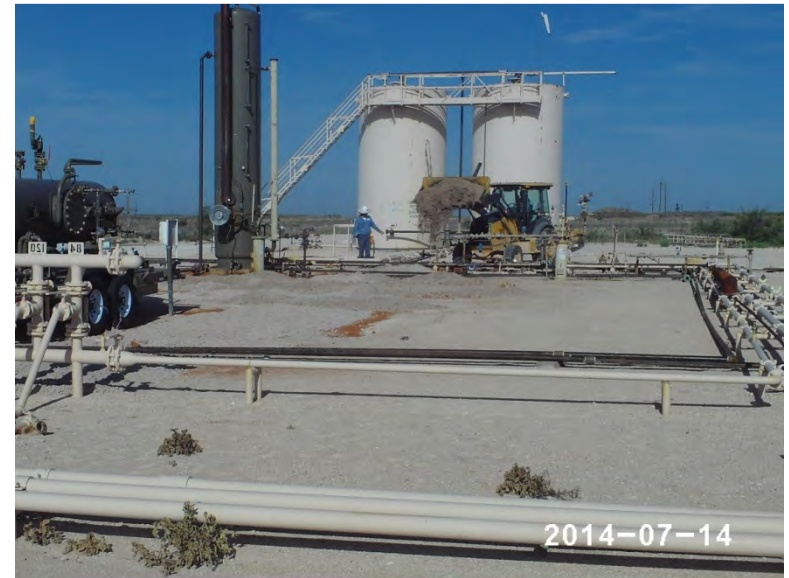
Backfilling the site with caliche, facing west 7/14/14

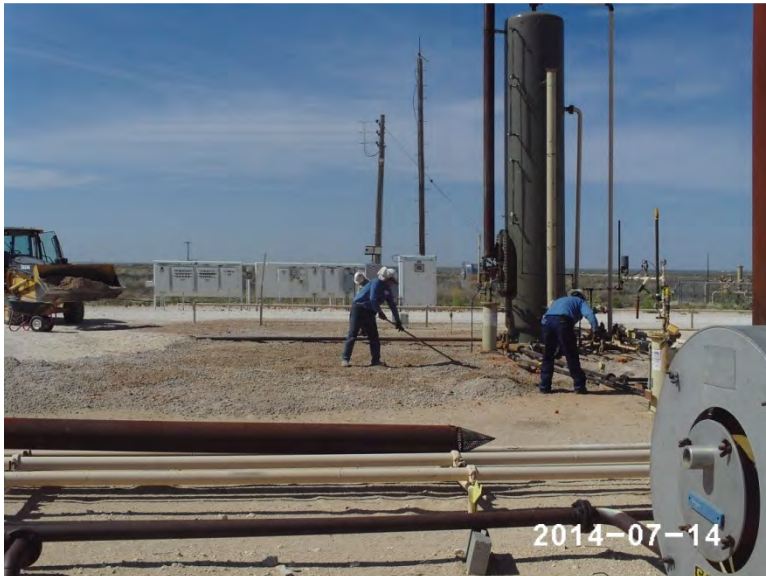
Backfilling the site with caliche, facing south 7/14/14

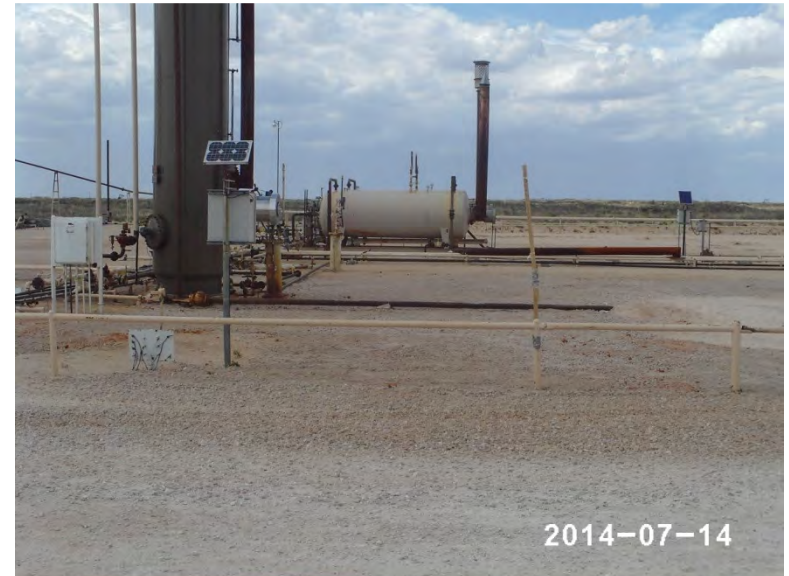
Site completed, facing north 7/14/14

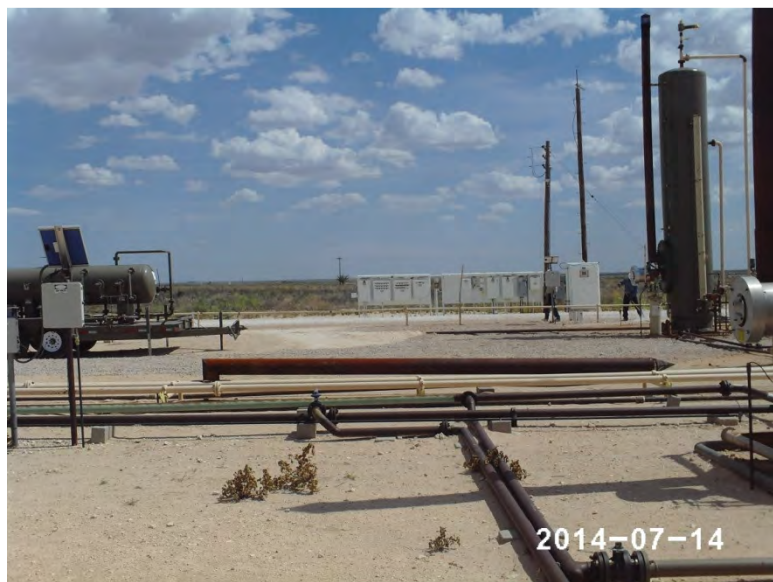
7/14/14

Site completed, facing south

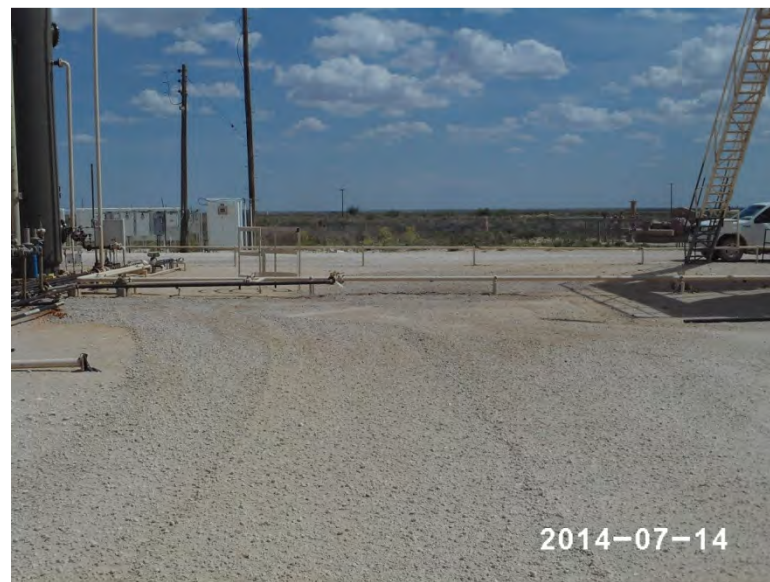
7/14/14

Site completed, facing south
