**Client:** LINN Energy

**Site Name:** 7 Rivers Queen Unit 60

**State Report No.:** 1RP-3213

Re: Corrective Action Plan  
LINN Energy, Seven Rivers Queen Unit 60  
API No.: 30-025-28122  
Legal: Unit L- Sec 35 – T22S – R36E, Lea Co., NM  
GPS: 32.3482077157592, -103.257434938142

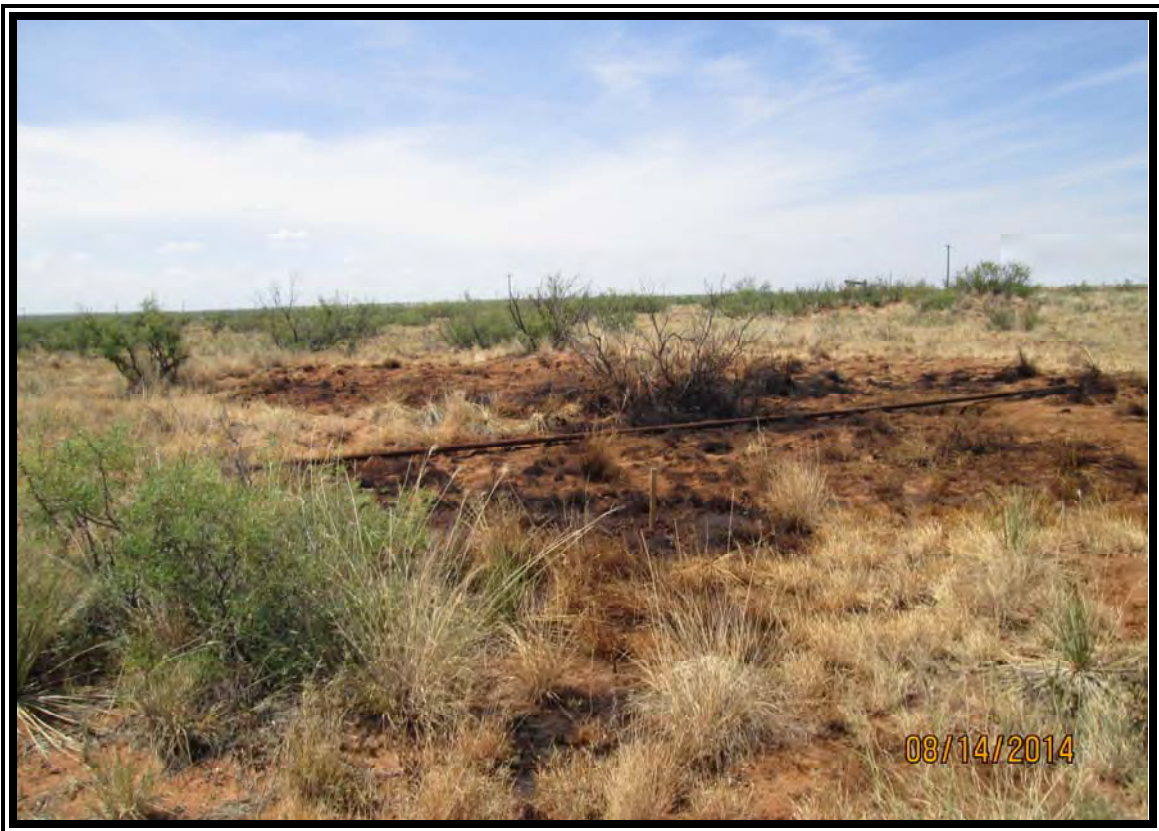
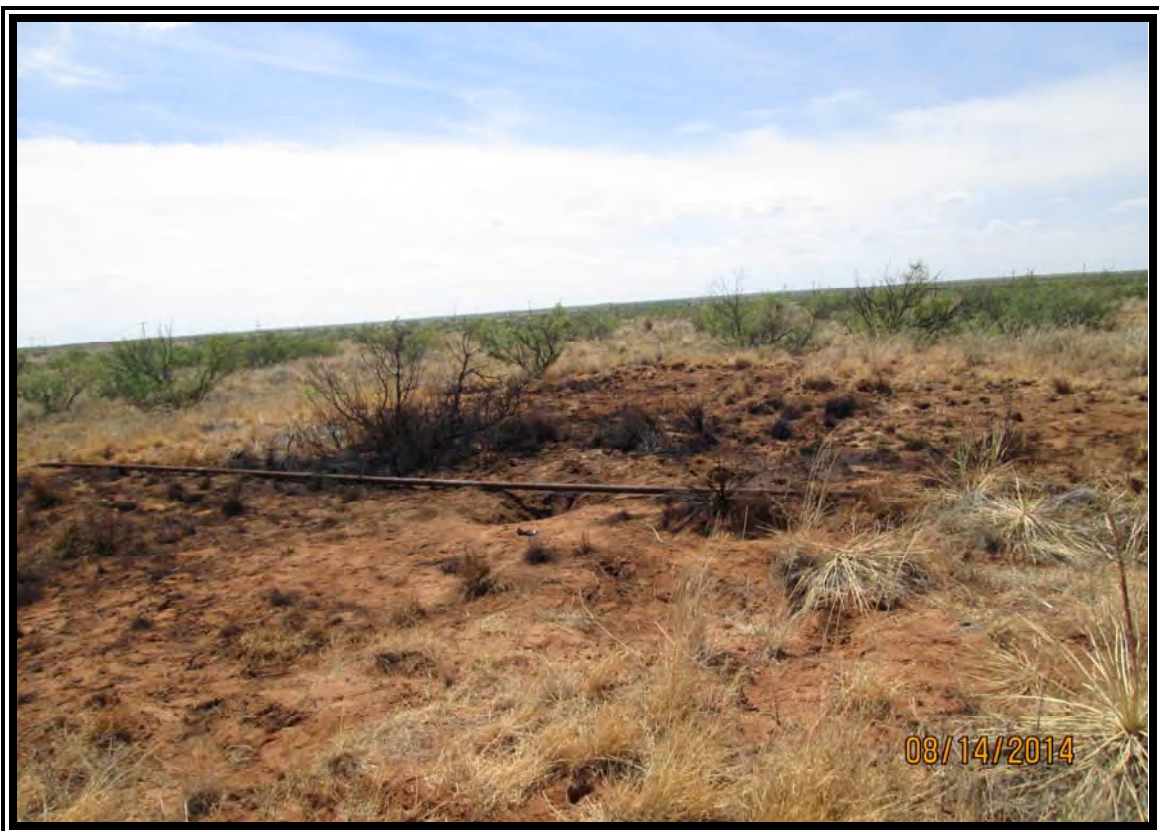
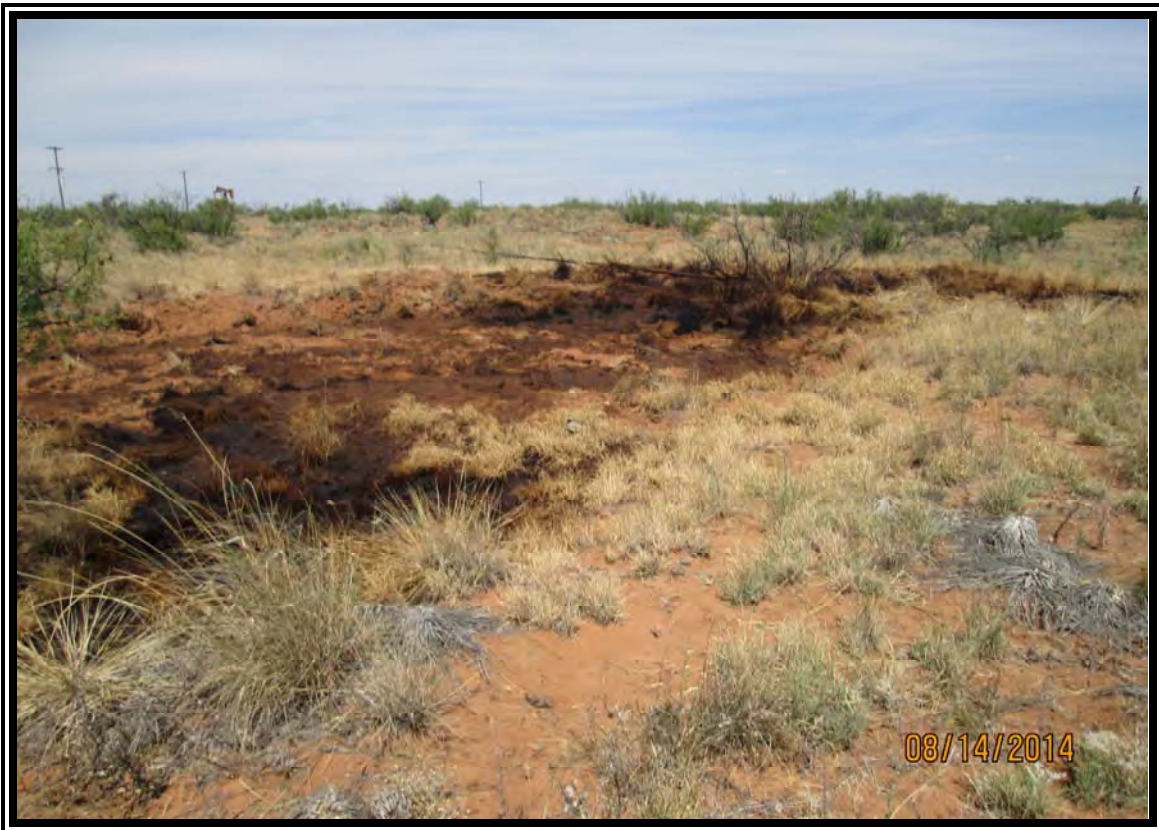
Spill area before excavation.

Impacted soils above regulatory threshold levels were manually and mechanically excavated from the spill area.

The affected area was excavated and hauled to Lealand for disposal. The bottom of the excavation still has elevated levels of chlorides ranging from 1800 to 5040 mg/kg. The presence of lines restricted further excavation due to safety concerns. Two (2) soils borings via hand auger were advanced within the bottom of the excavation to attempt to delineate the vertical extent of the impact. SP2 400 mg/kg at 12', SP3 272 mg/kg at 18'. An OCD approved calcium amendment was installed to the bottom of the excavation (gypsum) then backfilled with clean compacted material to within 1.5 – 2 feet of surface then the backfill was completed with compatible soil which is conducive to growing vegetation. Then the site was seeded with an approved BLM mix.

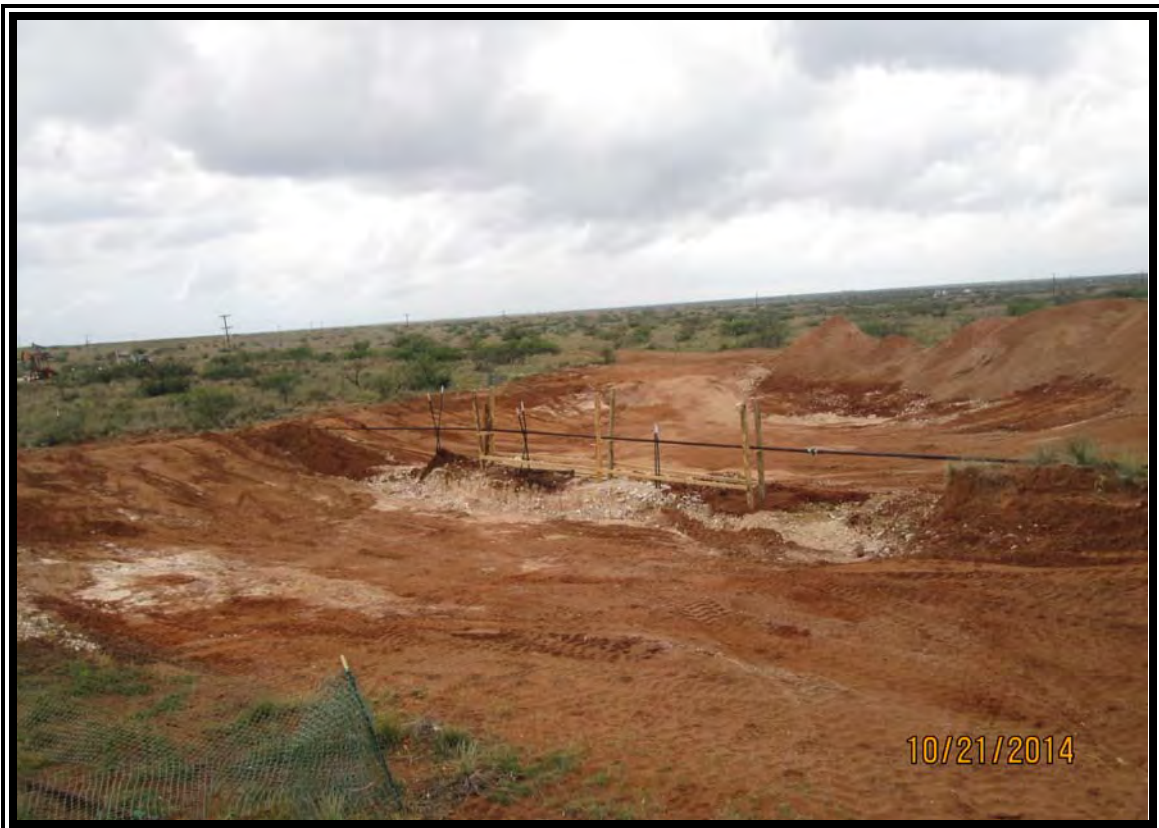
Spill area during excavation.

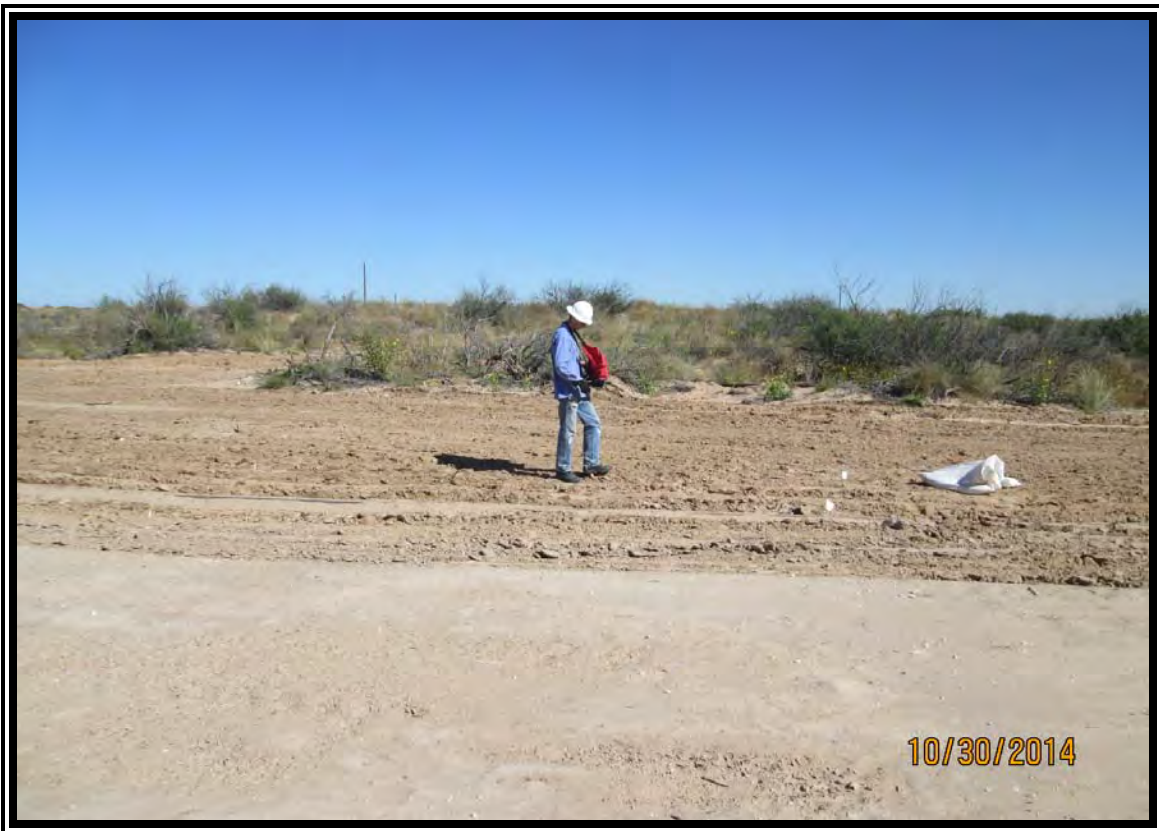
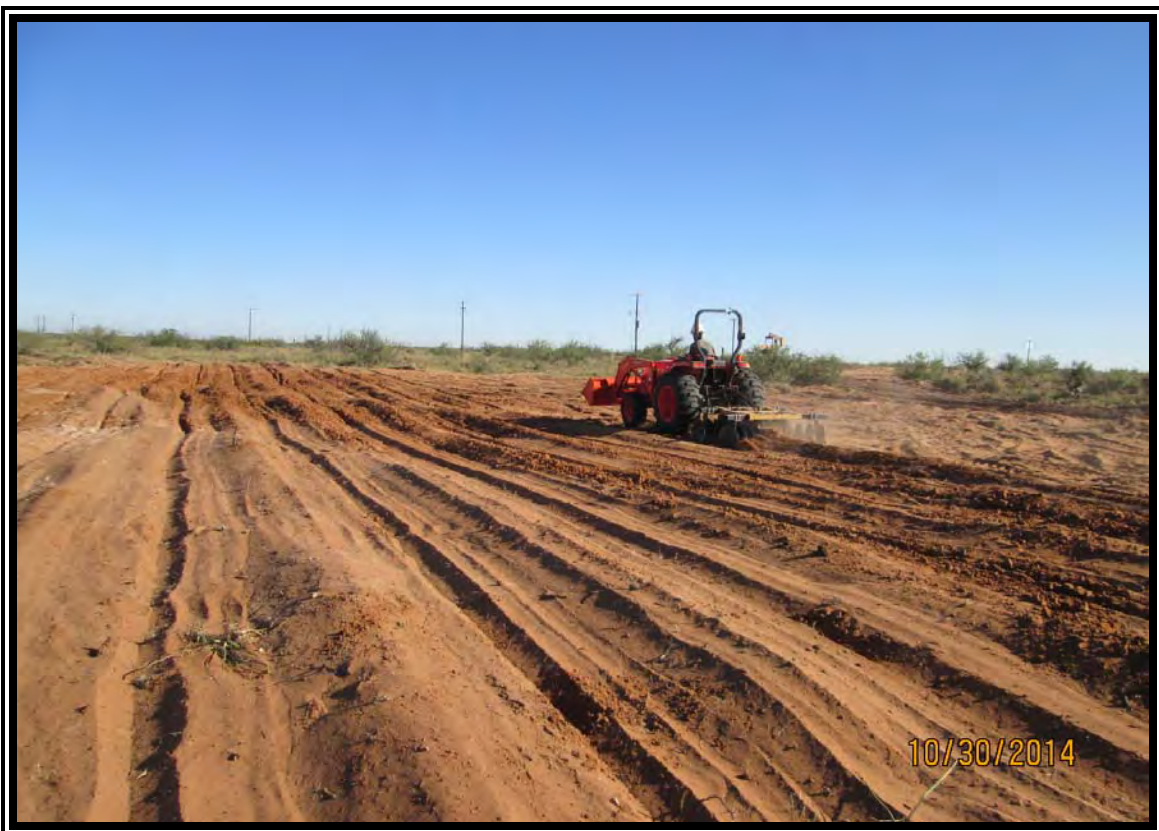
Site being seeded.

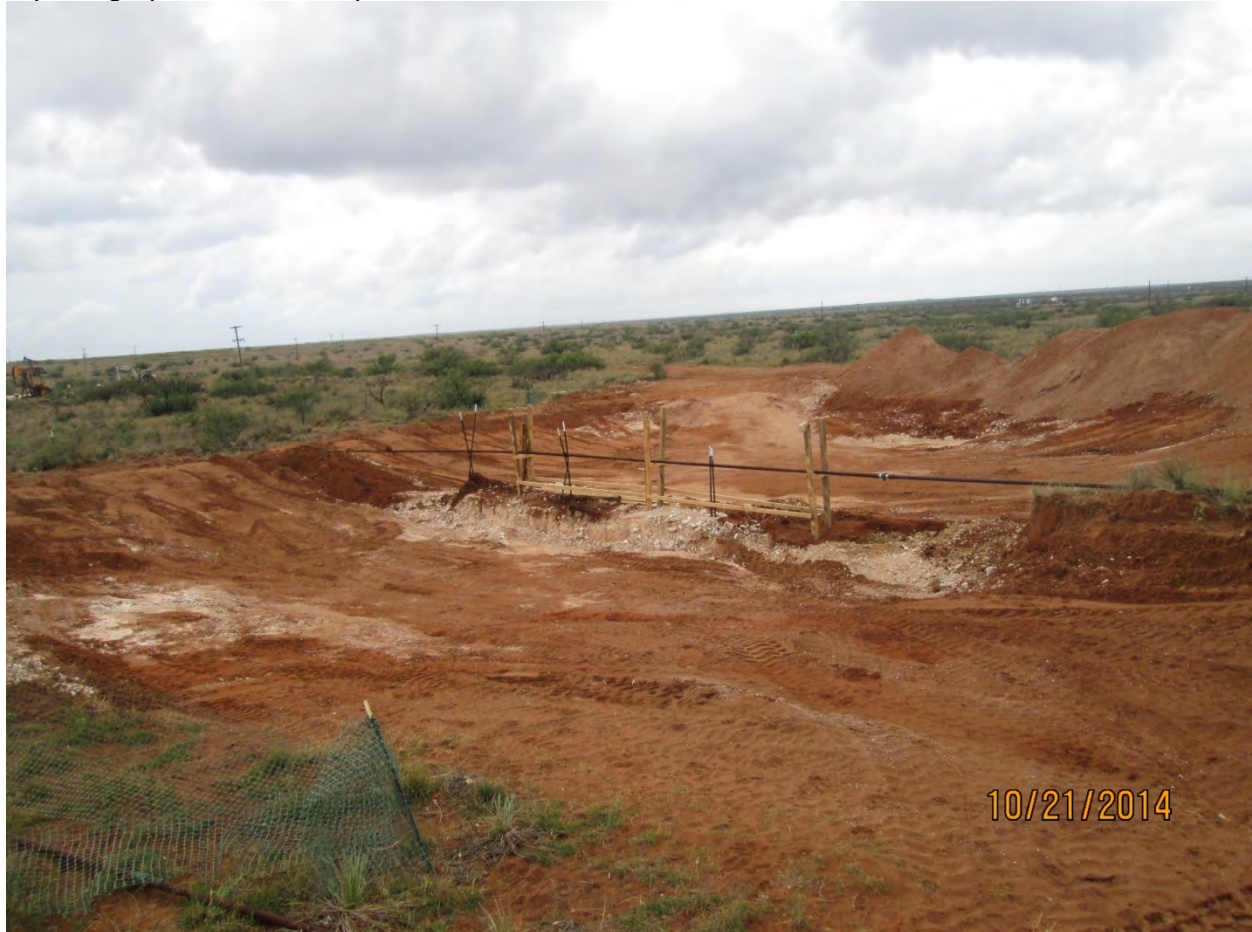
A photograph of the site is provided below:

After review of the above options, LINN believes, the best approach is Option 2, utilizing the application of a calcium amendment to the bottom of the excavation (gypsum) then backfill with clean compacted fill material to within 1.5 – 2 feet of surface then complete the backfill with compatible soil which is conducive to growing vegetation. Using gypsum will effectively ensure that any residual chlorides in the bottom of the excavation will not migrate further vertically and not cause any adverse impact to the reclamation of the site.

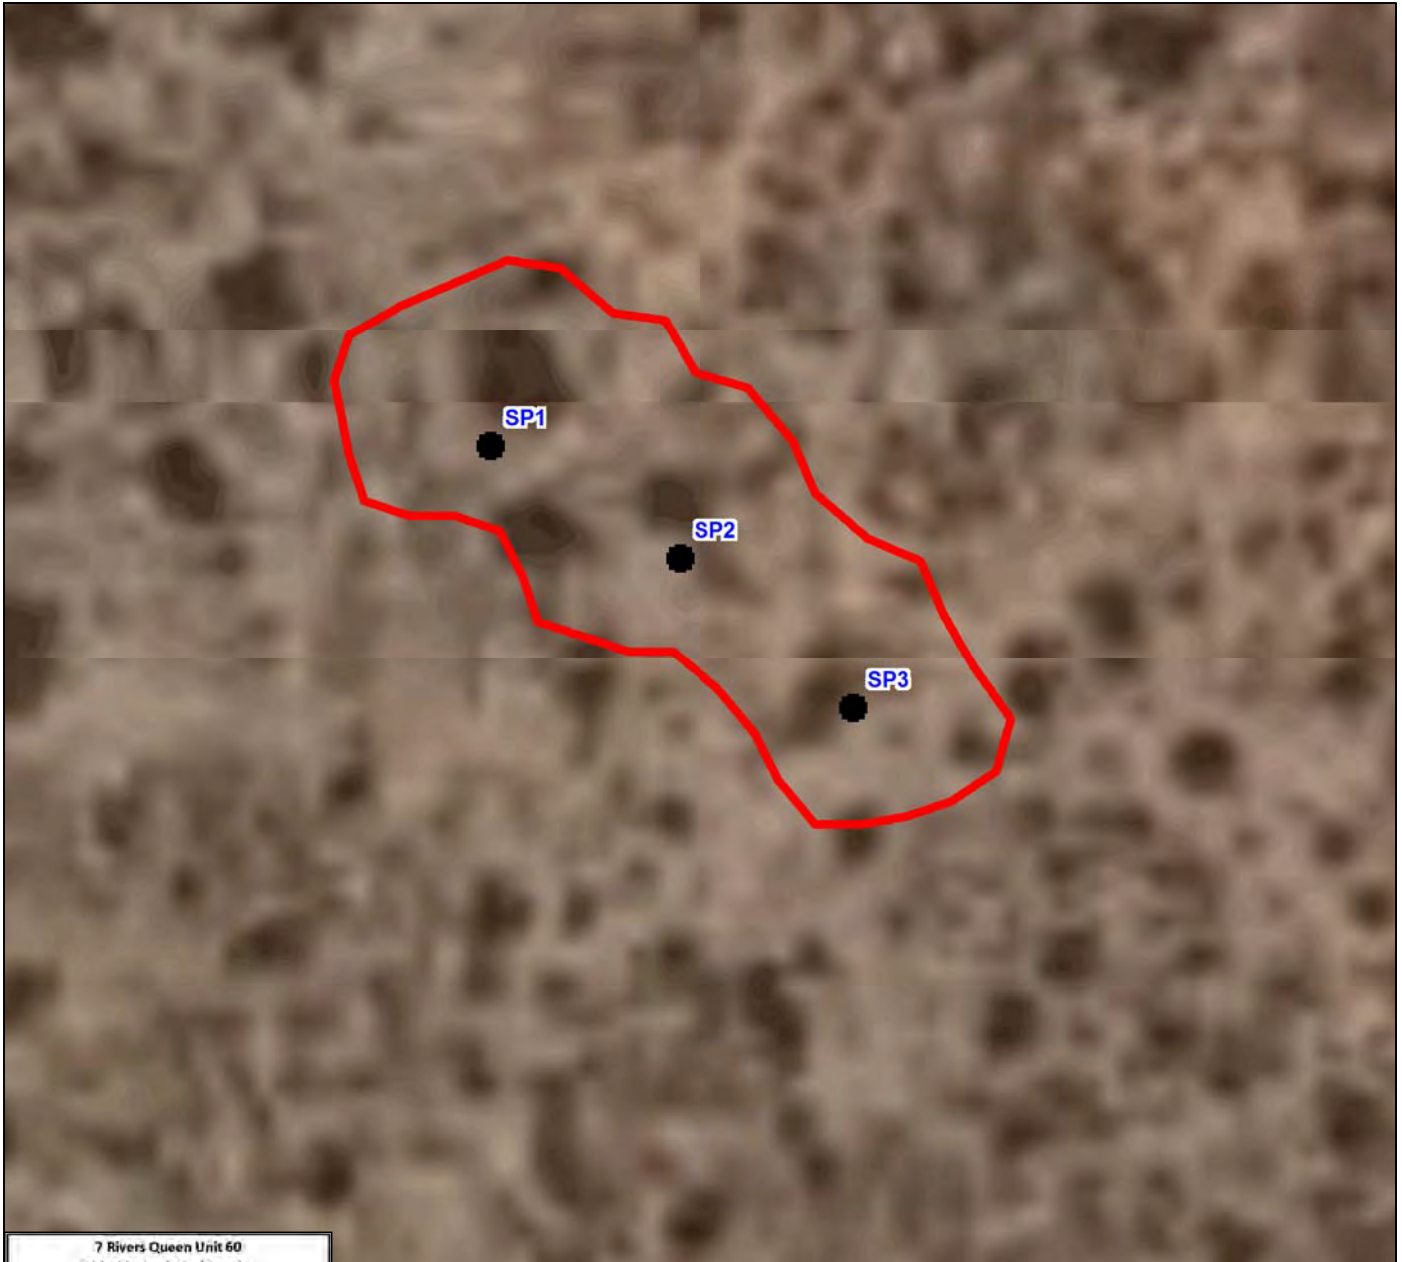
7 Rivers Queen Unit 60 Chloride Analytical Results October 14, 2014			
Results			
Sample Date	Sample I.D.	Depth (Feet)	Chlorides (mg/kg)
10/14/2014	SP1 Bottom	6	1800
10/14/2014	SP1 West Wall	3	48
10/14/2014	SP1 South Wall	3	32
10/14/2014	SP1 North Wall	3	<16.0
10/14/2014	SP2 Bottom	6	3760
10/14/2014	SP2 South Wall	3	<16.0
10/14/2014	SP2 North Wall	3	16
10/14/2014	SP3 Bottom	6	5040
10/14/2014	SP3 East Wall	3	96
10/14/2014	SP3 South Wall	3	144
10/14/2014	SP3 North Wall	3	<16.0
