REMEDIATION SUMMARY & SITE CLOSURE REQUEST

**PLAINS PIPELINE, LP
LYNCH SOUTH TO JAL 16-INCH SUMP
Plains SRS #2014-060
Lea County, New Mexico
Unit Letter "O" (SW/SE), Section 32, Township 25 South, Range 37 East
Latitude 32.081629° North, Longitude 103.181101° West**

December 2014

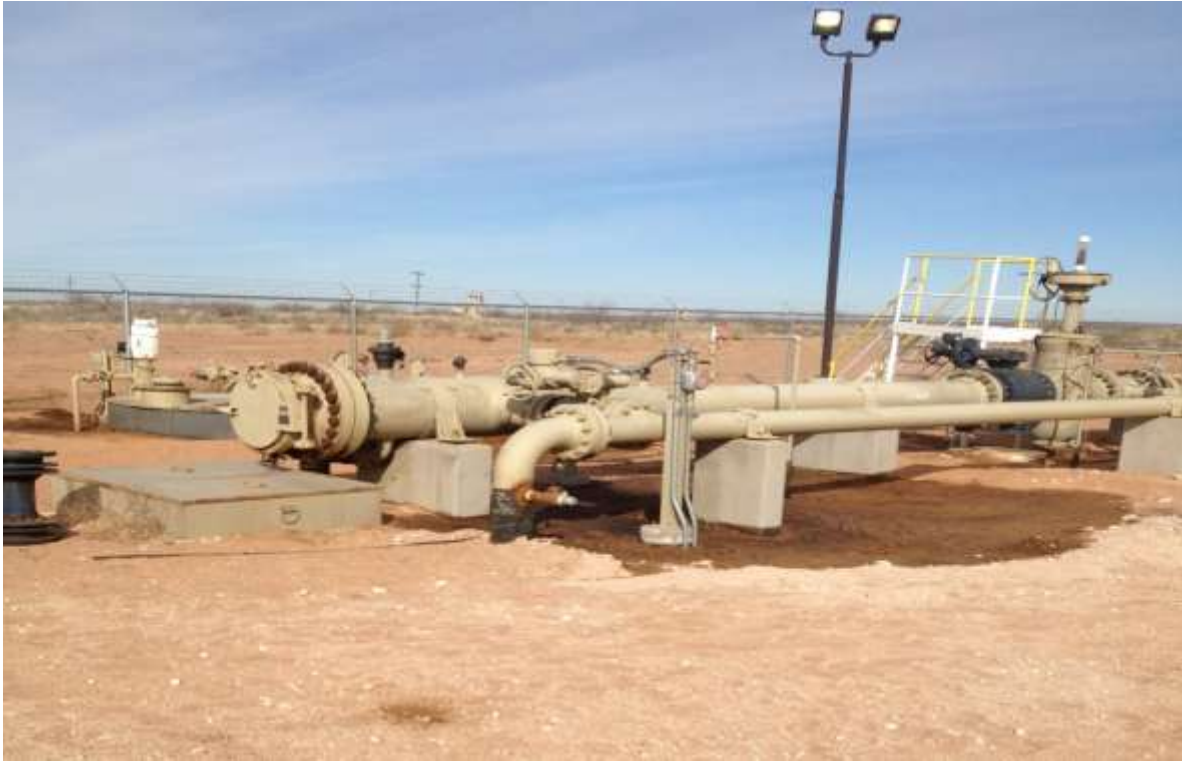
Lynch South to Jal 16-Inch Sump - Release Site (Looking Northwest)

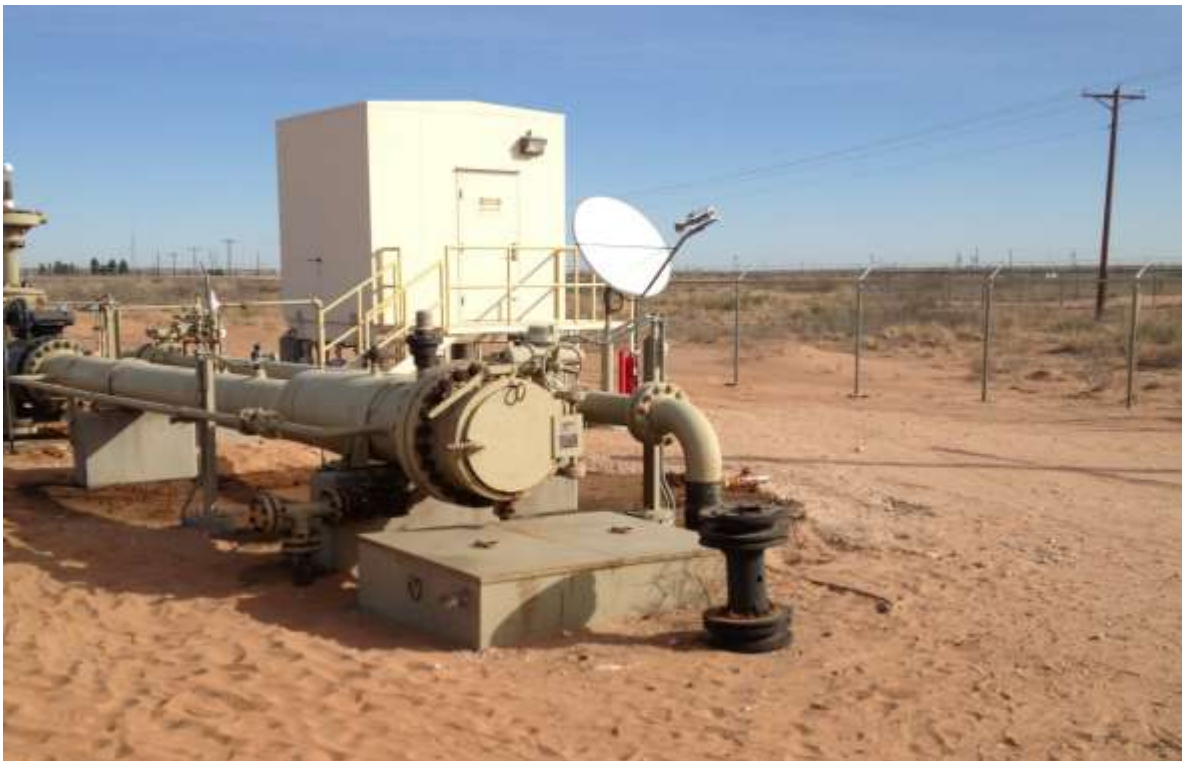
Lynch South to Jal 16-Inch Sump - Release Site (Looking Northeast)

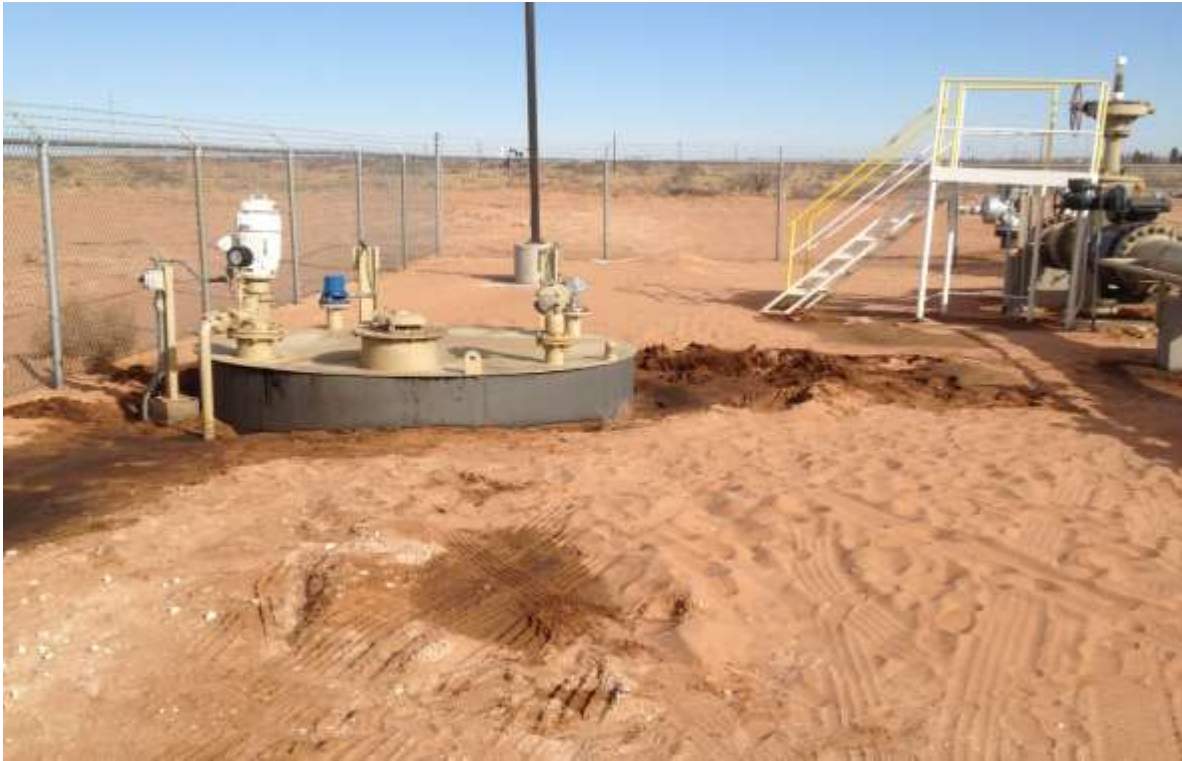
Lynch South to Jal 16-Inch Sump - Release Site (Looking North-Northwest)

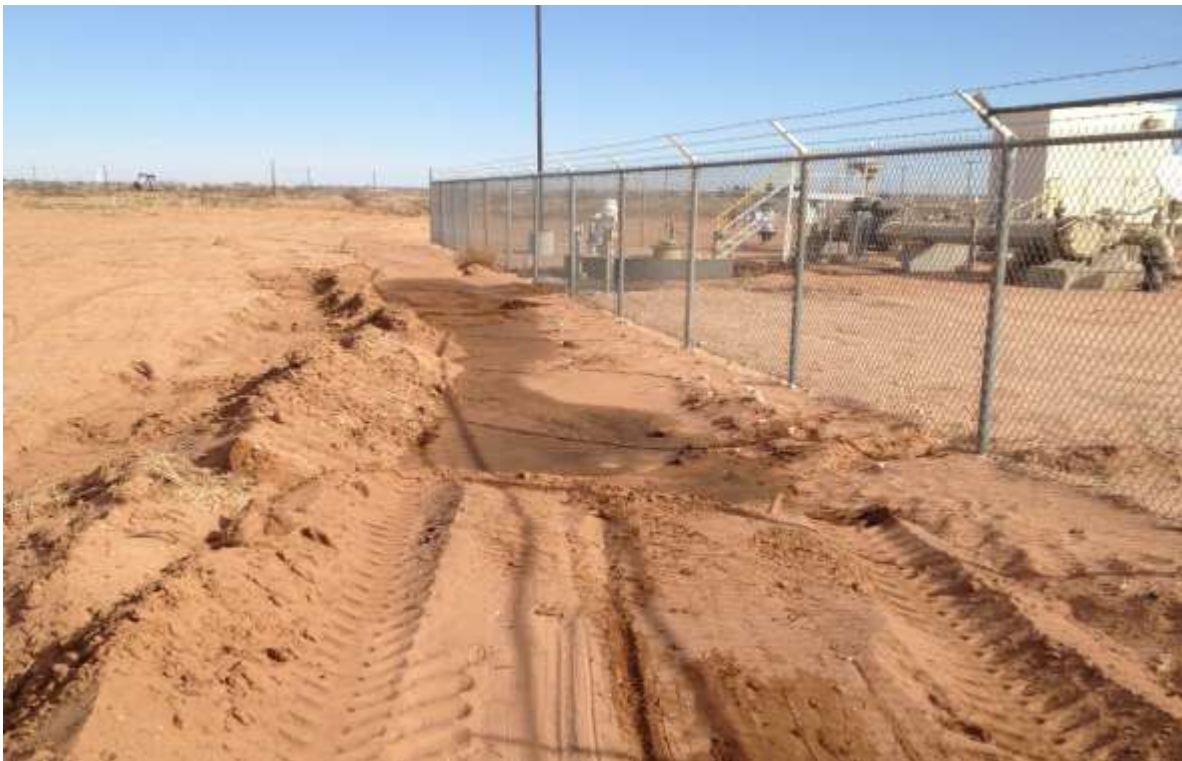
Lynch South to Jal 16-Inch Sump - Release Site (Looking North)

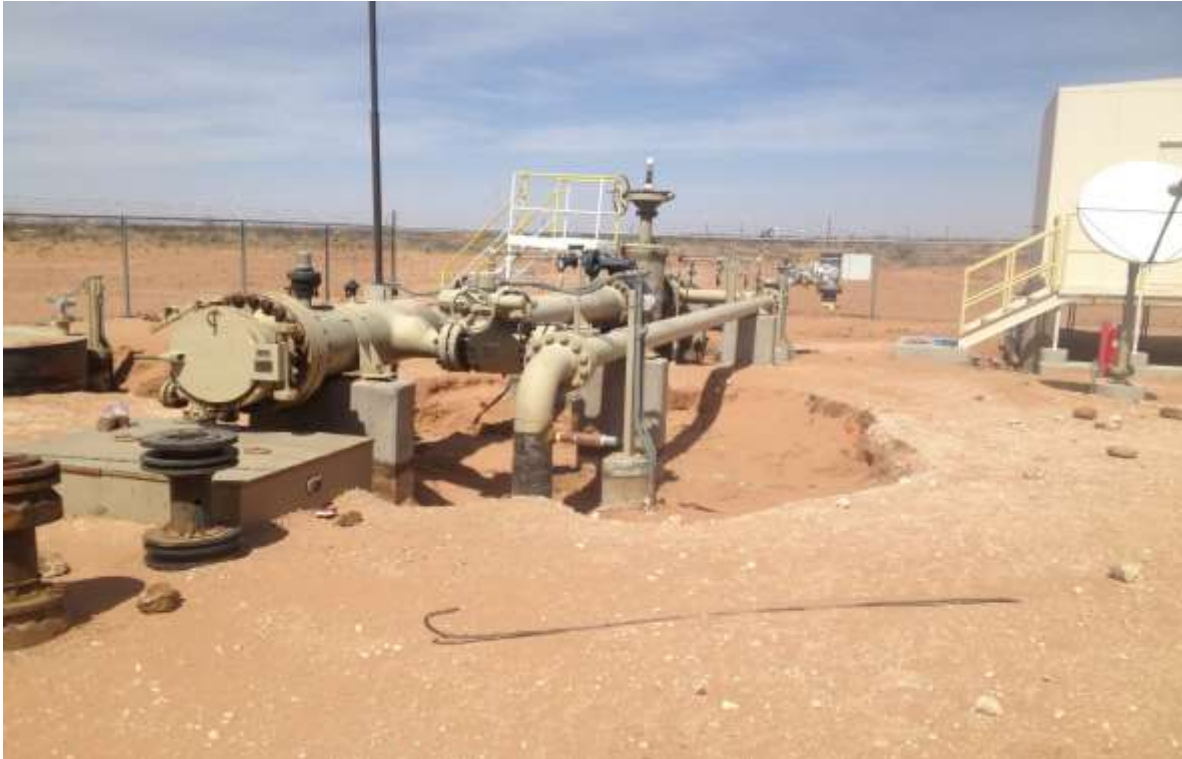
Lynch South to Jal 16-Inch Sump – Excavation (Looking North-Northwest)

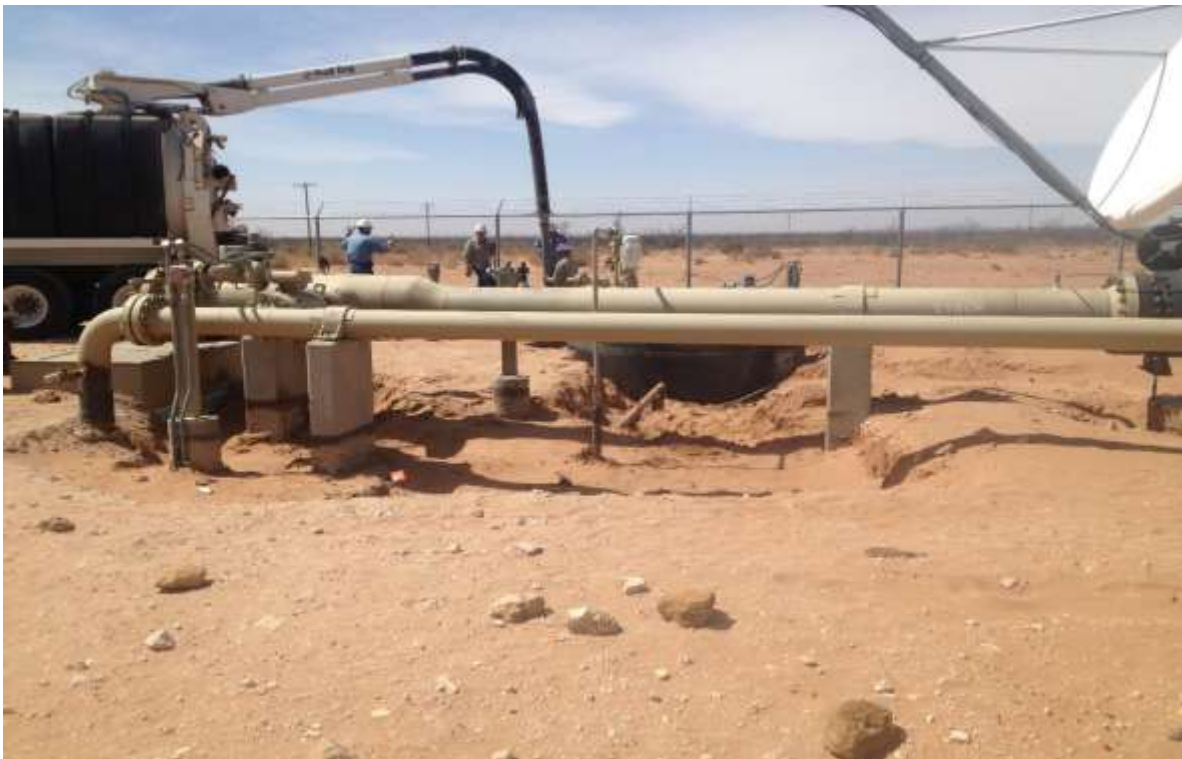
Lynch South to Jal 16-Inch Sump – Excavation (Looking West)

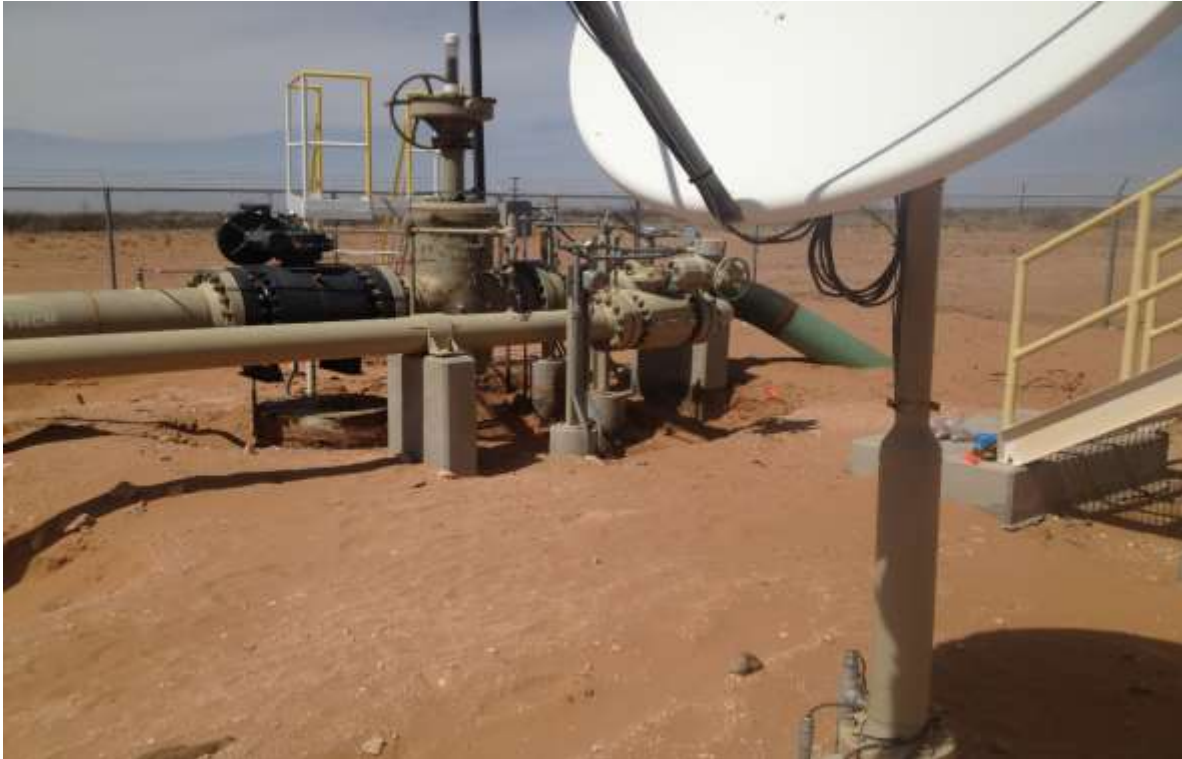
Lynch South to Jal 16-Inch Sump – Excavation (Looking West-Northwest)

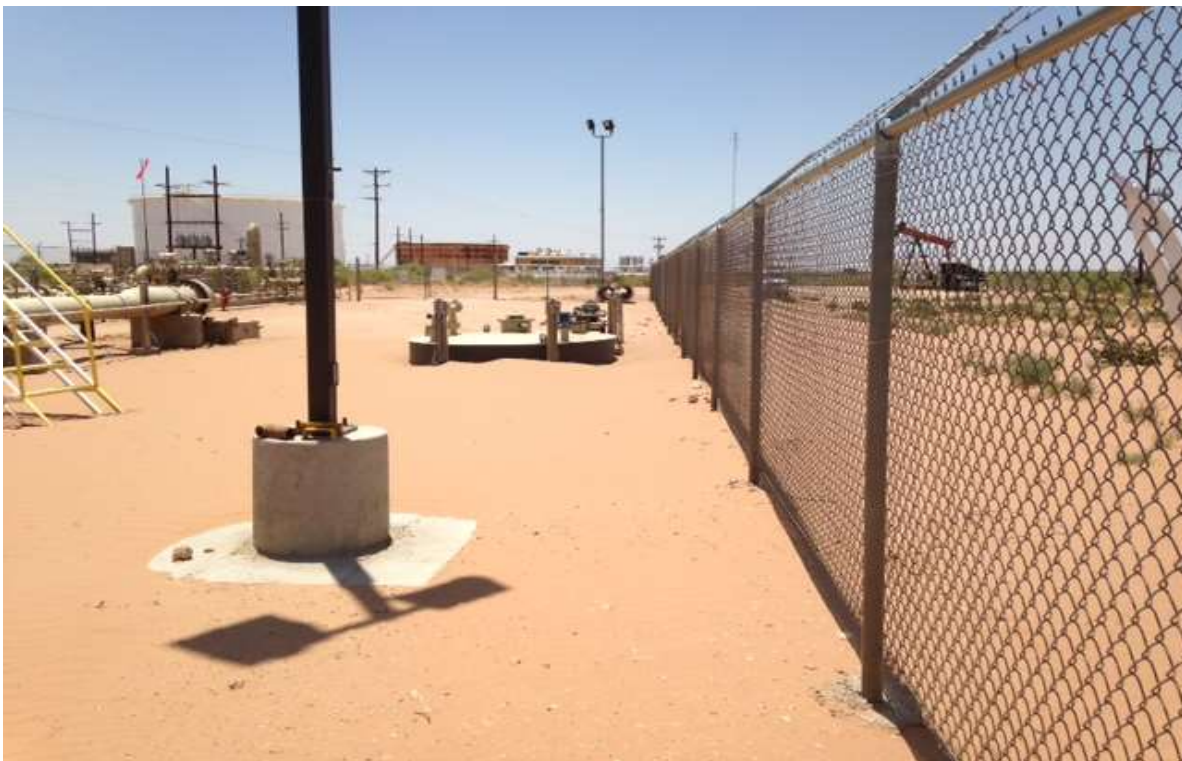
Lynch South to Jal 16-Inch Sump – Excavation (Looking South)
