REMEDIATION SUMMARY & SITE CLOSURE REQUEST

SOUTHERN UNION GAS SERVICES

TRUNK "O" LINE (1RP-2612)

NMOCD Reference # 1RP-2612

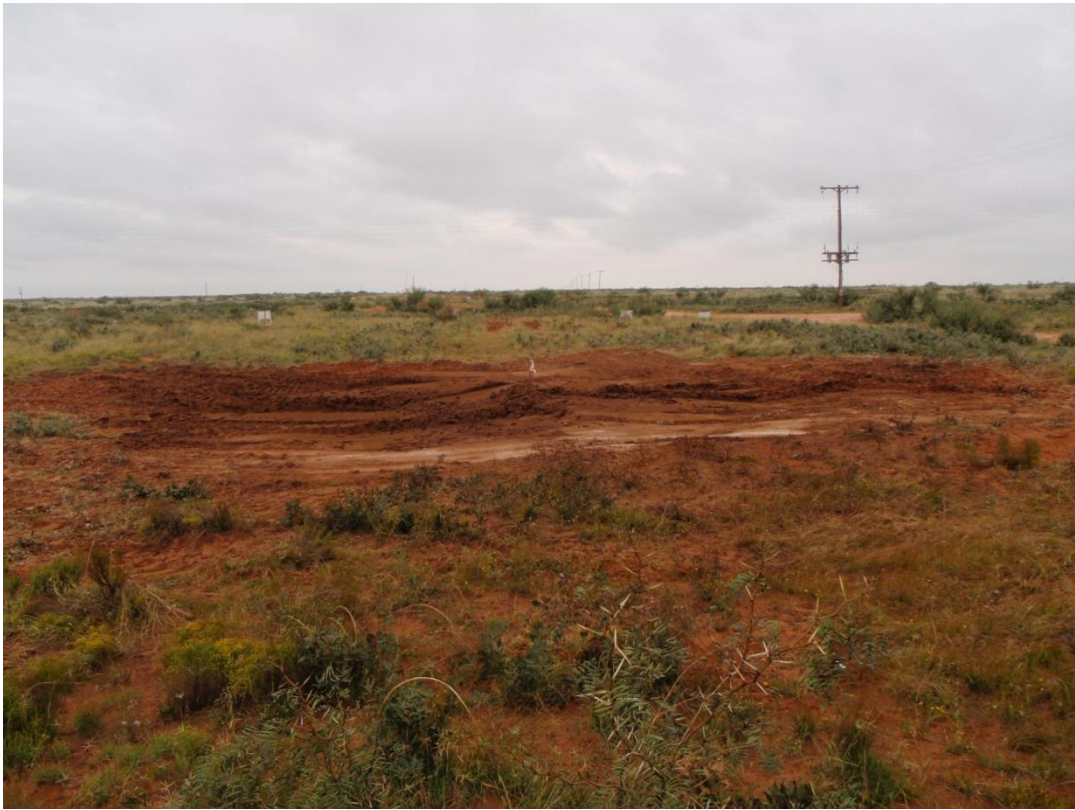
Photograph of the initial release at the Trunk "O" Line Historical Release Site.

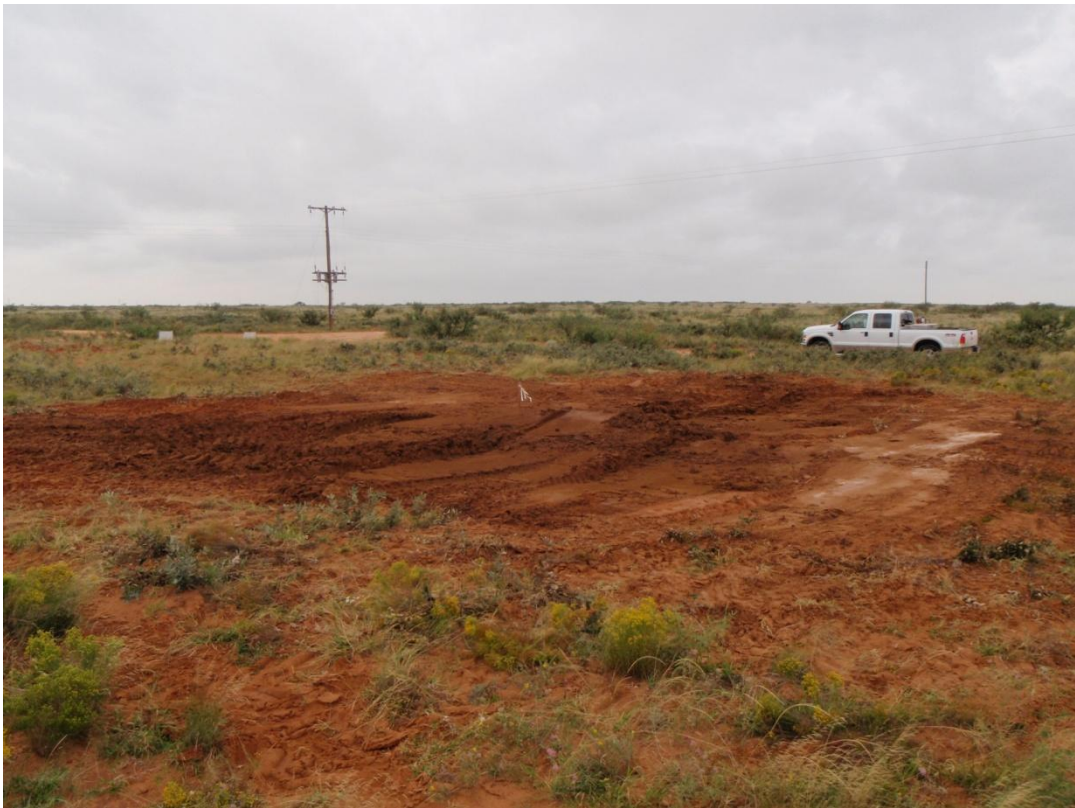
Photograph of the initial release at the Trunk "O" Line Historical Release Site.

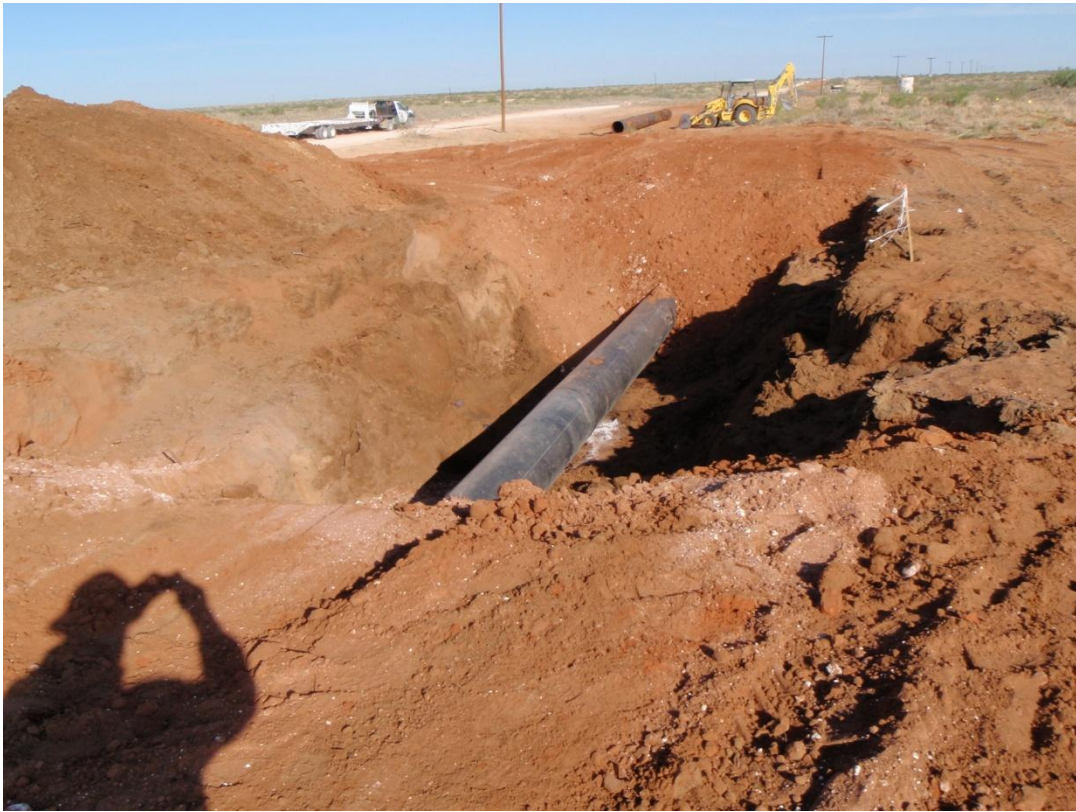
Photograph of the initial excavation at the Trunk "O" Line Historical Release Site.

On October 26, 2011, excavation of impacted soil commenced at the release site. Excavated material was blended and stockpiled on-site pending final disposition. A photo-ionization detector (PID) and chloride field test kit was used to field screen select soil samples and guide the excavation. The floor and sidewalls of the excavation were advanced to the maximum extent possible given the nature of the machinery and proximity to active natural gas pipelines.

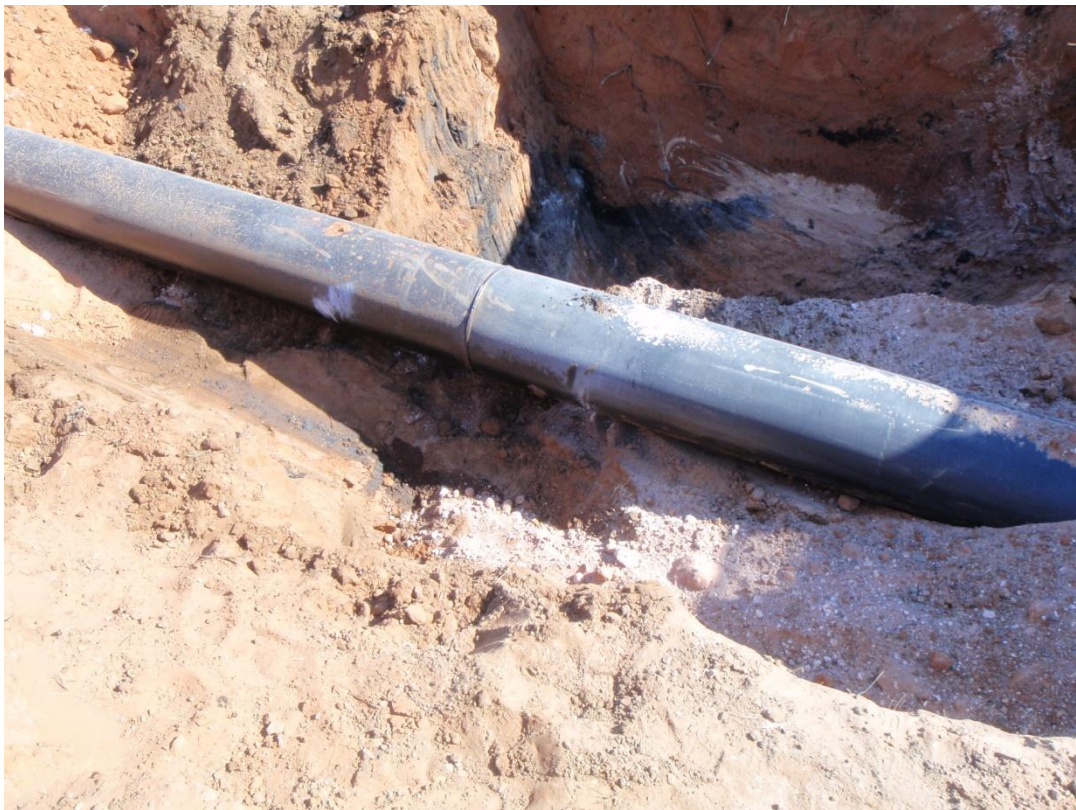
Photograph of the initial excavation at the Trunk "O" Line Historical Release Site.

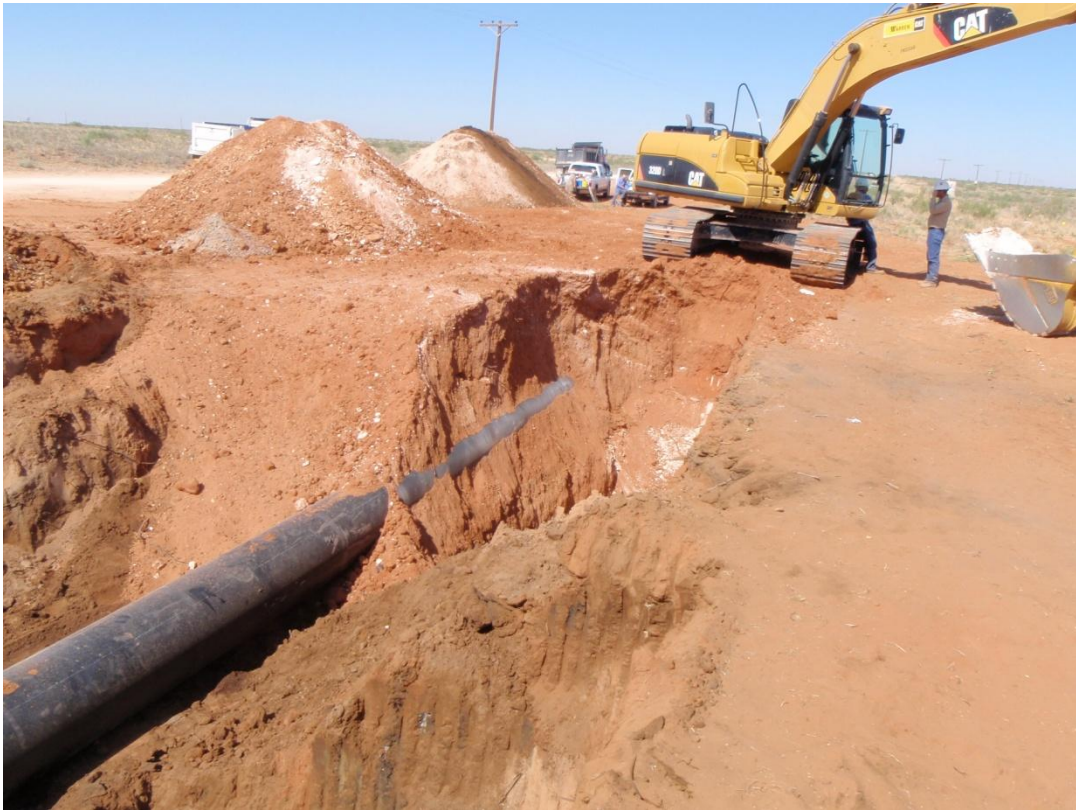
Photograph of the initial excavation at the Trunk "O" Line Historical Release Site.

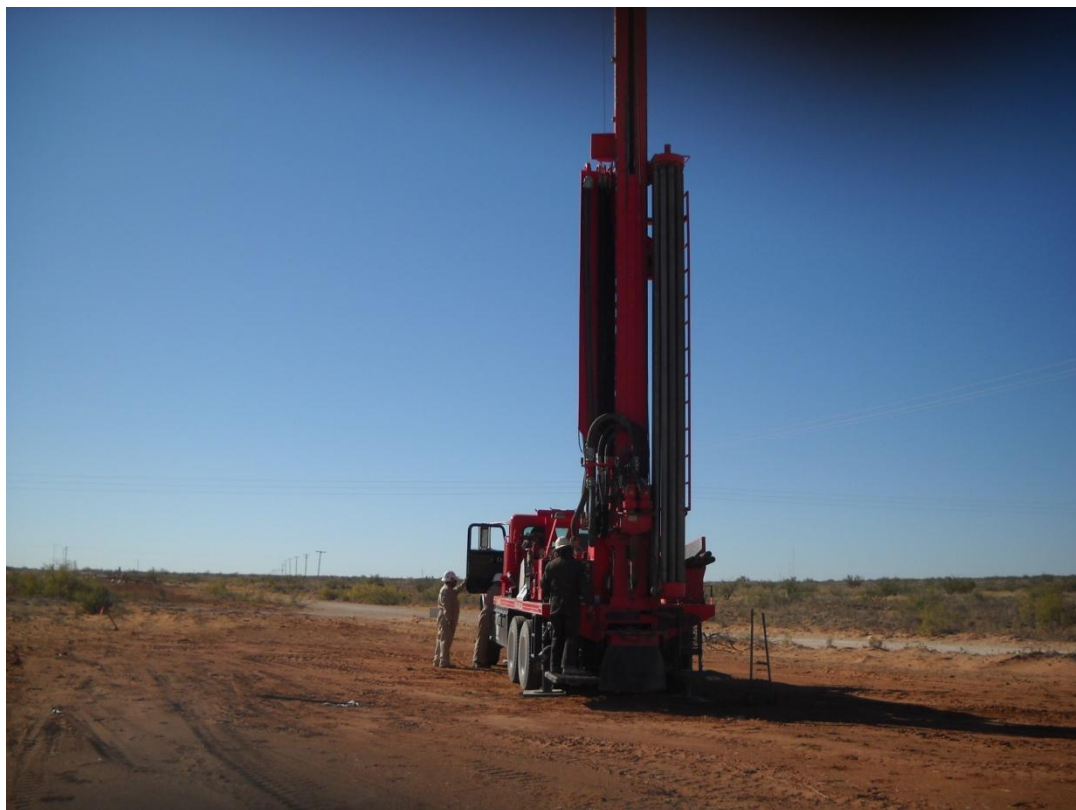
Photograph of the advancements of soil borings at the Trunk "O" Line Historical Release Site.

On November 16, 2011, two (2) soil borings (SB-1 and SB-2) were advanced at the release site in order to determine the vertical and horizontal extent of soil impact. Soil samples were collected at five foot (5') drilling intervals and field screened using a PID and chloride field test kit. Selected soil samples were submitted to the laboratory for determination of BTEX, TPH and chloride concentrations. Soil boring logs are provided as Appendix B.

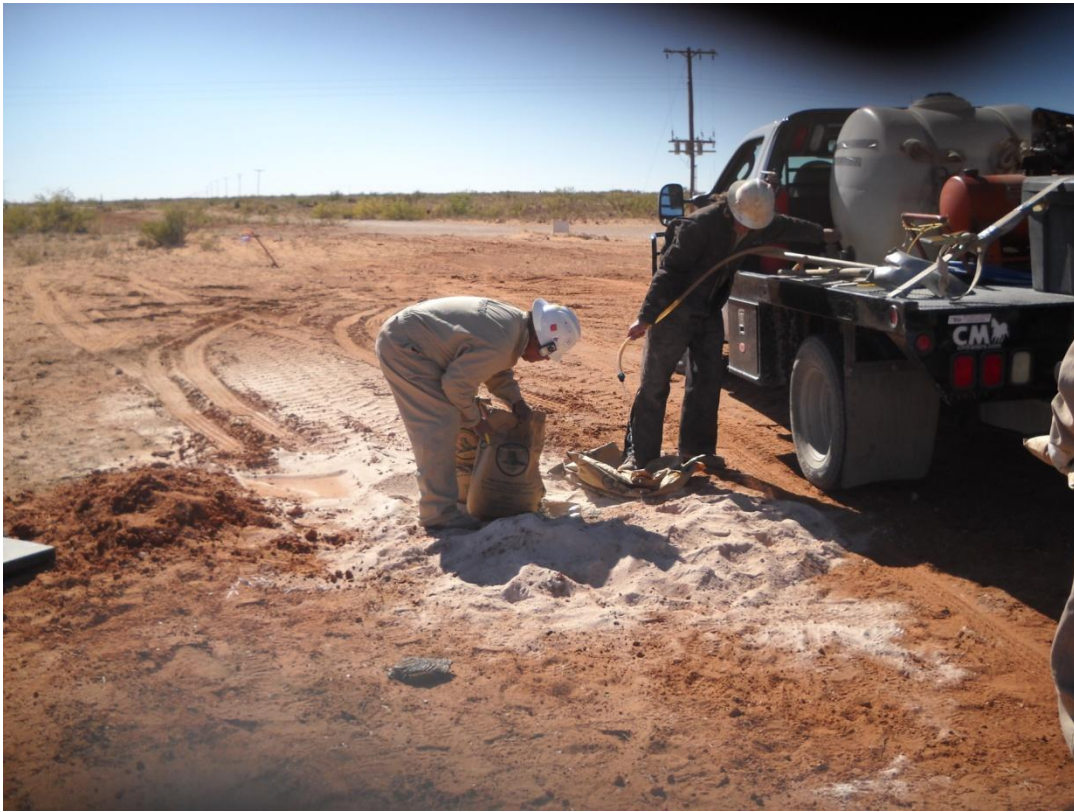
Photograph of the plugging of the soil borings at the Trunk "O" Line Historical Release Site.

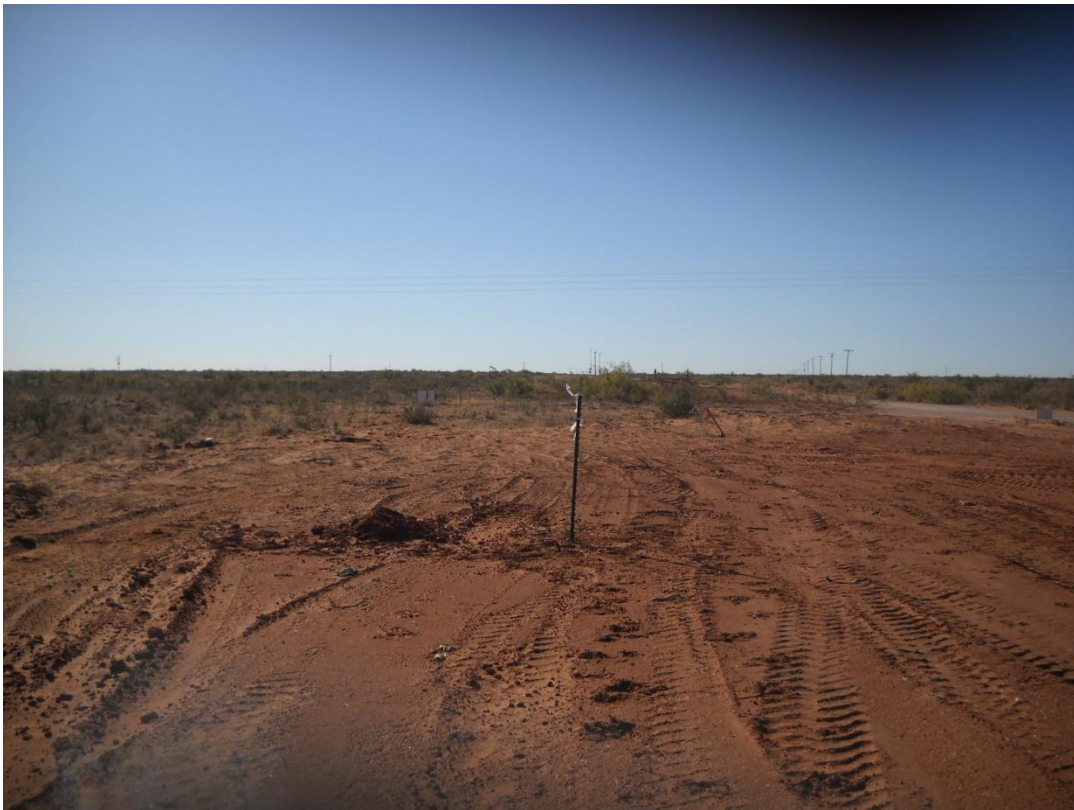
Photograph of the Trunk "O" Line Historical Release Site after being backfilled.

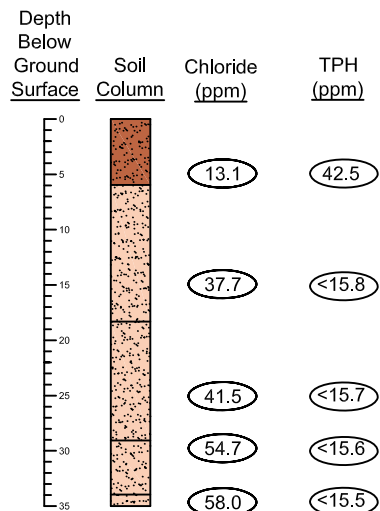
Soil Boring SB-1

0' - 6' - Red Sand, F. Grained

6' - 18' - Tan Sand, F. Grained, Consolidated

18' - 29' - Tan Sand, F. Grained

29' - 34' - Tan Sand, F. Grained, Consolidated

34' - 35' - Tan Sand, F. Grained

Date Drilled November 16, 2011
 Thickness of Bentonite Seal 33 Ft
 Depth of Exploratory Boring 35 Ft bgs
 Depth to Groundwater _____
 Ground Water Elevation _____

Soil boring SB-1 was located approximately fifteen feet (15') west of the release point, adjacent to the previously excavated area. The soil boring was advanced to a total depth of approximately thirty-five feet (35') bgs. Soil samples were collected at five (5), fifteen (15), twenty-five (25), thirty (30) and thirty-five (35) feet bgs and submitted to the laboratory. Laboratory analytical results indicated BTEX concentrations ranged from less than the laboratory MDL for soil samples SB-1 @ 25', SB-1 @ 30' and SB-1 @ 35' to 0.102 mg/Kg for soil sample SB-1 @ 5'. TPH concentrations ranged from less than the appropriate laboratory MDL for soil samples SB-1 @ 15', SB-1 @ 25', SB-1 @ 30' and SB-1 @ 35' to 42.5 mg/Kg for soil sample SB-1 @ 5'. Chloride concentrations ranged from 13.1 mg/Kg for soil sample SB-1 @ 5' to 58.0 mg/Kg for soil sample SB-1 @ 35'.

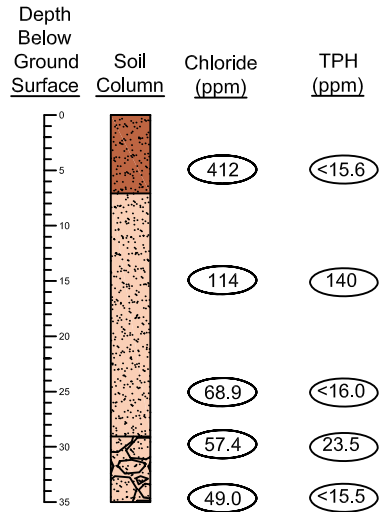
Soil Boring SB-2

0' - 7' - Red Sand, F. Grained

7' - 27' - Tan Sand, F. Grained, Consolidated

27' - 35' - Tan Sand, F. Grained, w/Caliche

Date Drilled November 16, 2011
 Thickness of Bentonite Seal 33 Ft
 Depth of Exploratory Boring 35 Ft bgs
 Depth to Groundwater _____
 Ground Water Elevation _____

Soil boring SB-2 was located approximately fifteen feet (15') east of the release point, west of El Paso Natural Gas's active pipeline. The soil boring was advanced to a total depth of approximately thirty-five feet (35') bgs. Soil samples were collected at five (5), fifteen (15), twenty-five (25), thirty (30) and thirty-five (35) feet bgs and submitted to the laboratory for analysis. Laboratory analytical results indicated BTEX concentrations ranged from less than the laboratory MDL for soil samples SB-2 @ 15' and SB-2 @ 35' to 0.0431 mg/Kg for soil sample SB-2 @ 5'. TPH concentrations ranged from less than the appropriate laboratory MDL for soil samples SB-2 @ 5', SB-2 @ 25' and SB-2 @ 35' to 140 mg/Kg for soil sample SB-2 @ 15'. Chloride concentrations ranged from 49.0 for soil sample SB-2 @ 35' to 412 mg/Kg for soil sample SB-2 @ 5'. Based on laboratory analytical results, the eastern extent of soil impact had been determined.
