REMEDIATION SUMMARY & SITE CLOSURE REQUEST

**SOUTHERN UNION GAS SERVICES
TRUNK "O" #1**

HISTORICAL RELEASE SITE

NMOCD Reference # 1RP-1507

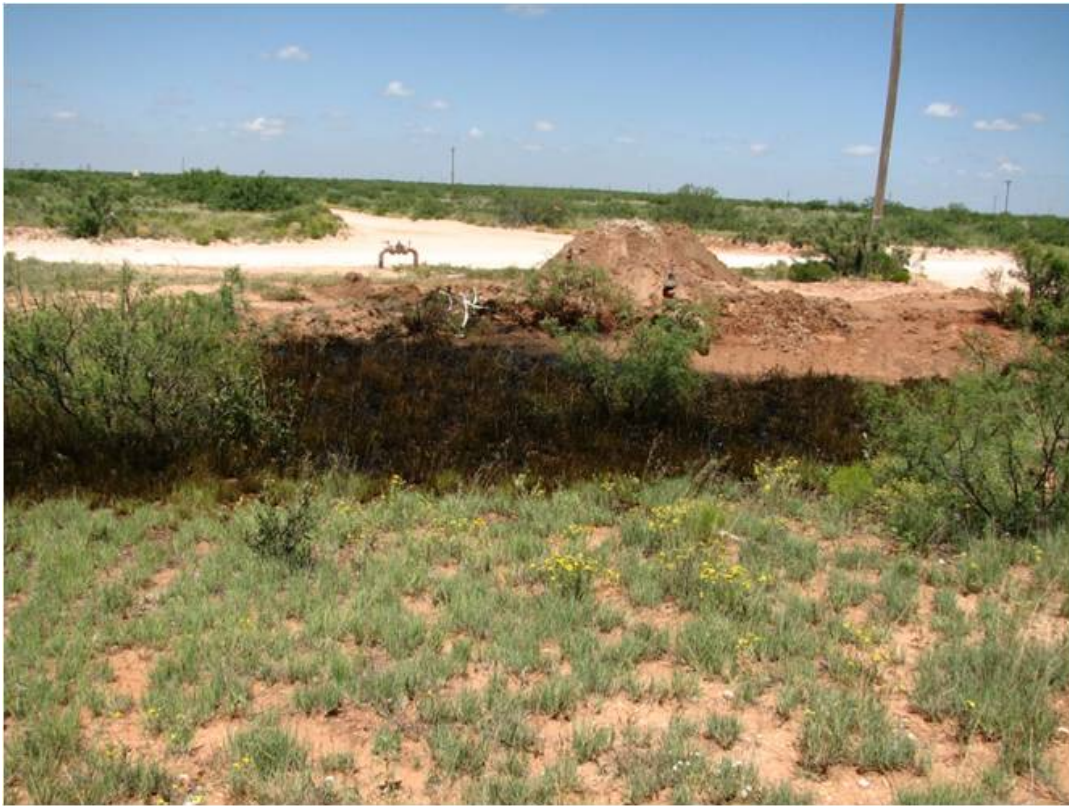
Photograph of the initial release at the Trunk "O" #1 Historical Release Site.

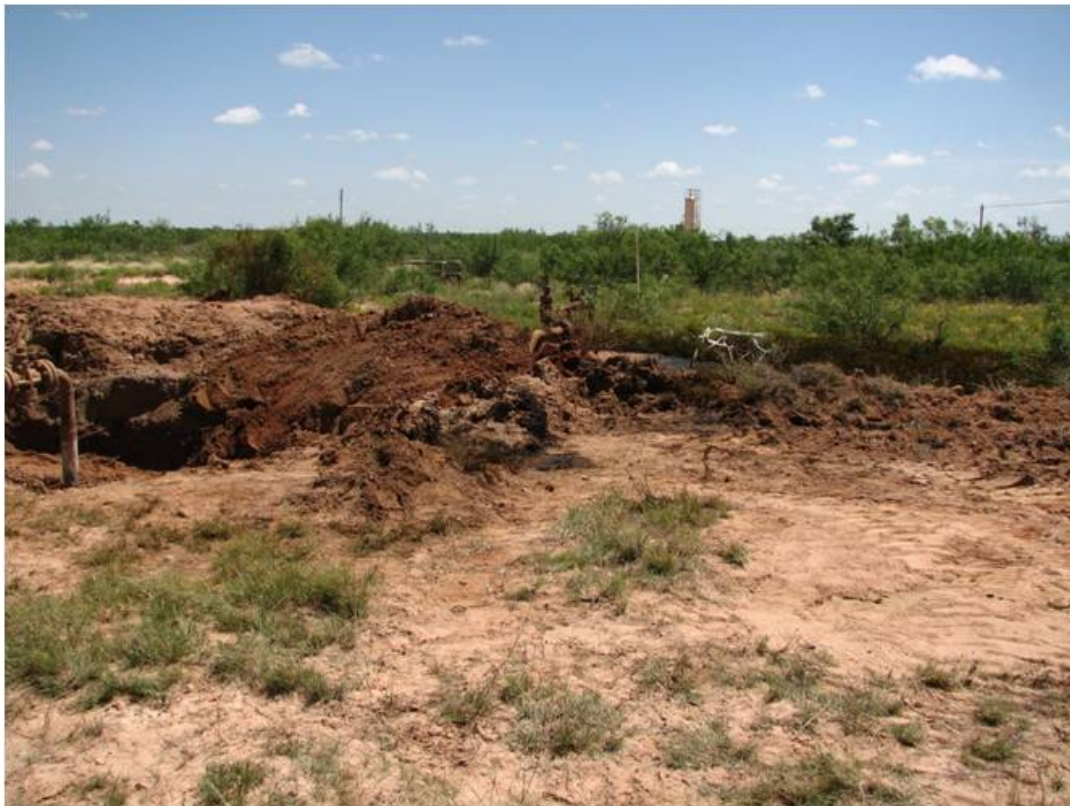
Photograph of the initial release at the Trunk "O" #1 Historical Release Site.

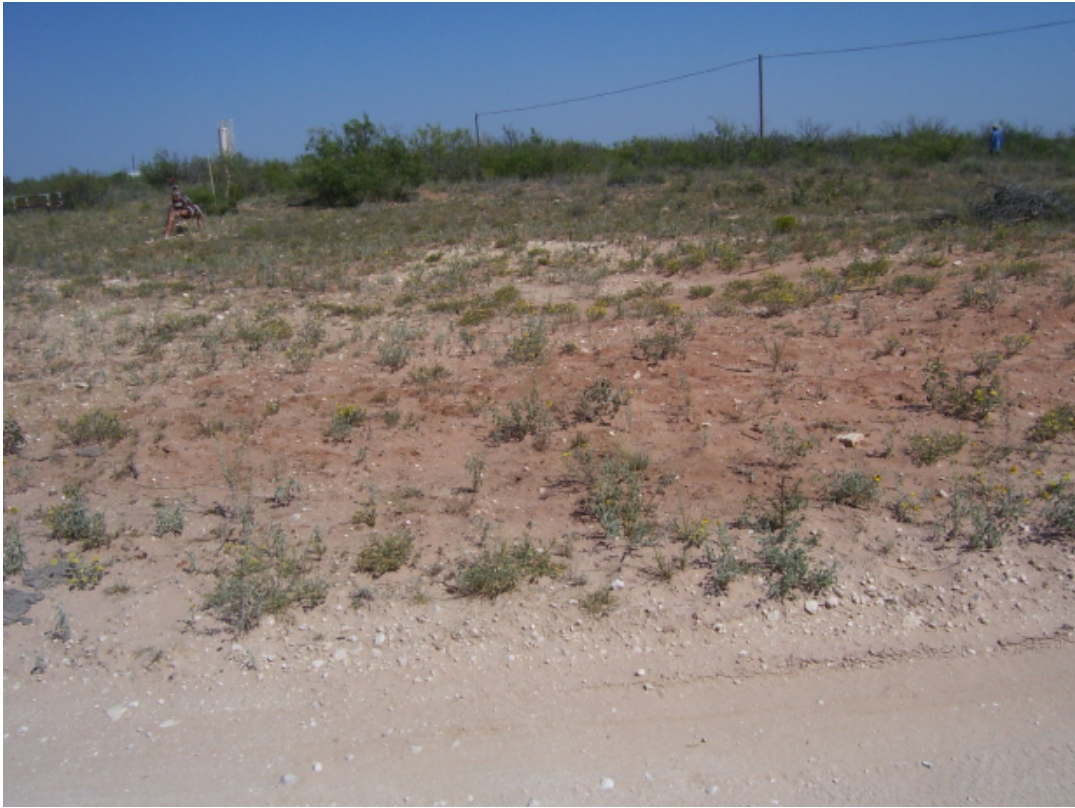
Photograph of the disturbed area Trunk "O" #1 Historical Release Site.

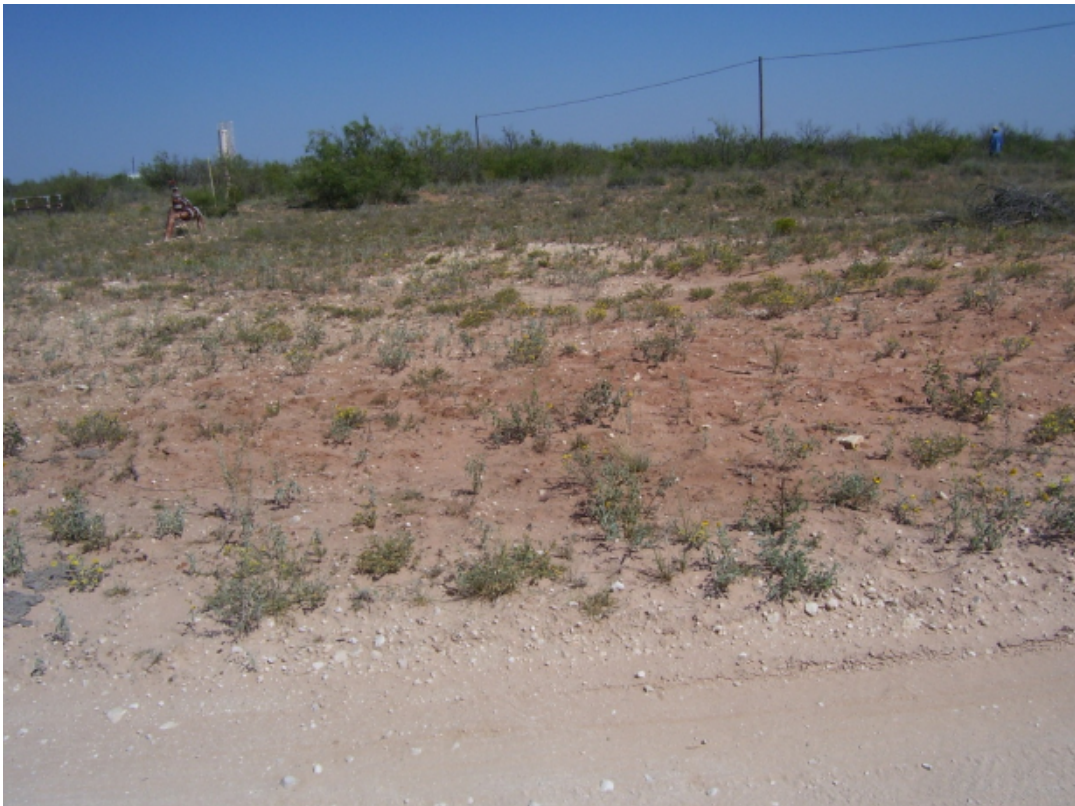
Photograph of the disturbed area Trunk "O" #1 Historical Release Site.

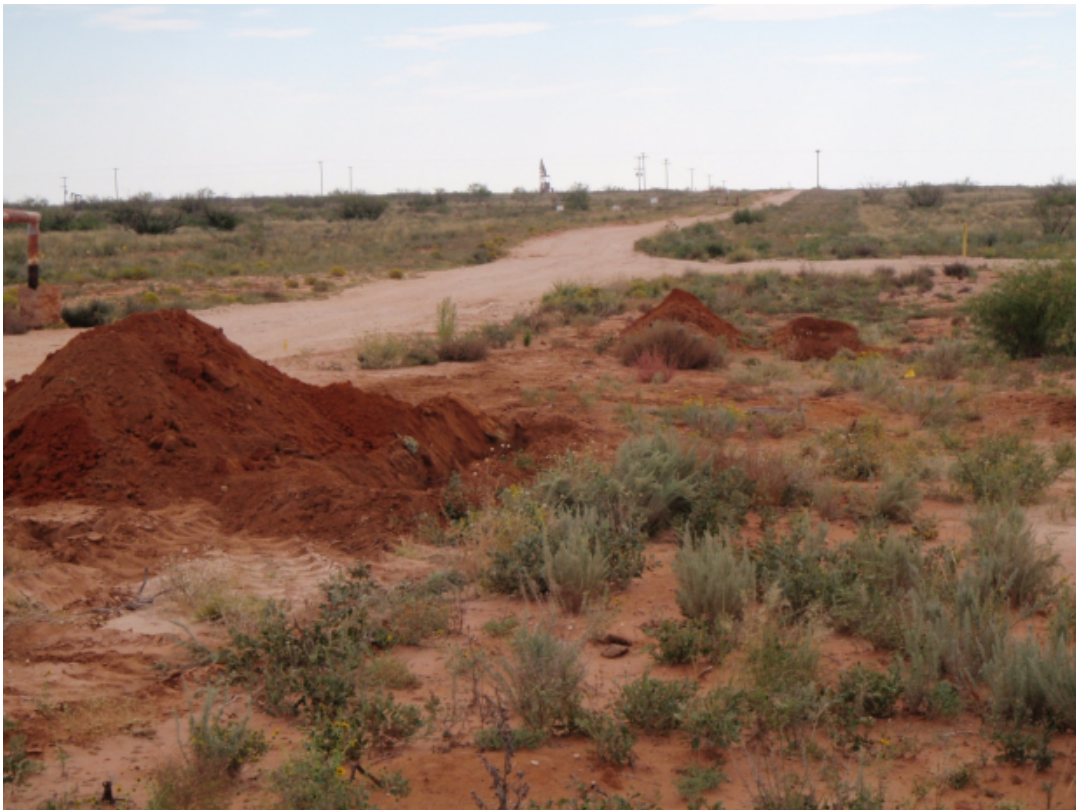
Photograph of delineation activities at the Trunk "O" #1 Historical Release Site.

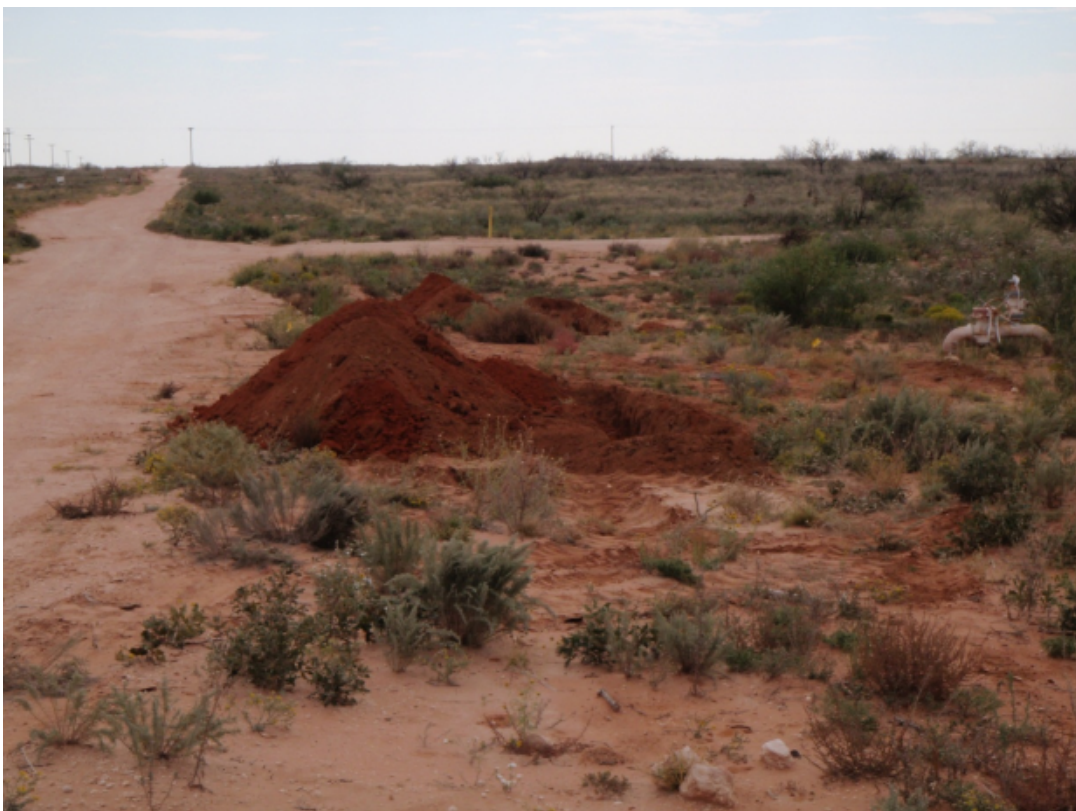
Photograph of delineation activities at the Trunk "O" #1 Historical Release Site.
