**OXY USA, Inc.  
Cotton Draw Unit #10  
Closure Report**

**Section 16, T25S, R32E  
Lea County, New Mexico**

**November 25, 2014**

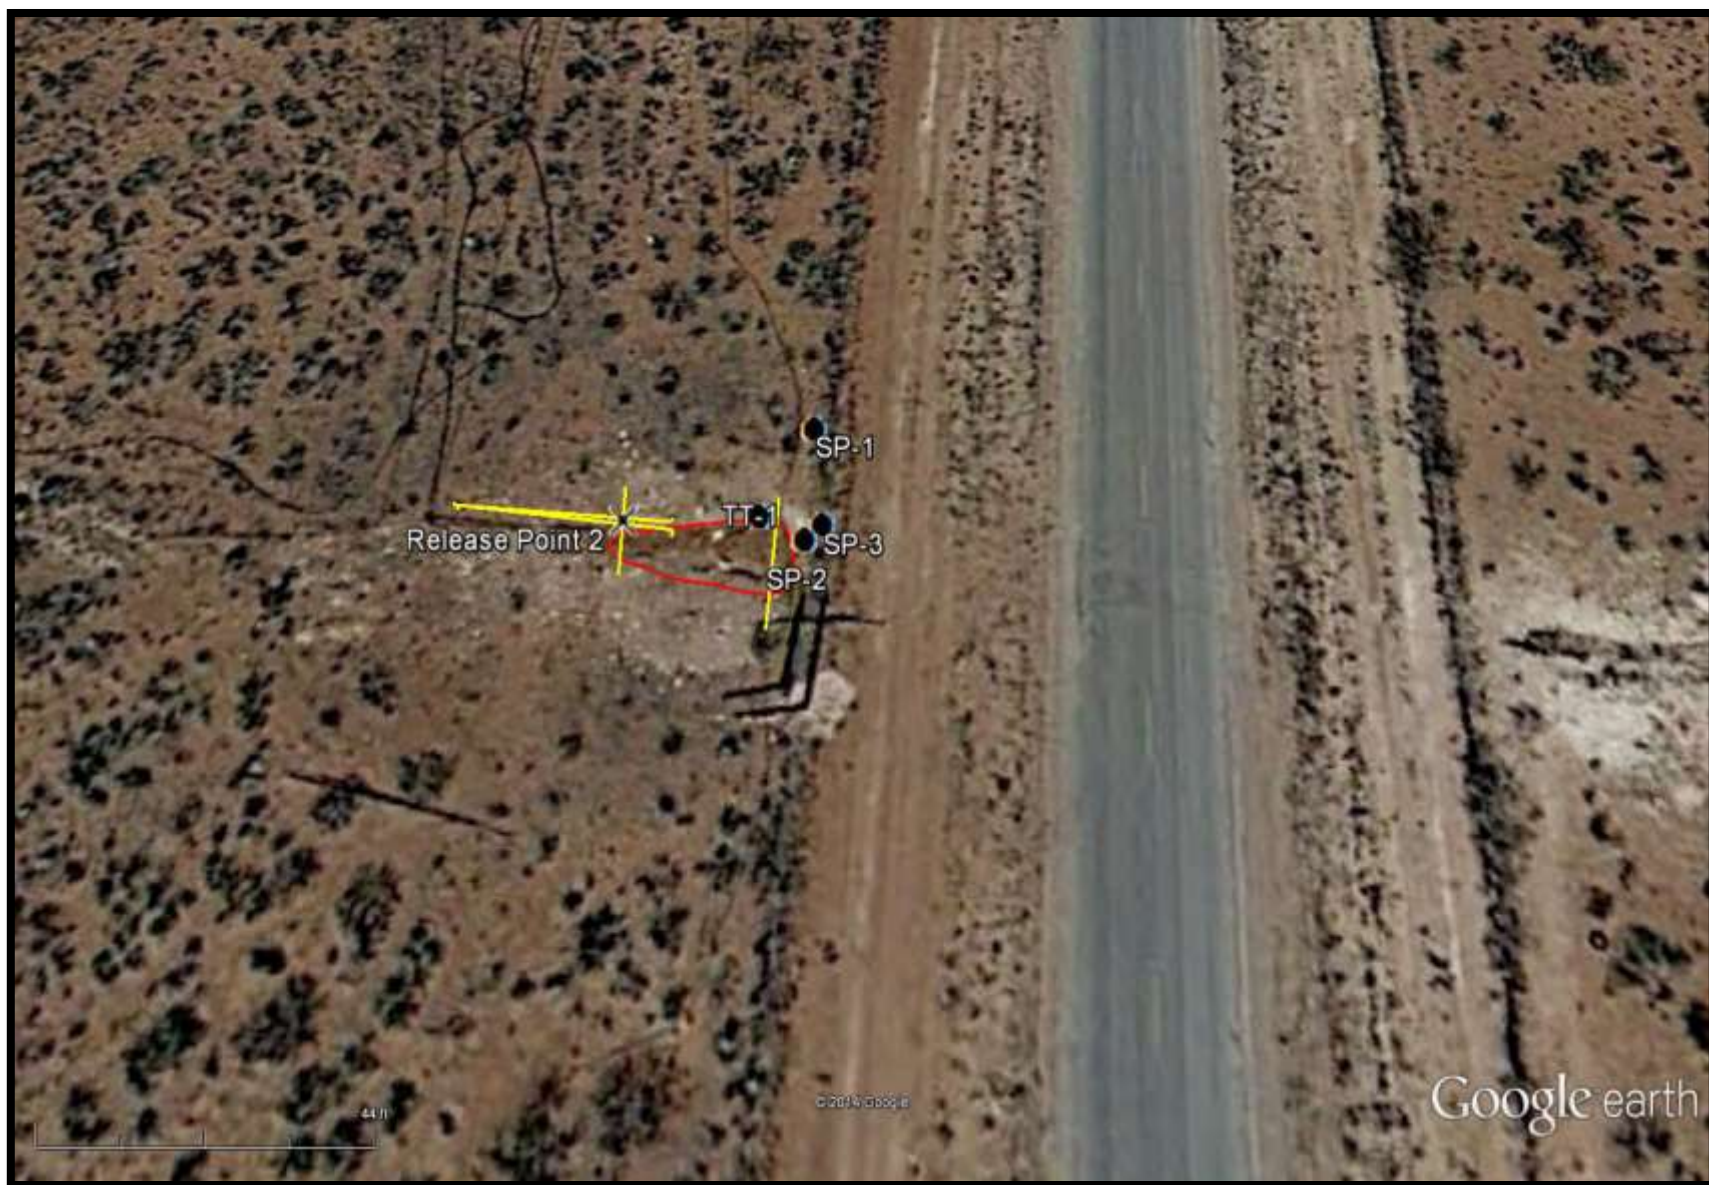
**Figure 2**  
**Site Plan**

OXY-14-008 Cotton Draw Unit #10

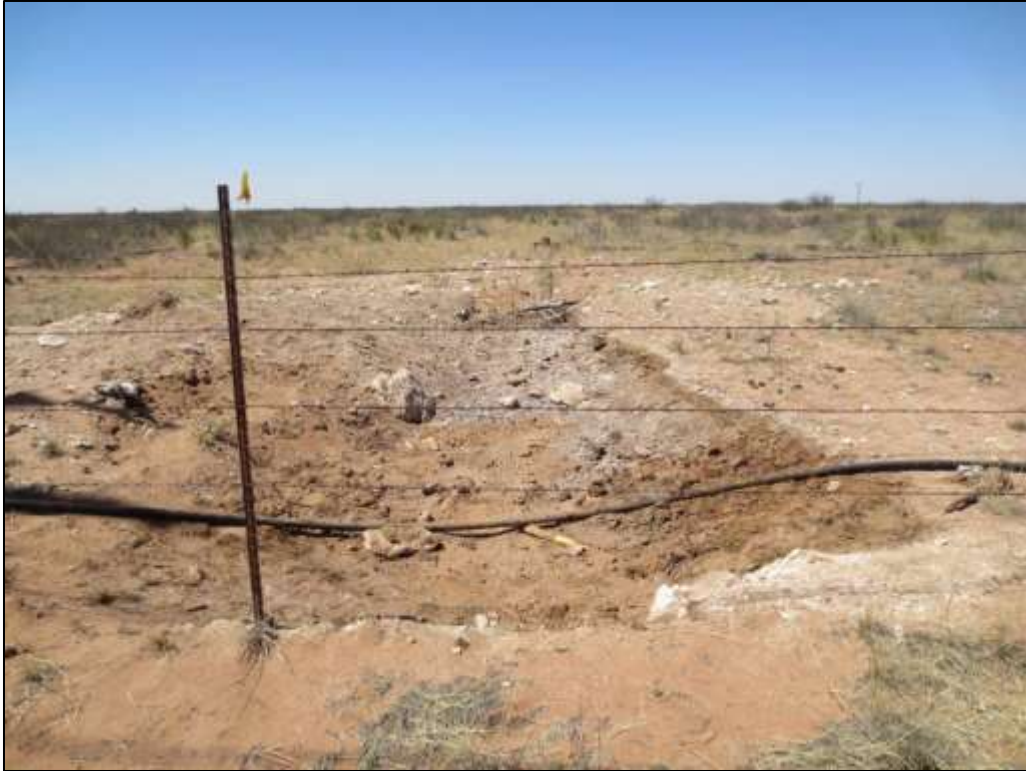
Photo #1 – East of fence line facing west

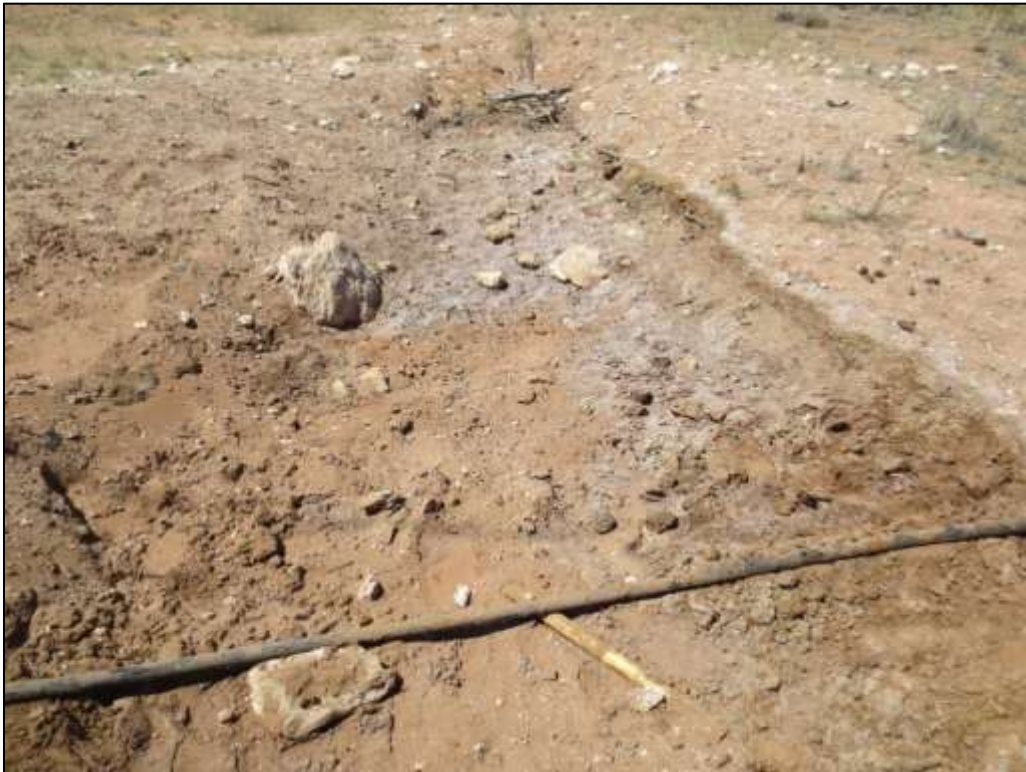
Photo #2 – West of fence line facing west

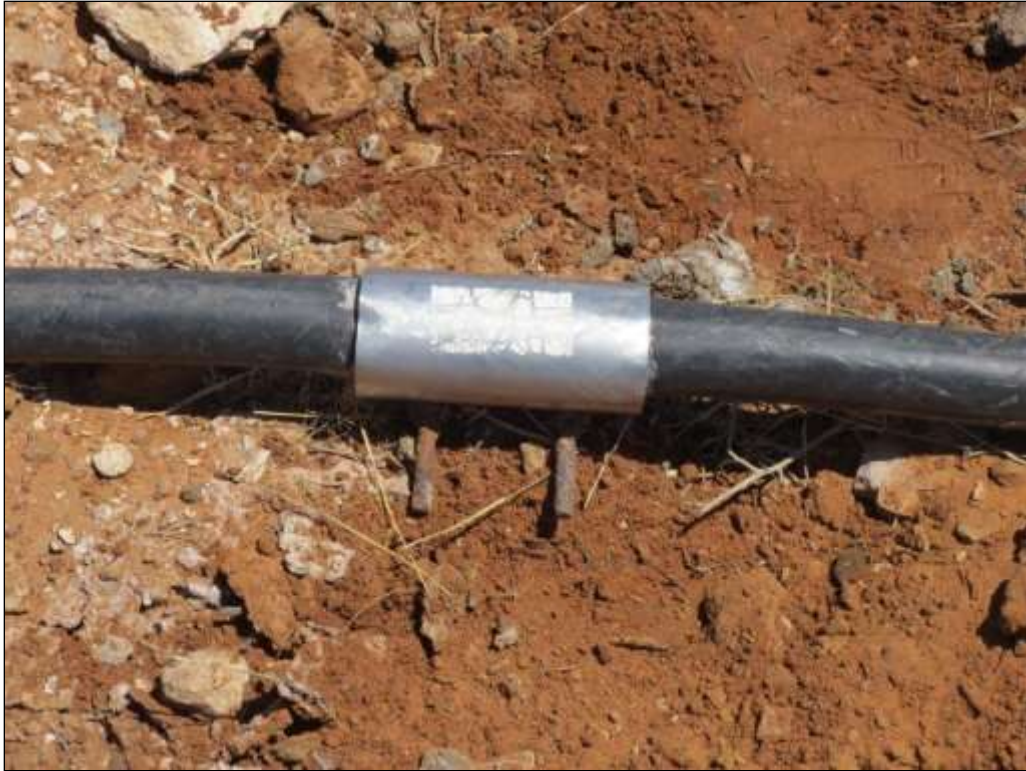
According to the C-141 dated April 01, 2014 the cause of release was internal corrosion of a 2" steel production flow line.

Photo #3 – Release Point

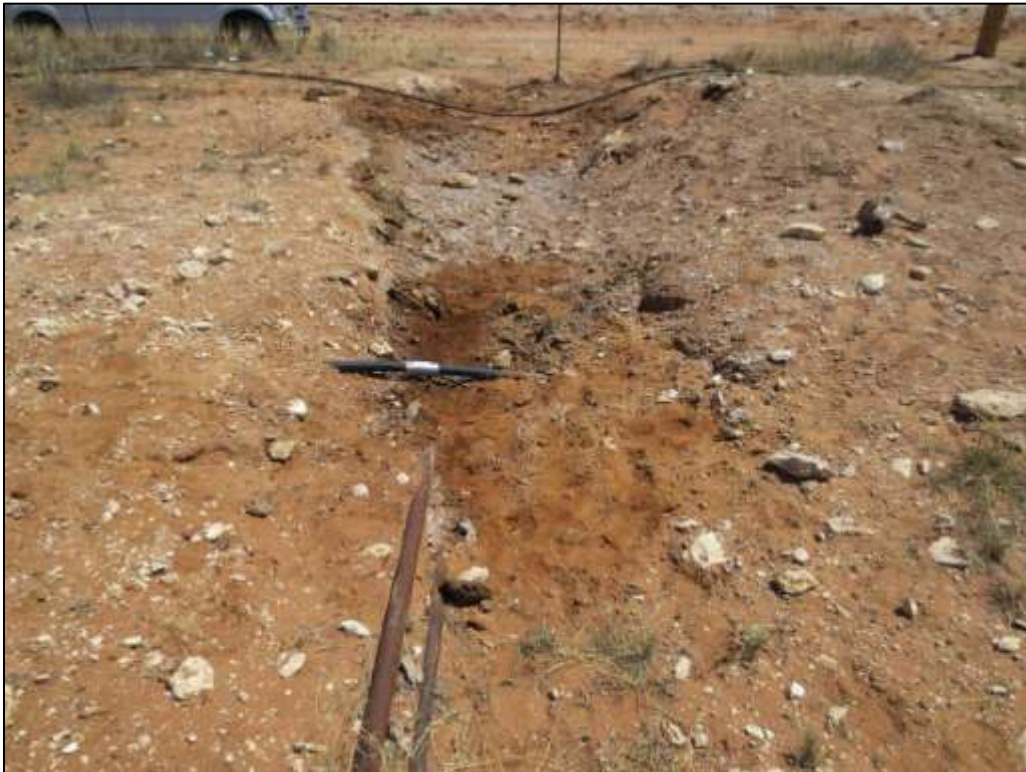
Photo #4 – Spill area facing east

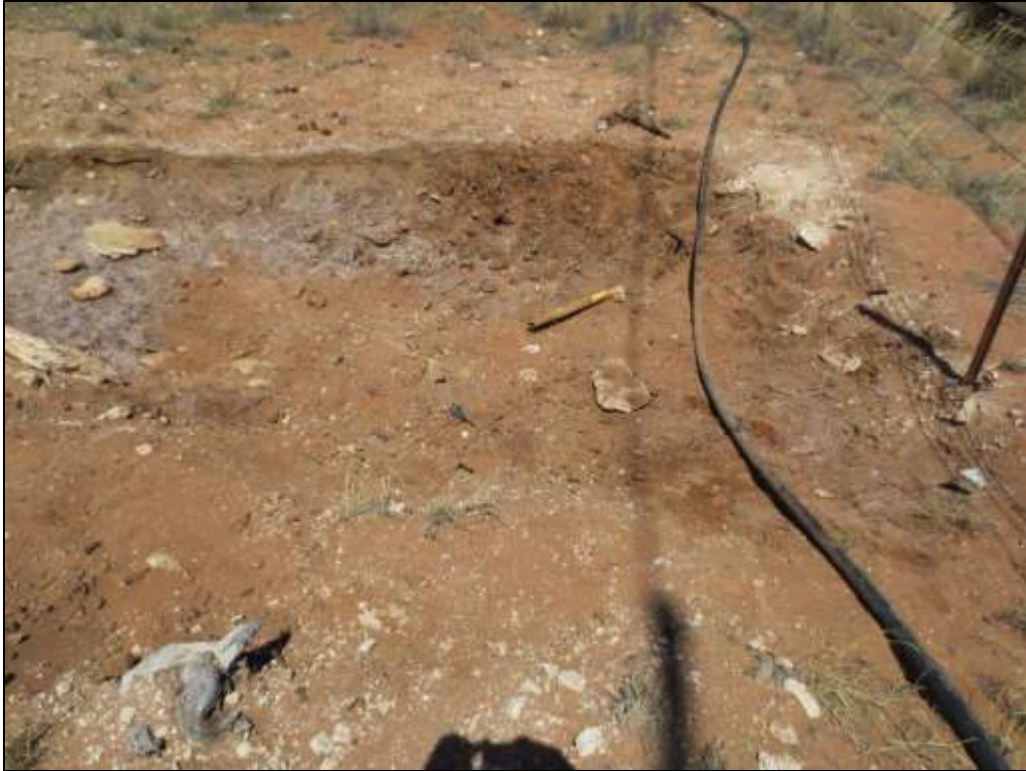
Photo #5 - Spill are facing north east end

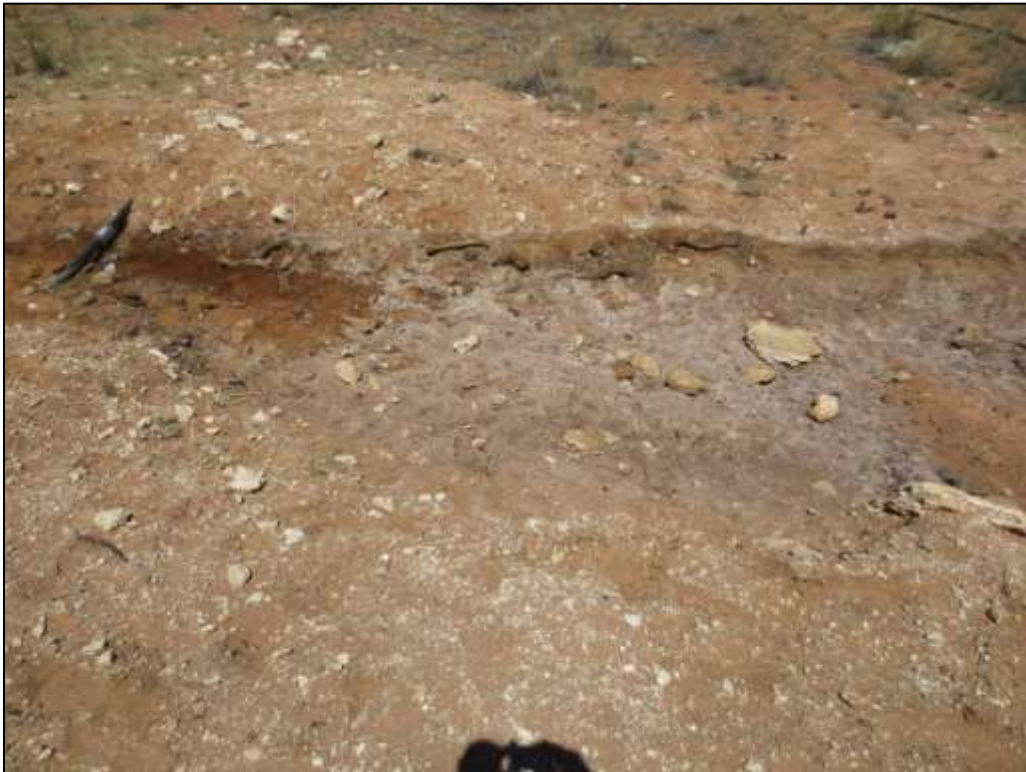
Photo #6 – Spill area facing north West end

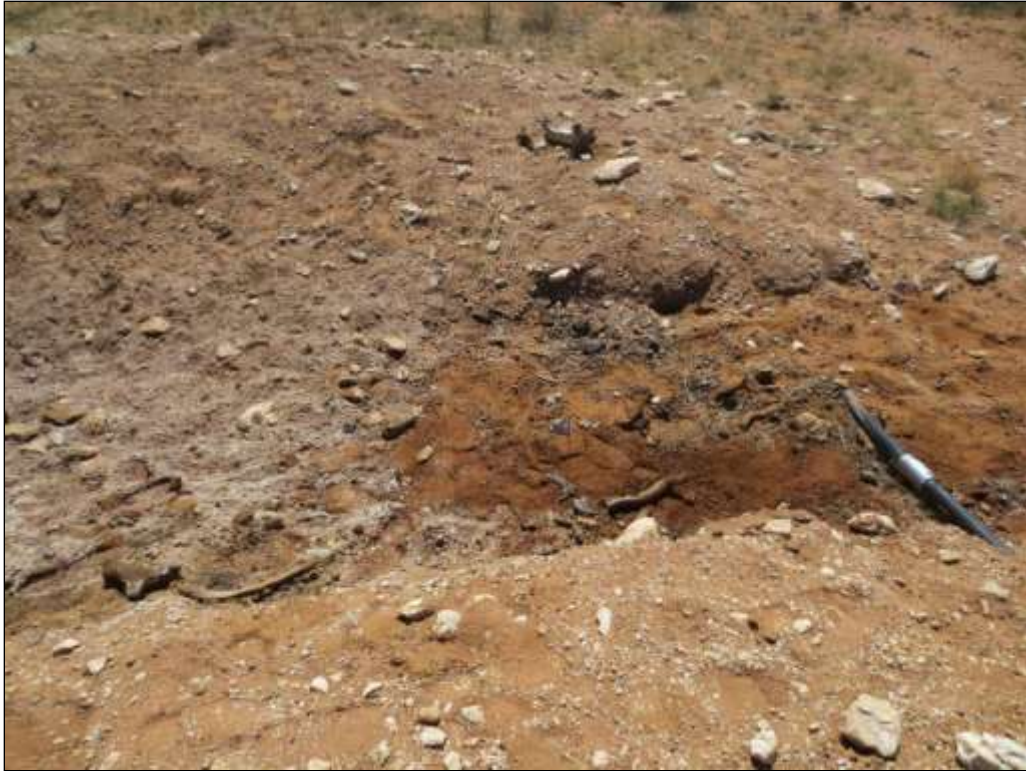
Photo # 7 – Spill area facing south west end

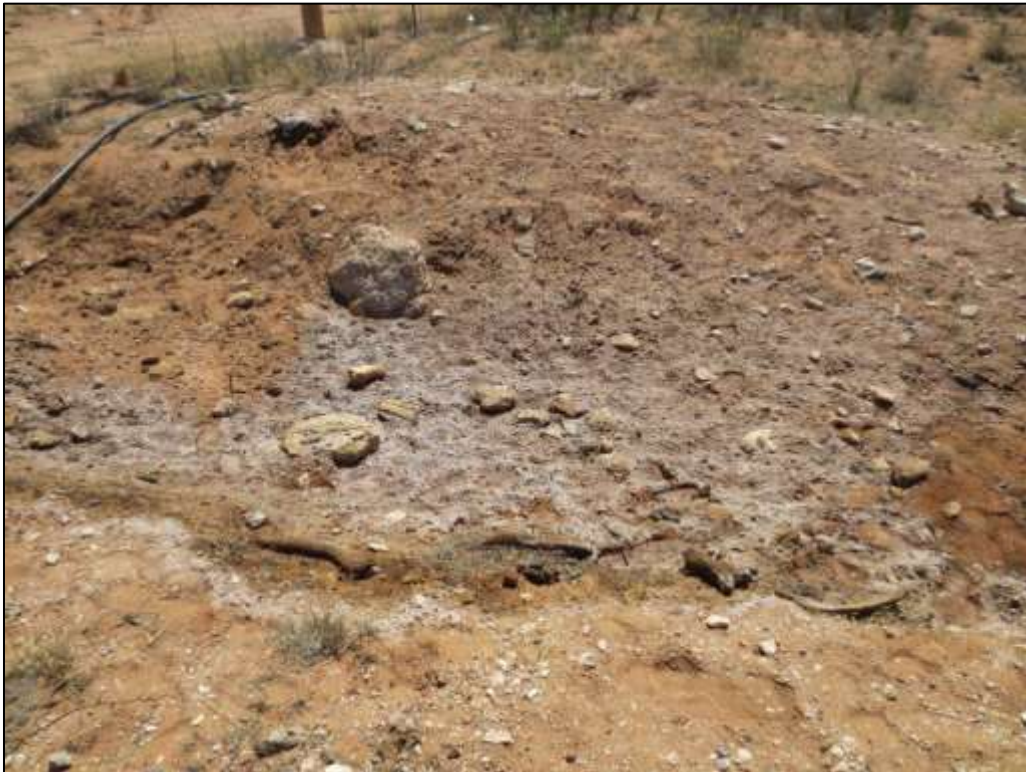
Photo #8 – Spill are facing south east end

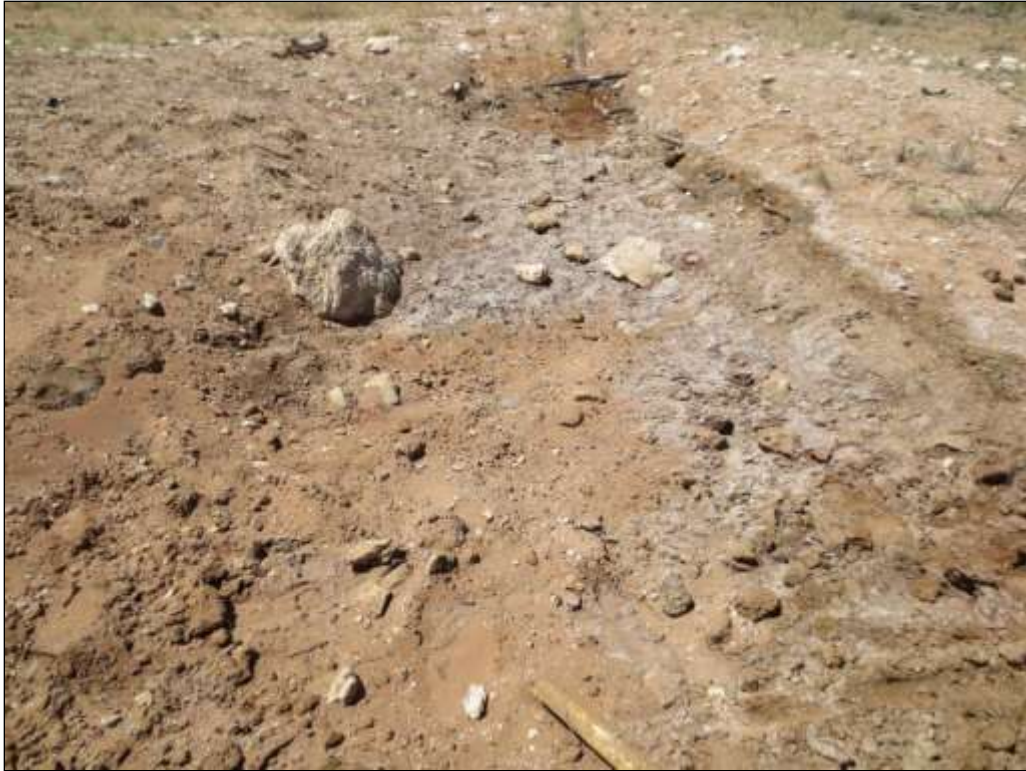
Photo #9 – Bottom of spill area

All sides and bottom were excavated to the target level of 1500 ppm Cl or less. At that point a polyethylene liner was installed and the excavation was backfilled and turned to natural grade. All contaminated were transported to an NMOCD approved disposal facility.
