WBDU #75
(1RP-3388)

Termination Request

January 16th, 2015

**RE: Termination Request
Apache WBDU #75 (1RP-3388)
UL/L sec. 16 T21S R37E
API No. 30-025-06615**

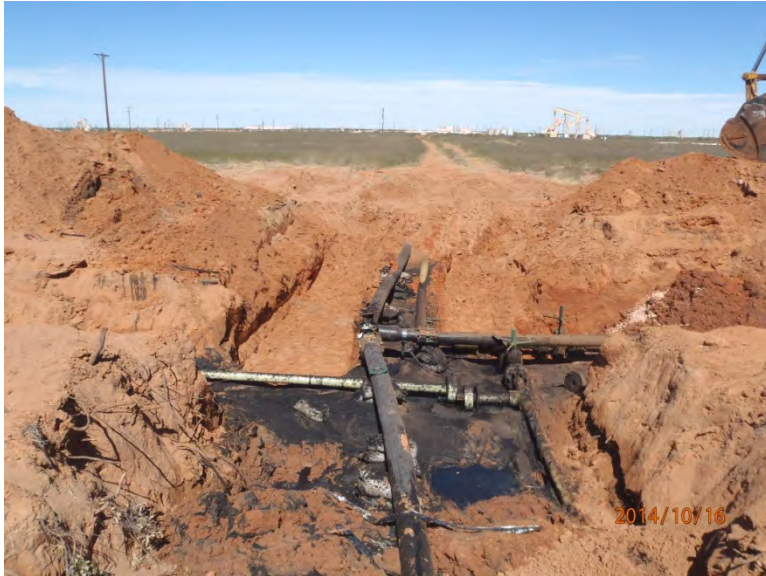
Initial site photo, facing north

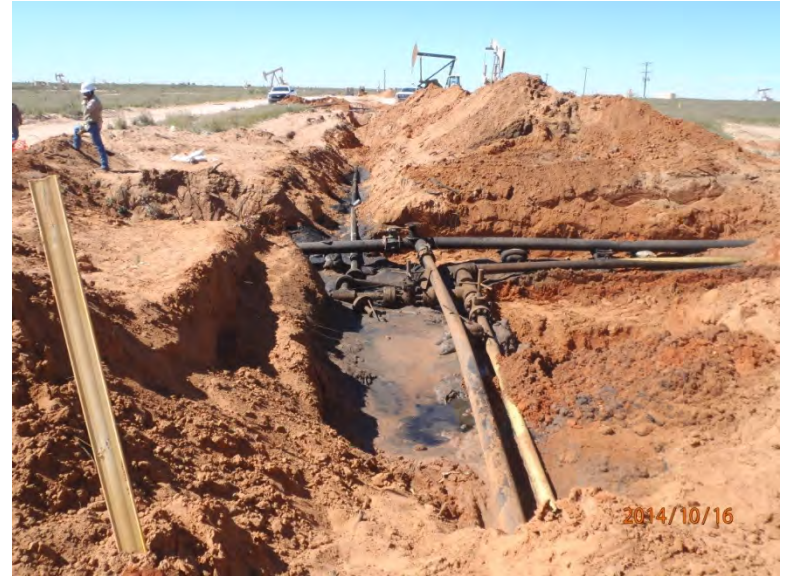
Initial site photo, facing west

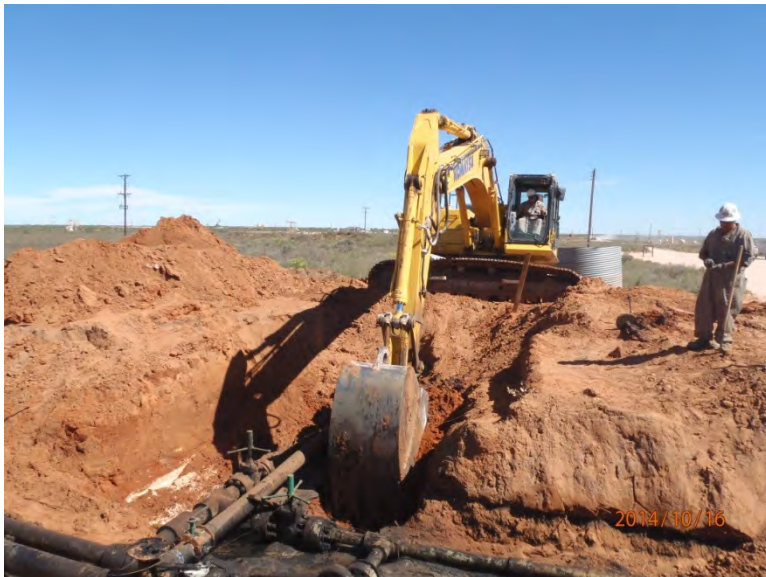
Scraping out wet material, facing northeast

RECS personnel were on site beginning on October 16th, 2014, to assess the release. The site was photographed and GPS mapped. A track-hoe was utilized to remove the wet soil in the easily accessible areas, and a shovel crew was utilized to remove the wet soil from beneath the pipelines. All excavated soil was taken to a NMOCD approved facility for disposal.

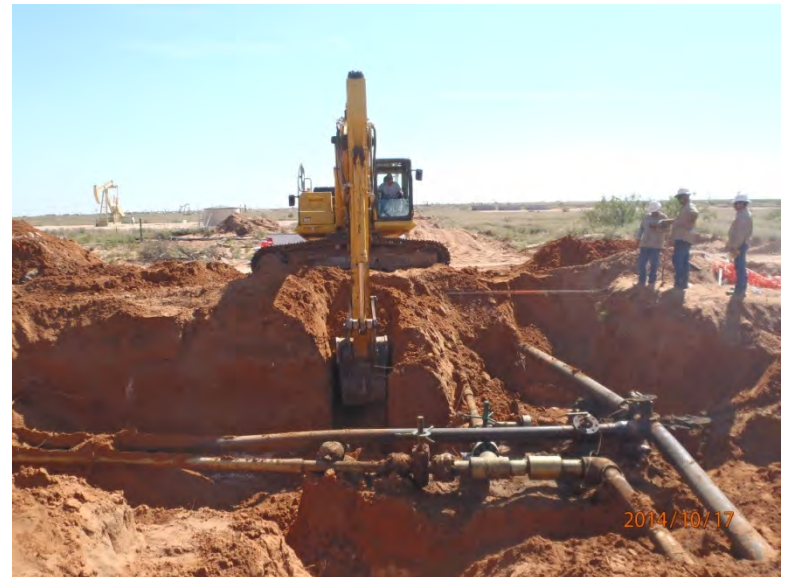
Continued excavation, facing south

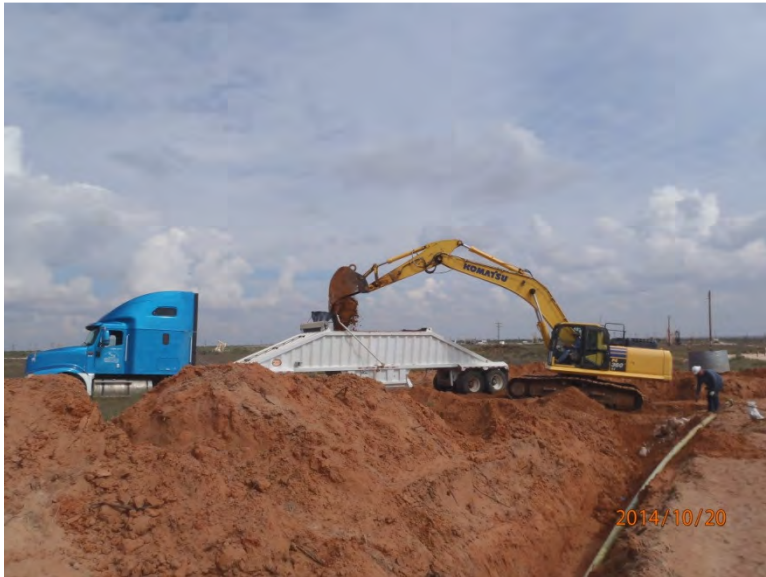
Exporting soil, facing east

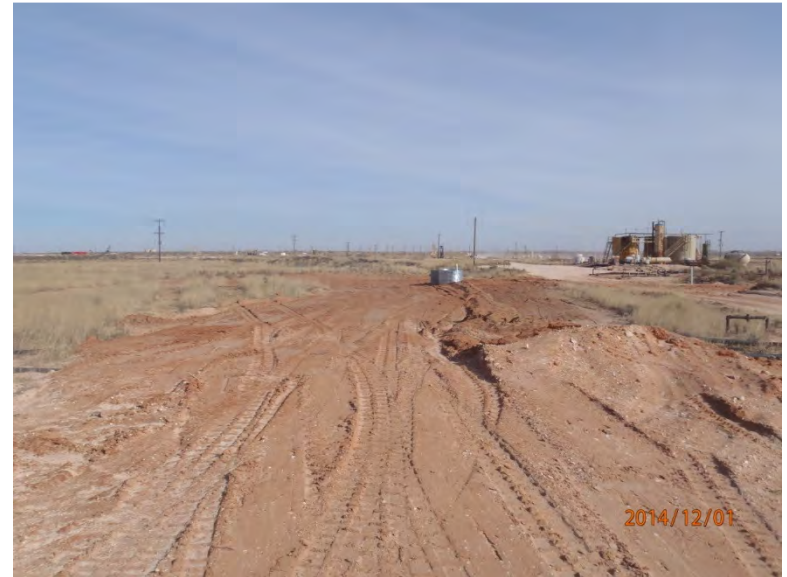
Site backfilled, facing east

Given that Apache removed the contaminated soil and replaced it with clean, imported soil, Apache respectfully requests 'remediation termination' and site closure. A final C-141 can be found in Appendix D.

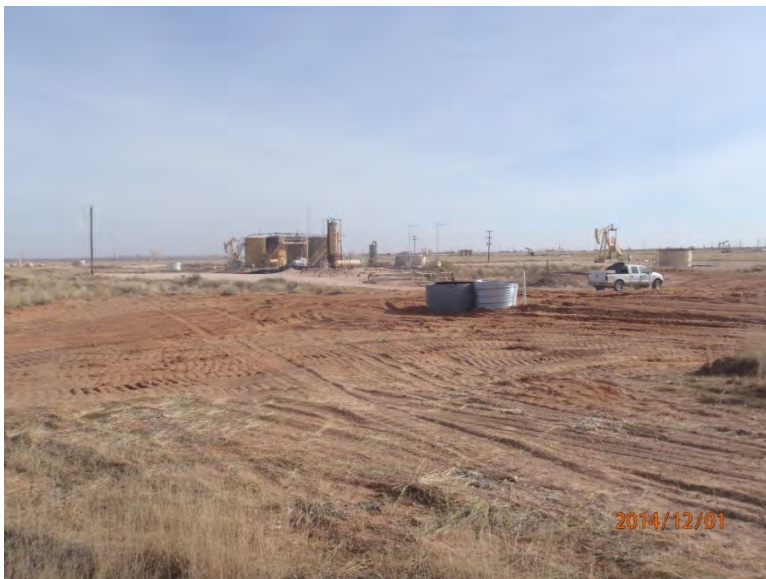
Site backfilled, facing southeast

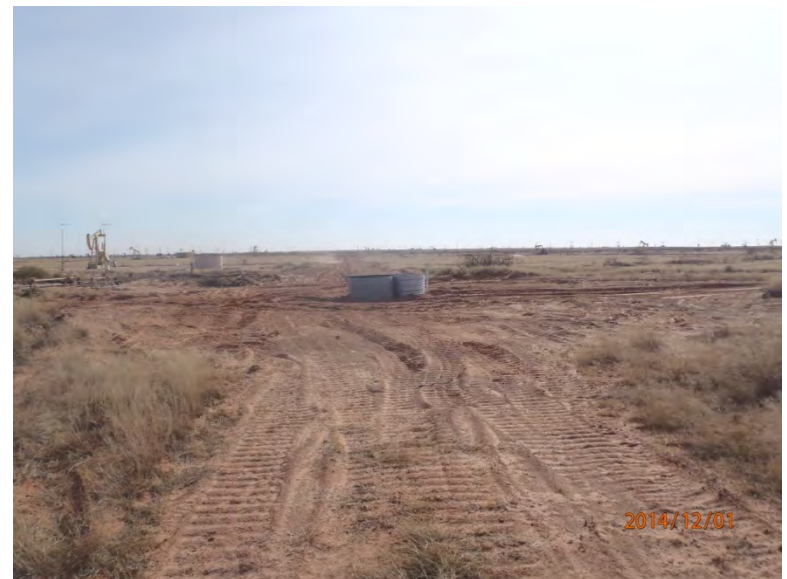
Site backfilled, facing south
