# Caprock Maljamar Unit #283

## CLOSURE REPORT

API No. 30-025-34193

Release Date: January 28<sup>th</sup>, 2015

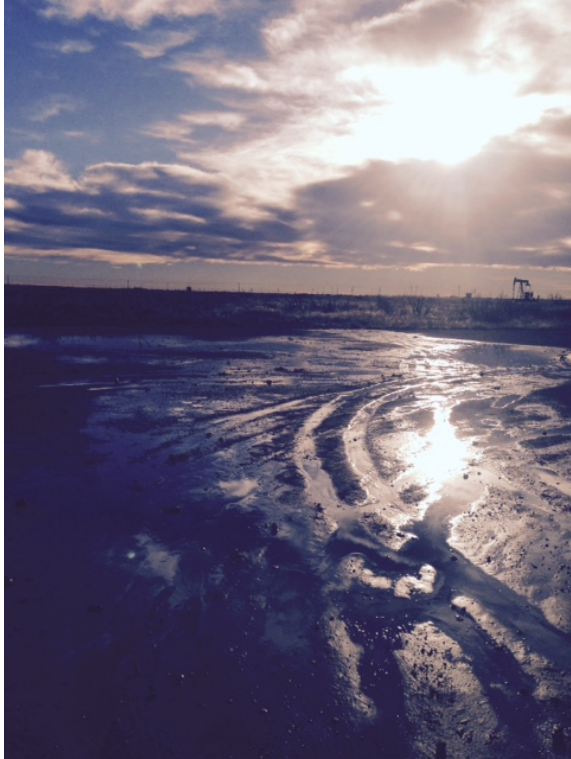
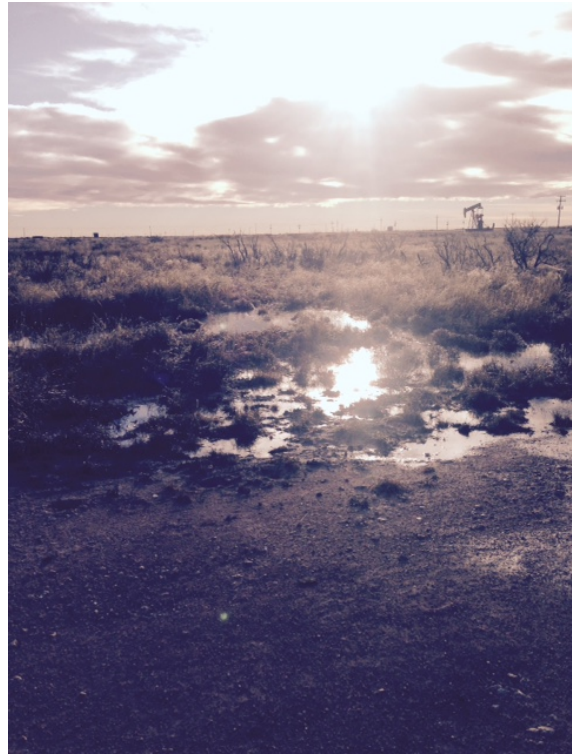
Describe Area Affected and Cleanup Action Taken.\* Appx 10bbls was spilled water ran about 192'ft from well head east to edge of location, and gathered just off location. The wind carried the mist east out in the pasture appx another 150' from the edge of location. Water misted out in the pasture on north side of location about 100' long and appx 110' wide. Clean up will be determined.

Initial spill photos

Describe Cause of Problem and Remedial Action Taken.\* At appx 7:20am I received a phone call that I had an injection leak at CMU C#283. We got line shut in and dug down to find that it was leaking around the threads on the collar of the pipe. Line coming into injection well is a 2 3/8 steel plastic coated line. We stripped back one joint and replaced with fiber glass line.

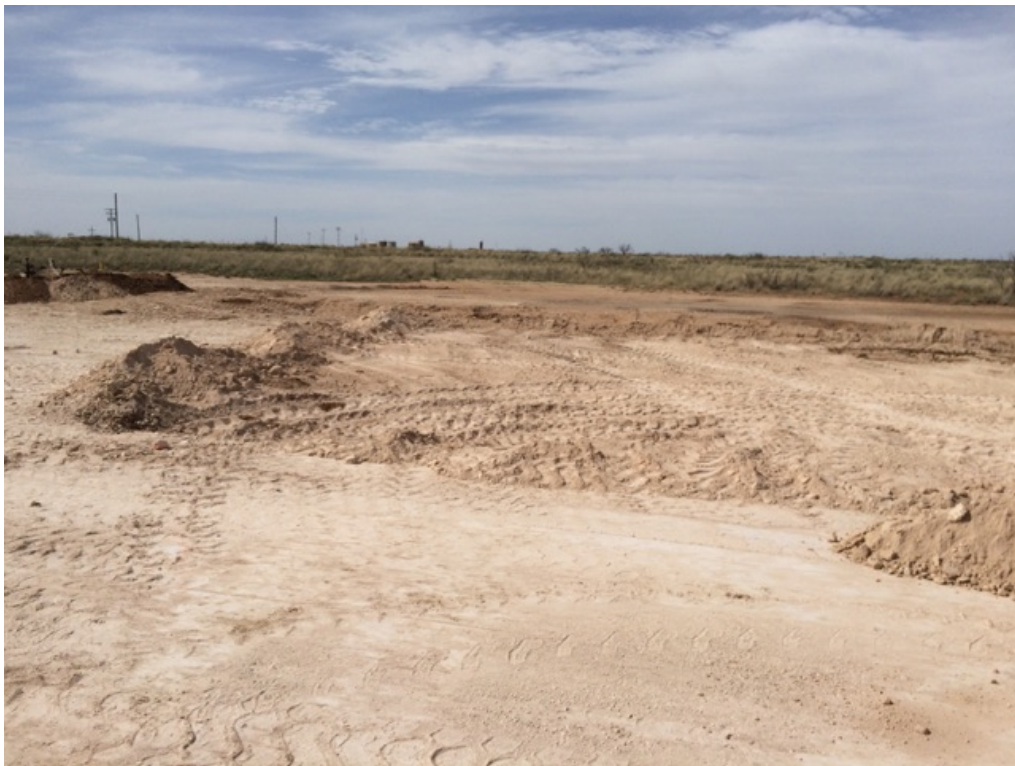
Excavation on caliche pad

On April 14, 2015, DFSI personnel visited the site to begin the excavation process. The caliche pad was dug out 6" below ground surface (bgs). The affected pasture area was excavated to 1'bgs. Native topsoil was brought in to backfill the pasture area, and fresh caliche was brought in to backfill the pad. All contaminated soil and caliche was hauled to an approved disposal facility.

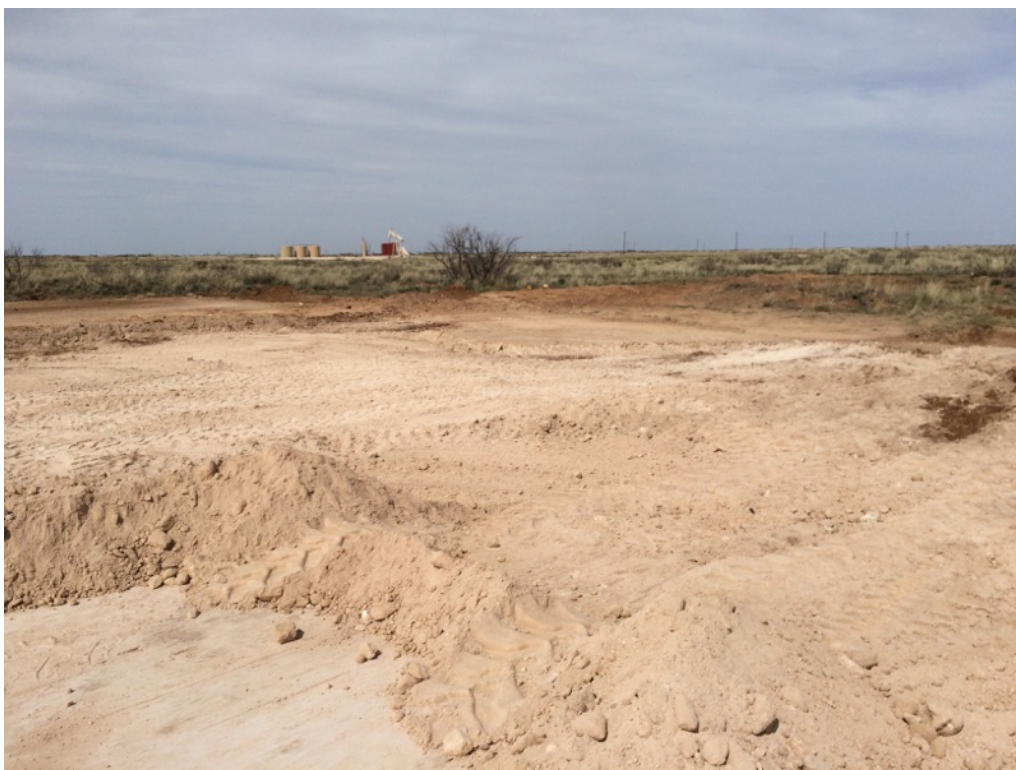
Excavation on pad and in pasture area

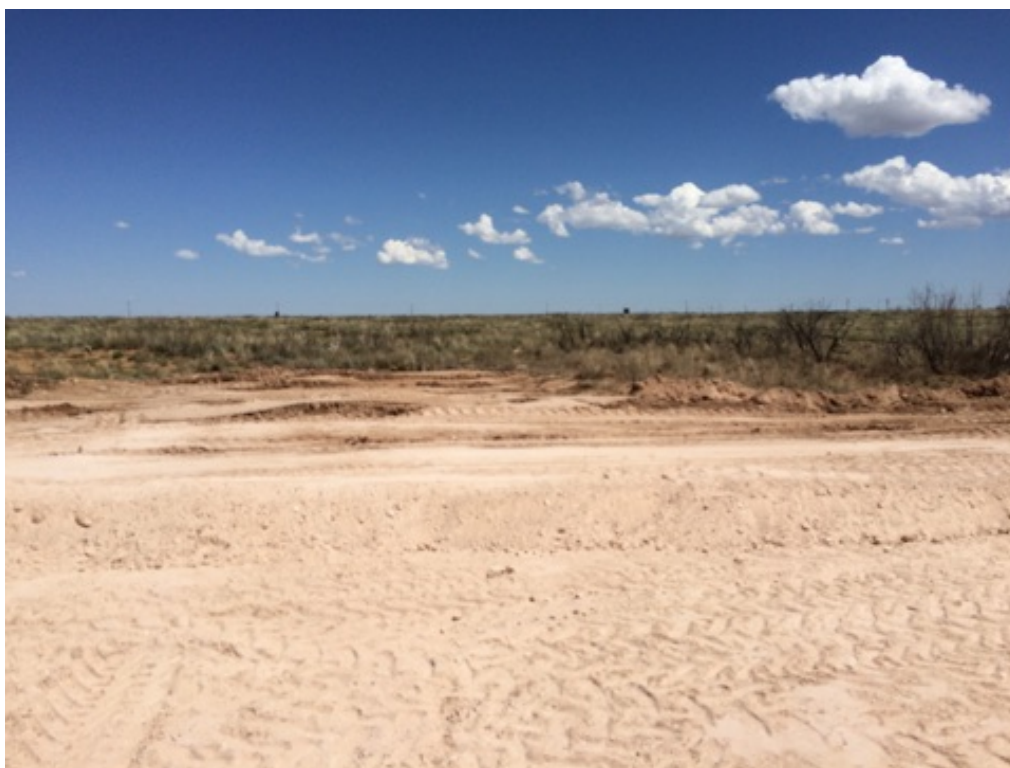
Backfilled pad and pasture area

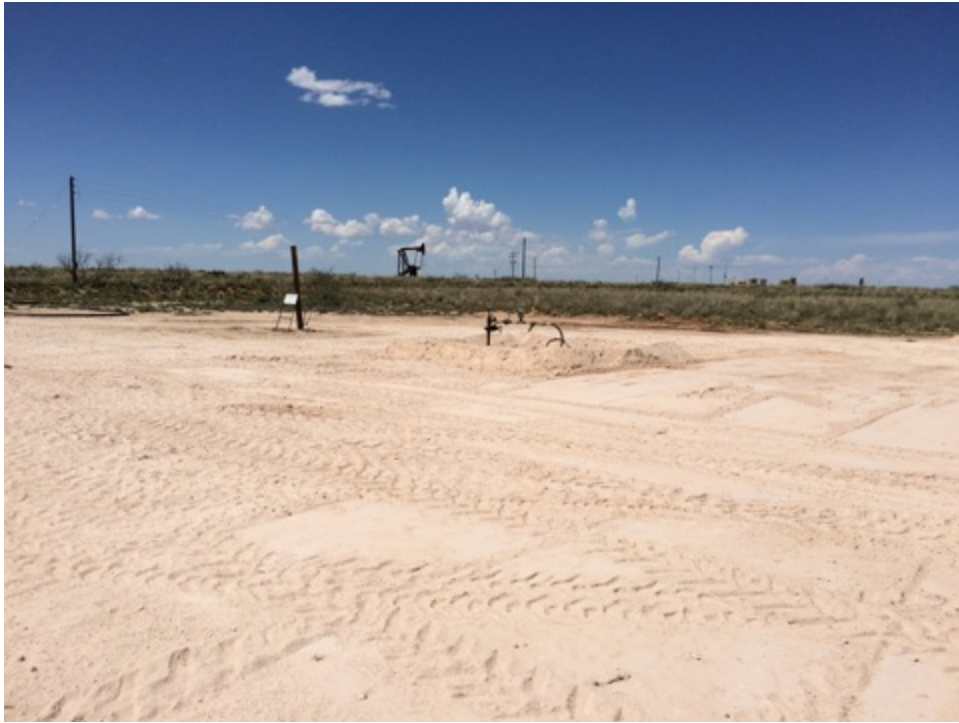
Completely backfilled pad area

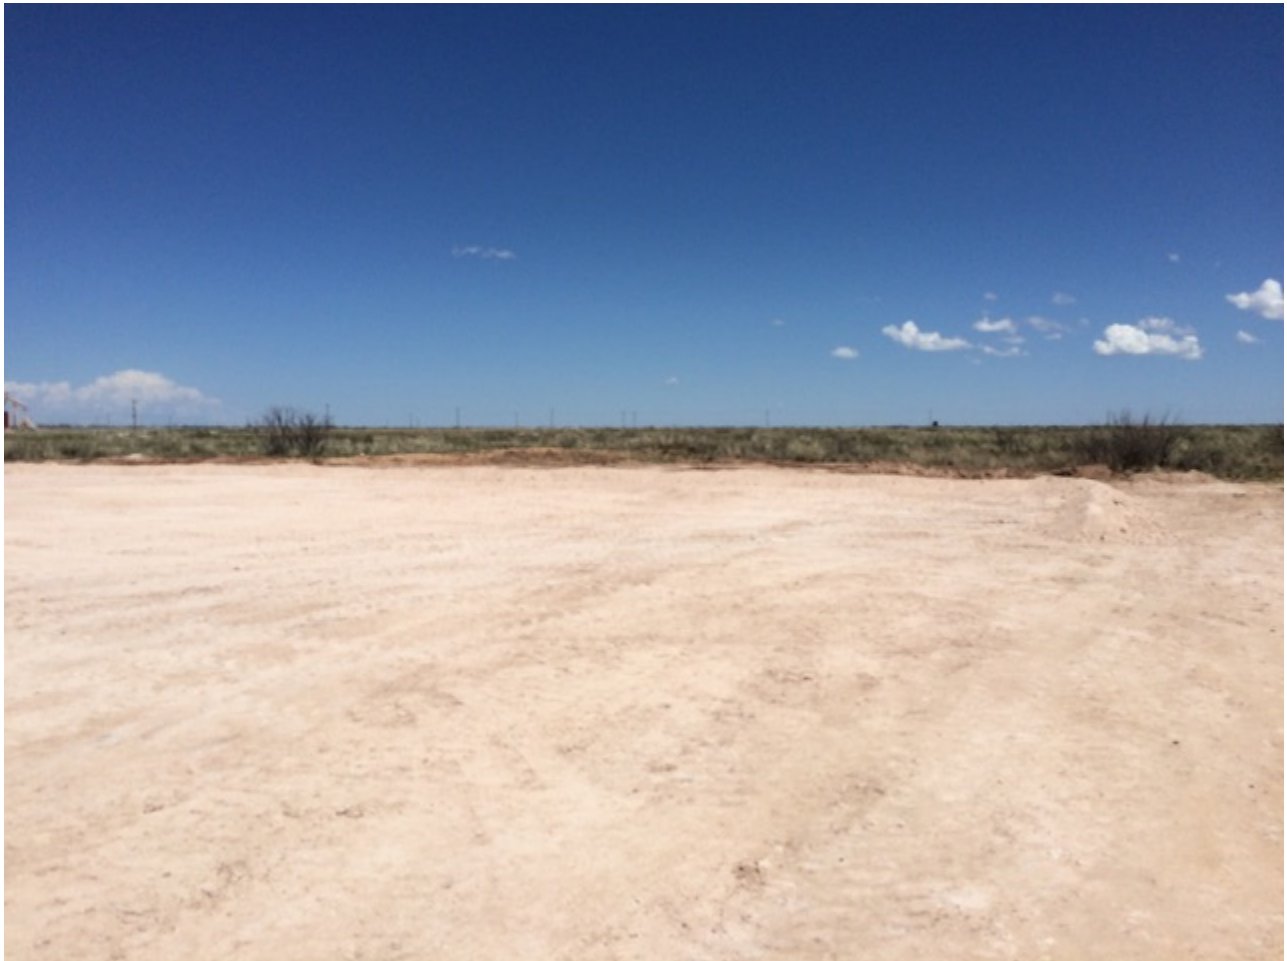
Completed location

The location will be seeded with a BLM-OCD approved mix once approved by Linn Energy, Inc.

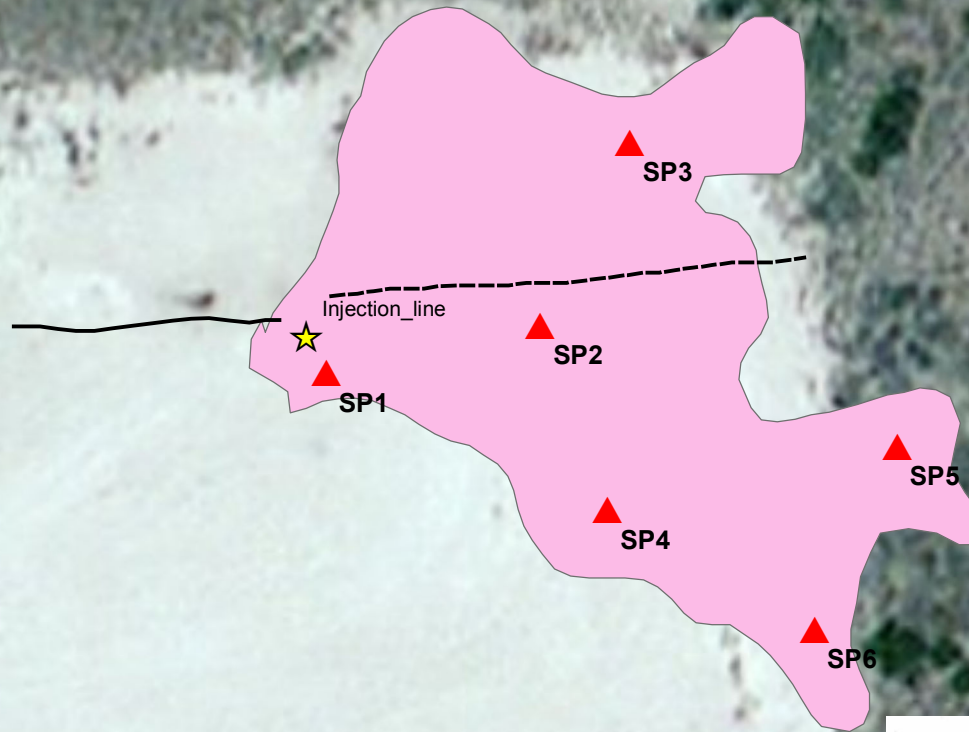
# Site Diagram

Linn, CMU C #283  
UL/O, Sec. 28 T17S R33E  
Lea County, NM  
Drafted By: Lance Crenshaw, 2-16-15

Spill Area:  
16,333 sq. ft.
