Cascade 29 Fed #3

CLOSURE REPORT

API # 30-025-41241

May 27, 2015

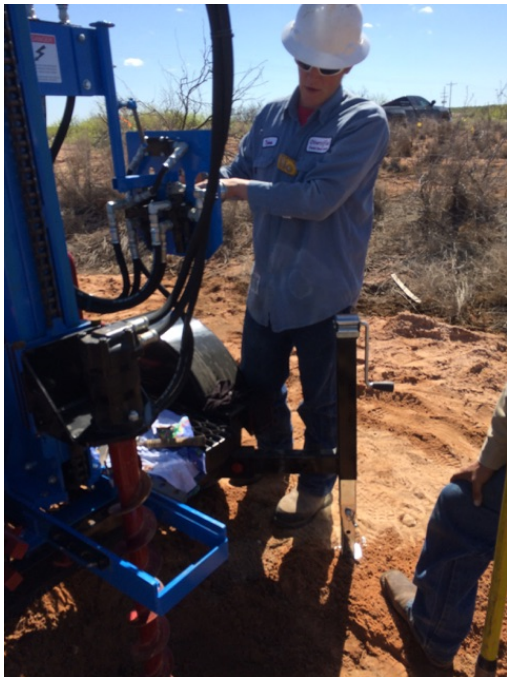
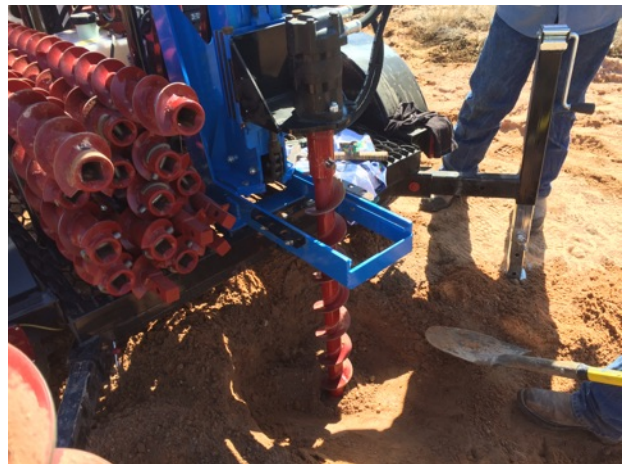
4/14/2015

Auger drilling

On April 14, 2015, DFSI personnel used a mechanical auger to drill down and complete delineation of the site in one sample point. Two clean samples were obtained at 30' and 31'. The same testing method as above was used. Two connective clean samples were taken to the lab for confirmation. The results are attached.

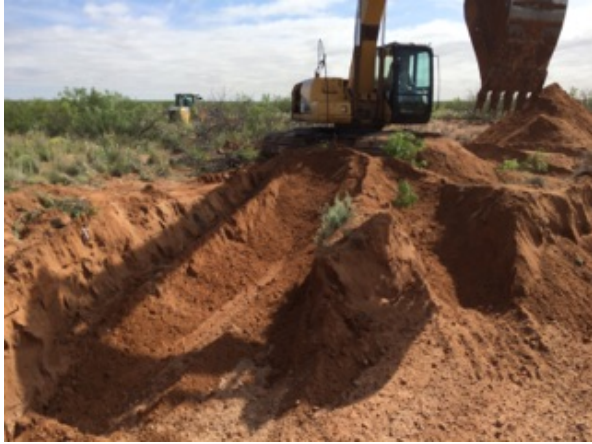
Excavating spill area to 3' bgs

DFSI personnel returned to the site to begin excavation. The entire spill area of 10,180 sq. ft. was dug to 4' bgs and hauled off to an approved disposal. A hydrovac was used to dig out the area between two trunk lines that ran through the spill area. A .20 mil liner was installed and fresh topsoil was used to backfill. The backfilled area was then seeded with a BLM approved seed mixture to restore the site to its previous state.

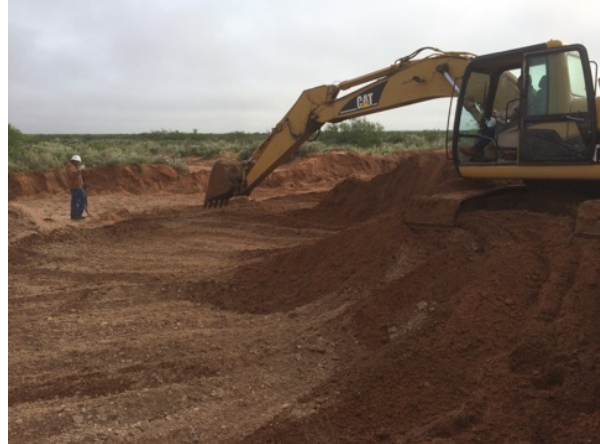
Excavating spill area to 3' bgs

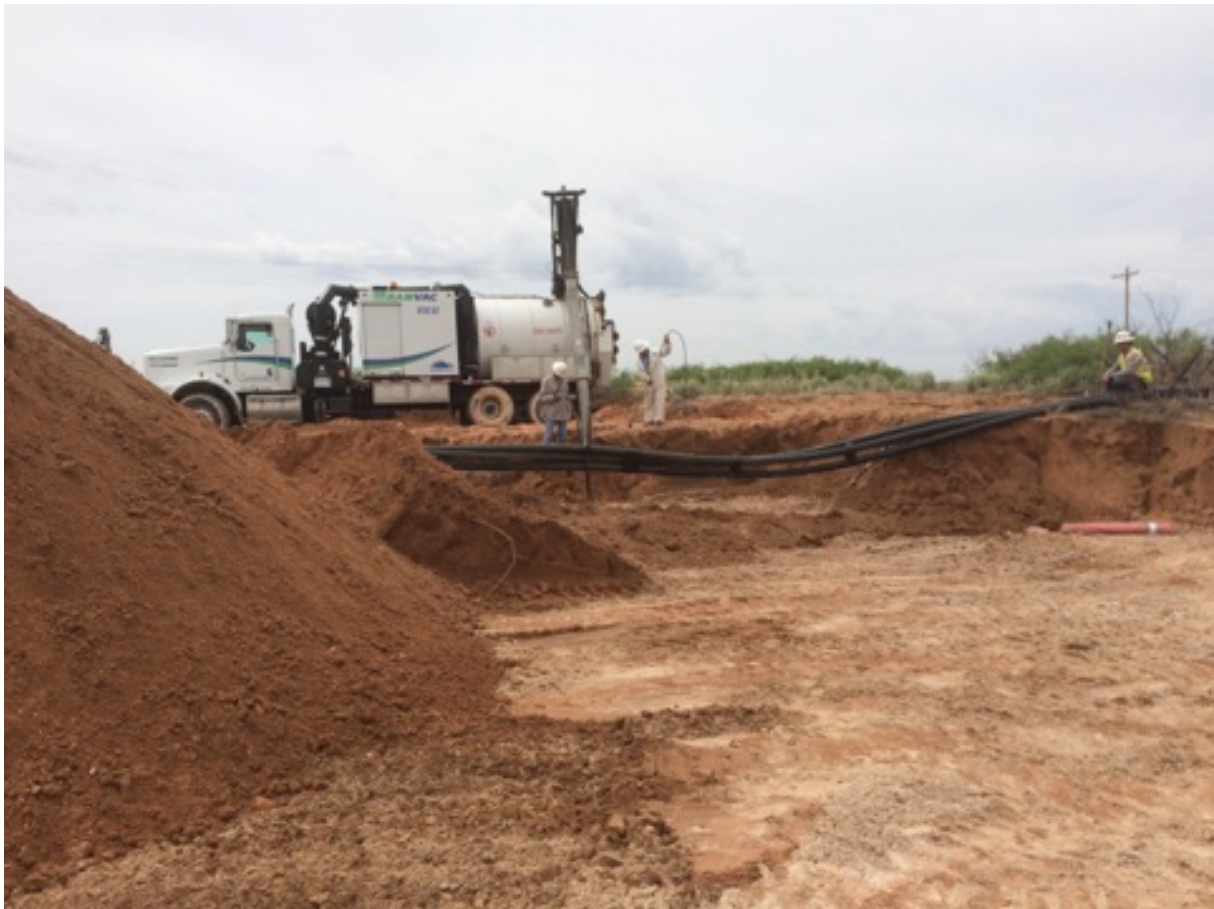
Using hydrovac to dig between trunk lines

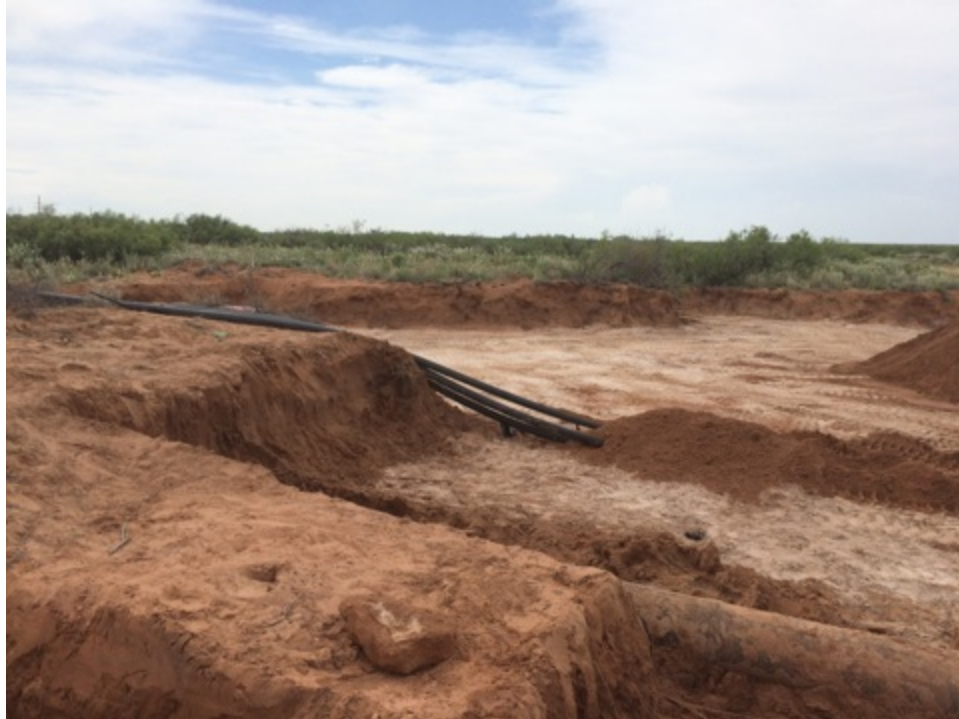
Excavated spill area, ready for liner installation

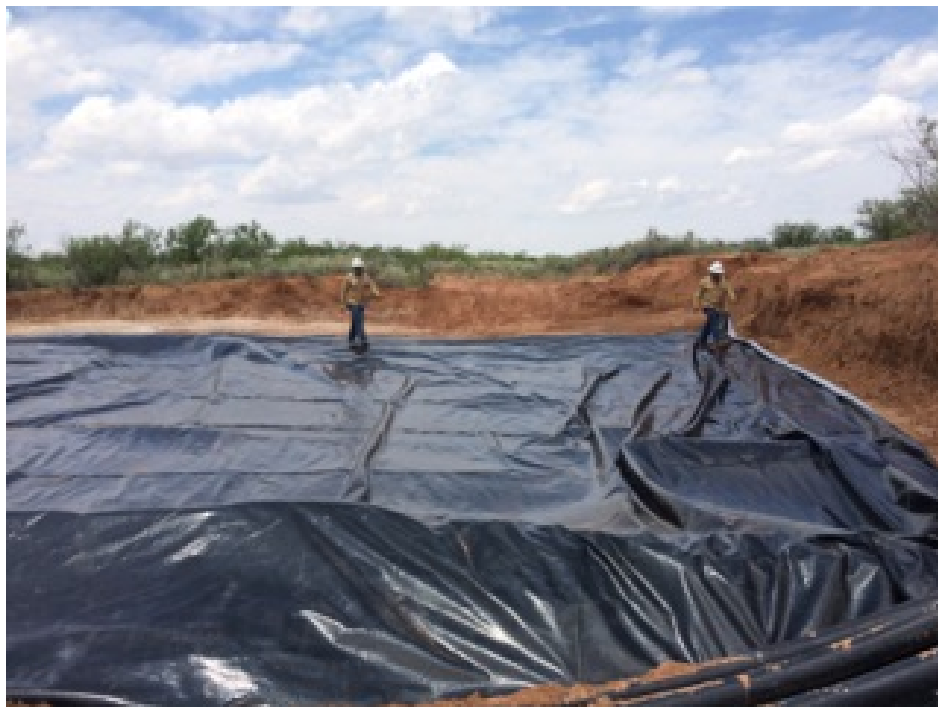
Liner installation in excavated area

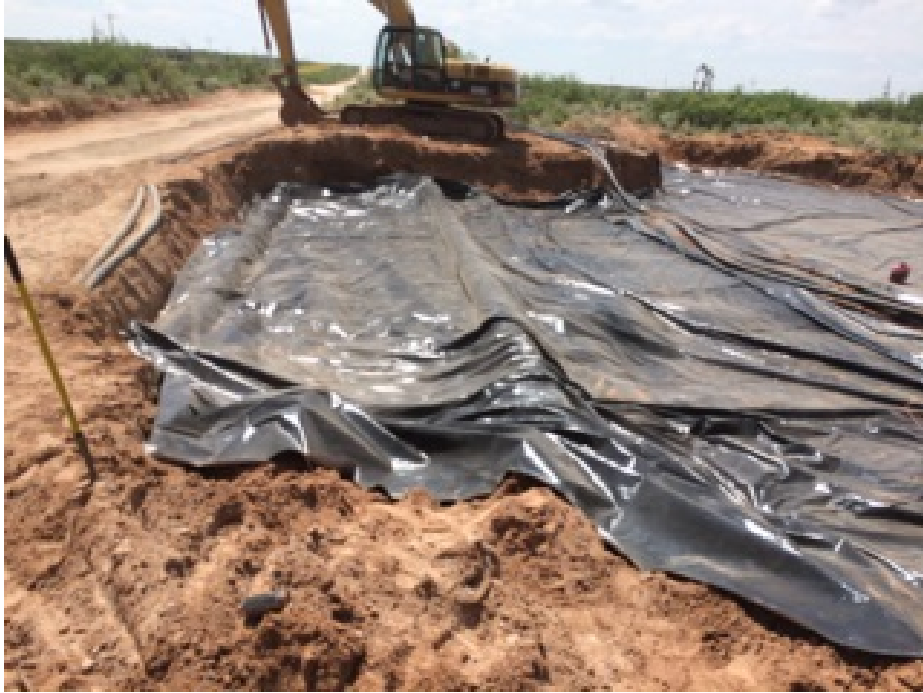
Liner installation in excavated area

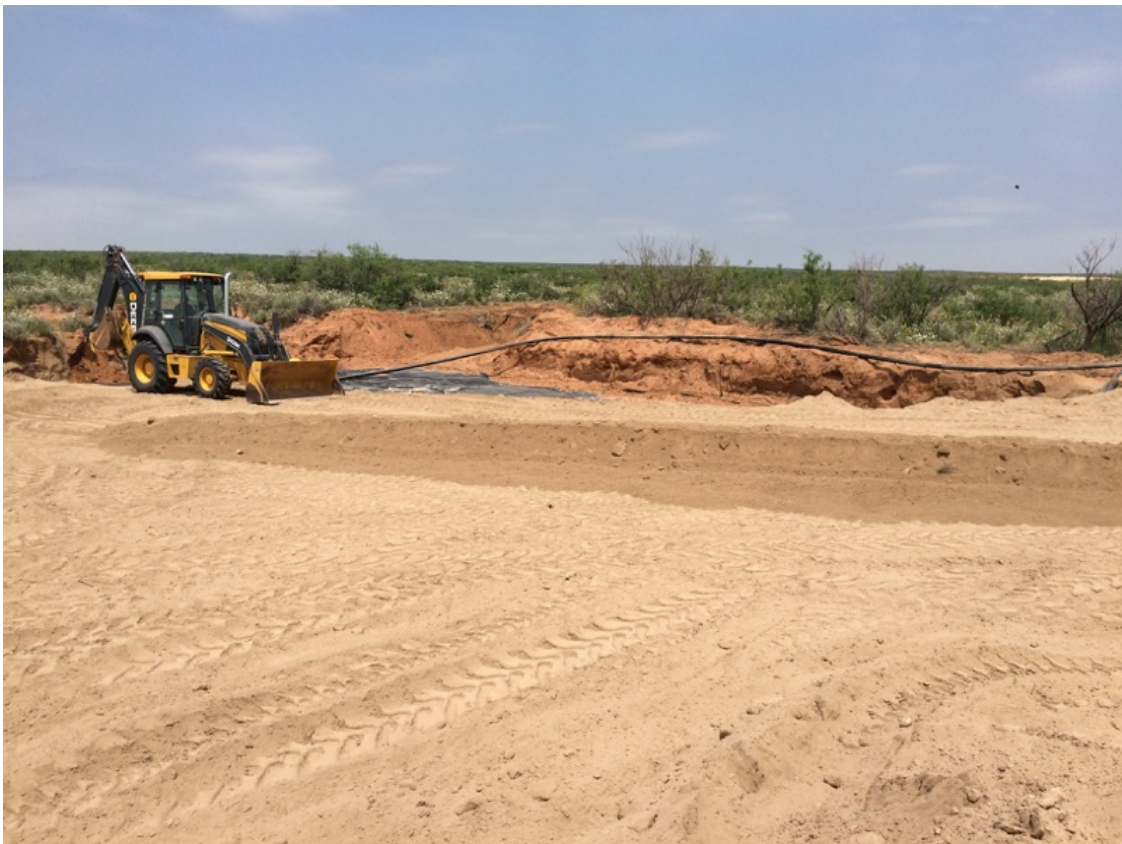
Backfilled area after liner installation

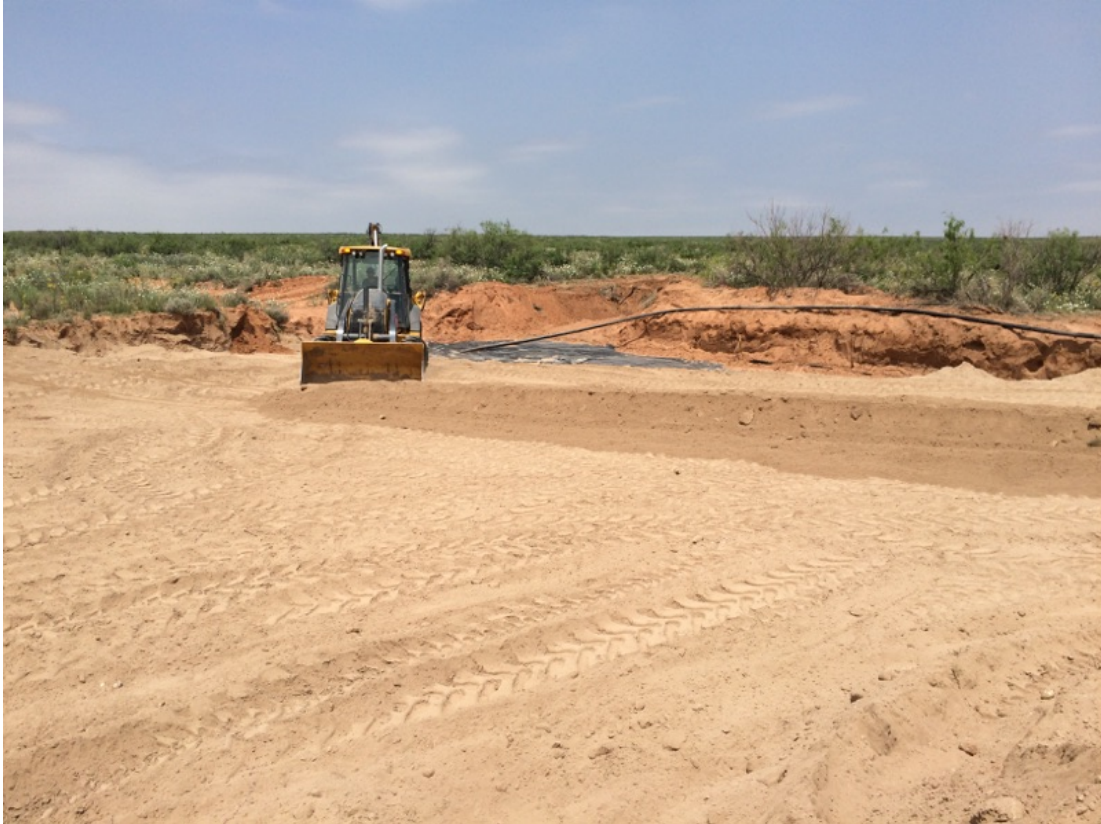
Backfilled area after liner installation

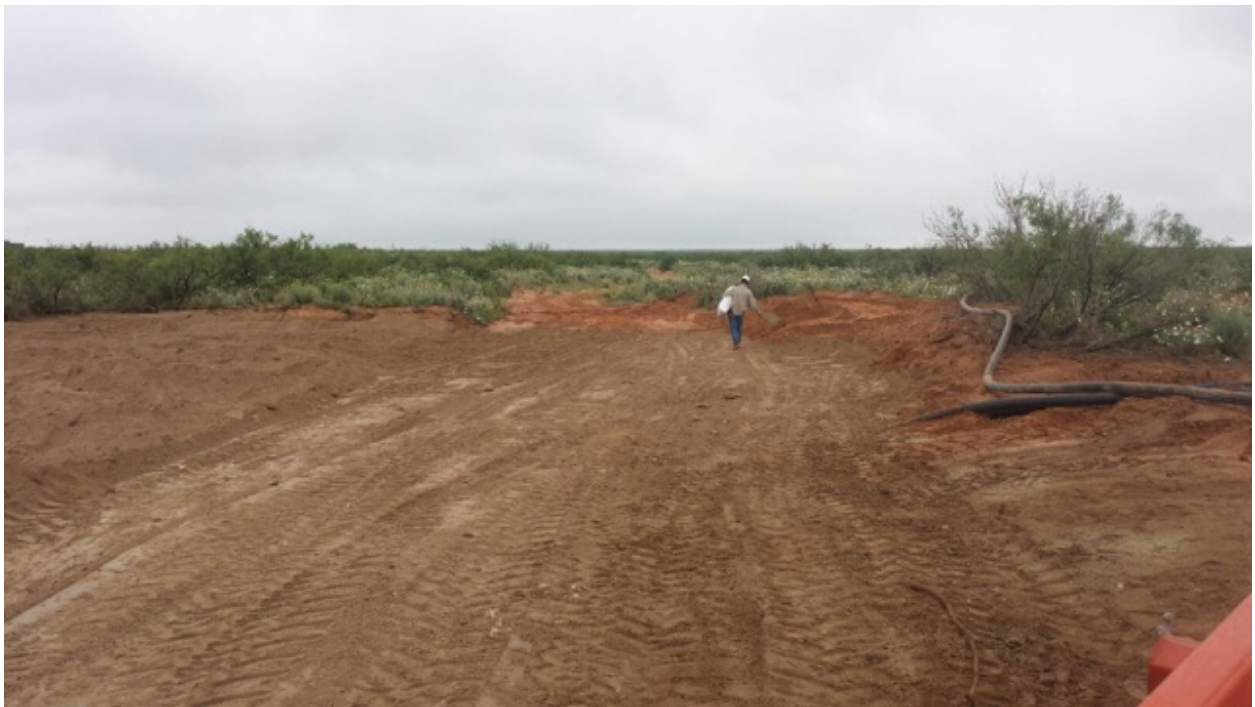
Seeding backfilled area

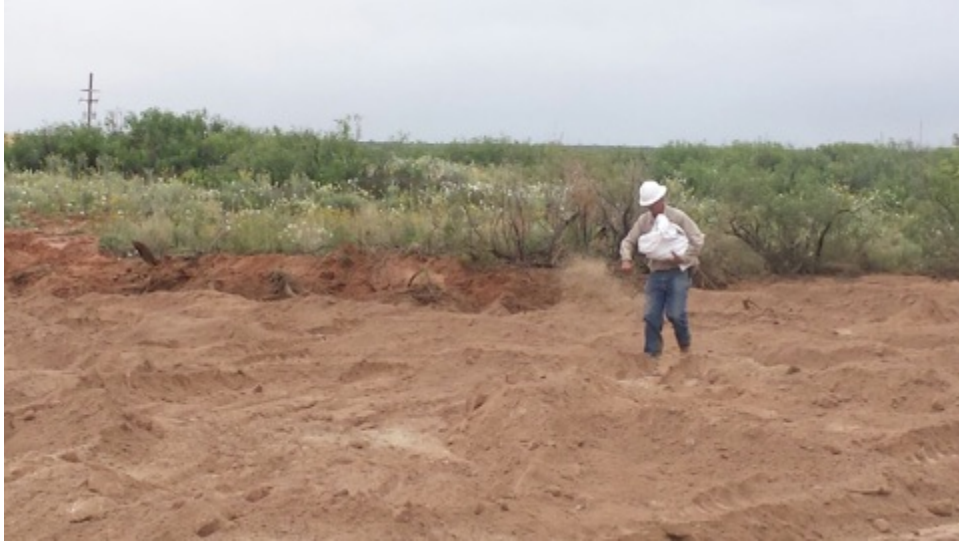
Seeding backfilled area

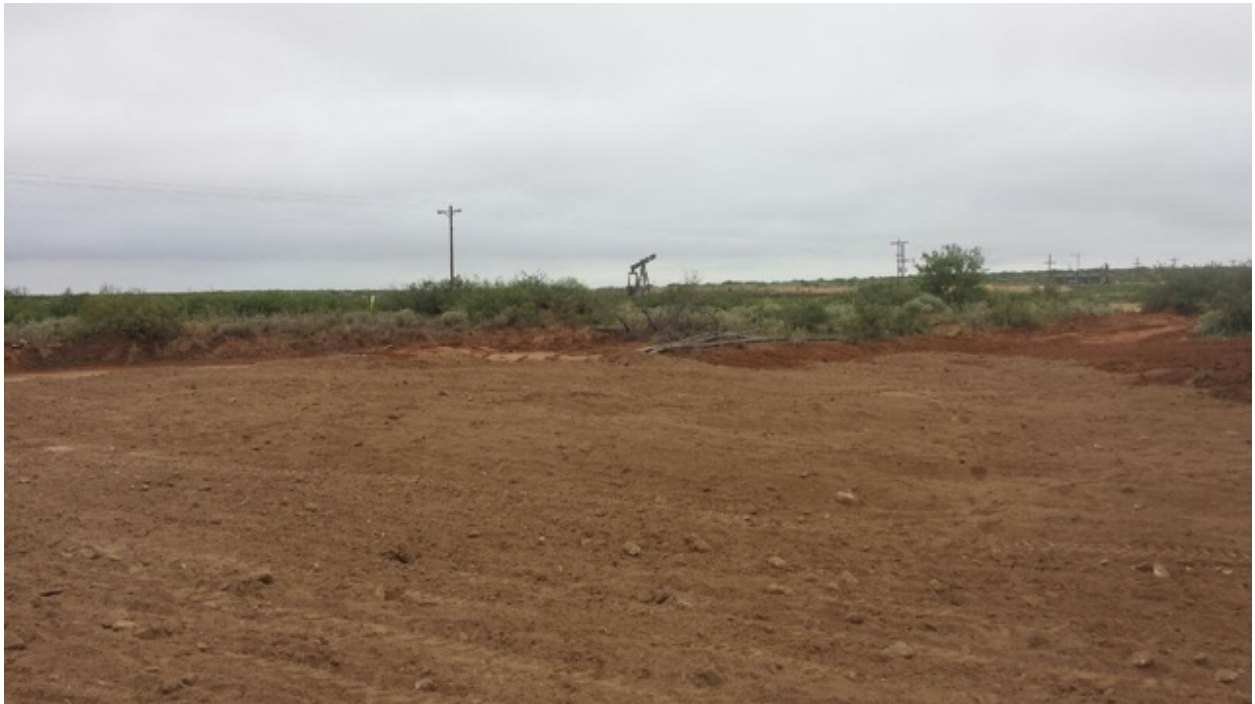
Completed location after seeding and tilling

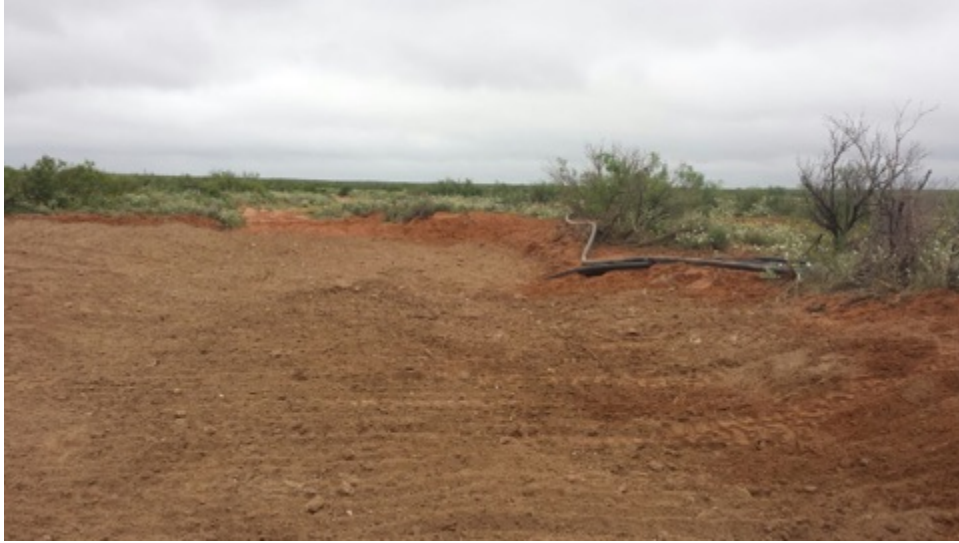
Completed location after seeding and tilling

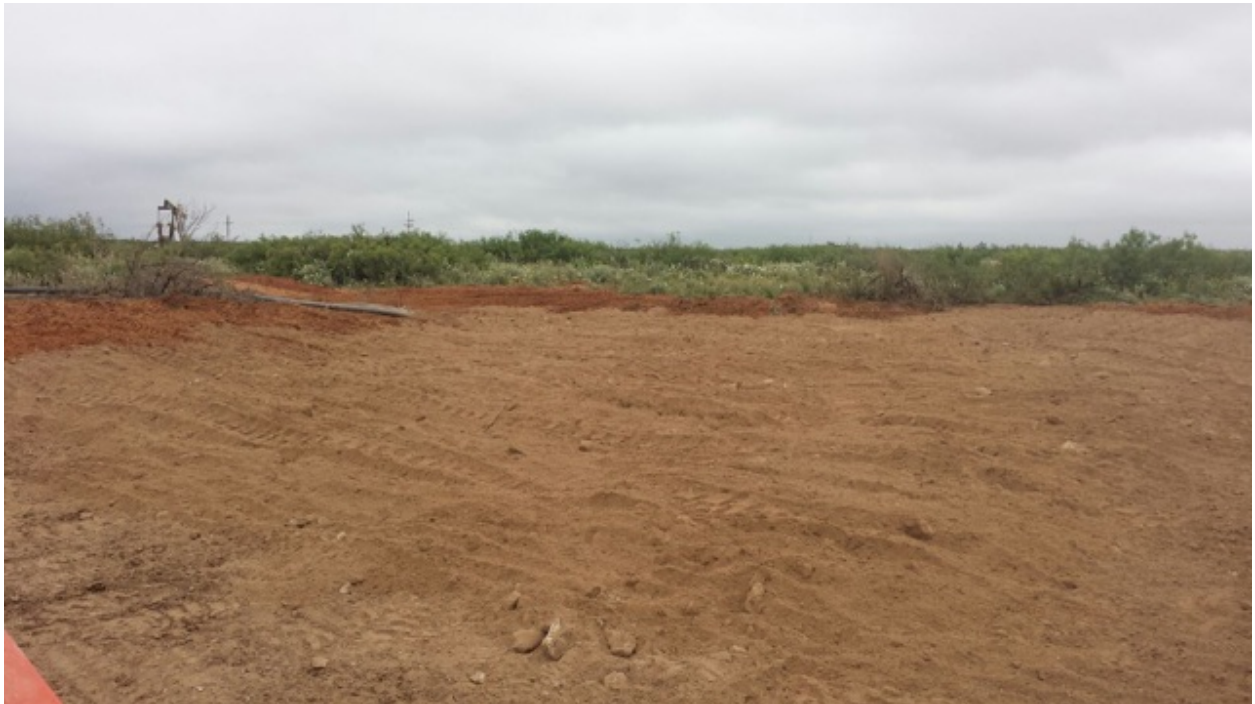
Completed location after seeding and tilling

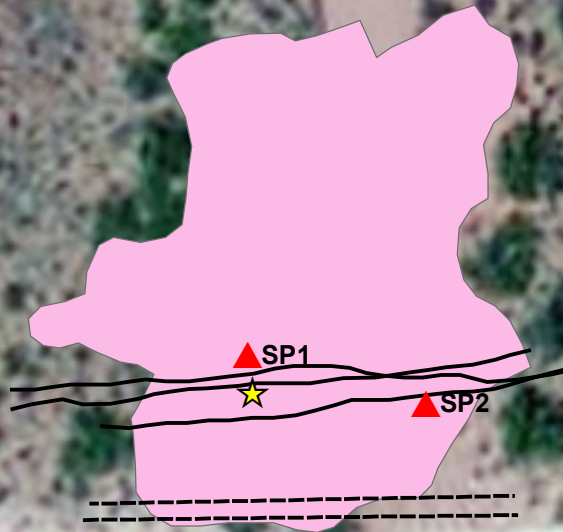
Site Diagram

Spill Area:
10,180 sq. ft.
