# Shell D State Com #13

## CLOSURE REPORT

UL/L Sec 36, T21 south, R36 east, Lea county NM

API # 30-025-31684

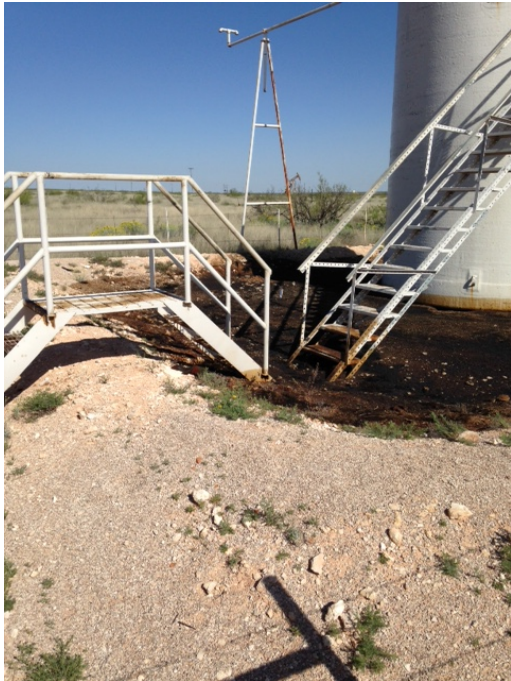
Spill area inside bermed facility

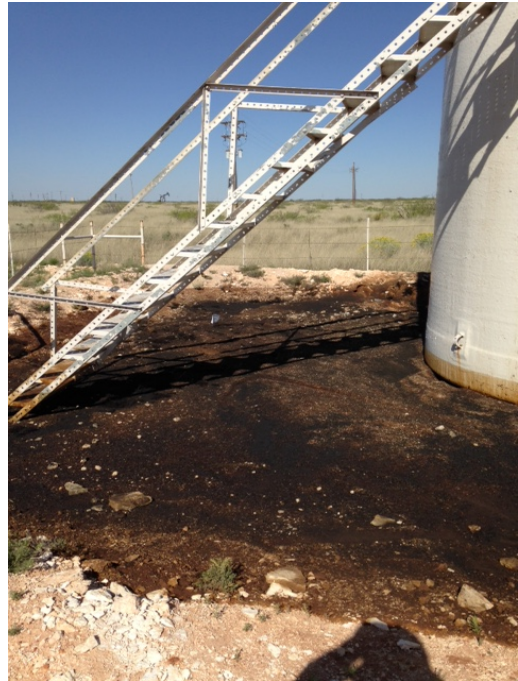
Spill area inside bermed facility

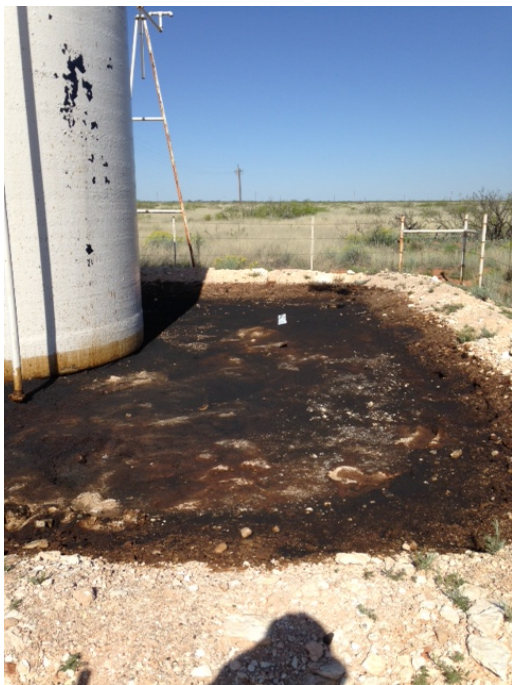
Spill area inside bermed facility

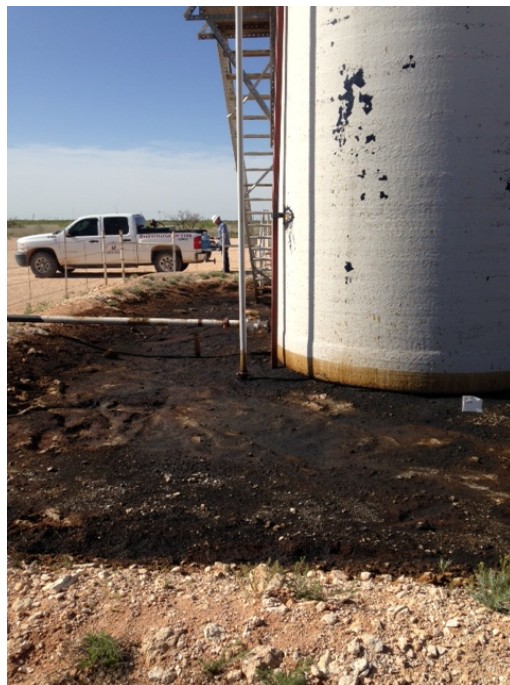
Spill area inside bermed facility

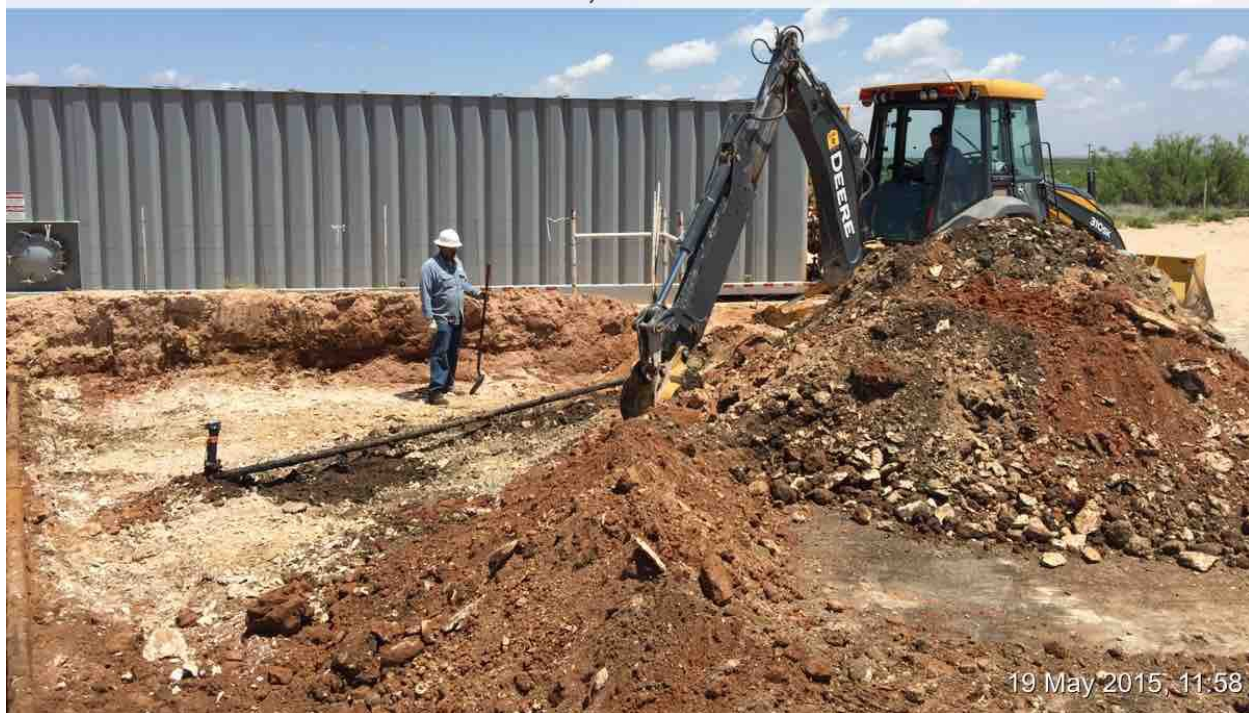
Excavating area inside bermed facility after tank removal

DFSI personnel returned to the location to begin remediation. The fiberglass tank was removed by Cimarex personnel. A total of 154 yards of contaminated soil was hauled out, after the entire bermed facility was dug out to 2' bgs. DFSI personnel then backfilled the area with fresh caliche and installed a .20 mil liner. Two inches of fresh caliche was backfilled on top of the liner per Jaime Castillo of Cimarex. DFSI personnel also built new berms for the facility and the location was restored to its previous state.

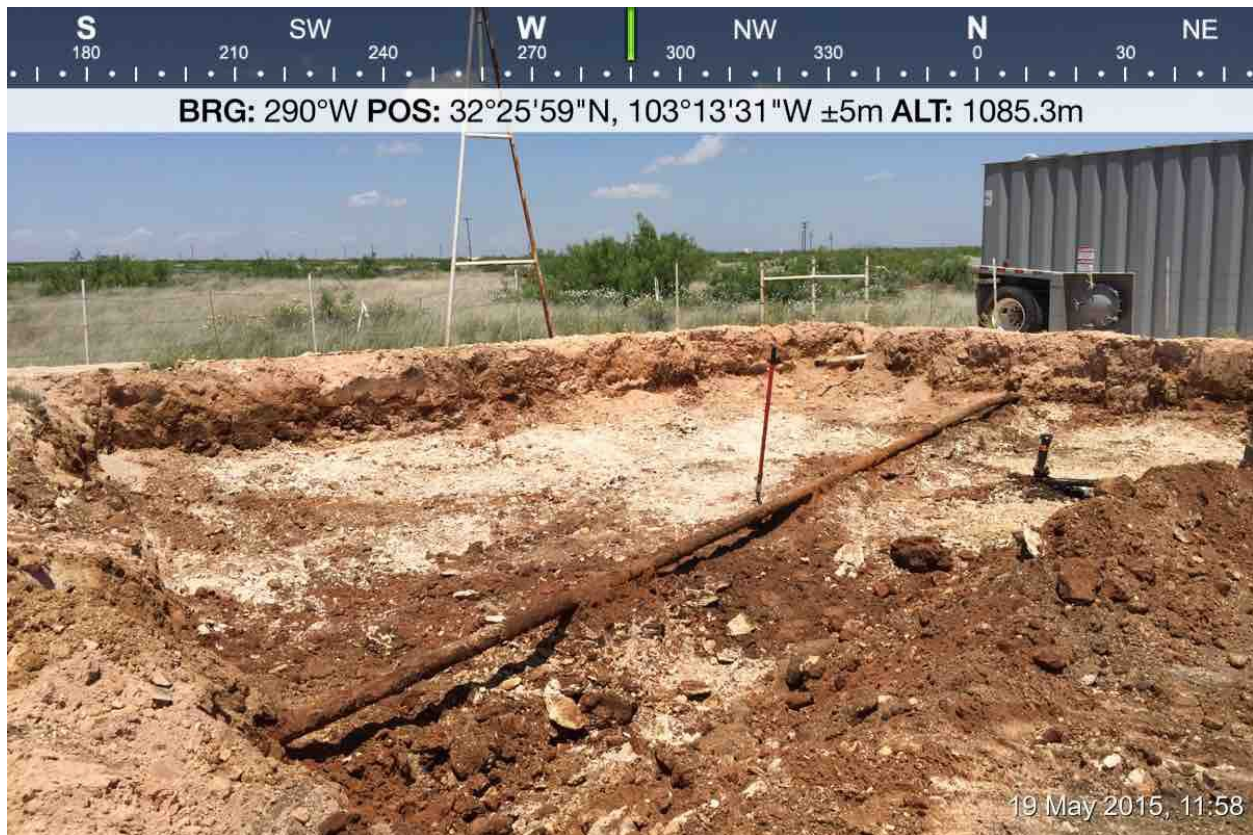
Entire bermed area excavated to 2' bgs

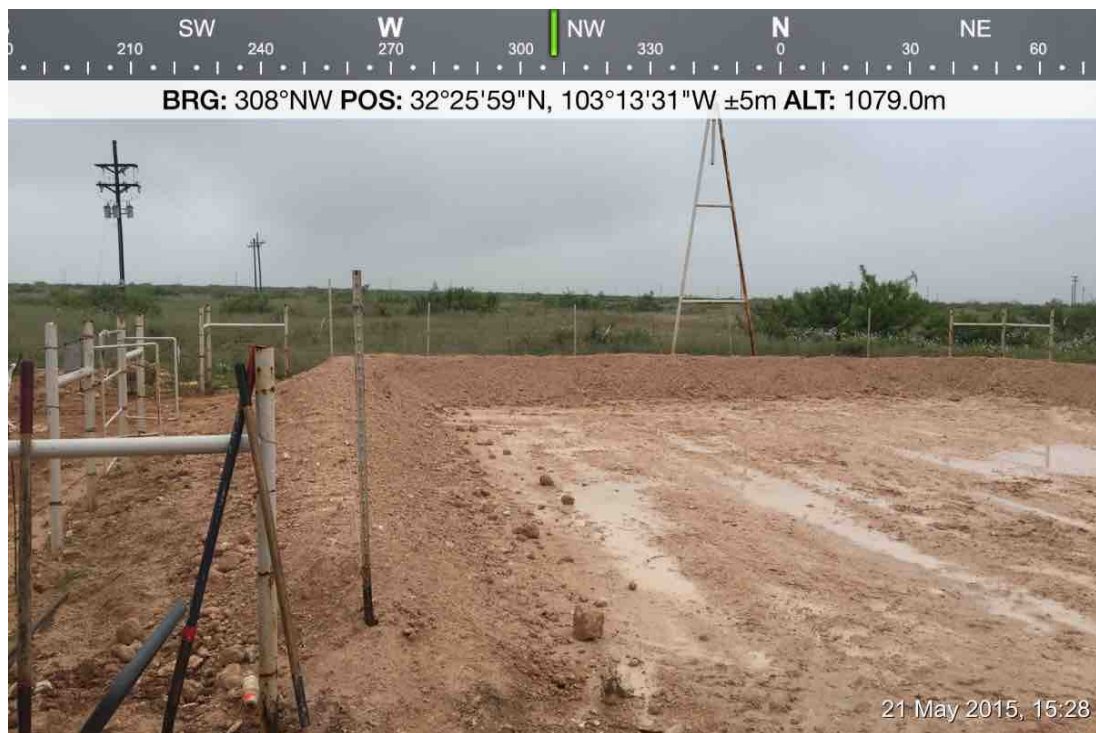
Backfilled area with fresh caliche

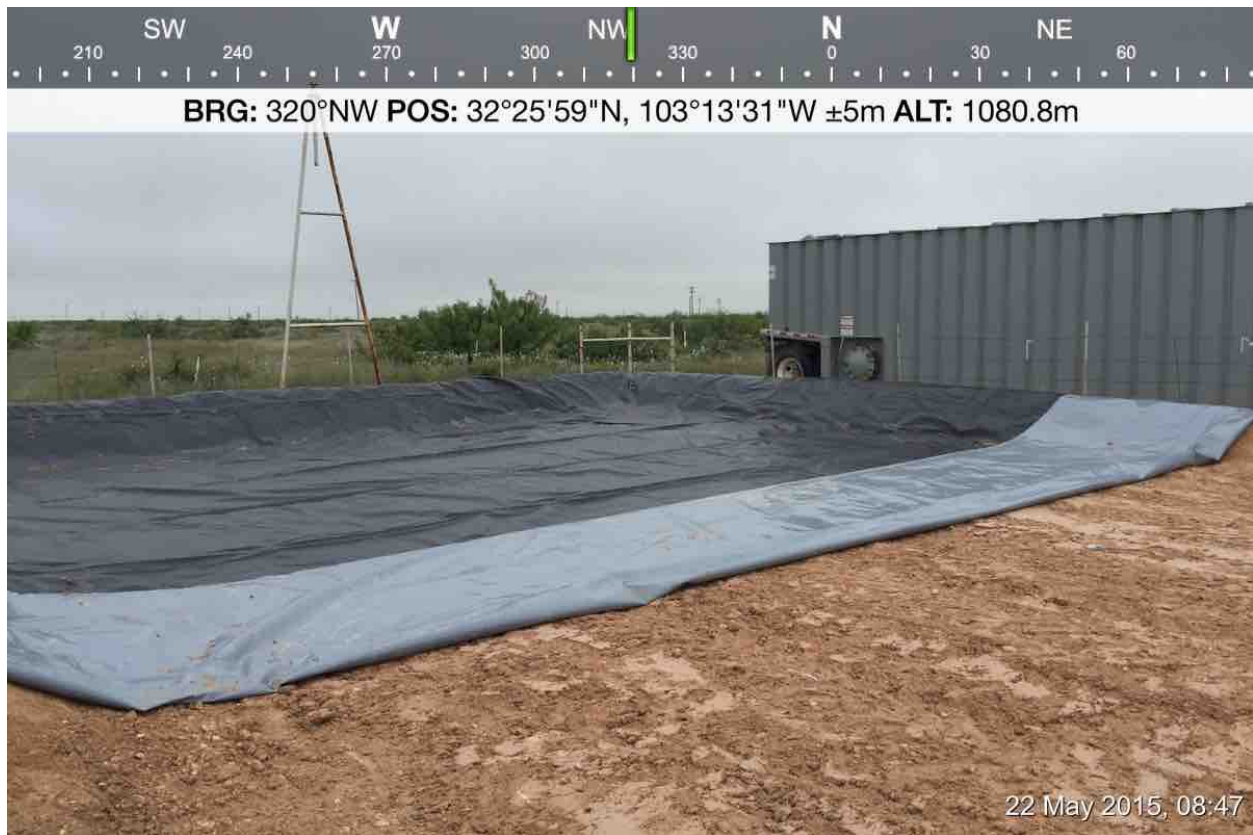
.20 mil liner installation inside bermed area

All fluids contained in unlined containment. Diversified Field Services excavated the affected area to 2' bgs. Fresh caliche was brought in for backfill, and a .20 mil liner was installed and backfilled with two inches of caliche. Firewalls were also rebuilt and the location was returned to its previous state.

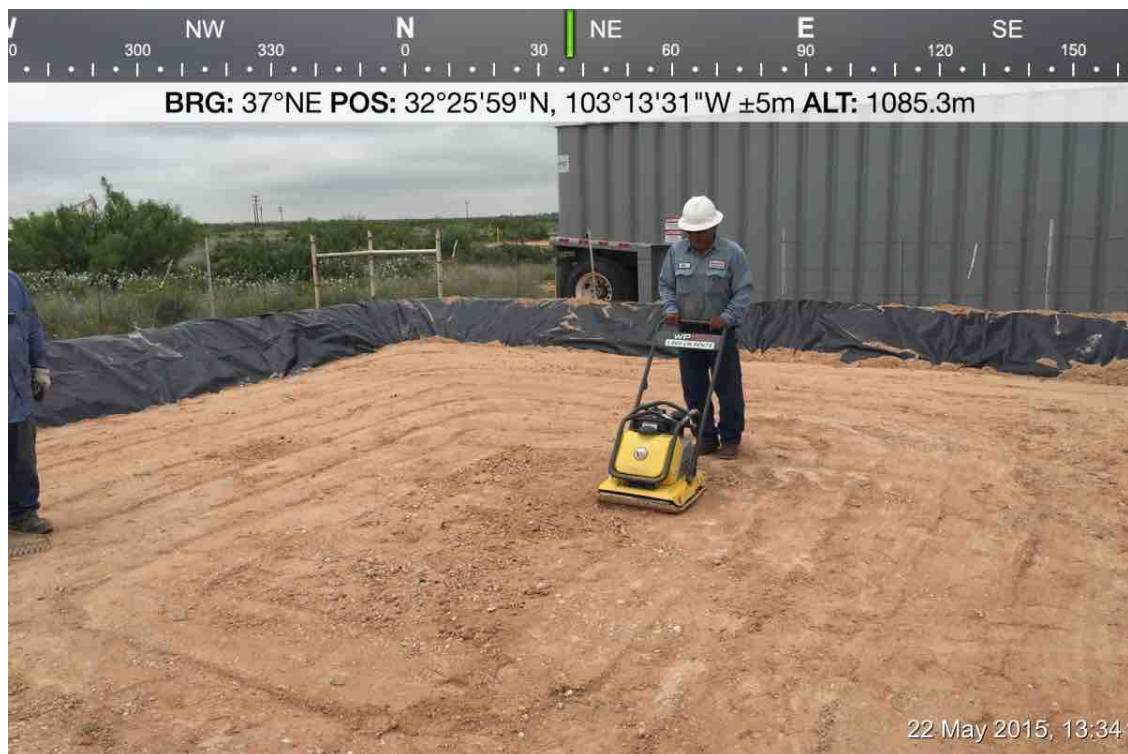
Compacting caliche after liner installation

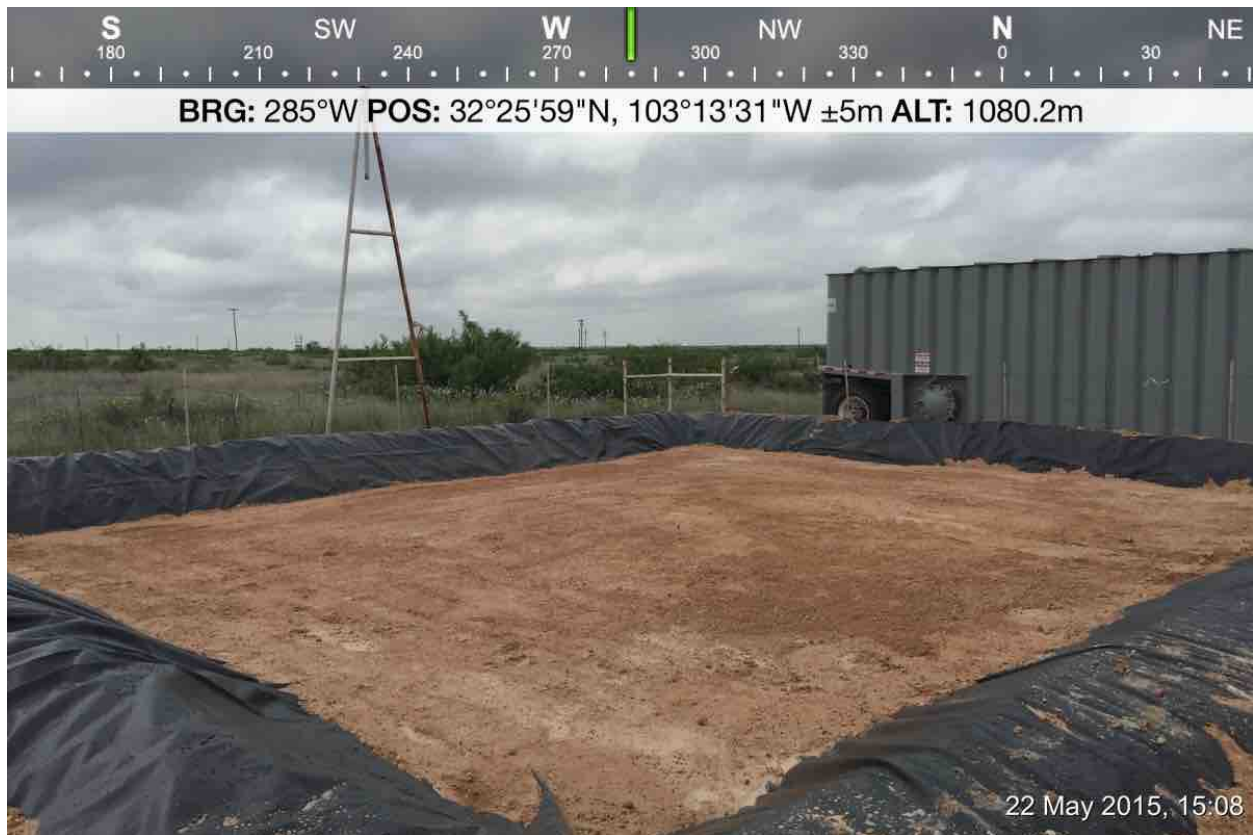
Completed location with liner installation and rebuilt berms

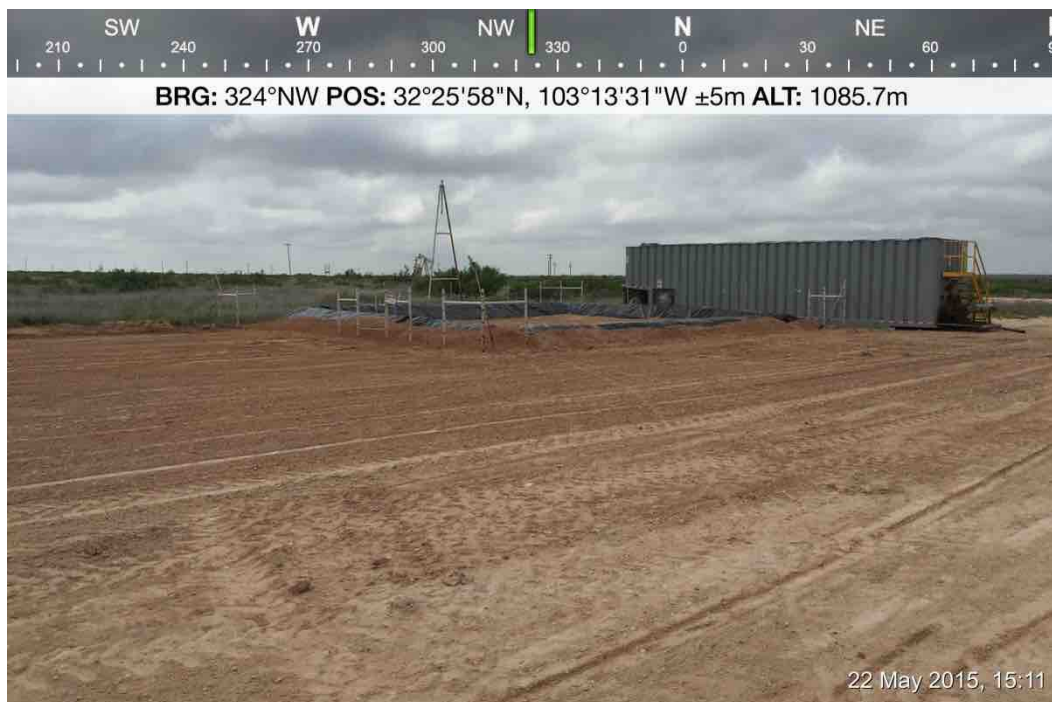
Completed location with site returned to its previous state
