Release Notification and Corrective Action

REMEDIATION SUMMARY & RISK-BASED SITE CLOSURE REQUEST

**PLAINS ALL AMERICAN PIPELINE, LP
JAL STATION 2-INCH SUMP LINE
Plains SRS #2014-314
Lea County, New Mexico
Unit Letter "A" (NE/NE), Section 5, Township 26 South, Range 37 East
Latitude 32.078268° North, Longitude 103.179757° West
NMOCD Reference #1RP-3468**

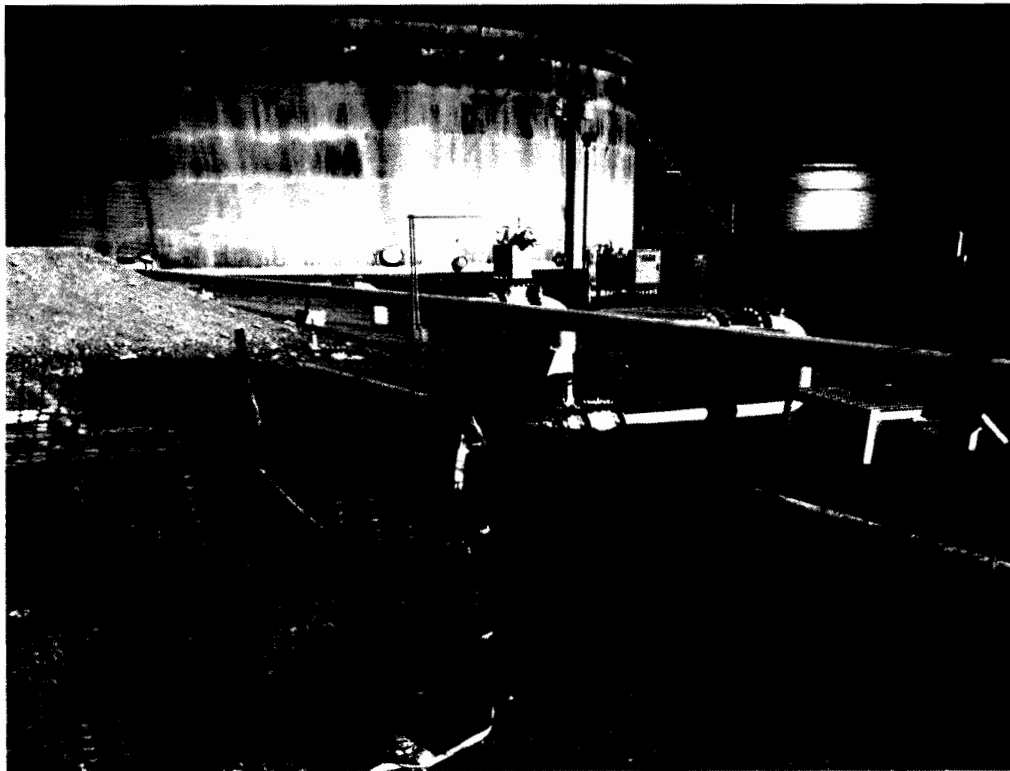
Jal Station 2-Inch Sump Line - Release Site (Looking Northeast)

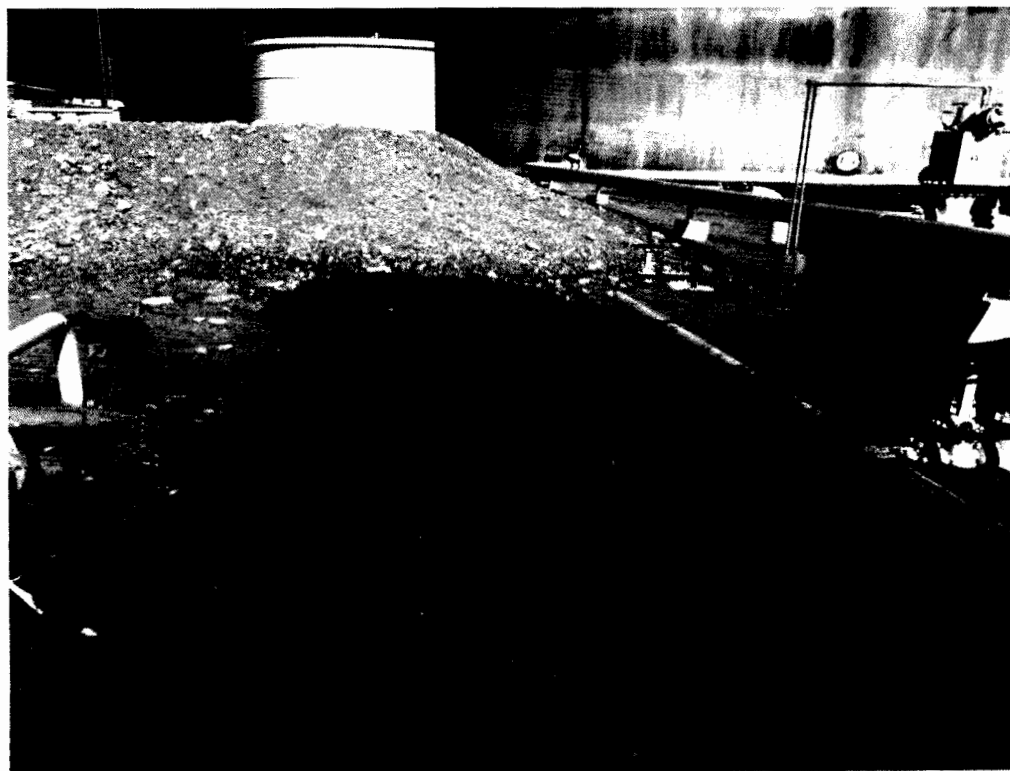
Jal Station 2-Inch Sump Line - Release Site (Looking North)

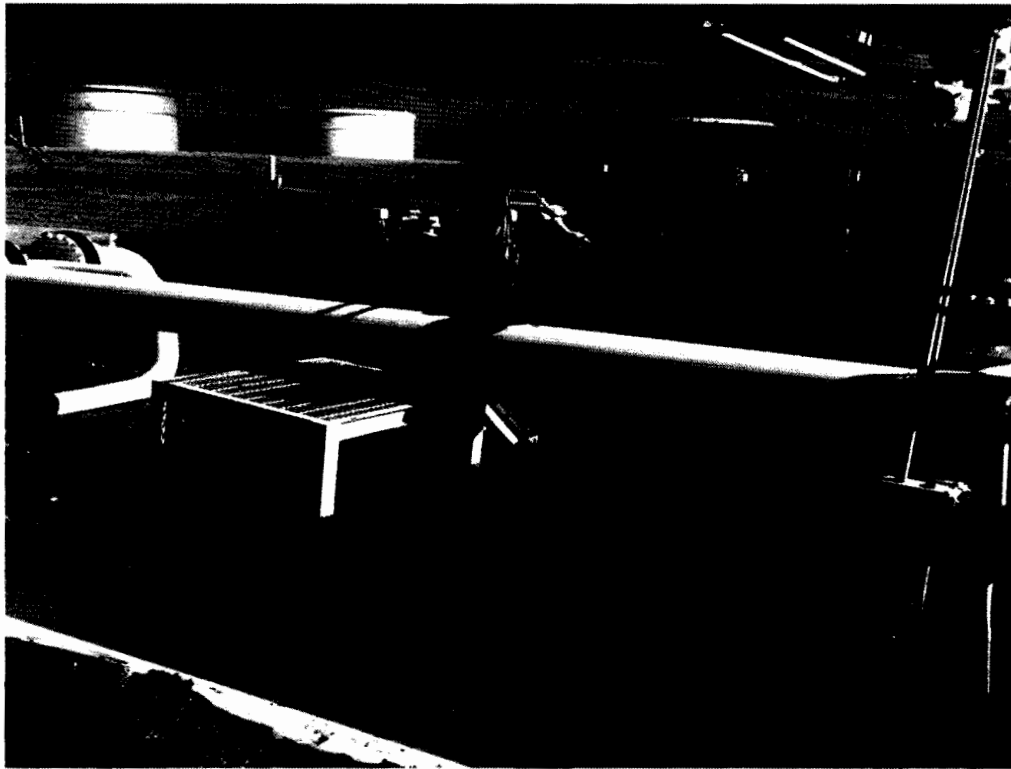
Jal Station 2-Inch Sump Line - Release Site (Looking Northeast)

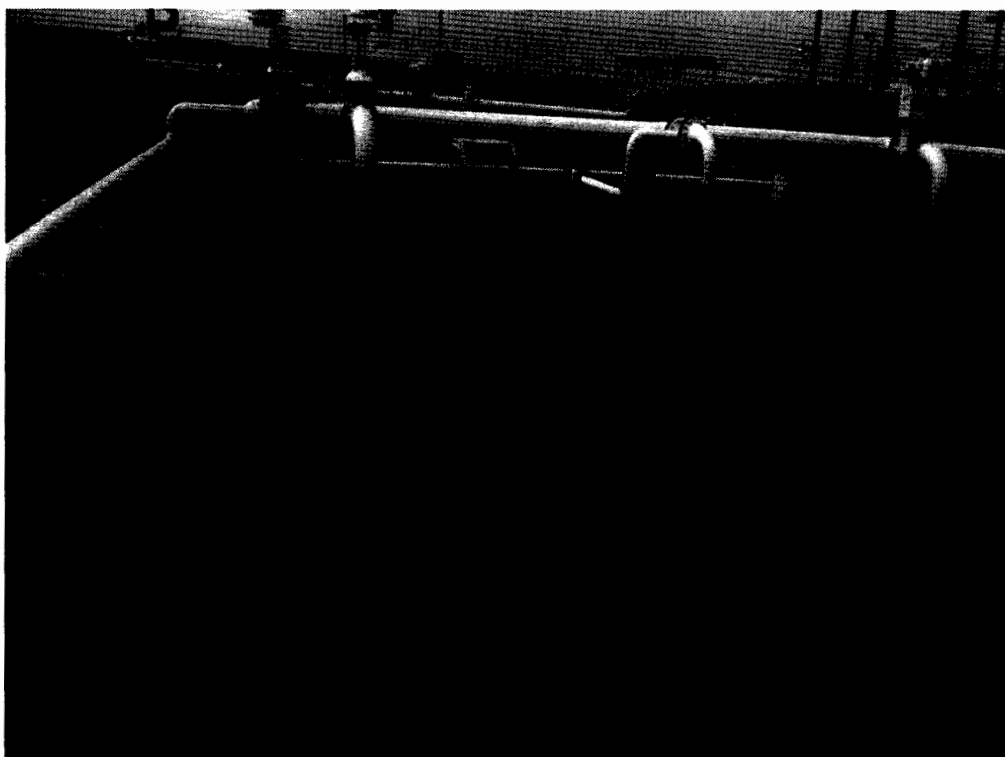
Jal Station 2-Inch Sump Line – Excavation (Looking West)

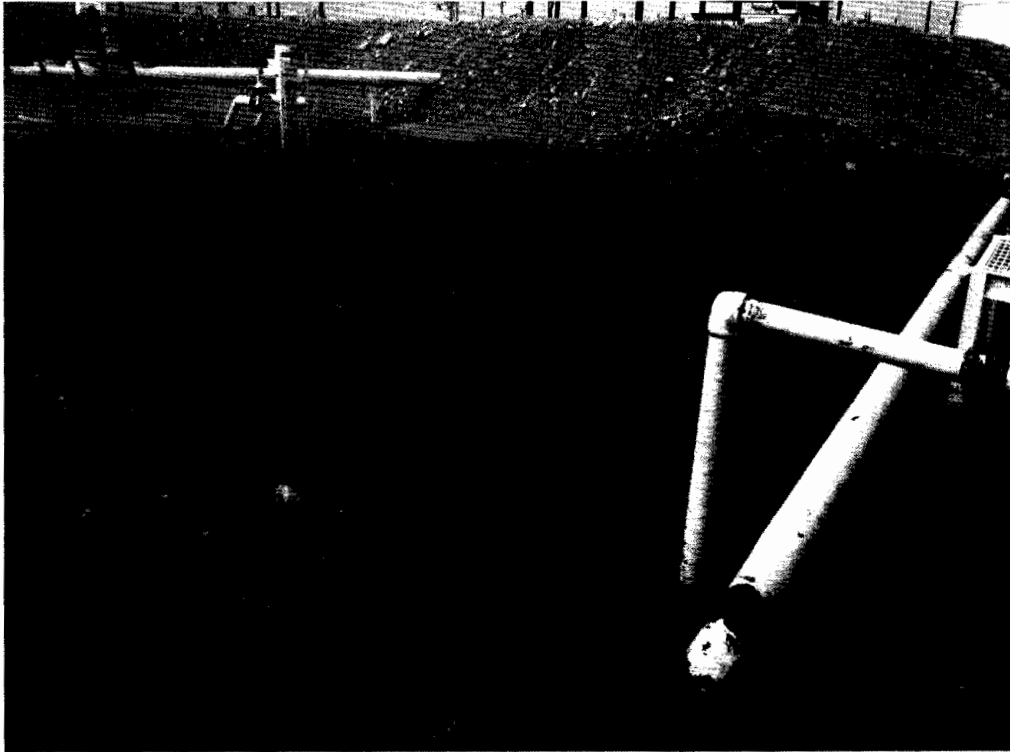
Jal Station 2-Inch Sump Line – Excavation (Looking Northwest)

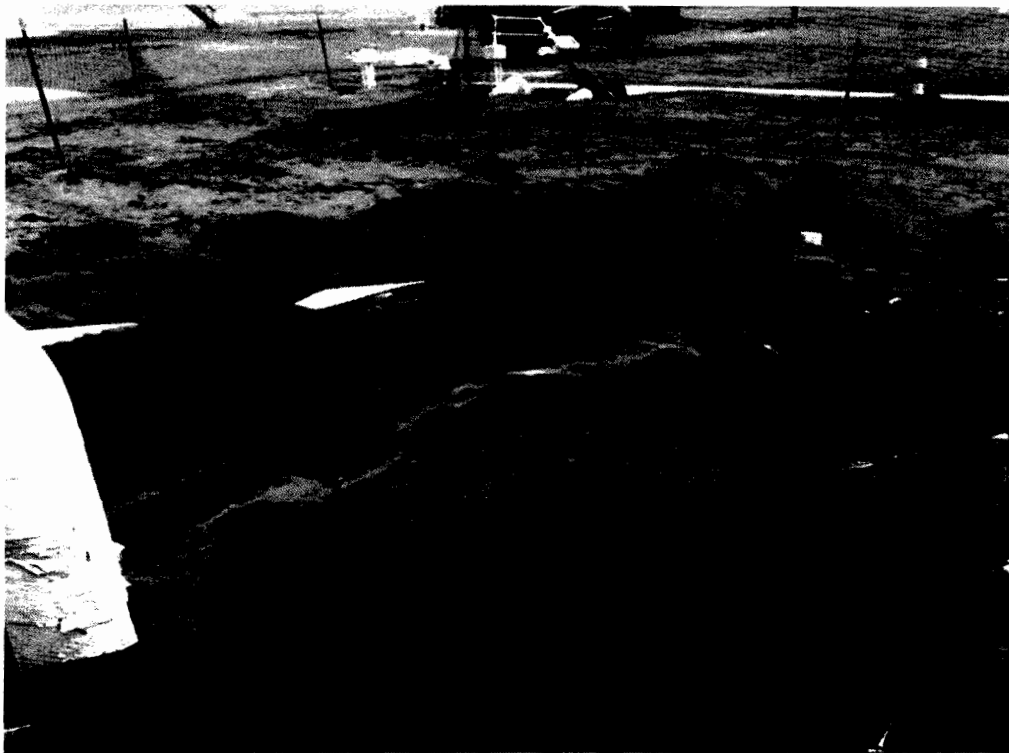
Jal Station 2-Inch Sump Line – Liner Installation & Backfilling (Looking Northeast)

With NMOCD approval, from April 6 through April 10, 2015, the excavation was backfilled with non-impacted material, compacted, and contoured to fit the surrounding topography. Prior to backfilling, a twenty (20) mil, polyethylene liner was installed in the excavation at approximately four and one-half feet (4.5') bgs. A cushion of sand was installed approximately one foot (1') both above and below the liner to protect the liner from damage during installation and backfilling activities. The final dimensions of the excavation were approximately eighty feet (80') in length, eighteen feet (18') to forty feet (40') in width, and six inches (6") to five and one-half feet (5.5') in depth.

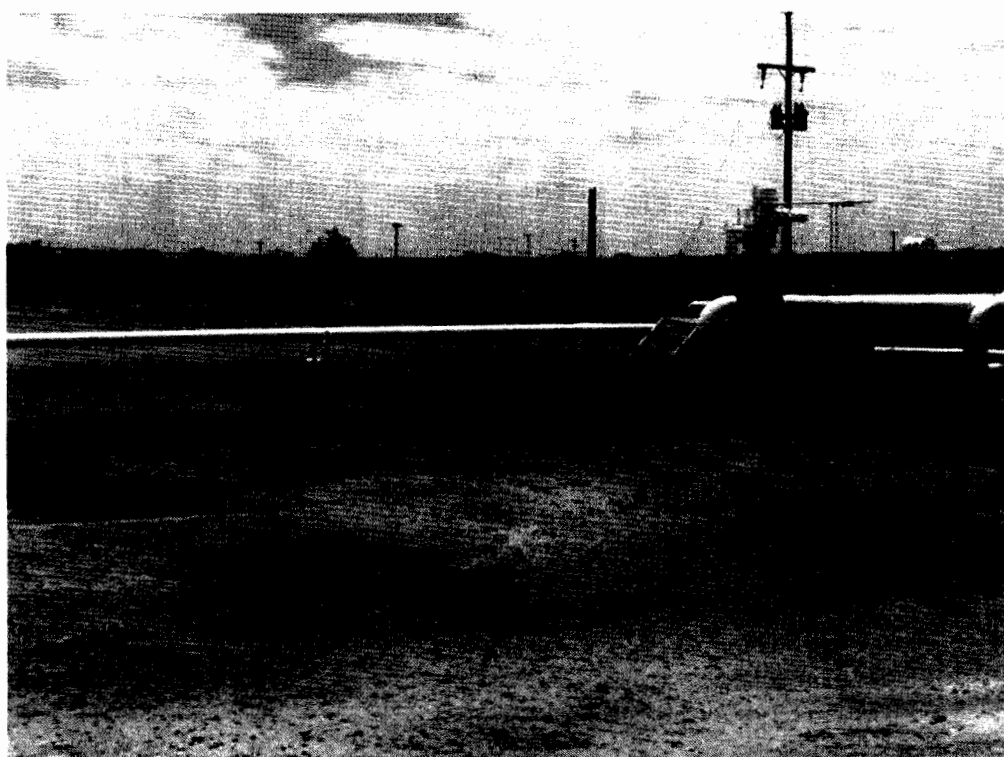
Jal Station 2-Inch Sump Line –Backfilled Excavation (Looking Southwest)

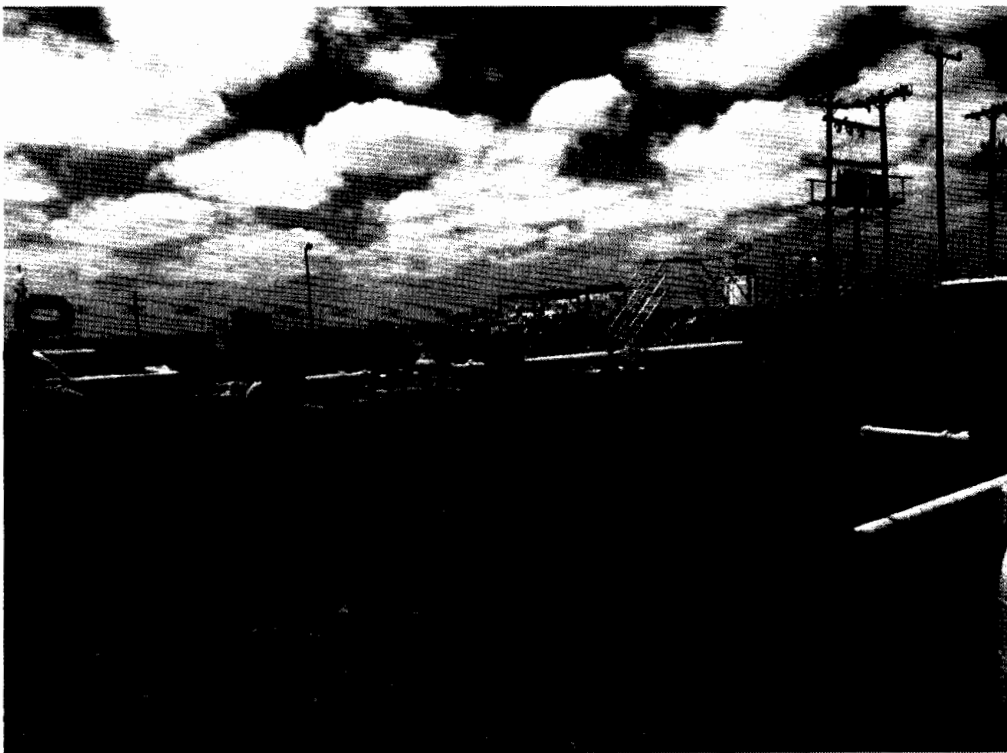
Jal Station 2-Inch Sump Line –Backfilled Excavation (Looking Northwest)
