Re: Closure Report
Jay Management, LLC
New Mexico State BB No. 1 Tank Battery
Mescalero Field - Lea County, New Mexico
NW1/4 SE1/4, Sec.14, T10S R32E

At the request of Jay Management, LLC (Jay Management), Timberwolf Environmental, LLC (Timberwolf) prepared this notification of completed remedial actions to remedy impacted soils at the New Mexico BB State No. 1 Tank Battery ("Site"). The Site is located approximately 5.5 miles northeast of Caprock, New Mexico (Figures 1 - 3).

Release Notification and Corrective Action

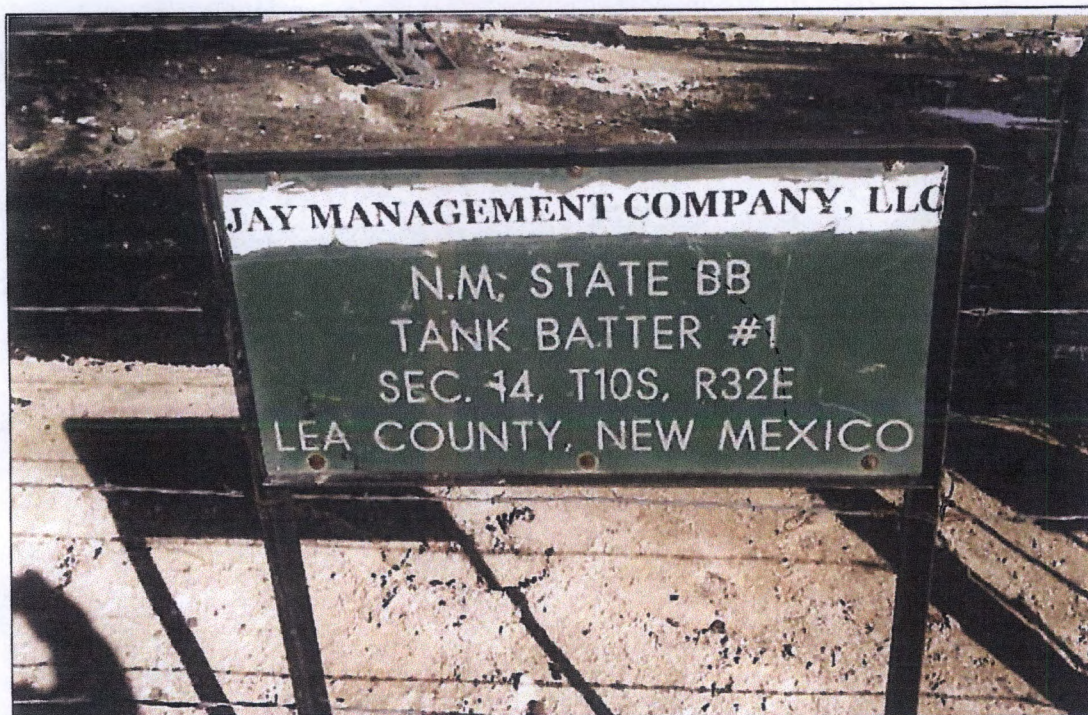
On 01/23/15, approximately eight (8) barrels (bbls) of crude oil and produced water were released due to a produced water tank overflowing. All released fluids were contained within the firewall. A vacuum truck recovered five (5) bbls of fluids on the same day of release.

Photograph 1 – A view of the New Mexico State BB No. 1 Tank Battery sign with oil and produced water spill in background. The photograph was taken by Mark Whitaker of the New Mexico Oil Conservation Division on 01/27/15.

Jay Management contractors excavated approximately 24 cubic yards of impacted soil from inside the tank battery on or about 02/20/15. Excavated soils were trucked and disposed at a permitted commercial landfarm in Caprock, NM. Clean fill was used to replace the excavated soil. Work conducted is documented in the attached Form C-141 and Photographic Documentation.

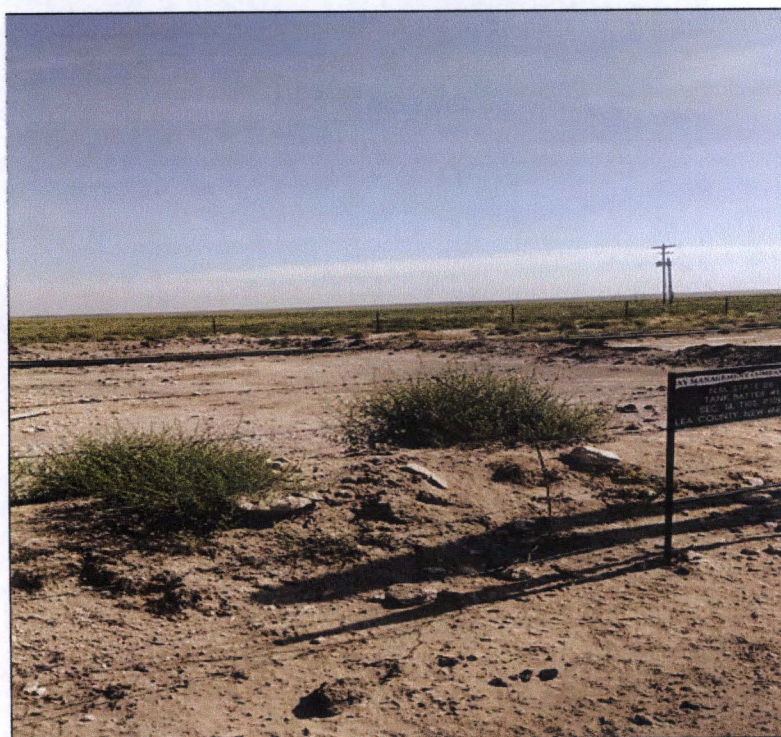
Photograph 2 – A view of the New Mexico State BB No. 1 after remediation. The photograph was taken by Jay Management personnel.

On 02/21/15, approximately 24 cubic yards of impacted soil were excavated and disposed at an approved off-site landfarm in Caprock, NM. Clean fill was used to replace excavated material.

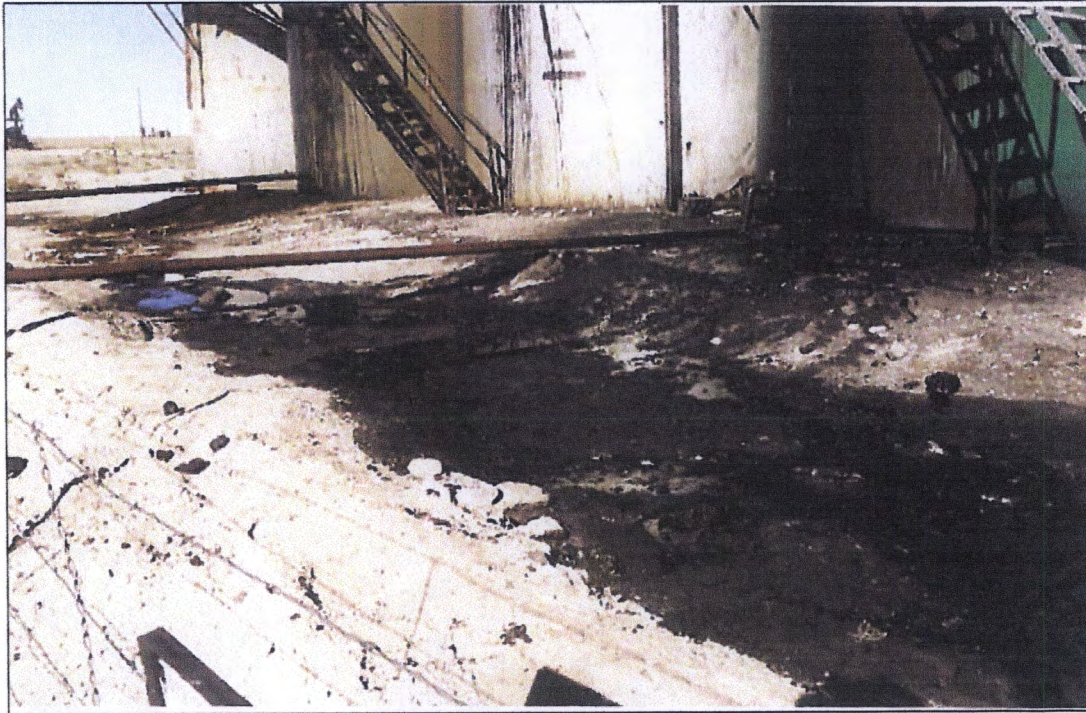
Photograph 3 – A view of the crude oil and produced water spill at the New Mexico State BB No. 1 Tank Battery. The photograph was taken by Mark Whitaker of the New Mexico Oil Conservation Division on 01/27/15.
