To: Kellie Jones, New Mexico Oil Conservation Division
Shelly Tucker, Bureau of Land Management
Reference: Remediation Work Plan
Operator: Devon Energy Production Company
Location: Tomcat 21 Fed 1
API: 30-025-33356
Legals: UL. F, Sec. 21, T23S, R32E
GPS: 32.2927 -103.6815

Proposed Remediation

DEVON ENERGY PRODUCTION- Tomcat 21 Fed 1

Devon Energy Production- Tomcat 21 Fed 1 Battery

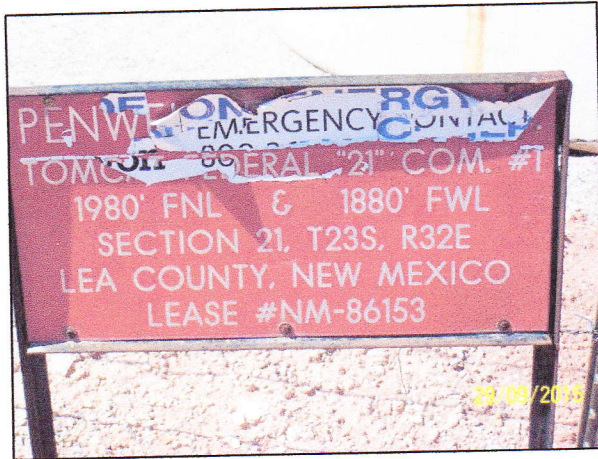
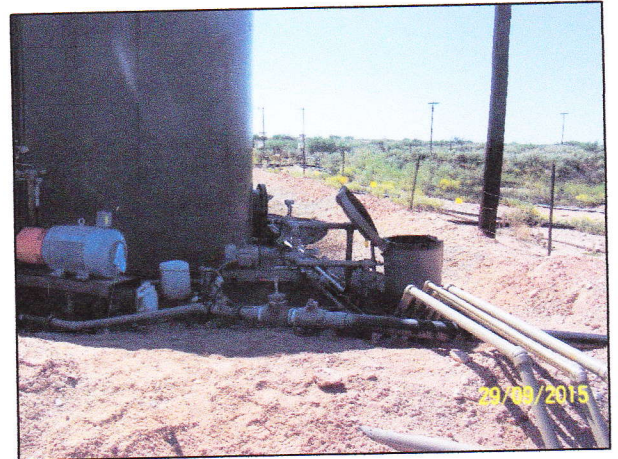
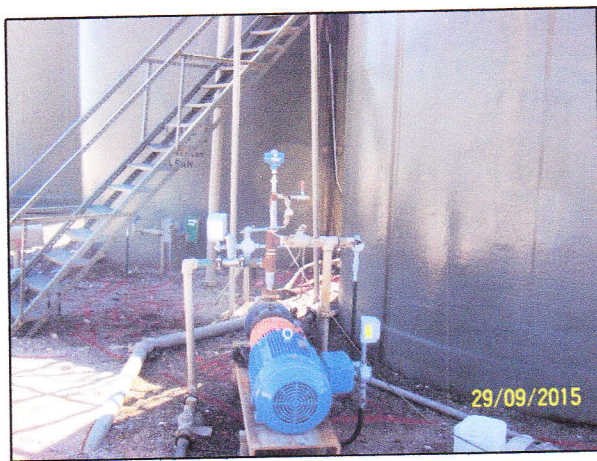
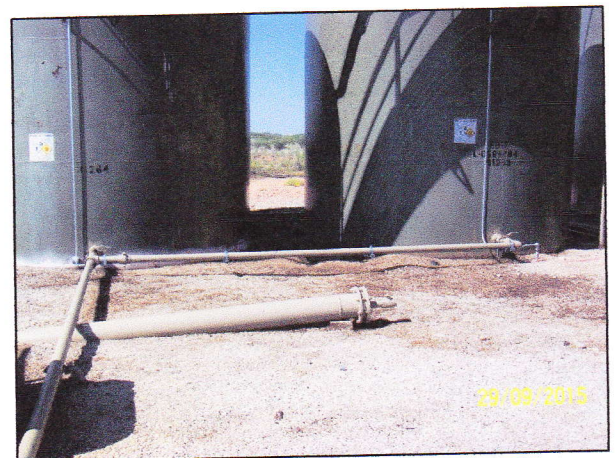
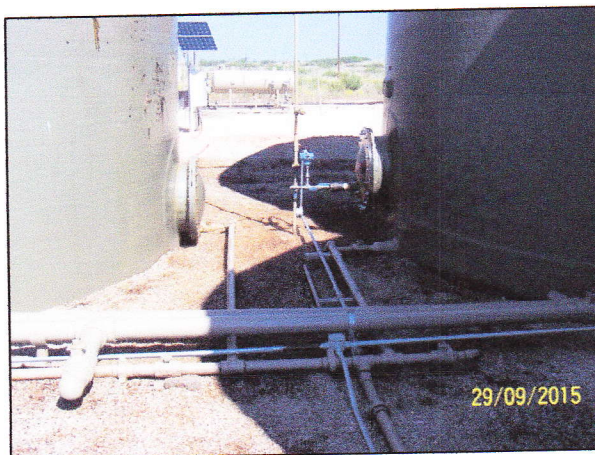
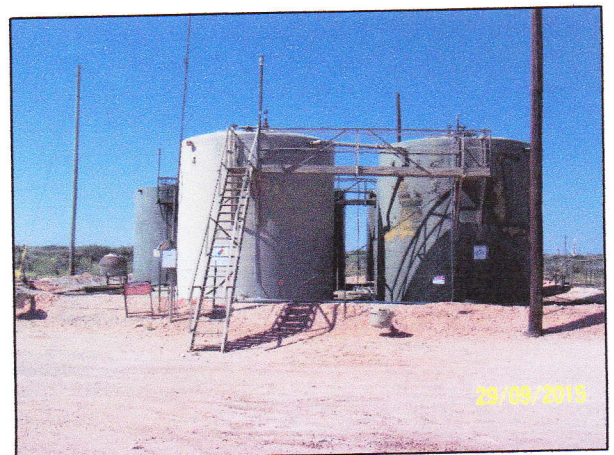
This battery is an active and working site. The produced water release that occurred on 12Apr15, had no impact outside the berms of the battery. All fluid released, remained inside the earthen berms.

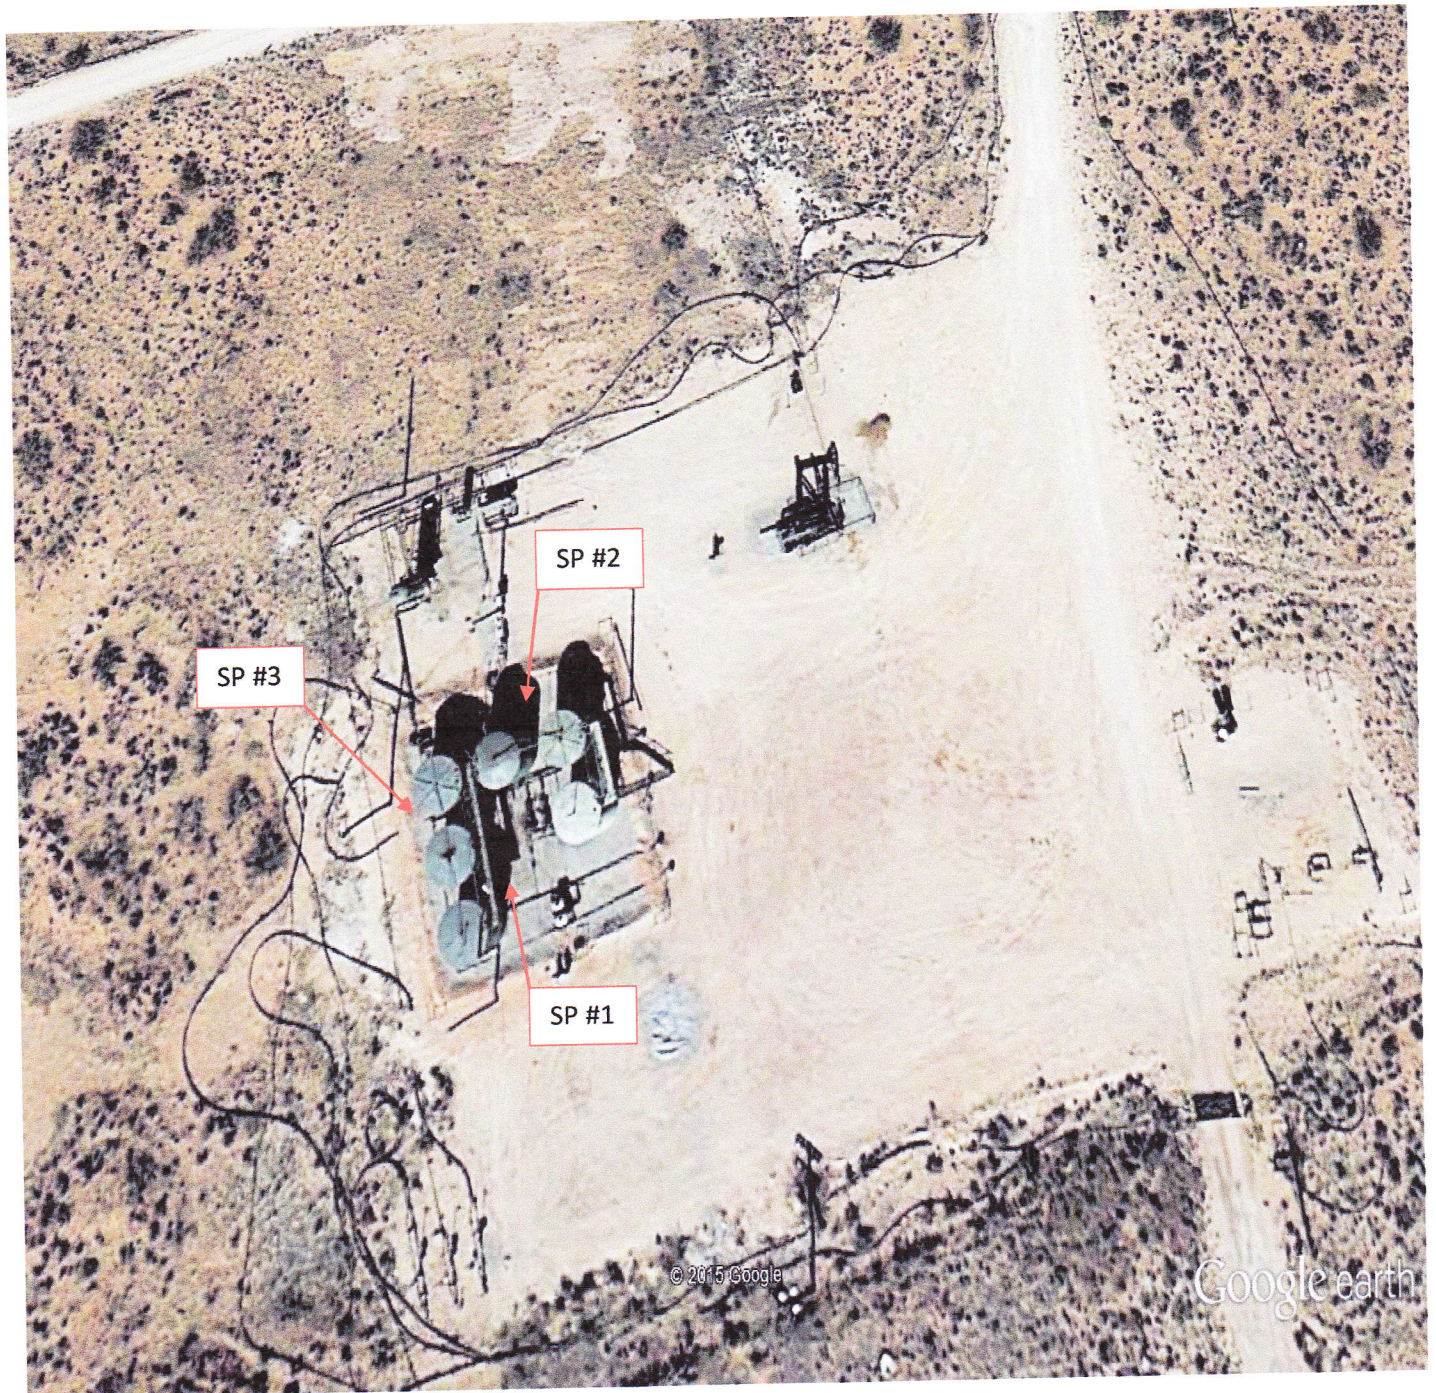
A delineation was conducted by use of hand tools on 29Sept15. Due to safety concerns, no mechanical equipment was used. Soil samples were obtained at three sample points from the surface to 3' below ground surface (BGS). Lab analysis was conducted for Chlorides. (See attached map with sample points and lab results.)

Surface	1' BGS	2' BGS	3' BGS															
SP #1	4880	13200	7760	6900															
SP #2	128	576	736	736															
SP #3	3040	576	240	5760

Based upon the delineation results, depth to ground water, and the safety concerns of working inside a battery, I propose to hand excavate 2' of impacted material from the area of Sample Point #1 and 1' from the area of Sample Point #3. This encompasses the area between and on both side of the tanks. A complete delineation and remediation will be conducted at the time the facility is shut in and taken out of service.
