Mallon 34-16

CLOSURE REPORT

Release Date: 6/14/2015

UL/ Sec 34, T19 south, R34 east, Lea County NM

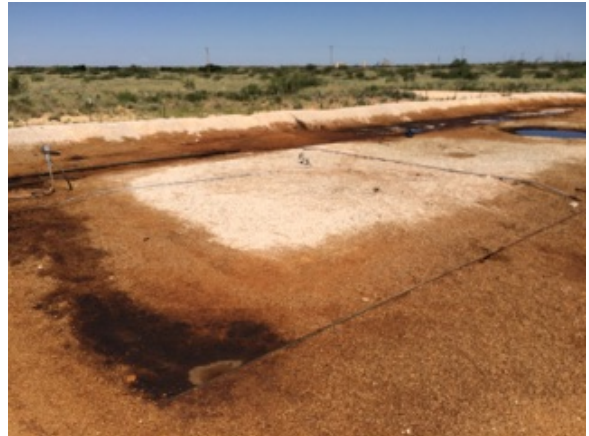
Spill area inside bermed facility

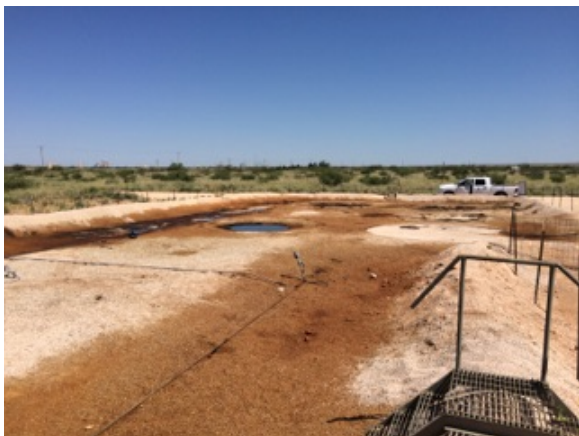
Spill area inside bermed facility

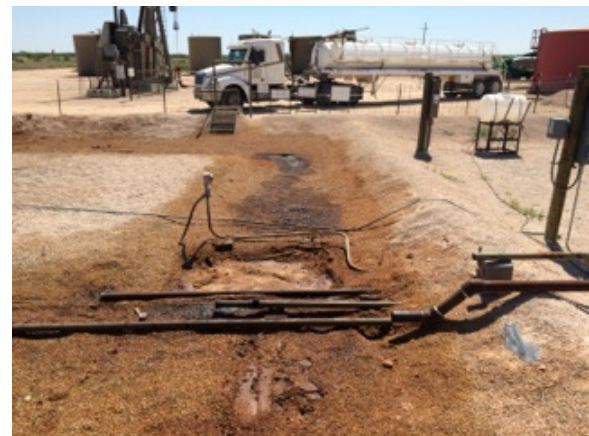
Spill area inside bermed facility

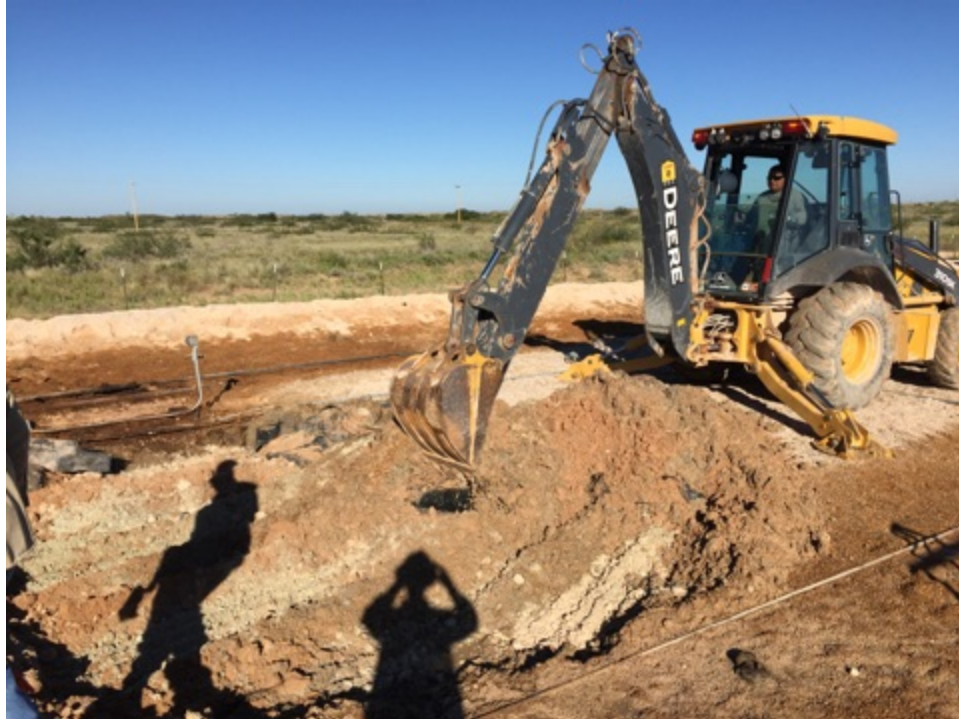
Excavating contaminated area to 2' BGS

On October 12, DFSI personnel returned to the location to begin excavation. The contaminated soil inside the bermed facility was removed to 2' BGS. All contaminated material was hauled to an approved NM state disposal. Fresh caliche was brought in for backfill, and the berms were knocked down. After backfill, the area was rolled and made even with the existing pad.

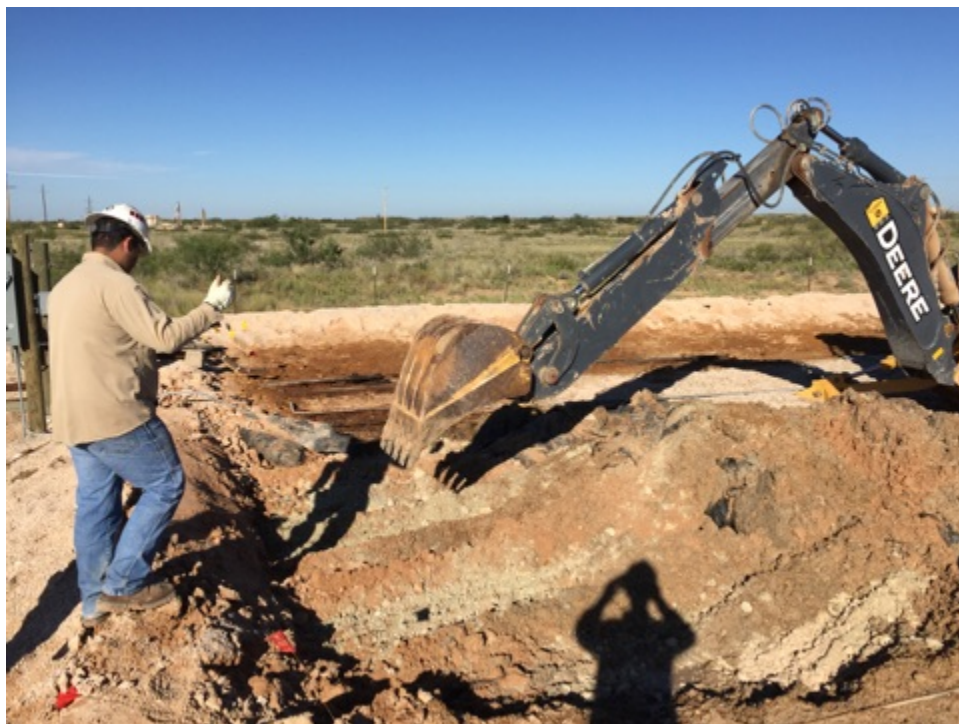
Excavating contaminated area to 2' BGS; knocking down berms

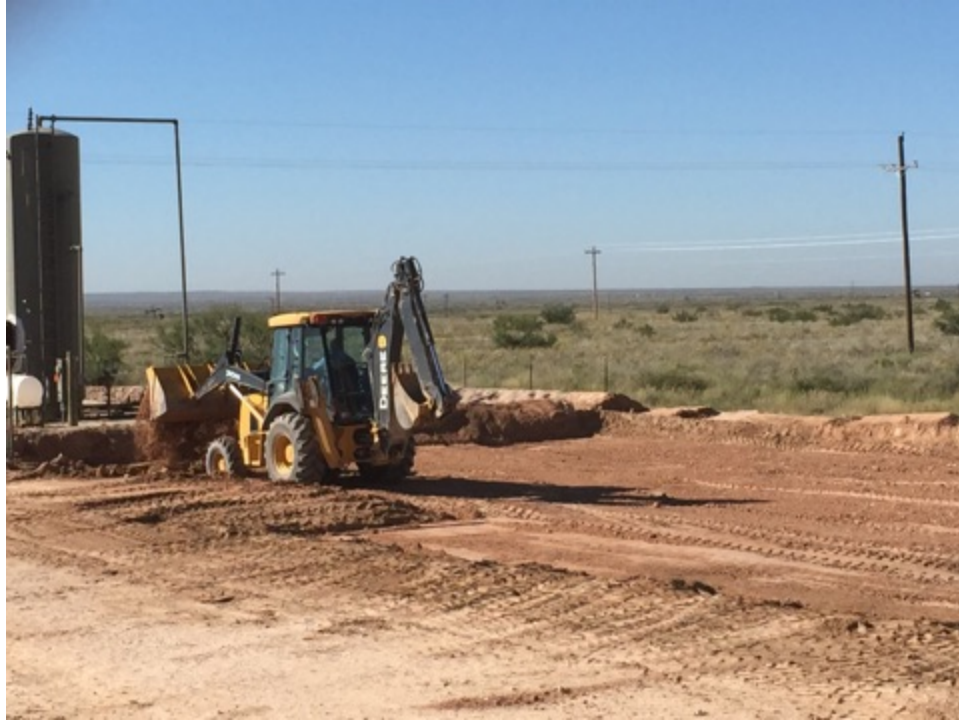
Finishing excavation of contaminated area

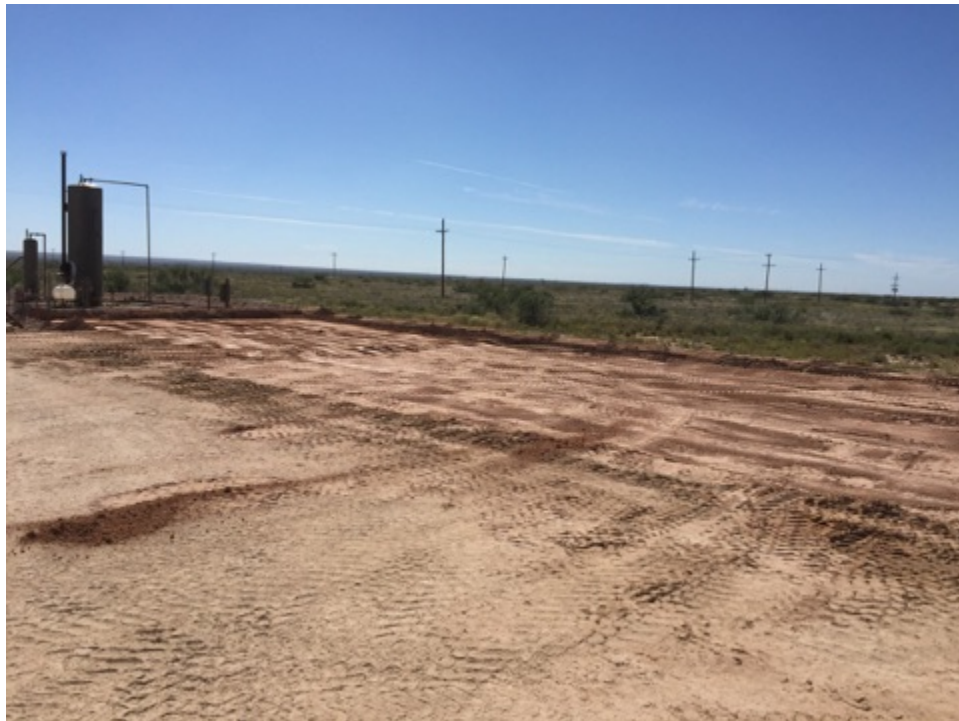
Completely excavated contaminated area

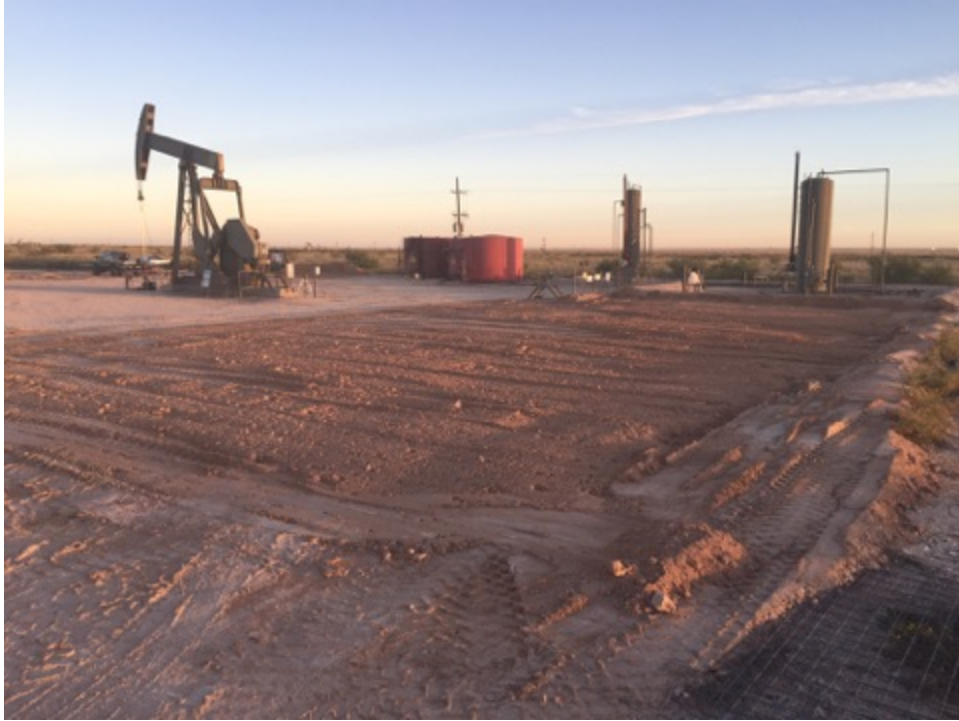
Excavated area backfilled with fresh caliche

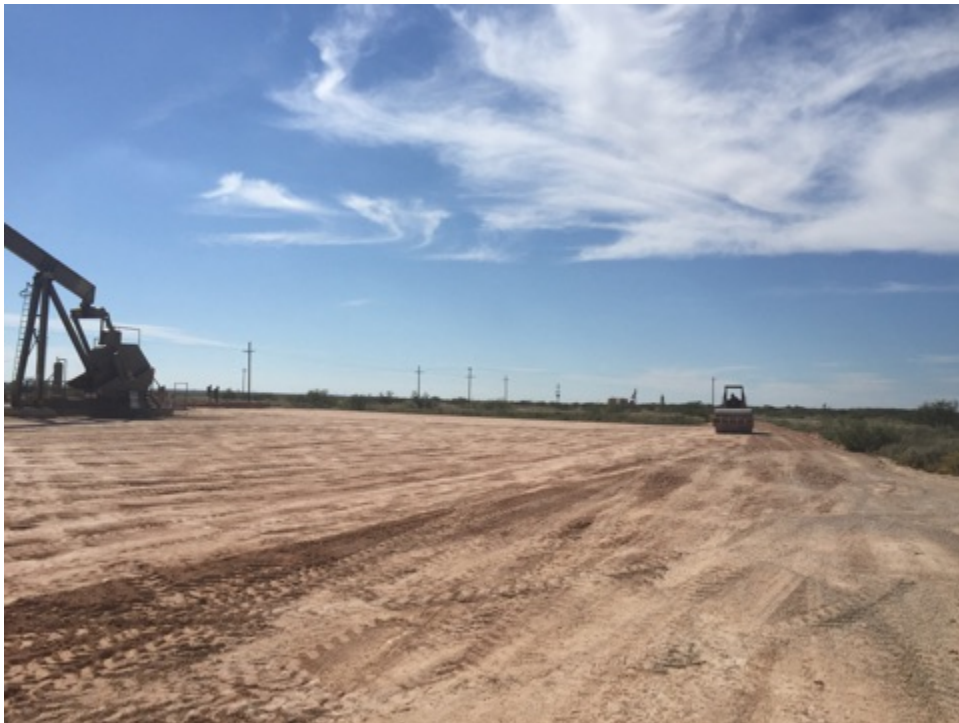
Using roller to even out area parallel to pad

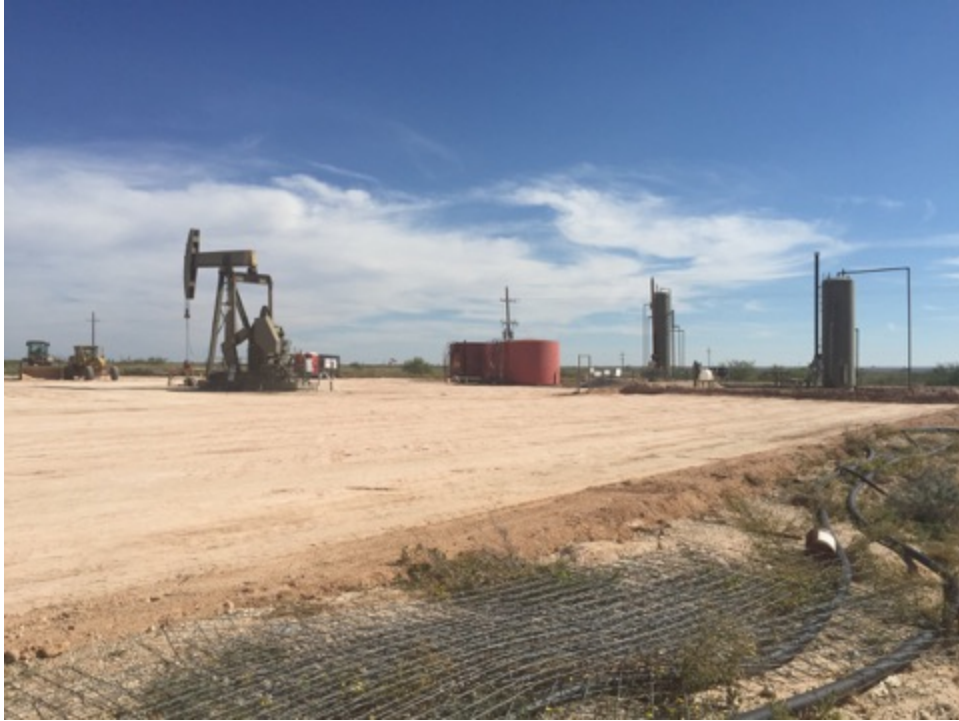
Completed location

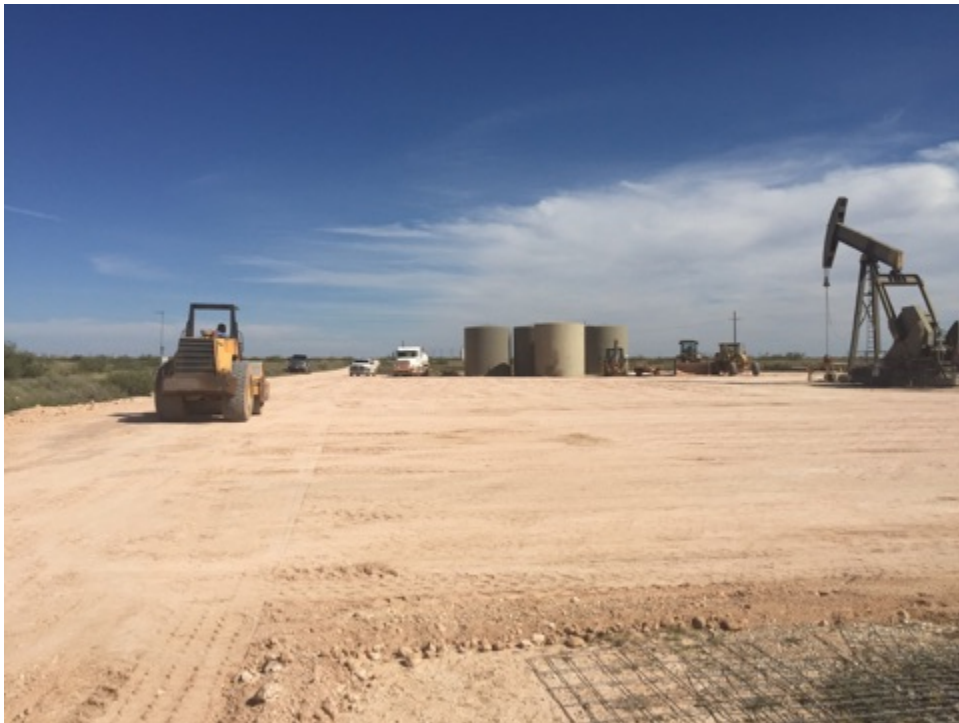
Completed location

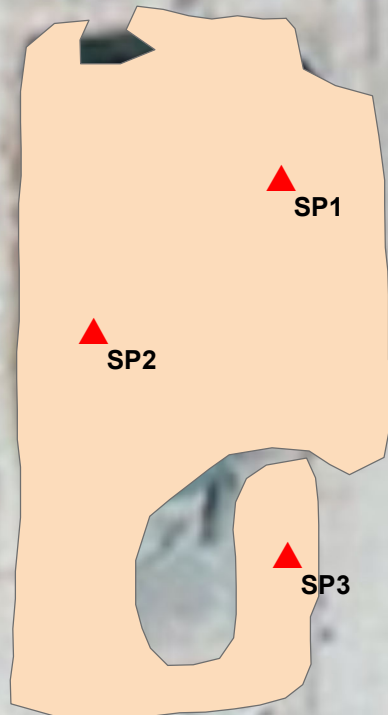
Site Diagram

Spill Area:
6,766 sq. ft.
