State J-2 Battery (1RP-3466)

Corrective Action Plan

**RE: Corrective Action Plan
ConocoPhillips State J2 Battery (1RP-3466)
UL/T sec. 2 T22S R32E
API No. 30-025-33277**

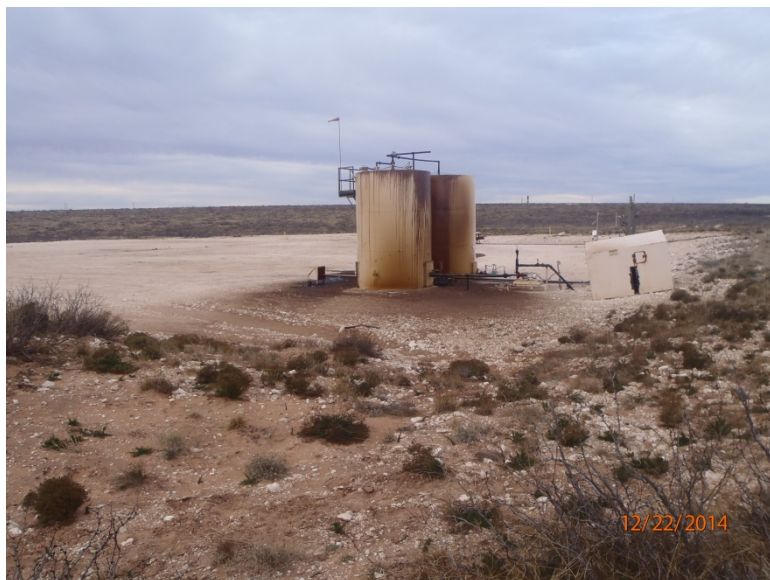
12/22/14

Initial release area, facing southwest

Based on the laboratory analysis, the release will be scraped down to 6 inches bgs around points 3 & 4. Once the scrape is completed, discrete samples from the bottom of the scrape will be taken and field tested for chlorides and organic vapors. If the field data indicates that the samples will not achieve chloride, Gasoline Range Organics (GRO), Diesel Range Organics (DRO) and BTEX readings below regulatory standards, the scrape will be deepened until field testing indicates that all constituents from the discrete samples will return values below regulatory standards. The discrete samples will then be taken to a commercial laboratory to confirm that all constituents return readings are below regulatory standards.

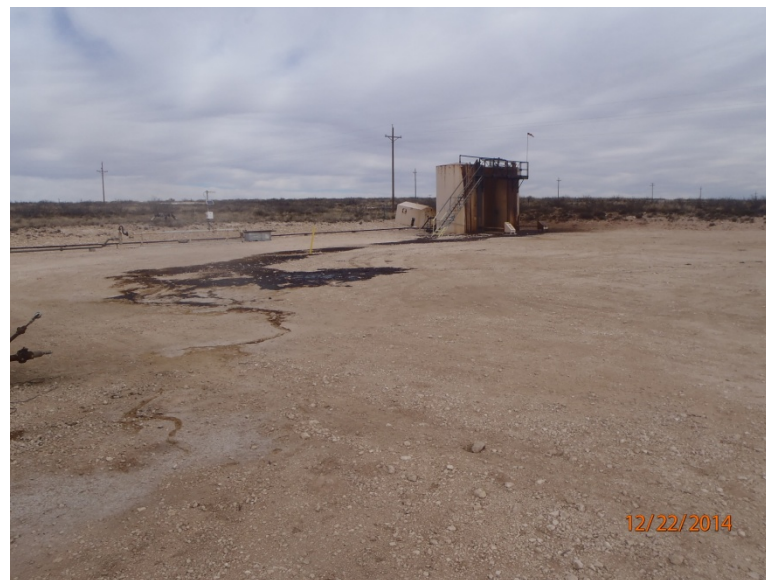
12/22/14

Initial release area, facing northeast

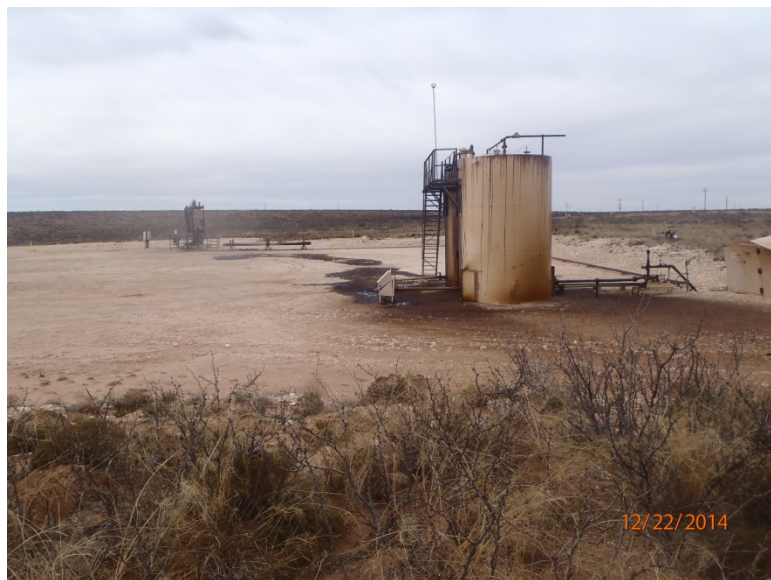
12/22/14

Initial release area, facing west

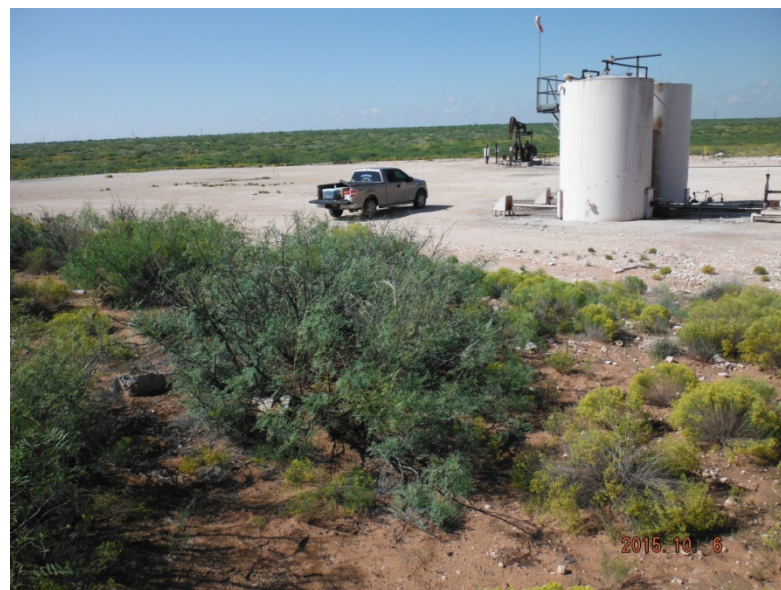
10/06/15

Washed overspray area, Facing southwest

The overspray on the pasture and pad around Points 1 and 2 was washed with clean water and Dawn dish soap to remove any staining.
