# CMU North Injection

## REMEDIATION WORK PLAN

API No. 30-025-32941

Unit Letter H, Section 20, Township 17 South, Range 33 East

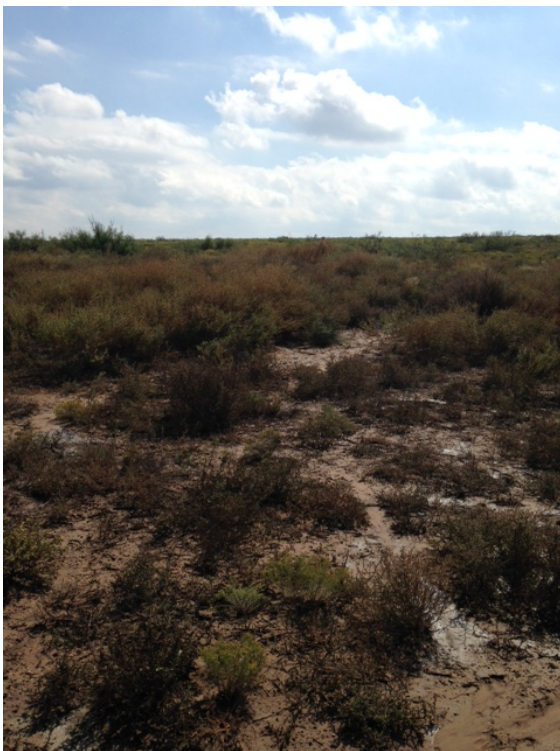
The site is located southeast of Maljamar, NM, in Lea County. The leak site resulted from a hole in the side of a fiberglass nipple. The impacted area is entirely in the pasture area. Approximately 168 bbls of produced water was released, with none recovered. A site map is attached. This spill occurred on top of the Caprock Escarpment. A C-141 was submitted to the NMOCD on October 12, 2015.

Spill area in pasture

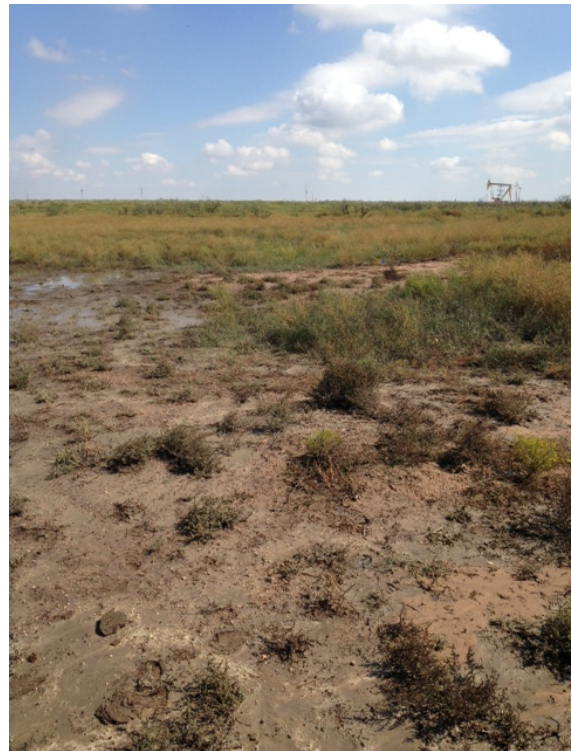
Spill area in pasture

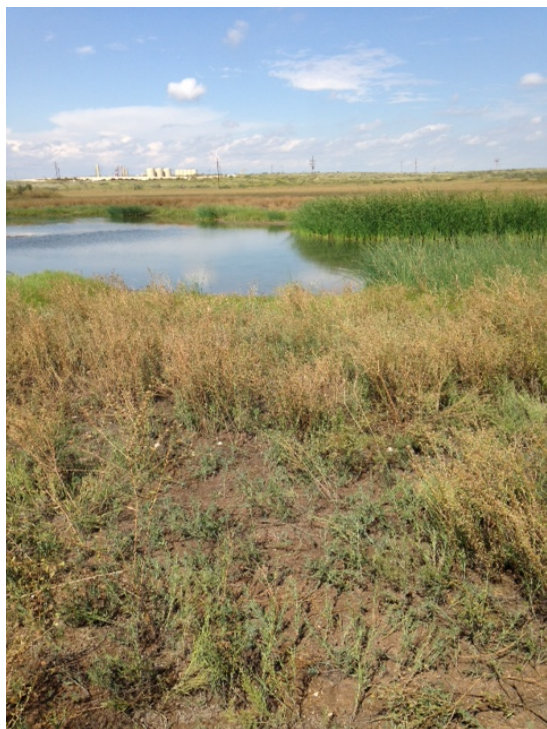
Spill area with pond in background

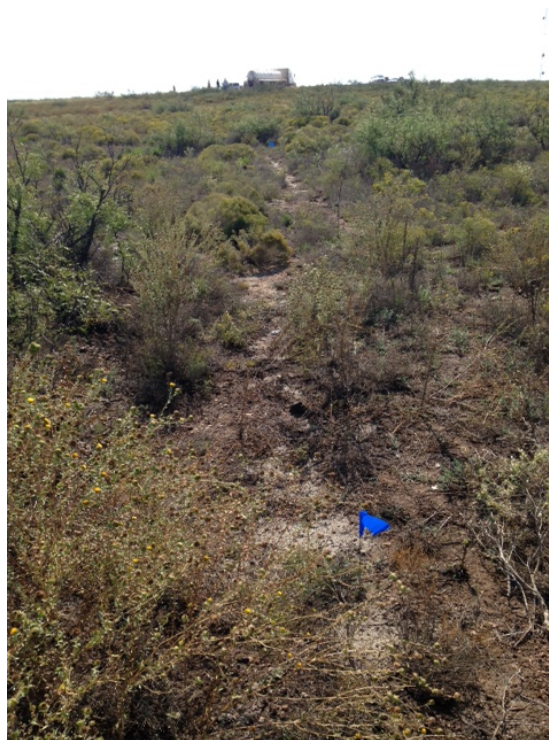
On October 16, 2015 DFSI personnel returned to the site and sampled the spill area. DFSI sampled 25 points of the spill area, and a water sample was taken from the pond. The samples were tested for chloride levels as well as BTEX. The BTEX samples were performed using a Mini Rae Photoionization Detector (PID). Due to the Caprock Escarpment, DFSI personnel encountered auger refusal at 1' BGS on every sample point except SP #10, where auger refusal was encountered at 2' BGS. The field sampling results are attached.

Spill area with sample points

Excavate the entire spill to 4' BGS, except in the area(s) of the playa, which include SP6-SP10, and SP17-SP18. These areas will be excavated to 1' BGS and backfilled with native topsoil. In the 4' excavation, a 20 mil liner will be installed, then backfilled with native topsoil. The area will be seeded with a BLM approved mix. All contaminated materials will be hauled to an approved NM State Disposal.

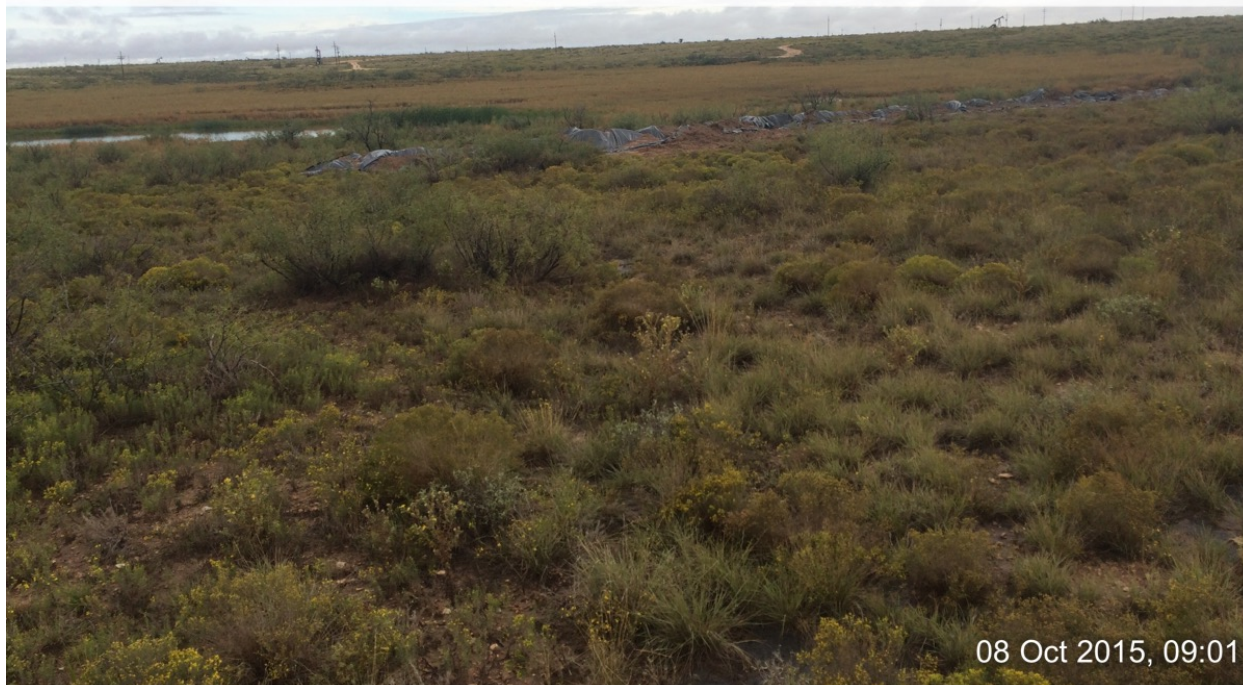
## South Elevation

On October 7, 2015 DFSI personnel responded to the release site and dug up the line so a crew could fix it. DFSI then scraped up the affected area to minimize the environmental impact. A soil berm was installed on the northern edge of the spill to prevent any extra runoff from seeping into a pond in that area.

Soil berm installation on north side of spill, with pond in background

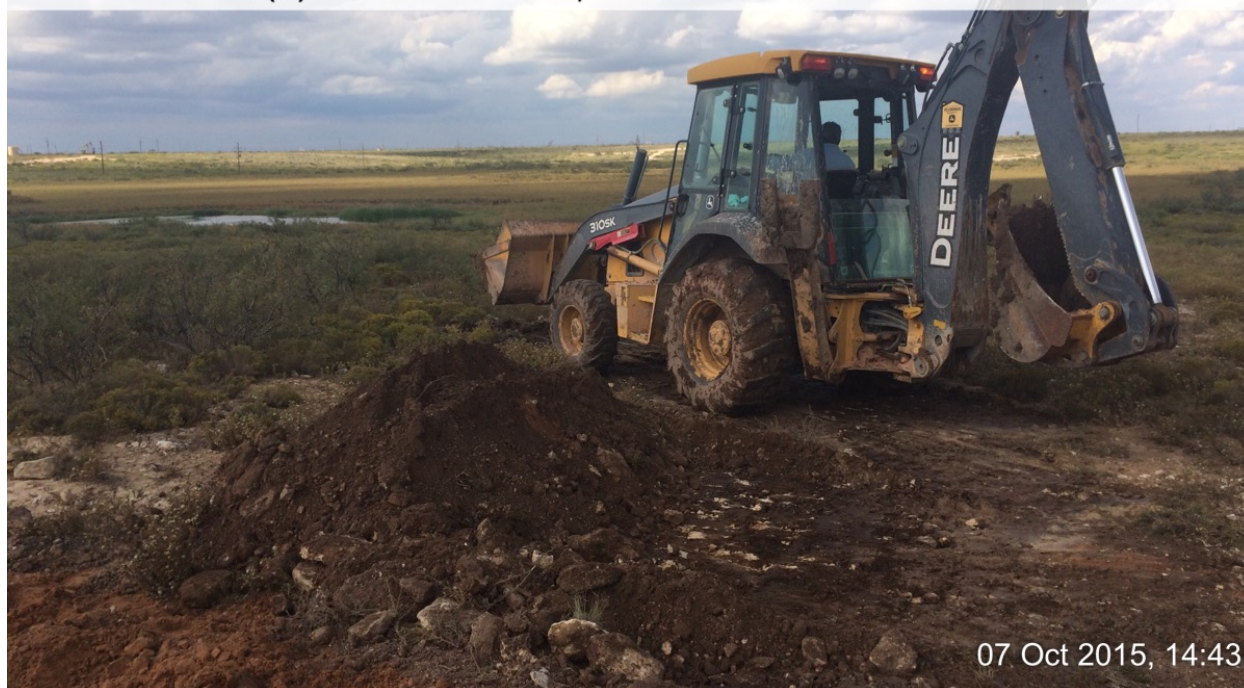
## South Elevation

Initial scrape of the spill area

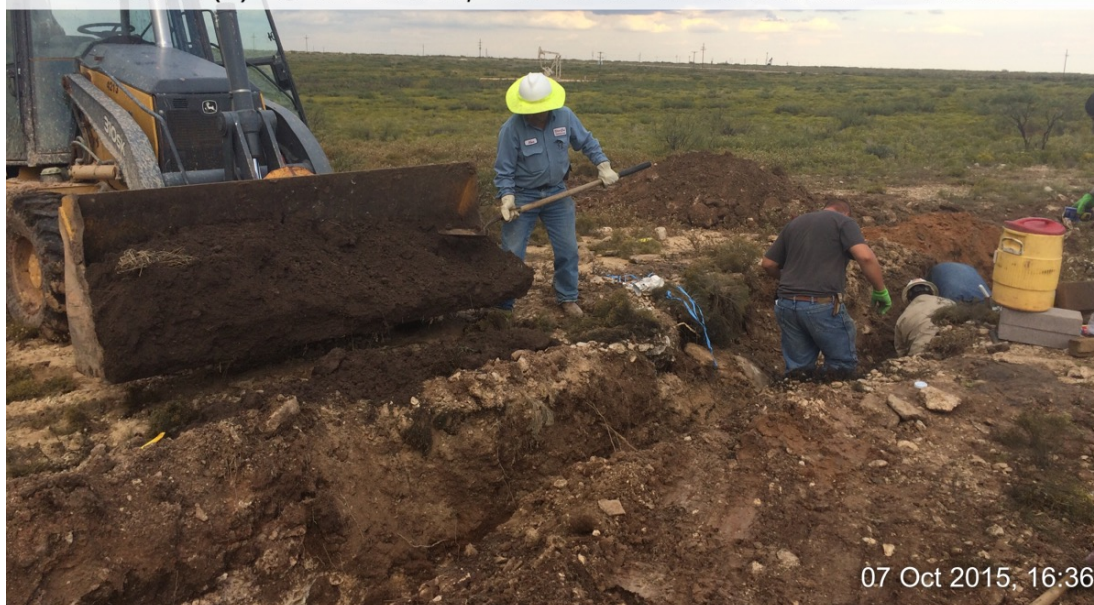
## West Elevation

Describe Cause of Problem and Remedial Action Taken.\* At approx. 6:30am leak was found, closet well was the CMU A #57. When I arrived water was spraying out of the ground towards the west. We got leak stopped and dug out and noticed a hole in the side of a fiberglass nipple.

Digging out source of spill so crews could fix line

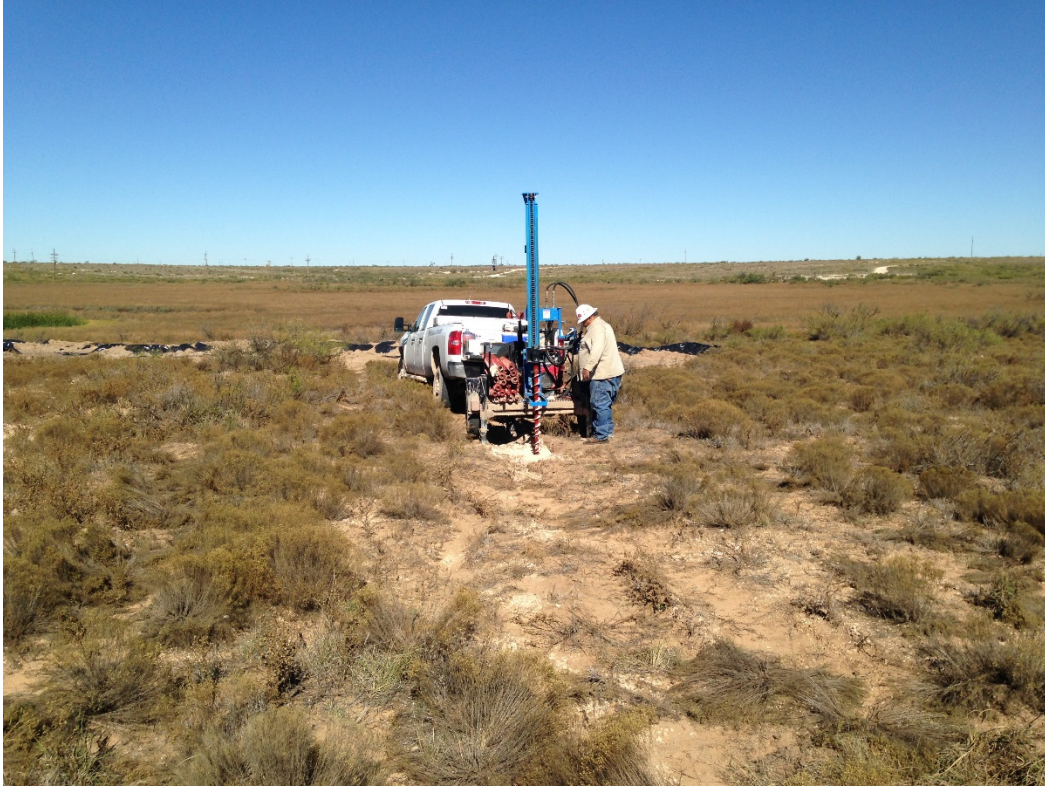
On November 6, 2015, DFSI personnel returned to drill five bore holes to obtain confirmation samples. Samples that field tested clean were sent to a commercial laboratory for confirmation. Those results are attached as well.

Drilling for confirmation samples

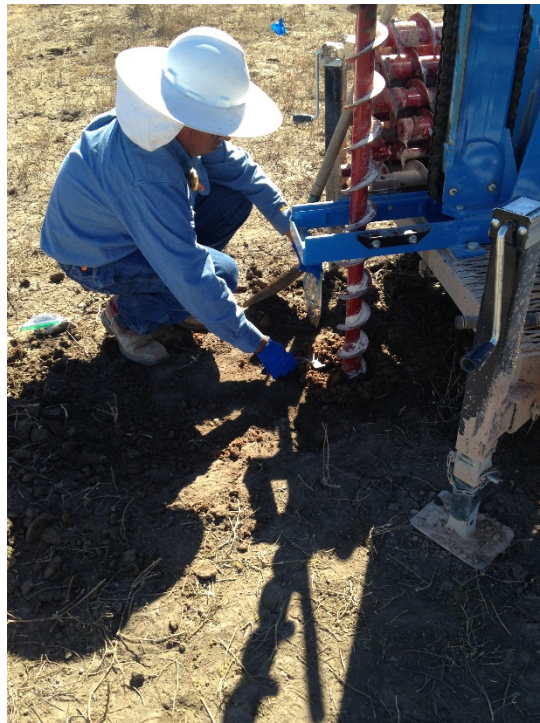
Obtaining confirmation samples from drilling bore holes
