Subject: **Remedial Activities and Closure Report**
Legacy Reserves Operating, LP
Rock Queen Unit #86
API #: 30-005-00931
(1RP-3900)

Rock Queen Unit #86
Legacy Reserves Operating, LP
Chaves County, New Mexico
Figure 1 - Site Plan

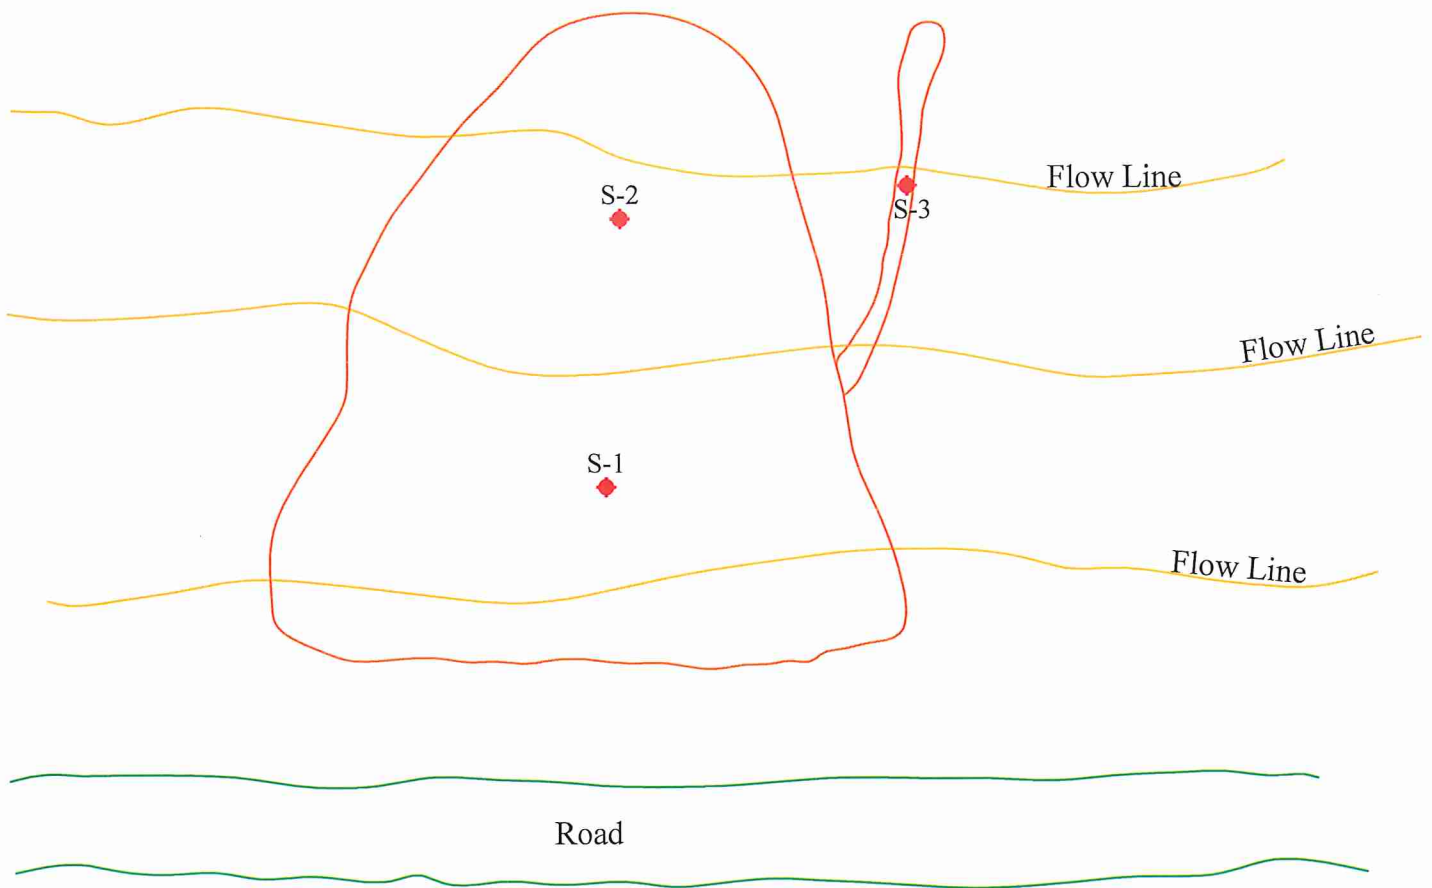
On August 28, 2015 a flow line leak was discovered. The amount of the mixed fluids released was approximately 20 barrels. All wells were shut in and the flow line was repaired. A vacuum truck was called to the location and recovered approximately 5 barrels of fluid. The impacted area is off the well pad and measured approximately 170-feet long by 100-feet wide. A site plan is presented in [Appendix I](#).

- The impacted area in the vicinity of sample location S-2 was excavated to a depth of 1-foot bgs.
- The impacted area in the vicinity of sample locations S-1 and S-3 was excavated to a depth of 4-feet bgs.
- A 20-mil liner was installed in the bottom of the 4-foot excavation at sample locations S-1 and S-3.
- All of the excavated soil was hauled to an NMOCD approved solid waste disposal facility.
- Geotagged photographs were taken of the remediation process. Photographic documentation is presented in [Appendix IV](#)
- The excavated areas were backfilled with top soil and contoured to match the surrounding terrain.
