**OXY USA, Inc.
Cotton Draw Unit # 30
Closure Report
Section 21, T25S, R32E
Lea County, New Mexico**

November 24 , 2014

**Safety & Environmental Solutions, Inc.
703 East Clinton Street
Hobbs, New Mexico 88240
(575) 397-0510**

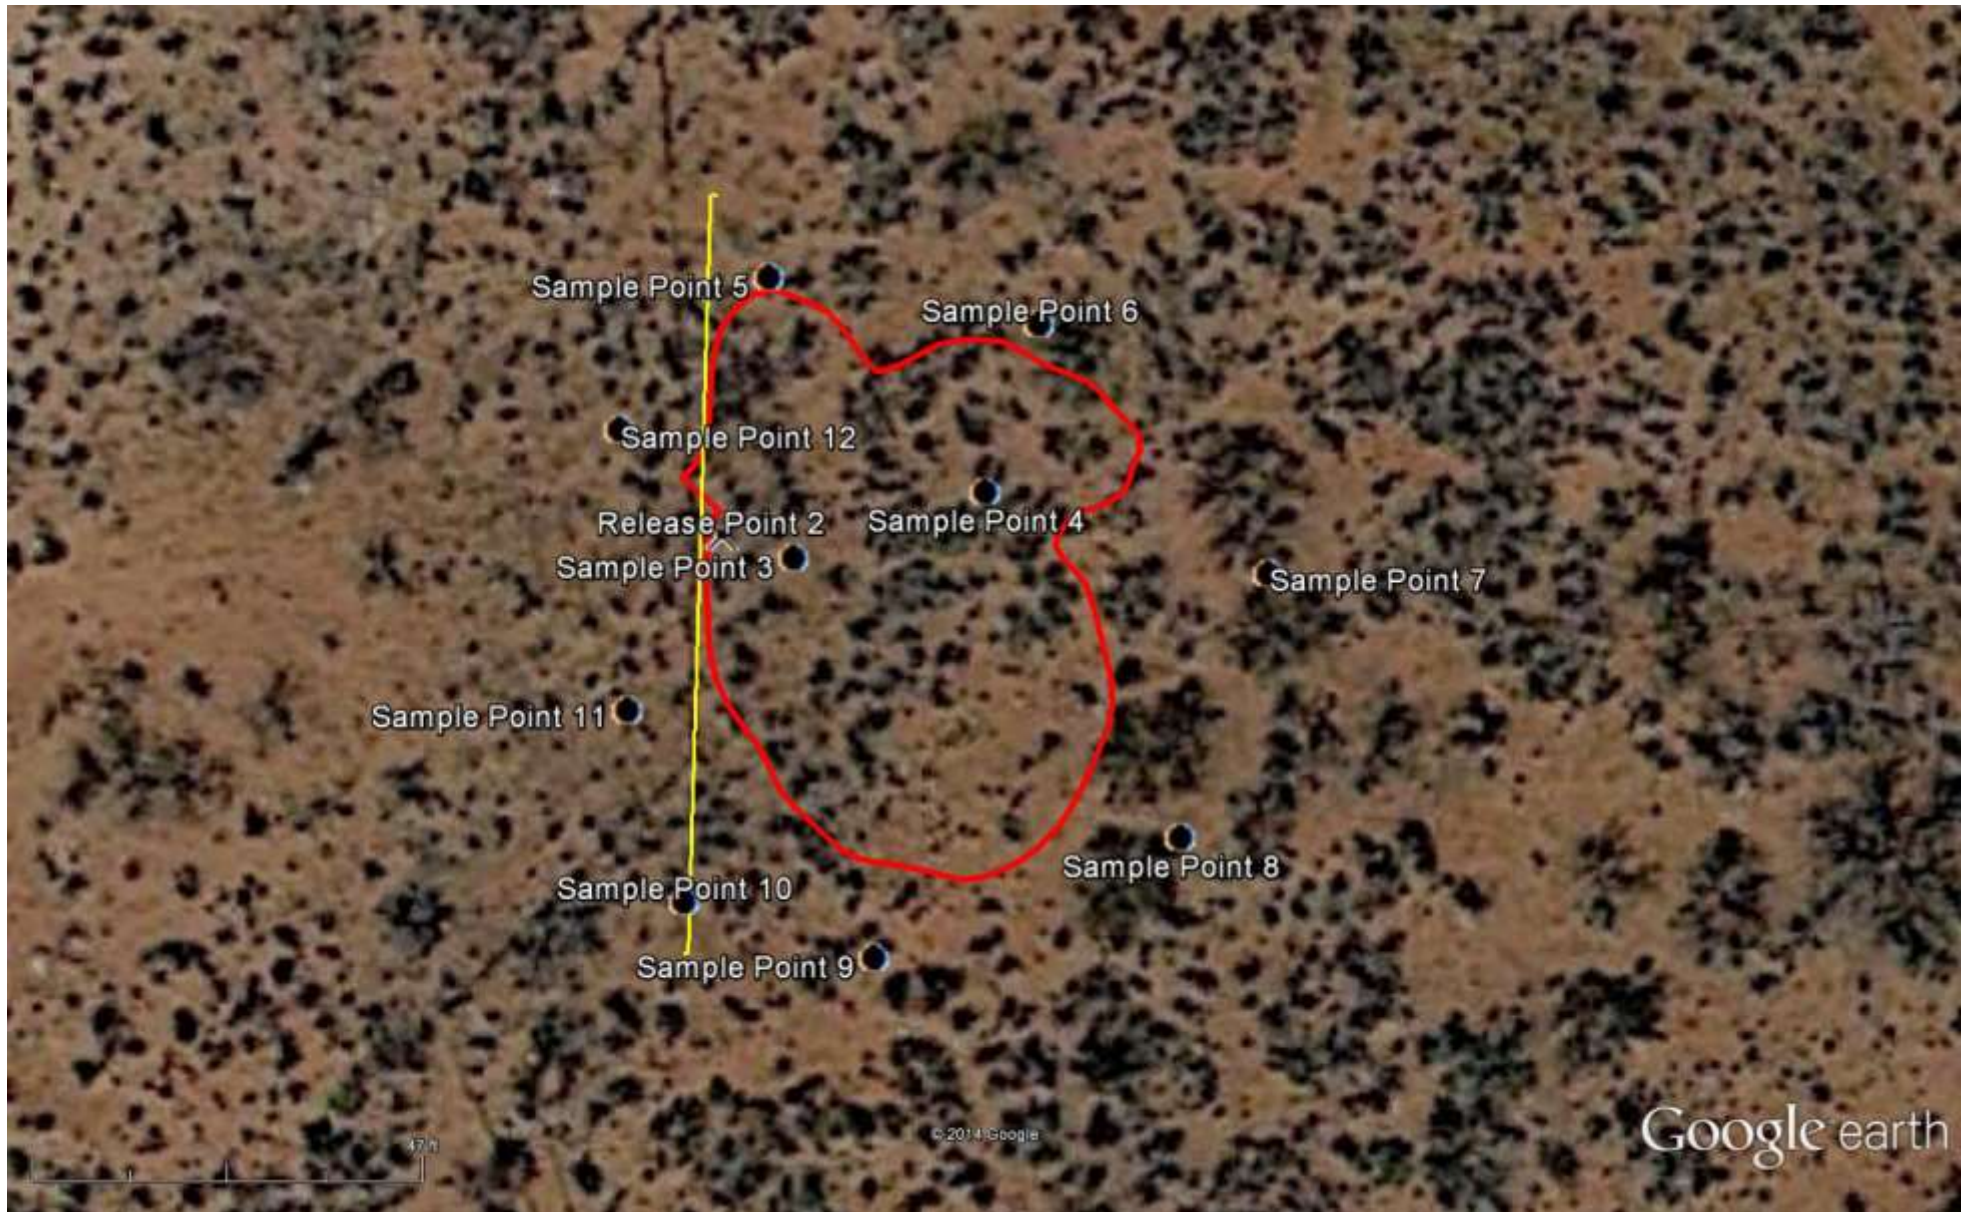
Figure 2 Site Plan

Cotton Draw #30

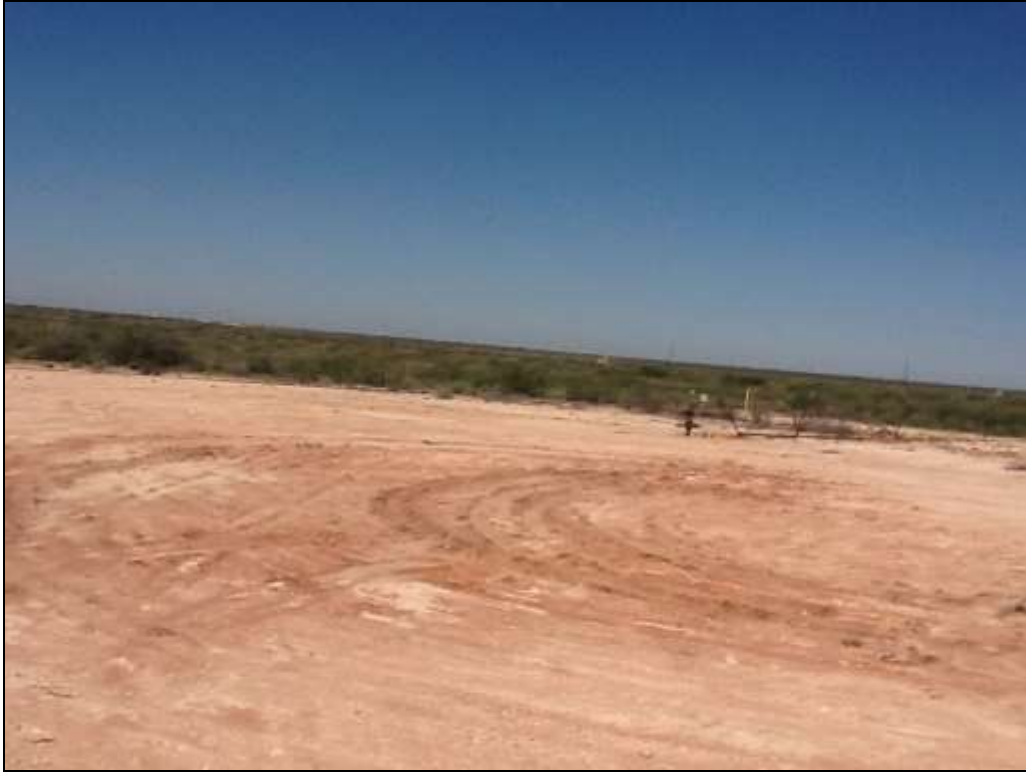
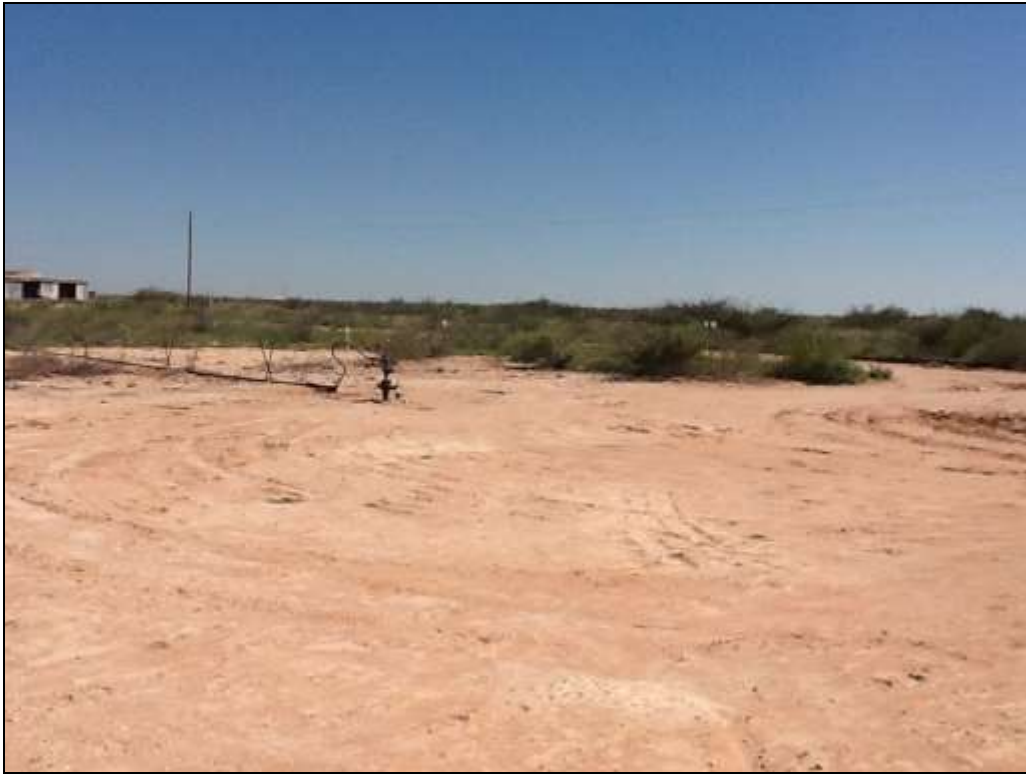
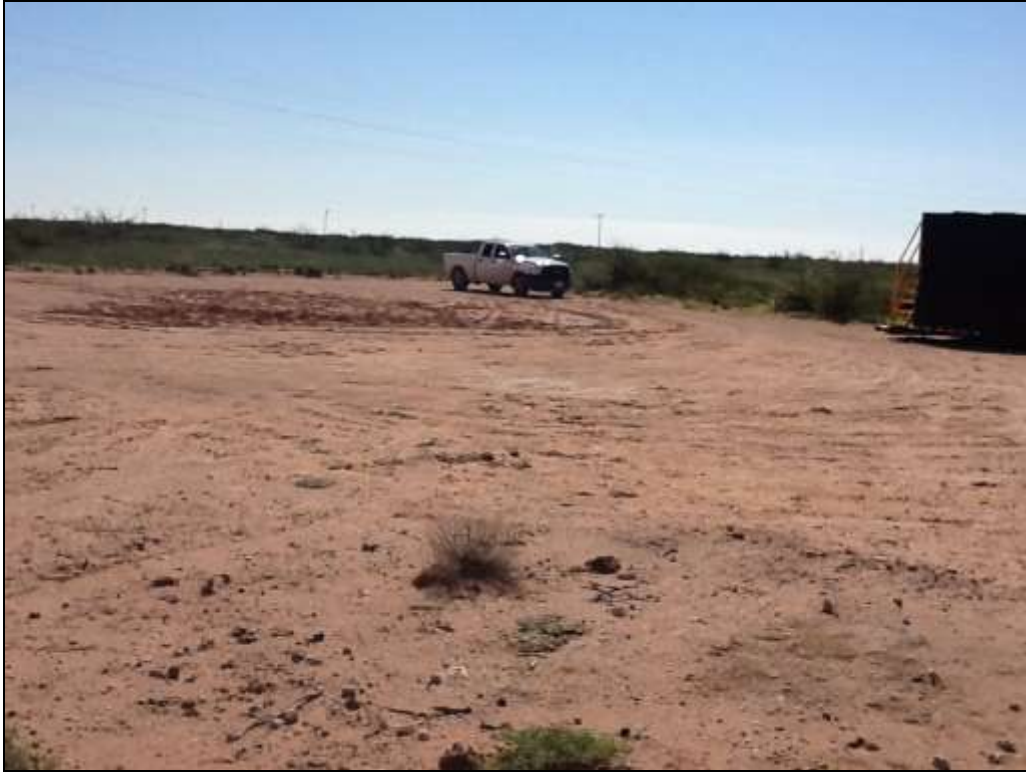
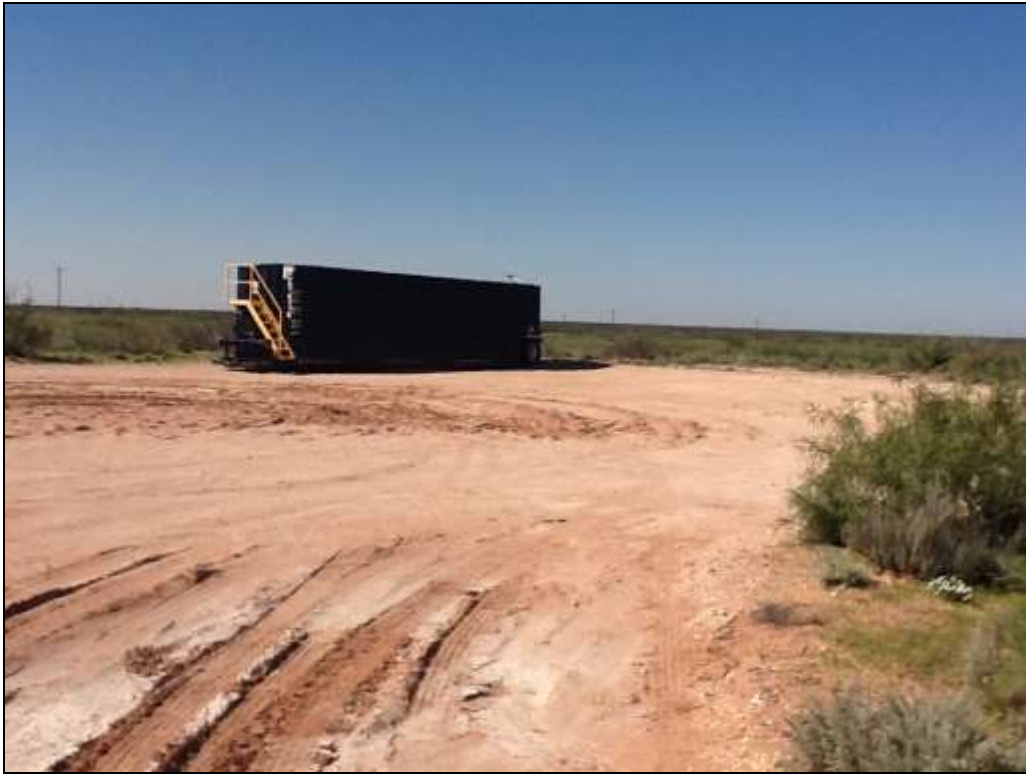
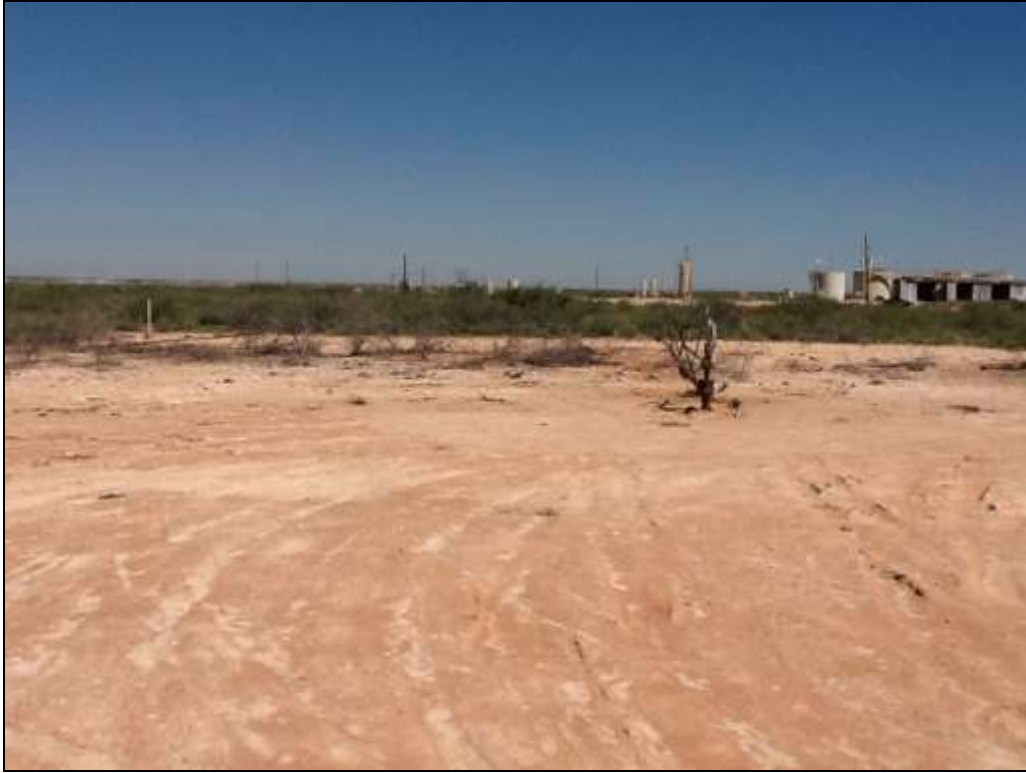
Site Photographs

Safety and Environmental Solutions, Inc. (SESI) was engaged by OXY USA, INC to perform site assessment of a release area at the Cotton Draw Unit #30 located in Section 21 of Township 25 South, Range 32 East, Lea County, New Mexico. The cause of the release as stated in the C-141 located in Appendix B was corrosion. The line has been repaired and no fluid was recovered.

On September 30, 2014 SESI was onsite to perform a site assessment. Site photos were taken.

On November 13, 2014, SESI was onsite with Custom Welding to excavate all contaminated soils above 1,000 ppm Cl. The excavation reached a depth of approximately 6" where through field testing it was determined that the chloride concentrations were well below 1,000 ppm. An 8 point composite sample was taken from the bottom of the excavation properly packaged, preserved and transported to Cardinal Laboratories, Hobbs New Mexico and analyzed for Chloride (Cl⁻) (Method SM4500Cl-B). The results of the analysis are presented in the table below:

All soils contaminated with chlorides over 1,000 ppm were excavated and transported to R360. Due to the shallow depth of the excavation, the surrounding area was used for backfill and returned to natural grade.
