ABO 13-10

1RP-3145

Termination Request

**RE: Termination Request
ConocoPhillips ABO 13-10 (1RP-3145)
UL/J sec. 5 T18S R35E
API No. 30-025-03070**

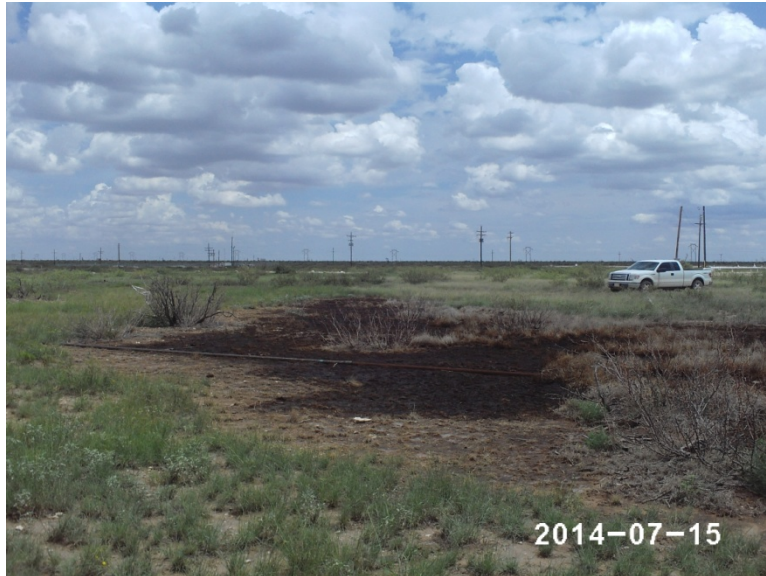
7/15/14

Initial release area, facing northeast

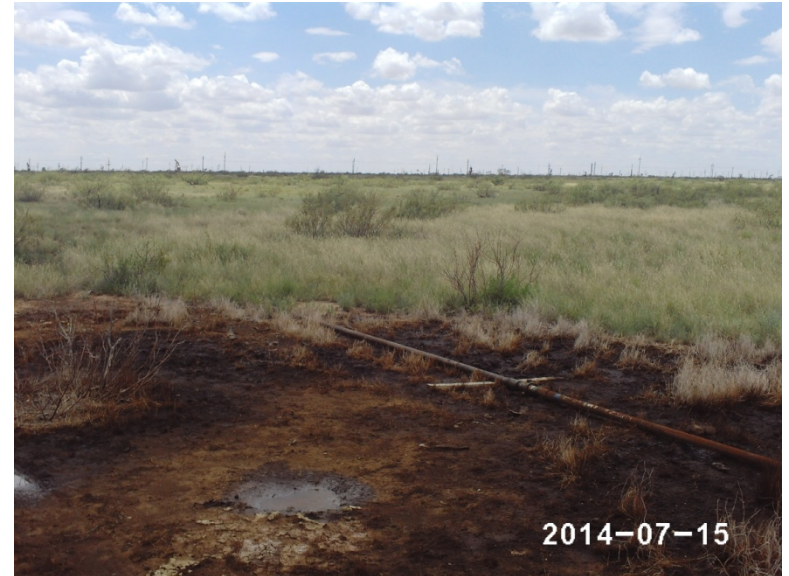
7/15/14

Initial release area, facing west

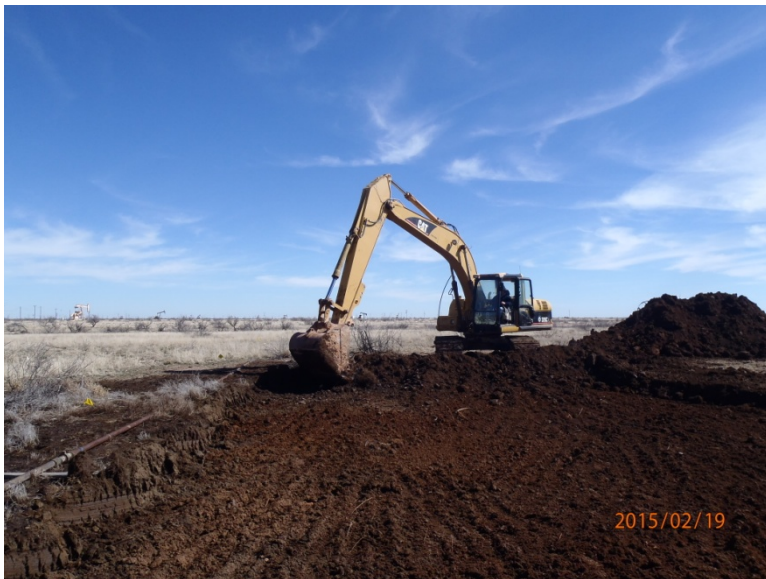
2/19/15

Excavating to 1', facing east

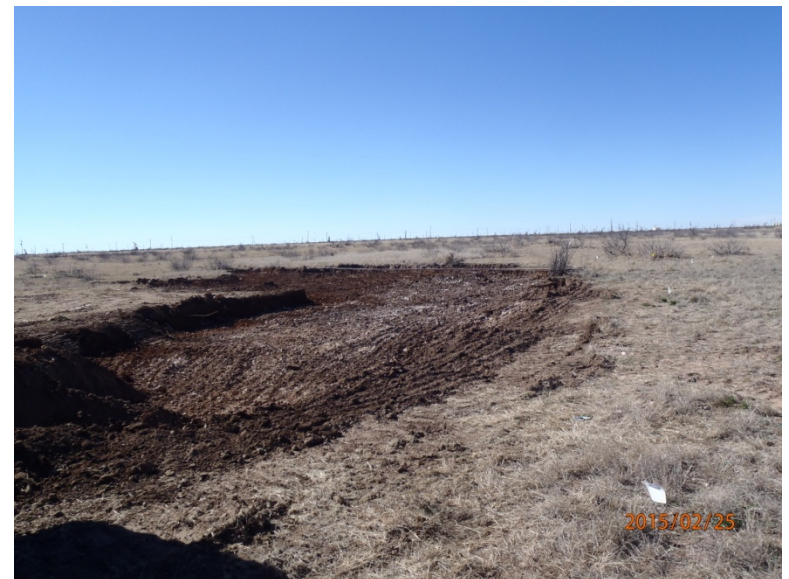
2/25/15

Completed excavation, facing northwest

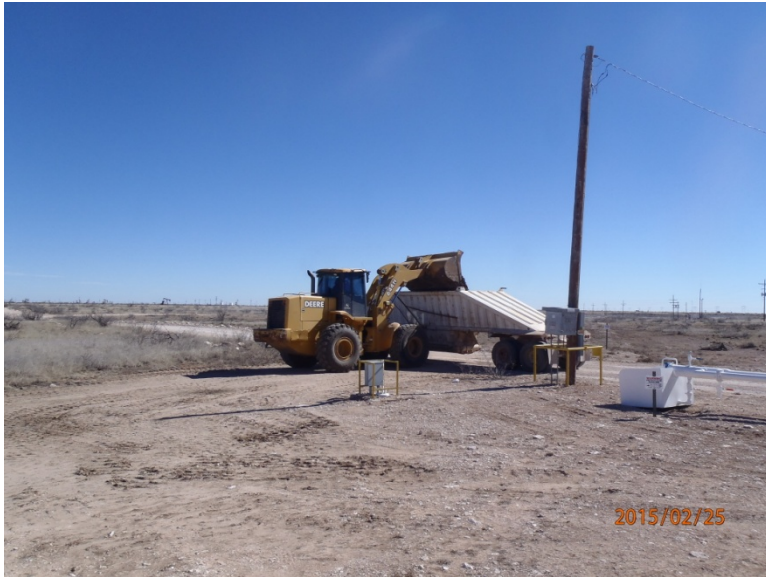
2/25/15

Exporting soil, facing southeast

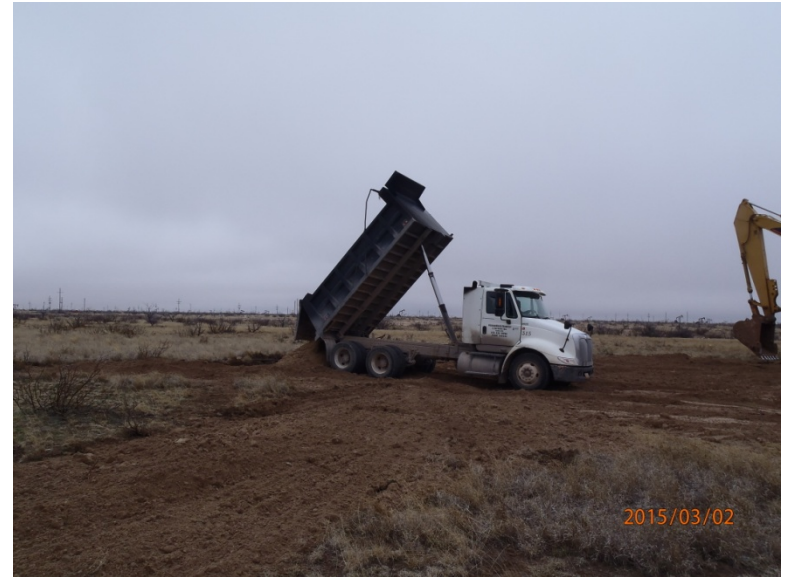
3/2/15

Importing soil, facing northeast

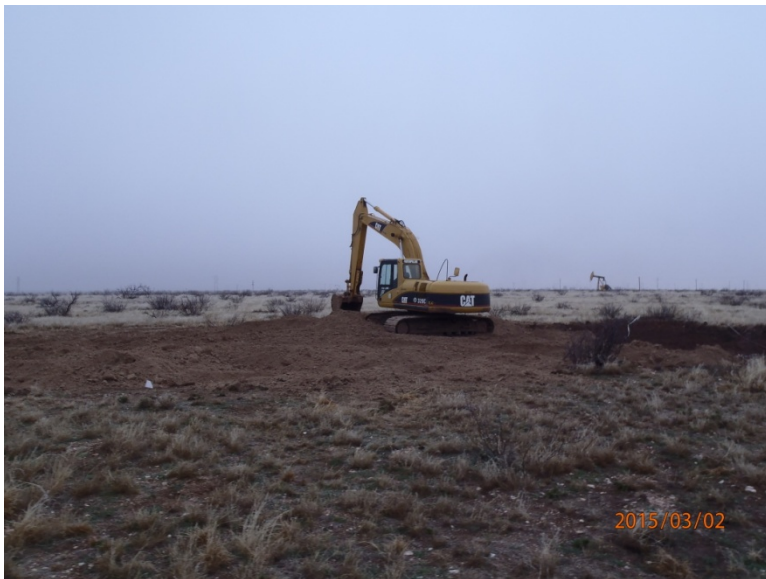
3/2/15

Backfilling excavation, facing east

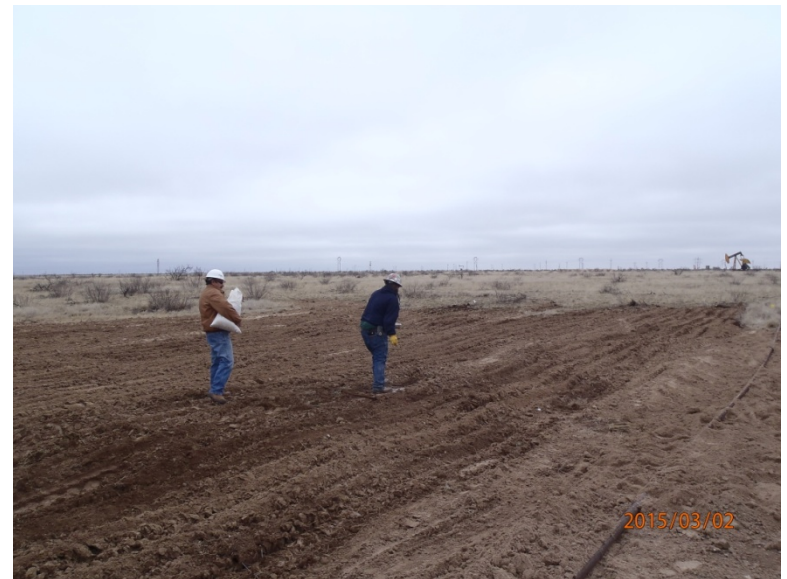
3/2/15

Spreading amendments, facing southeast

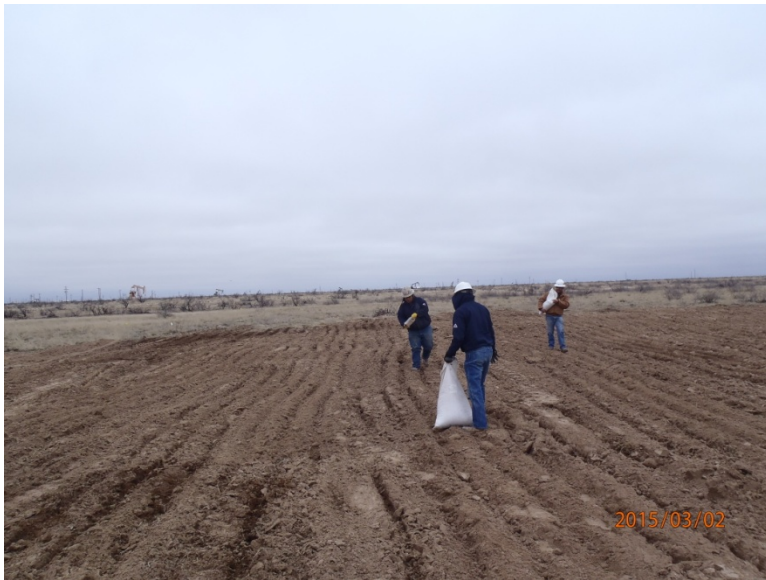
3/2/15

Seeding site, facing east

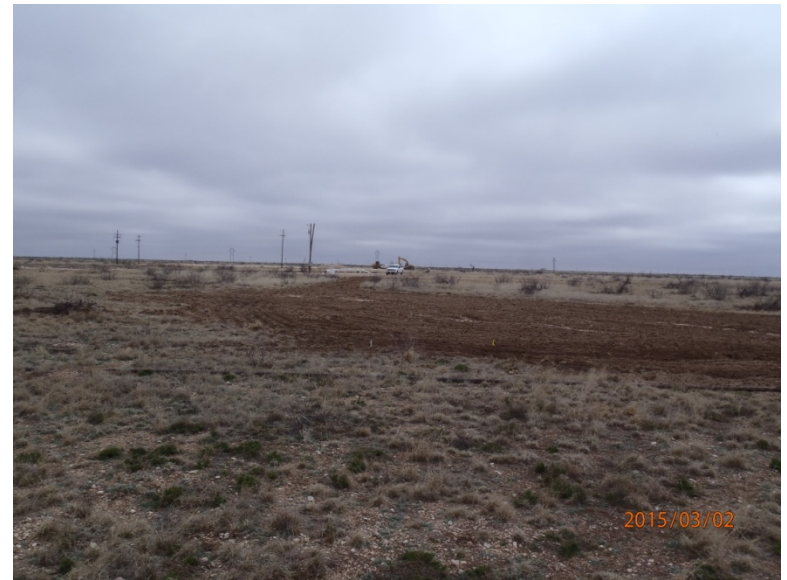
3/2/15

Completed site, facing south

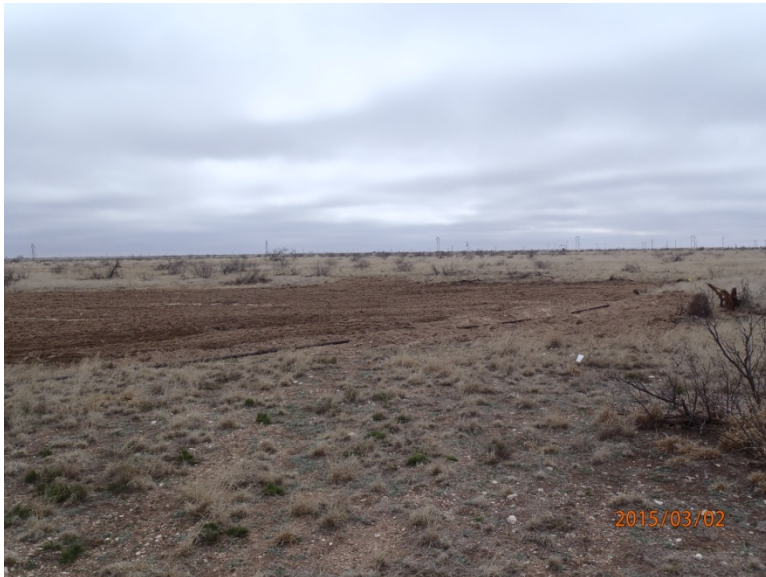
3/2/15

Completed site, facing southwest

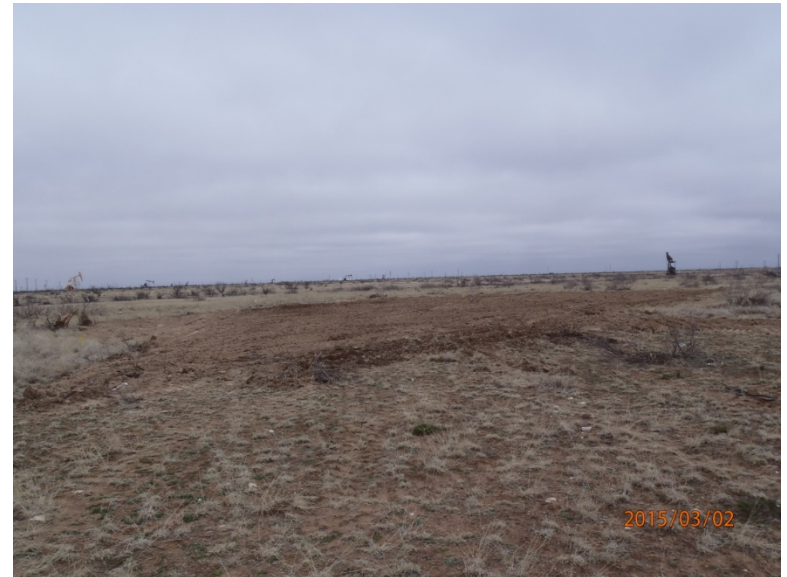
3/2/15

Completed site, facing west
