ENVIRONMENTAL PLUS, INC.  
CONSULTING AND ENVIRONMENTAL REMEDIATION

RE: Final Closure Report  
Chevron – WDDU #42  
UL-A, Section 32, Township 24 South, Range 38 East  
Lea County, New Mexico  
NMOCD Reference # 1RP-3535

The following *Final Closure Report* serves as a condensed update on closure activities undertaken for the above referenced Site.

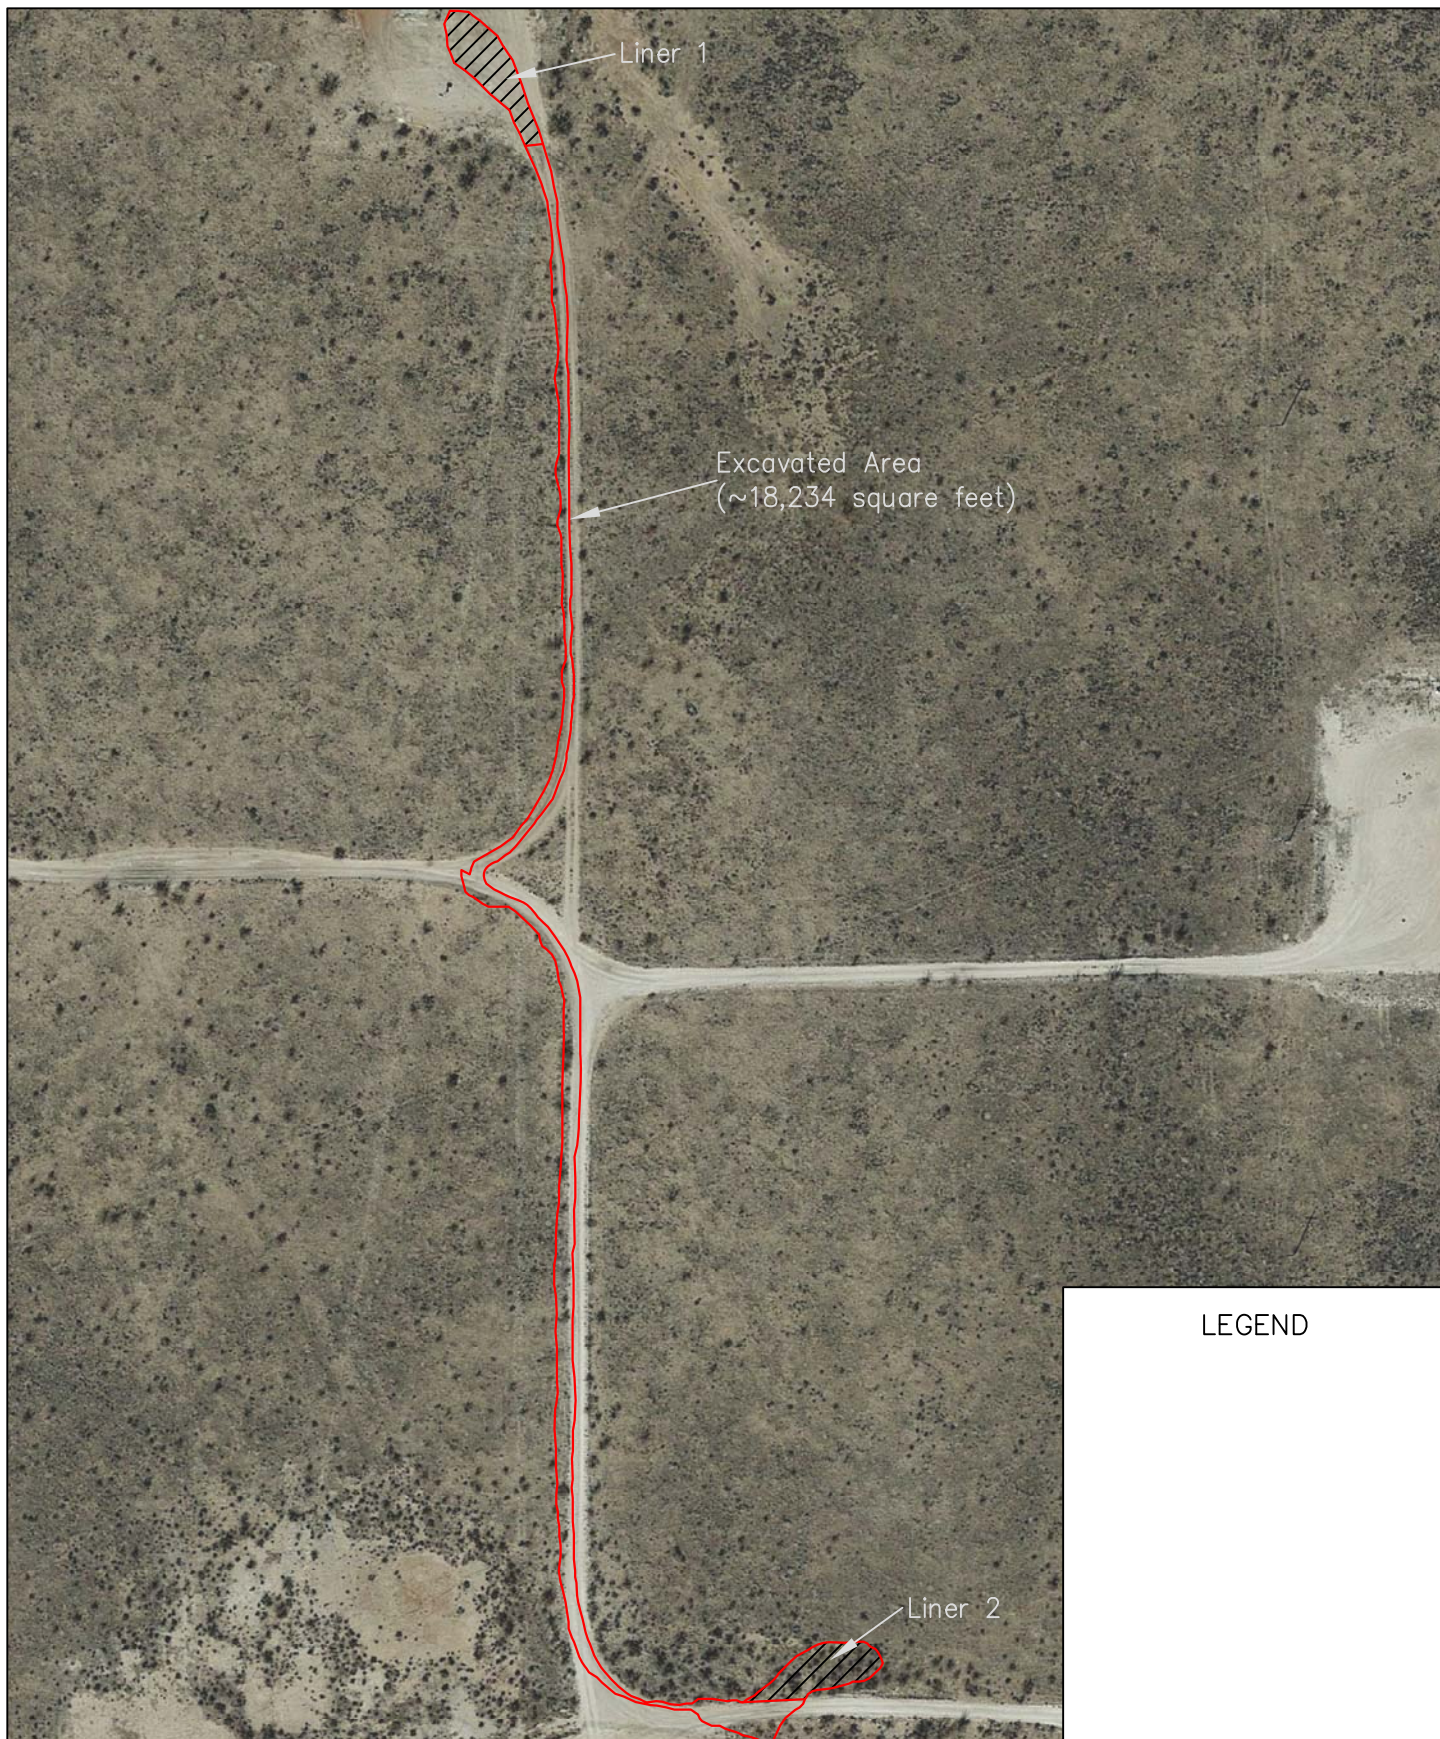
Figure 6  
Liner Location  
Chevron  
WDDU #42

The excavated area on the lease road between the excavations has been backfilled with clean caliche and a twenty (20) mil thick polyethylene liner has been installed in the bottom of the north and south excavations (reference *Figure 6*). The polyethylene liner has been placed on a one (1) foot thick layer of clean soil. Remainder of the excavations has been backfilled with selected clean soil to finish grade; soil is free of deleterious material or rocks or large clumps.

Backfilling continued until the entire excavation was closed. The excavation has been backfilled with approximately 1,612 cubic yards of clean soil. Upon completion of backfill activities, the entire disturbed area was contoured to blend with existing lease road, pad location, and pasture area and protected against wind/water erosion.

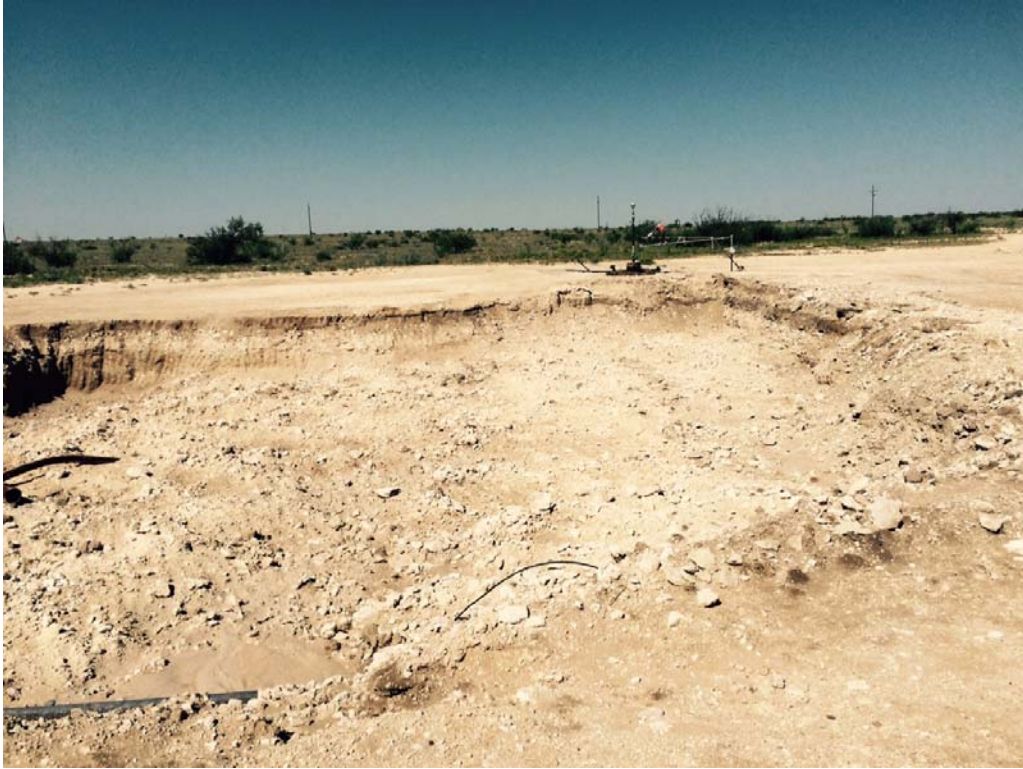
Photograph #1 – Looking across north excavation

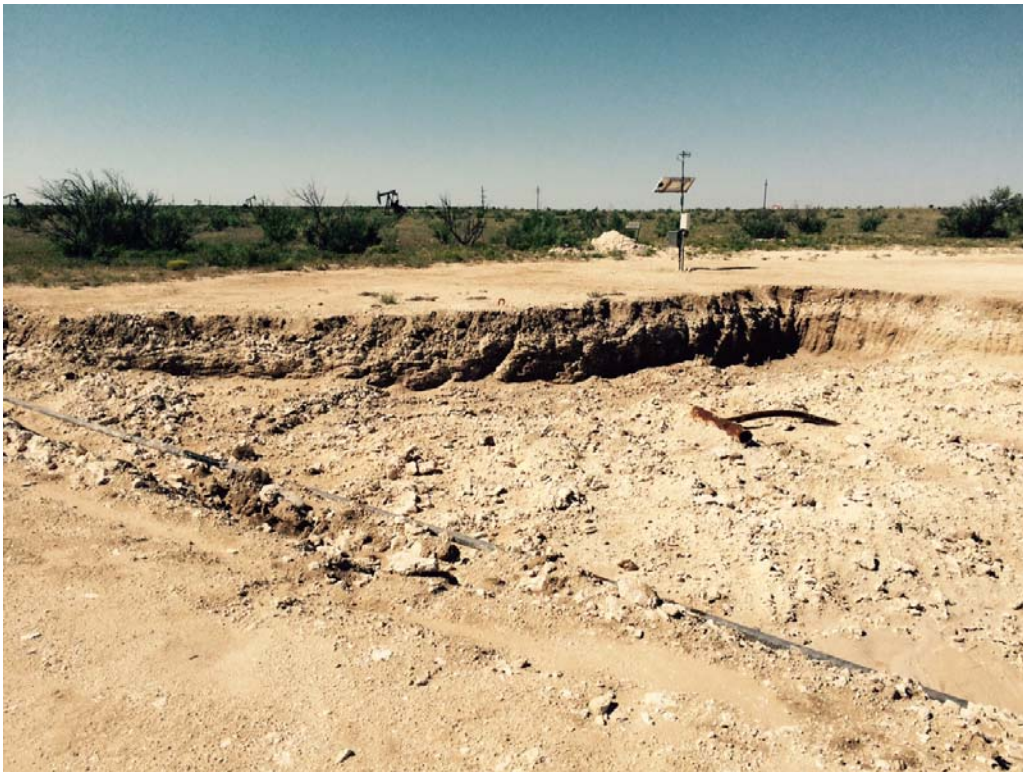
Photograph #2 – Looking across north excavation

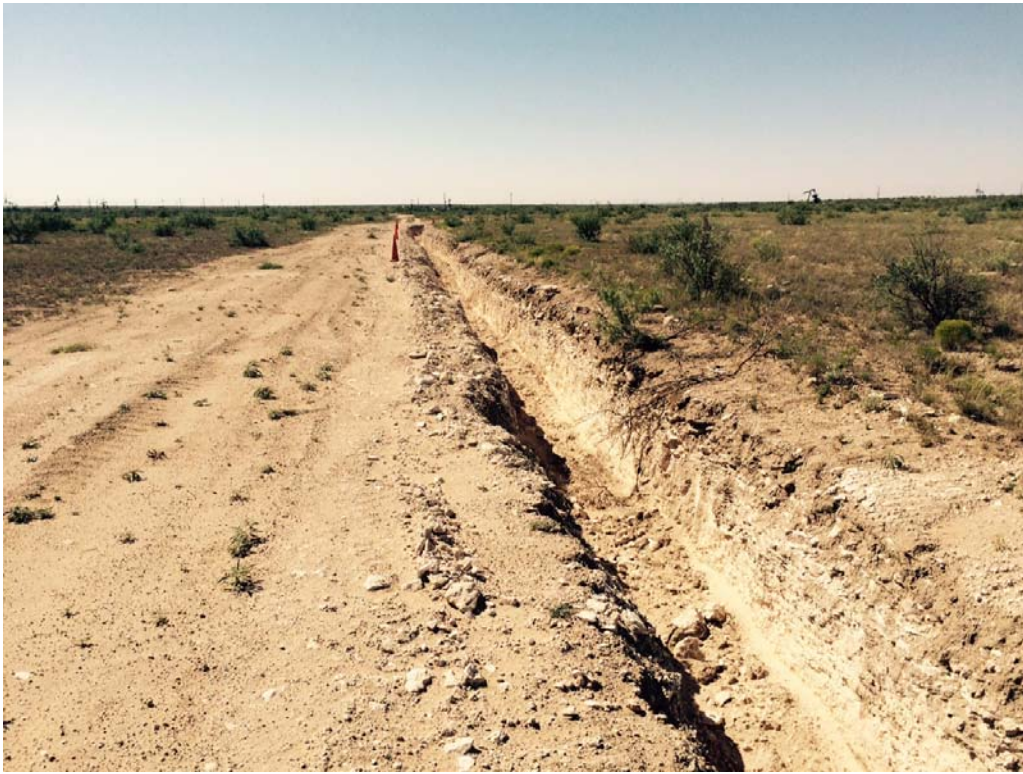
Photograph #3 – Looking south across excavation in road

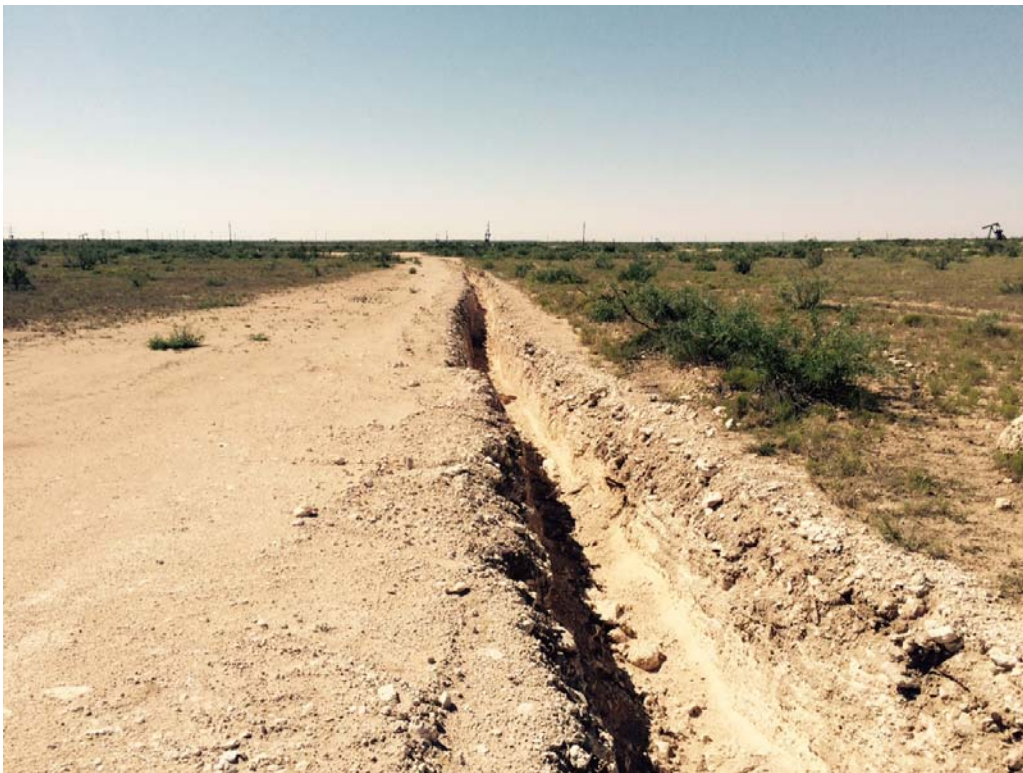
Photograph #4 – Looking south across excavation in road

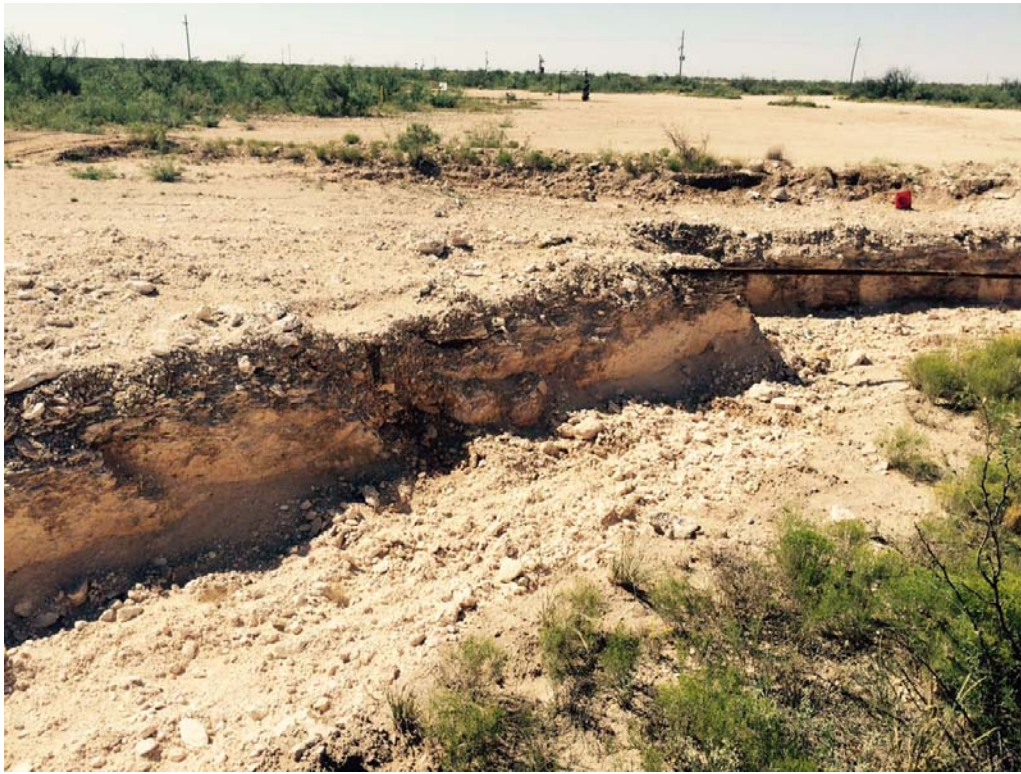
Photograph #5 – Looking across south excavation

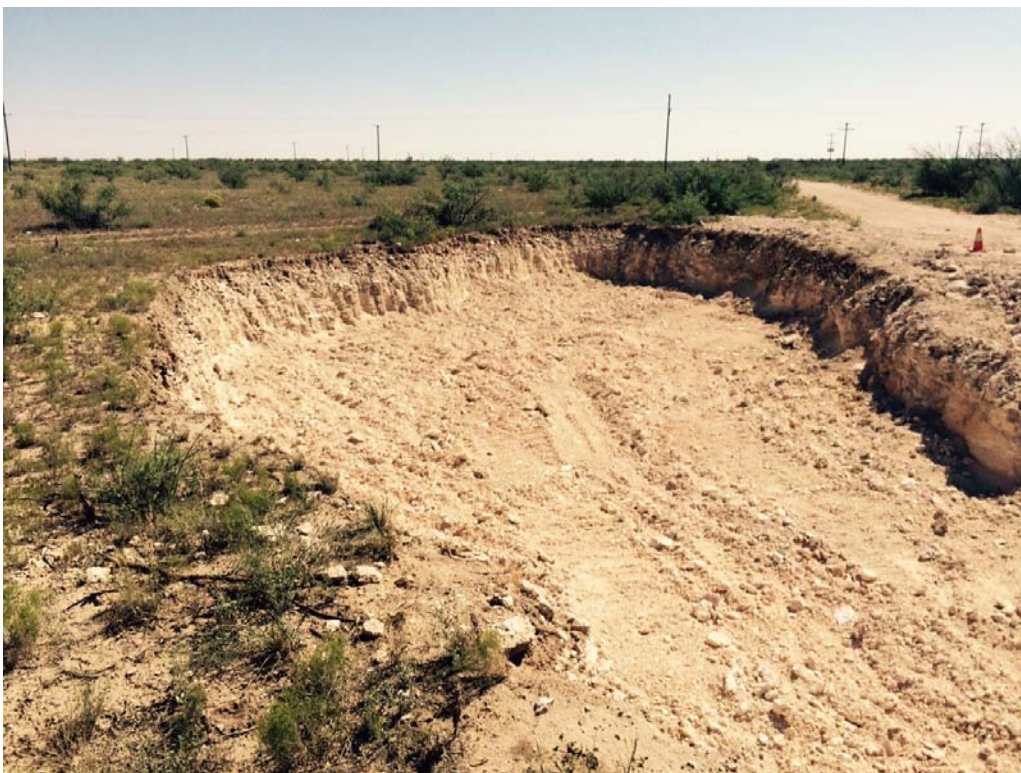
Photograph #6 – Looking across south excavation

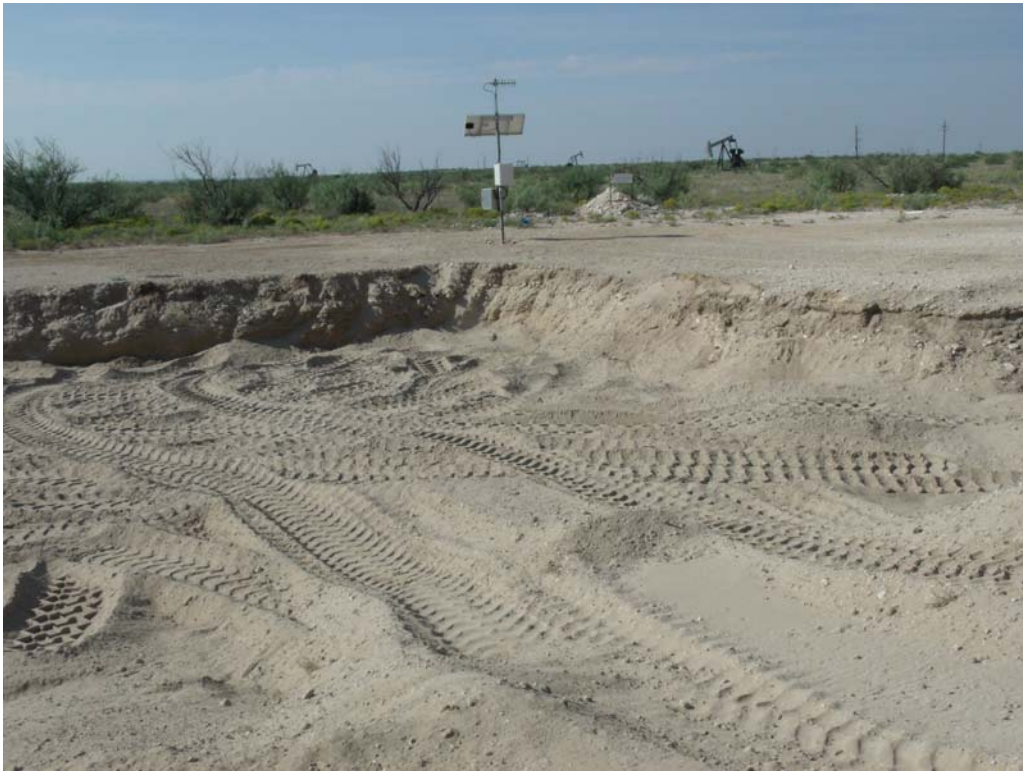
Photograph #7 – North liner installation and backfill

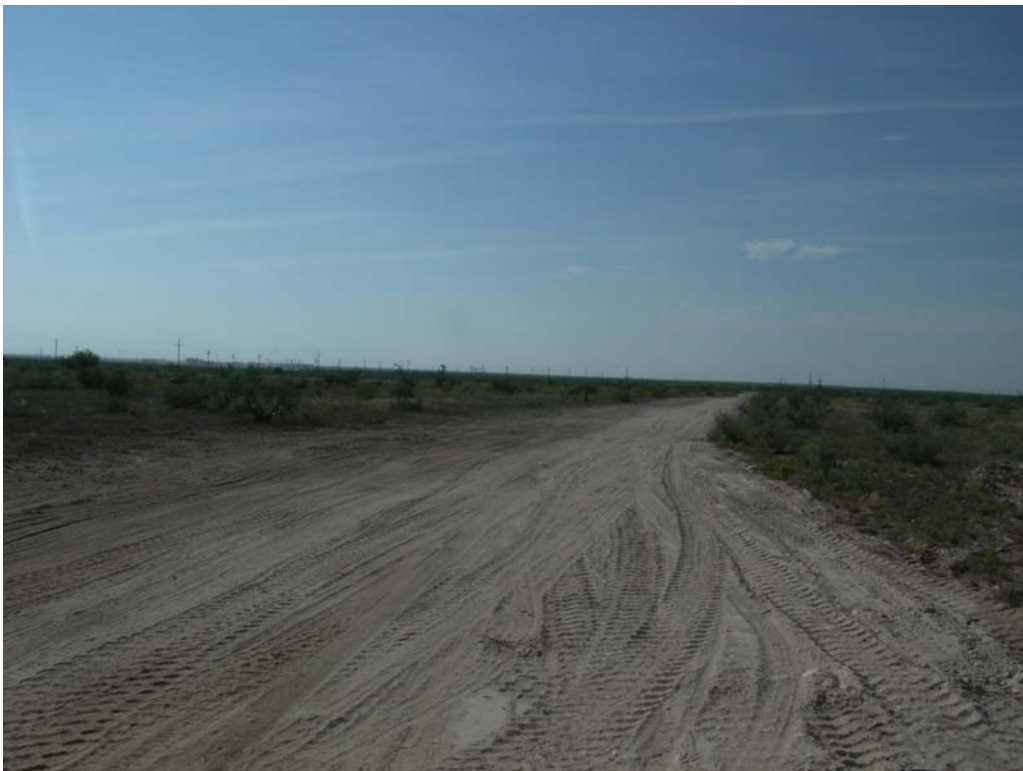
Photograph #8 – Backfilled

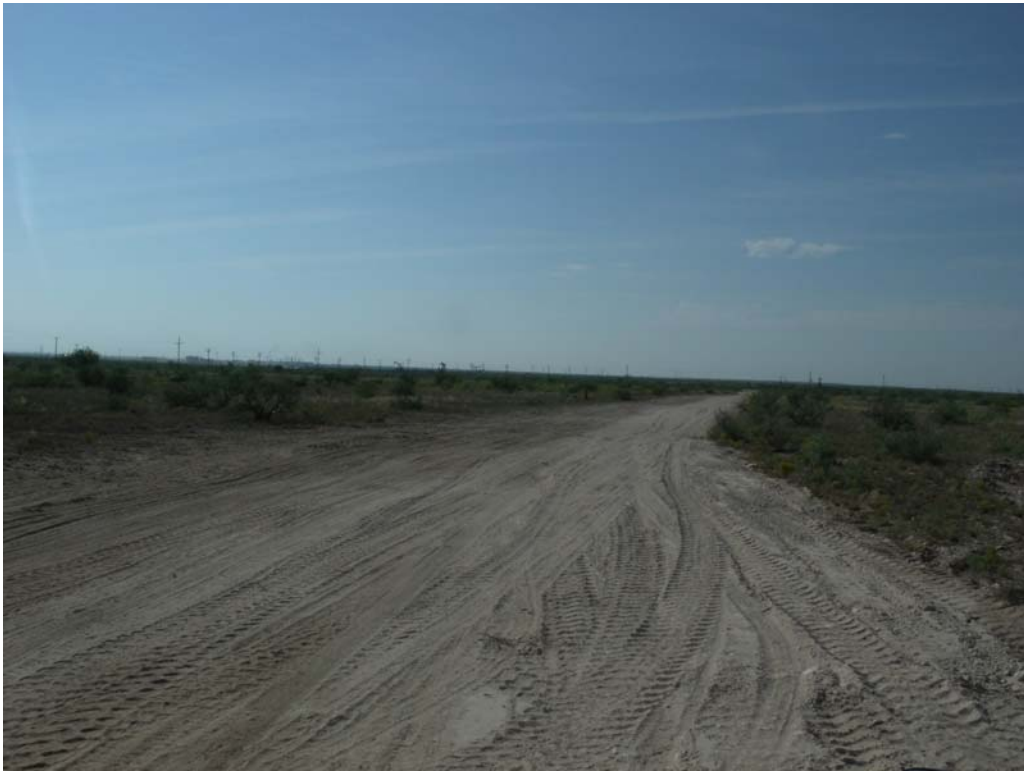
Photograph #9 – Backfilled

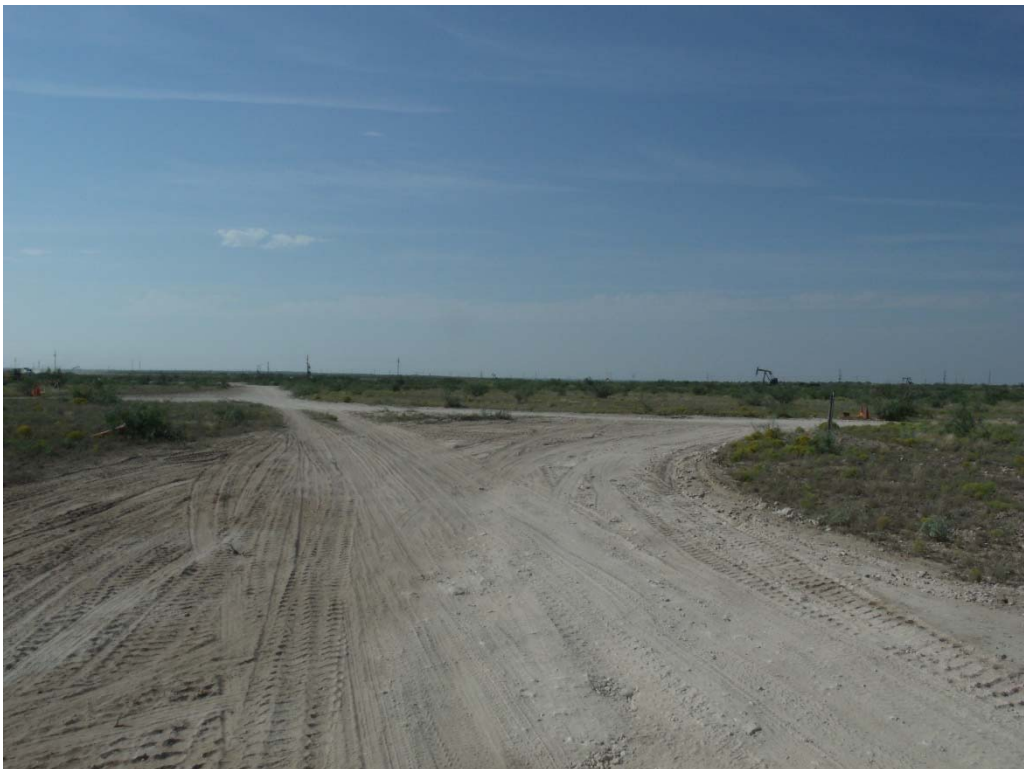
Photograph #10 – Backfilled

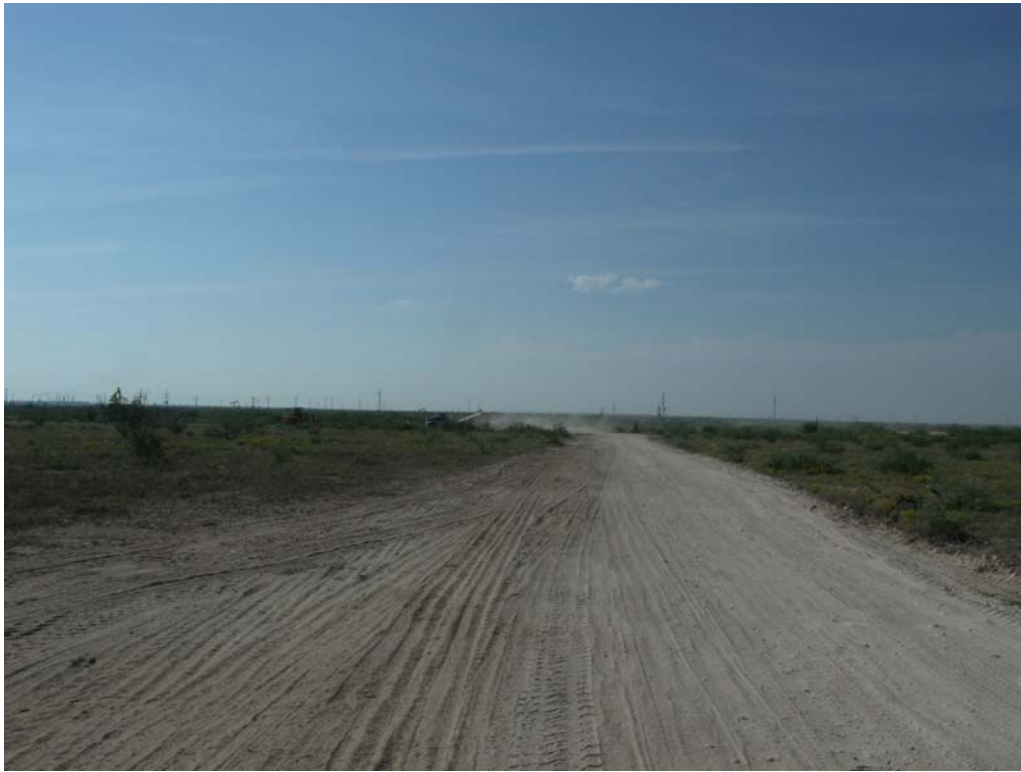
Photograph #11 – Backfilled

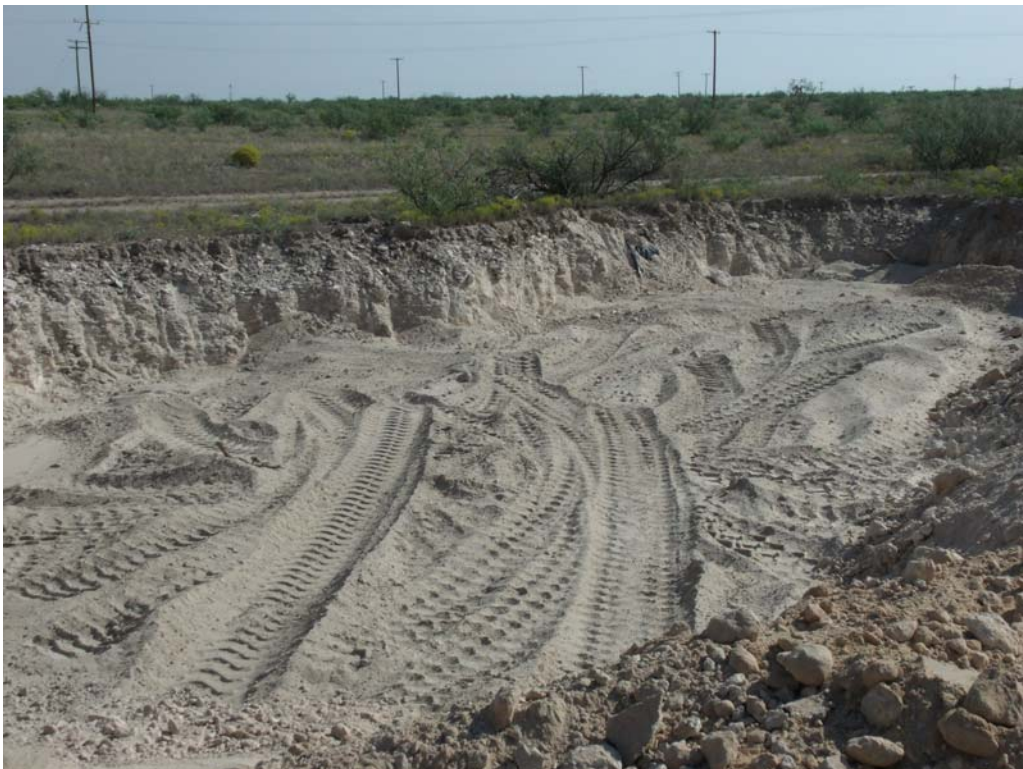
Photograph #12 – South liner installation and backfill
