## Santa Fe #133

(1RP-3494)

# Termination Request

**RE: Termination Request  
ConocoPhillips Santa Fe #133 (1RP-3494)  
UL/O sec. 31 T17S R35E  
API No. 30-025-32333**

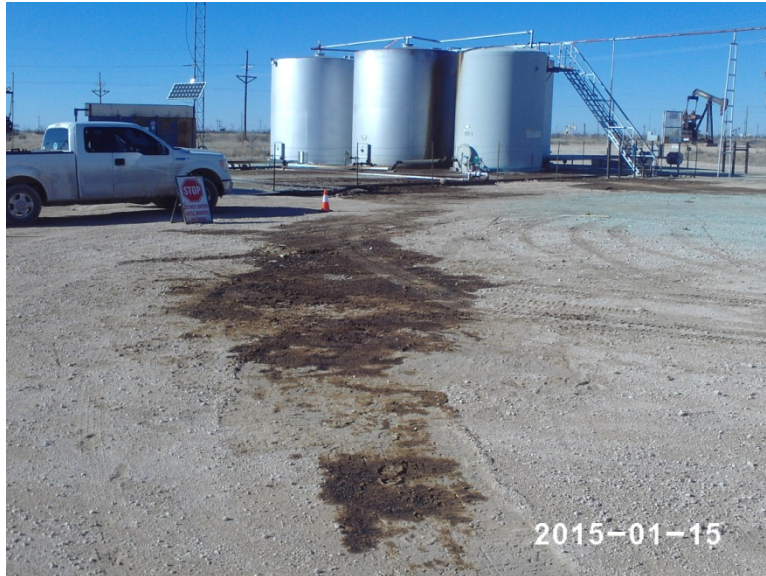
Initial release area, facing southwest

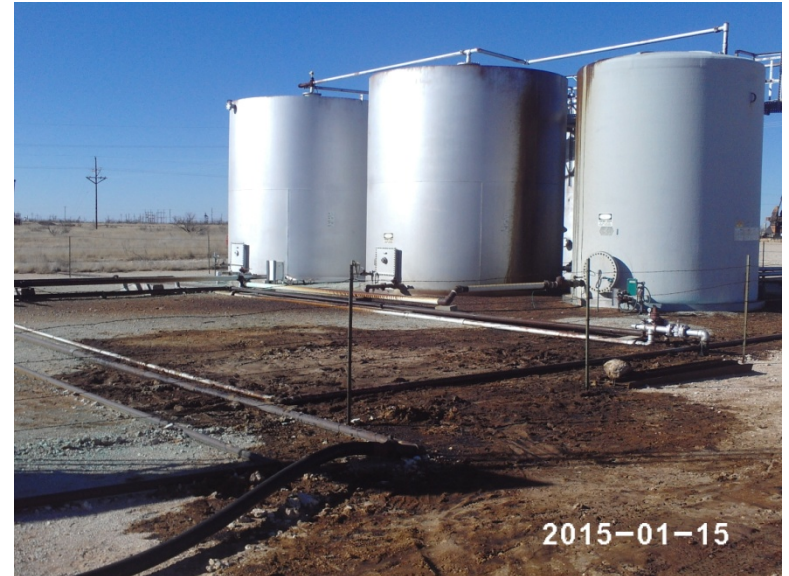
Initial release area, facing northwest

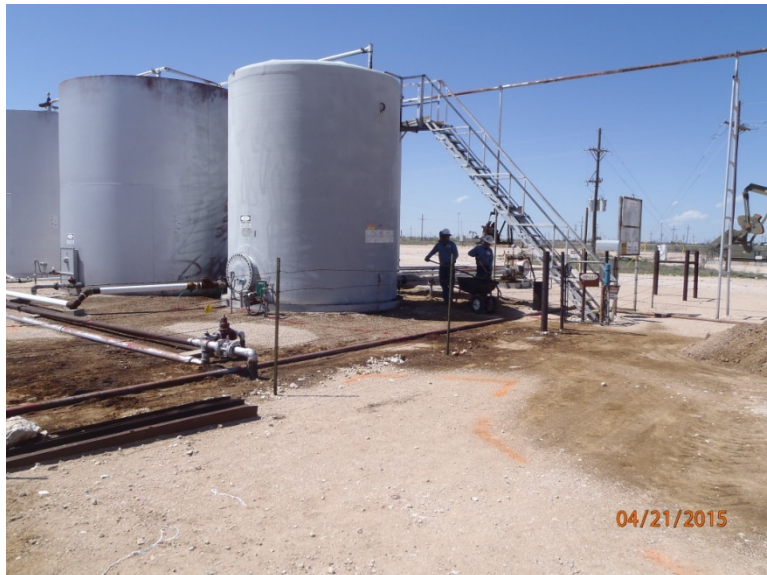
Shoveling release, facing northwest

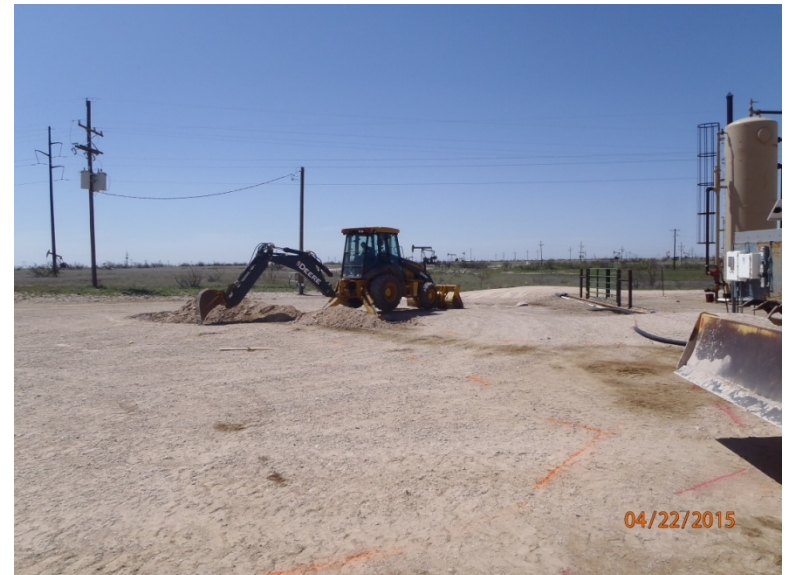
Scraping release, facing south

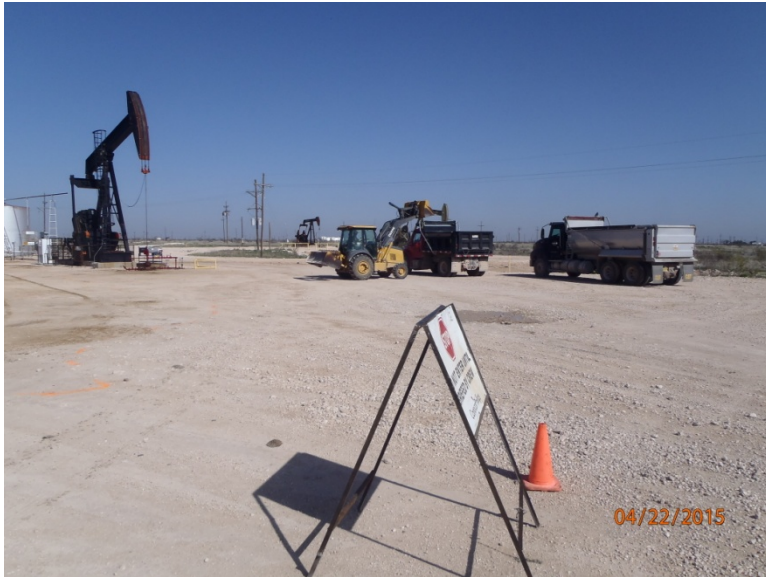
Exporting soil, facing northwest

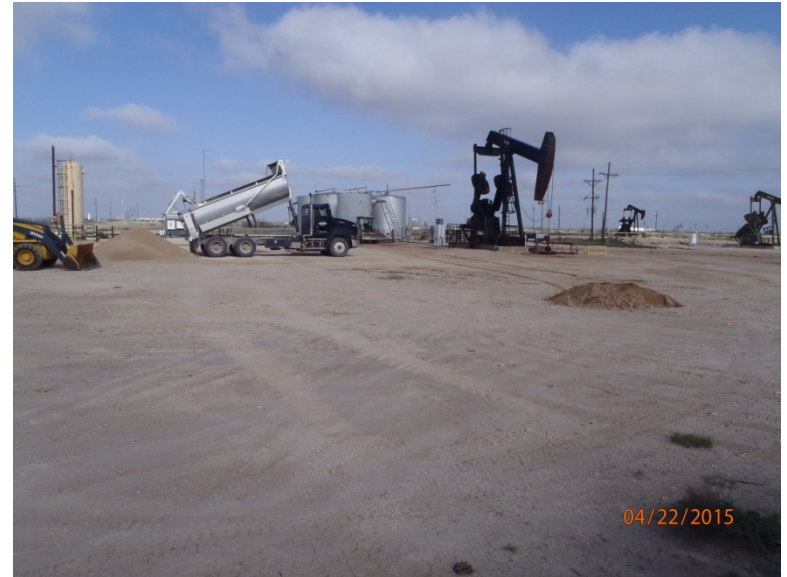
Importing soil, facing northwest

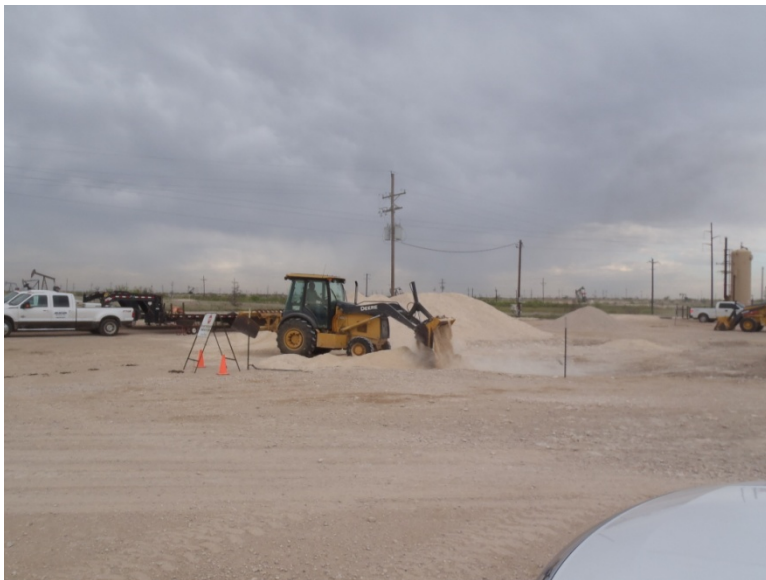
Backfilling scrape, facing south

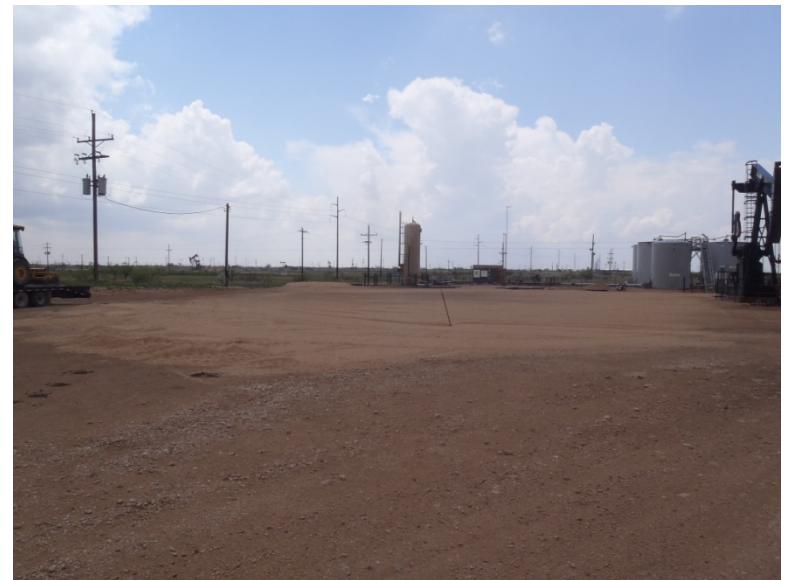
Completed site, facing southwest

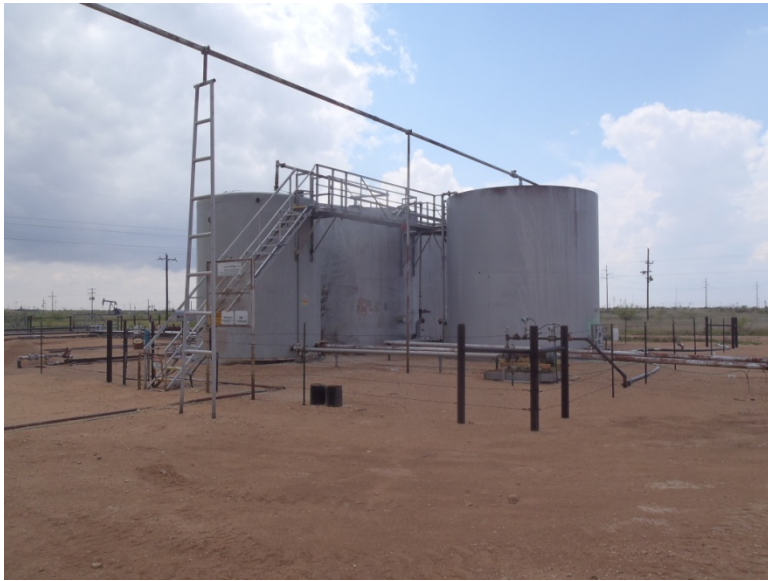
Completed site, facing southwest

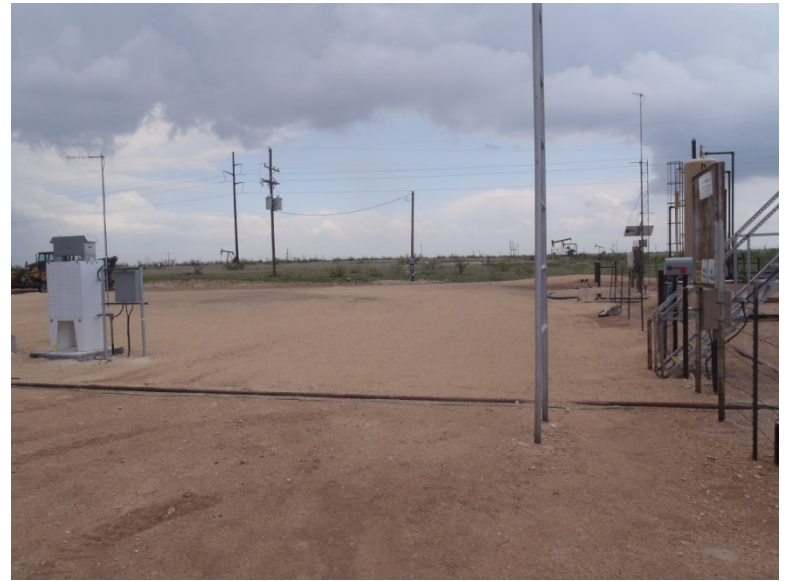
Completed site, facing south
