EVGSAU 2739-007

(1RP-3148)

Termination Request

**RE: Termination Request
ConocoPhillips EVGSAU 2739-007 (1RP-3148)
UL/K sec. 27 T17S R35E
API No. 30-025-26779**

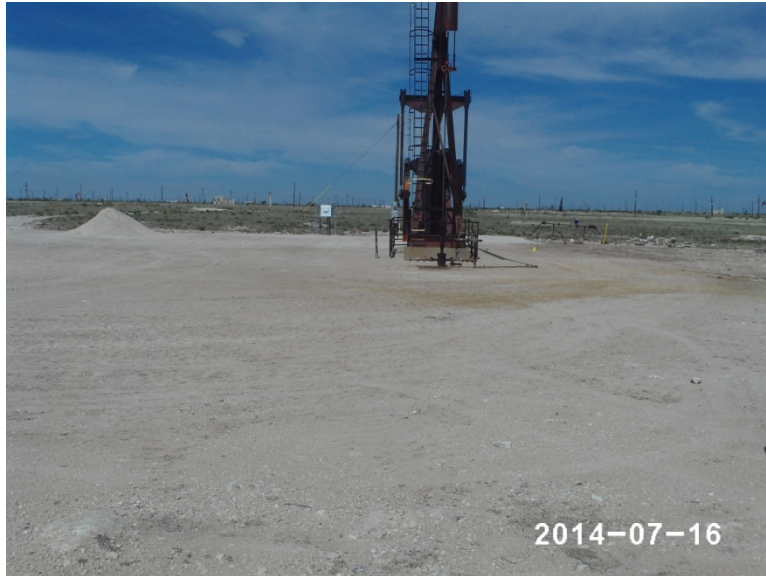
Initial release area, facing west

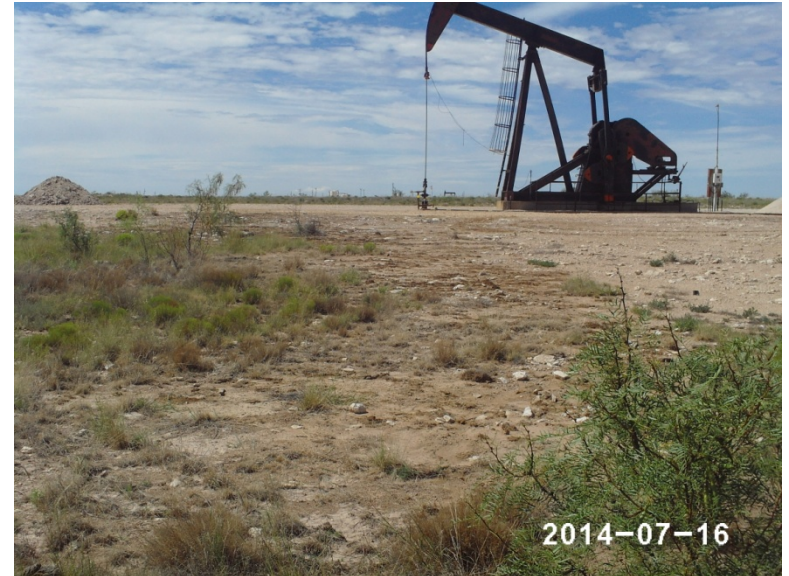
Initial release area, facing south

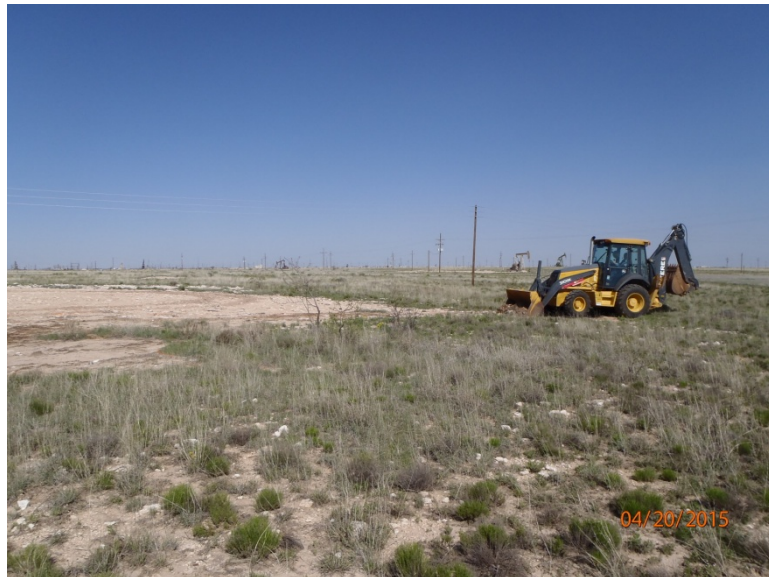
Scraping release, facing west

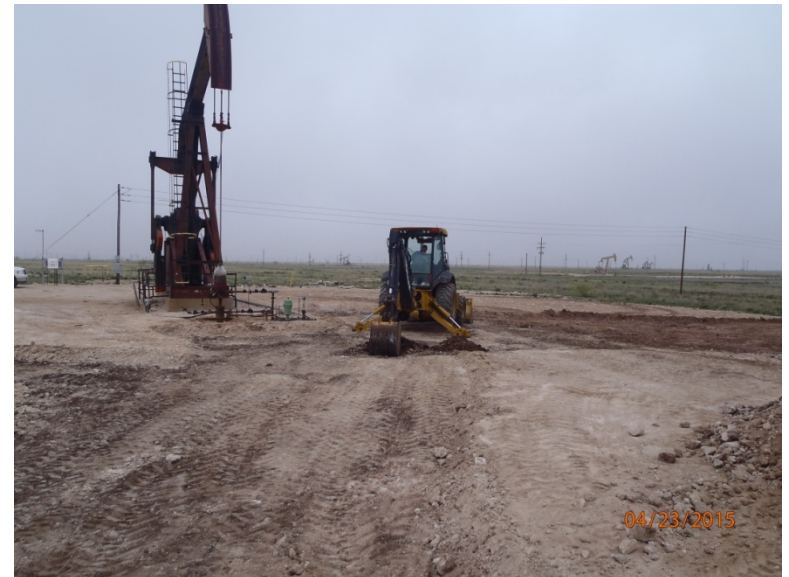
Installing vertical, facing northwest

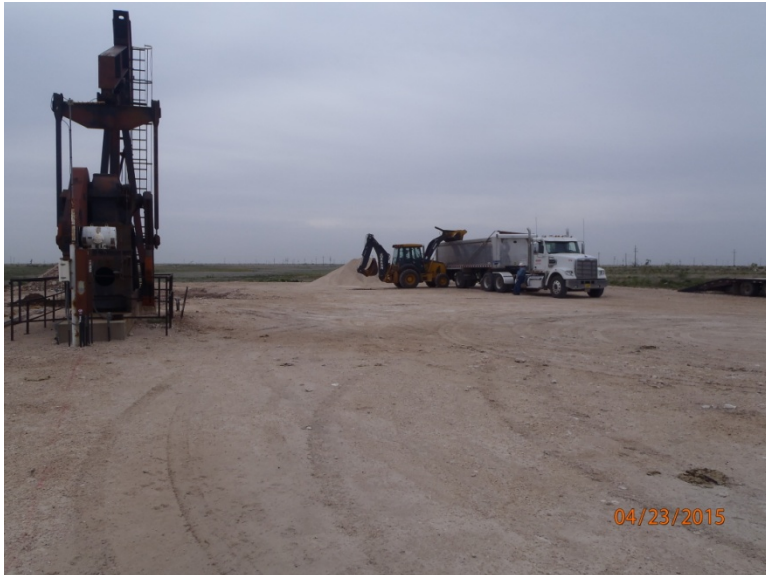
Exporting soil, facing east

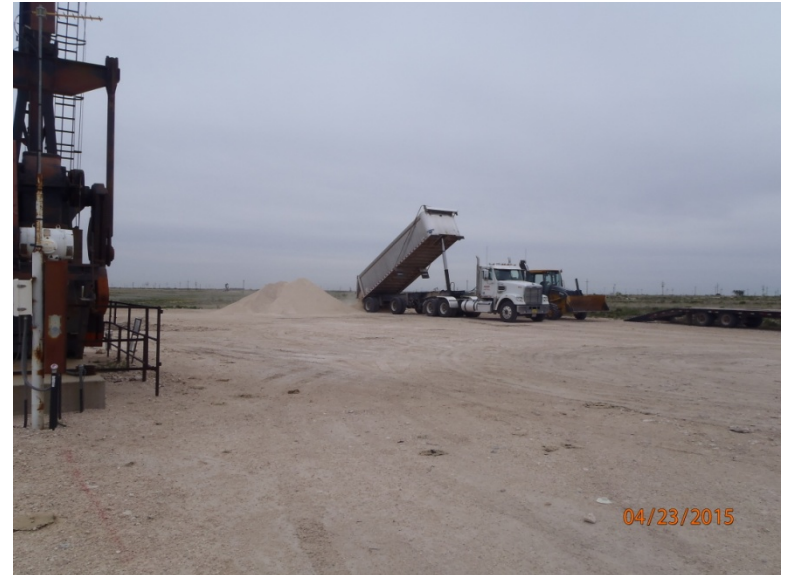
Importing caliche, facing southeast

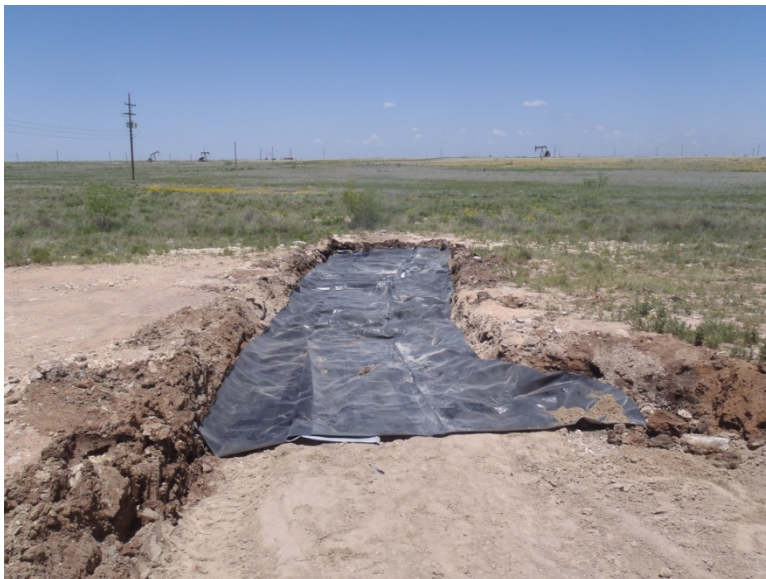
Installed liner, facing north

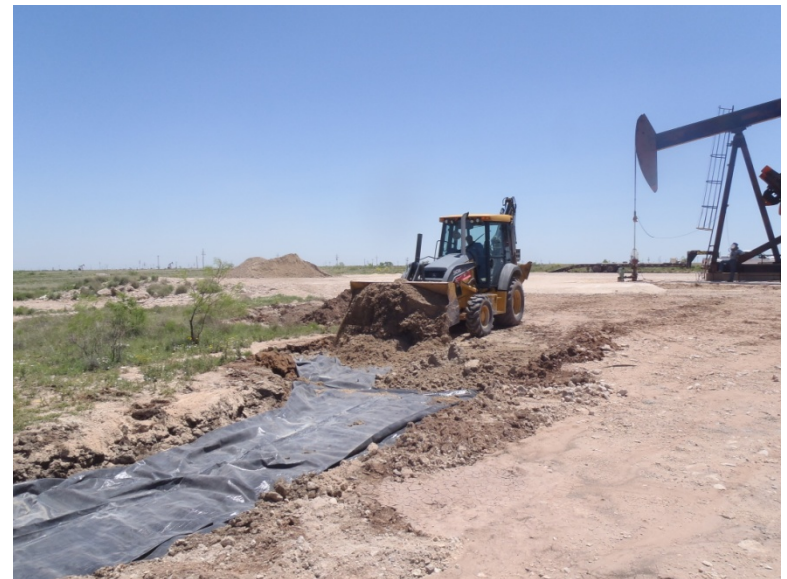
Backfilling excavation, facing south

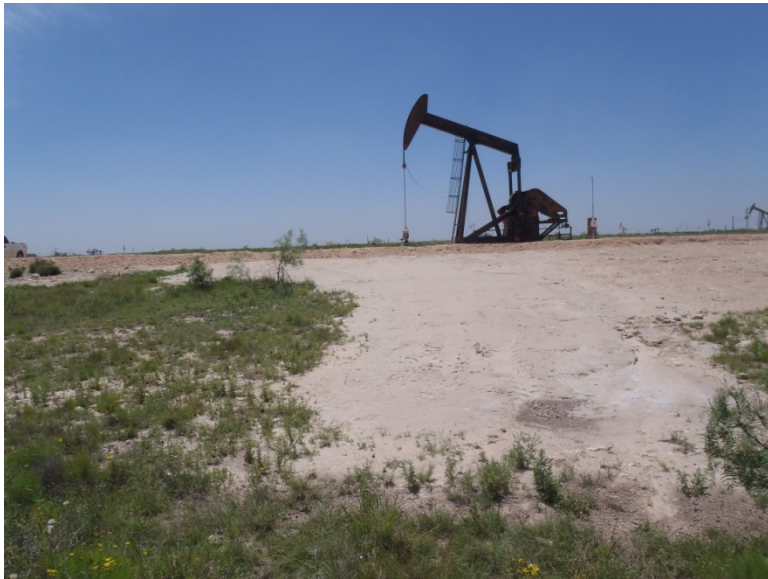
Completed site, facing east

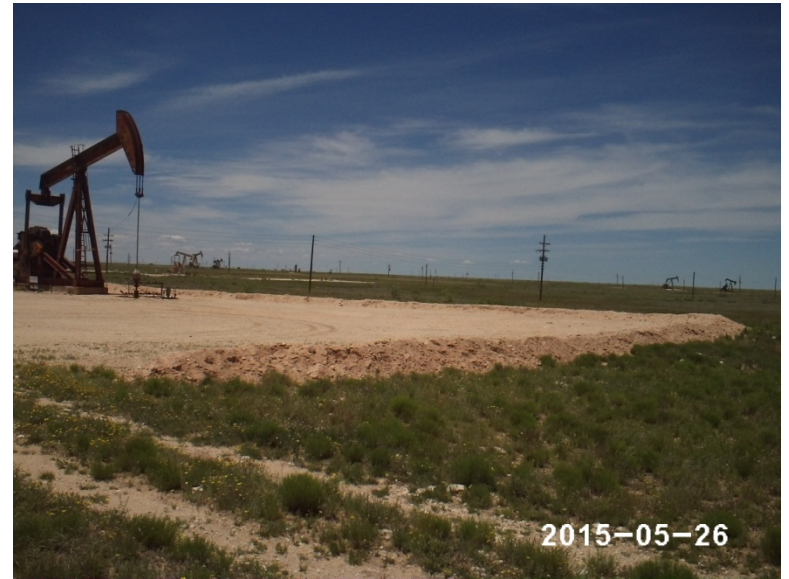
Completed site with berms, facing northwest

At the suggestion of NMOCD, berms were installed to the north and to the east of the well head.
