Remediation Summary and Soil Closure Report

Jal #3 Vent

NMOCD Ref. No. 1RP-3940

Lea County, New Mexico

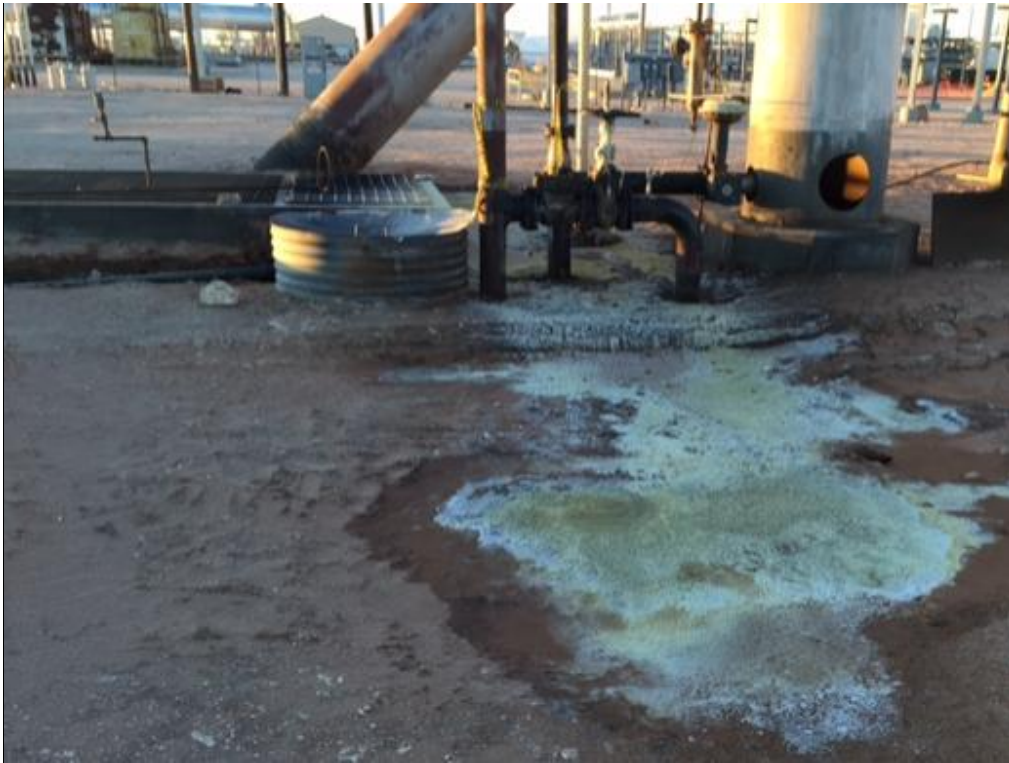
Photo 1: View of surface staining from the initial release, facing south. (32.17593, -103.17287)

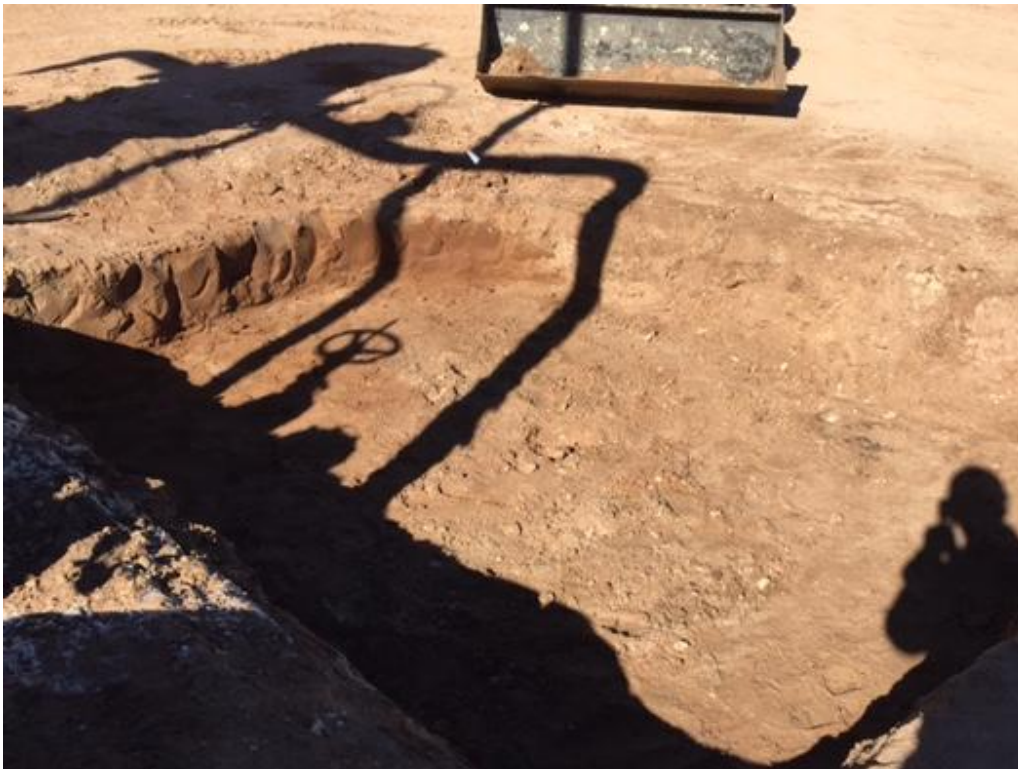
Excavation activities commenced at the release site. Affected soil in the northern portion of the release site adjacent to the vent pipe was excavated to approximately 2 feet bgs. Affected soil in the southern portion of the release site was excavated to approximately 6 inches bgs. Excavated soil was stockpiled on-site, atop a polyurethane liner, pending final disposition.

Photo 2: View of the excavated area adjacent to the release point, facing northwest. (32.17590, -103.172844)

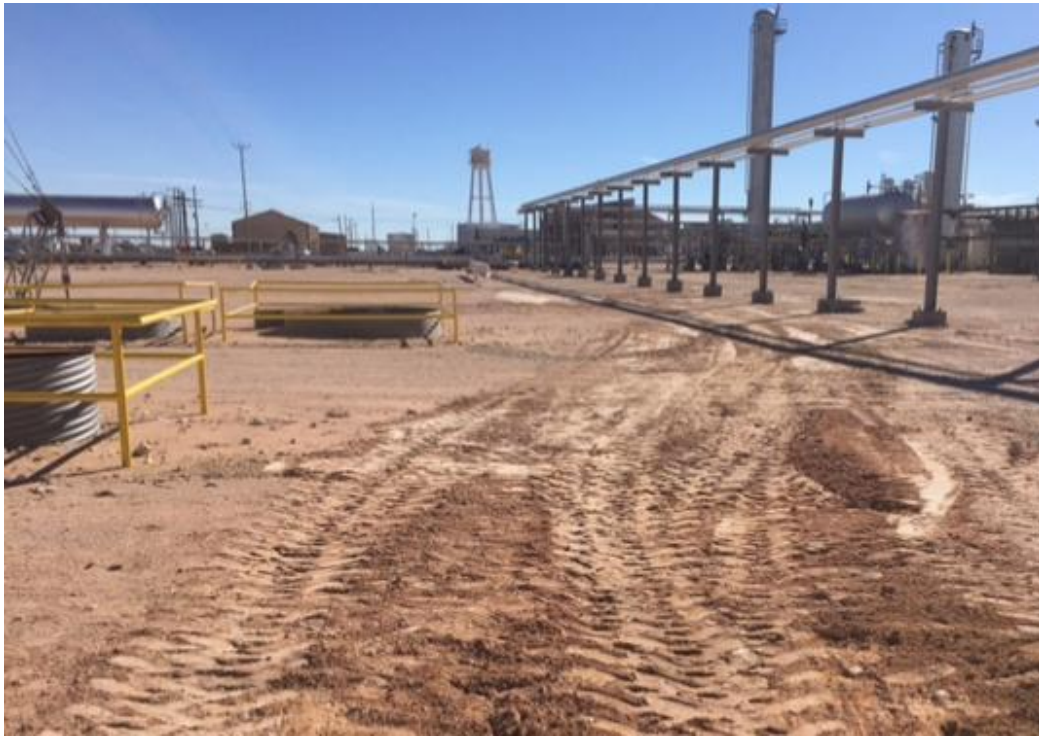
Photo 3: View of the excavated flow path, facing south. (32.17563, -103.17308)

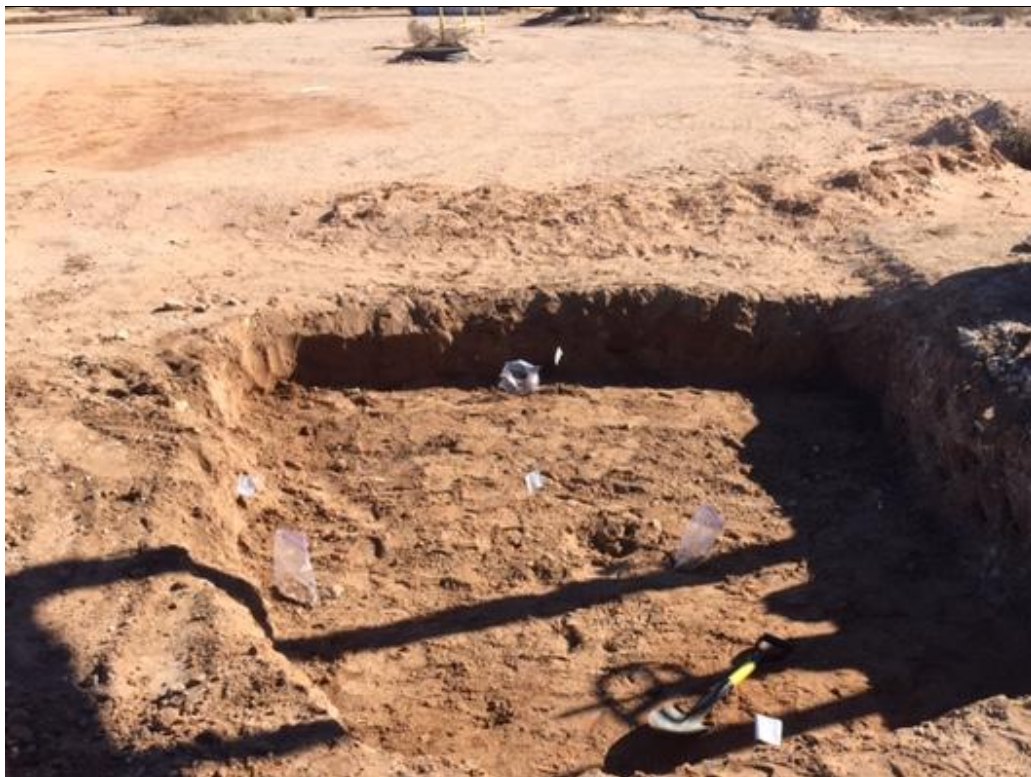
Photo 4: View the excavated area adjacent to the release point and sample locations, facing east. (32.17592, -103.17289)

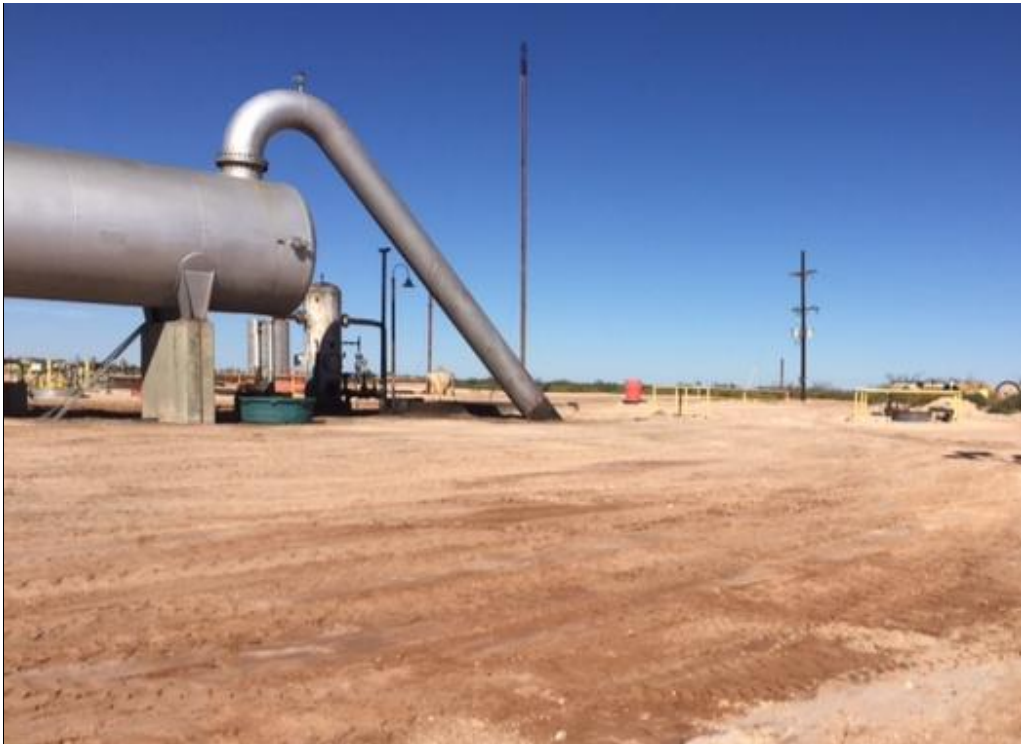
Photo 5: View of the release site after remediation activities, facing northeast. (32.17564, -103.17315)

Upon receiving laboratory analytical results from confirmation soil samples and NMOCD approval, the excavated area was backfilled with stockpiled soil represented by soil sample 11/18 Stockpile. Prior to backfilling, the excavated area in the northern portion of the release site adjacent to the vent pipe measured approximately 15 feet in length, 10 feet in width and 2 feet in depth. The excavated area in the southern portion of the release site measured approximately 200 feet in length, 8 feet in width and 4 to 6 inches in depth. Excavation backfill was compacted and graded to meet the needs of the facility.

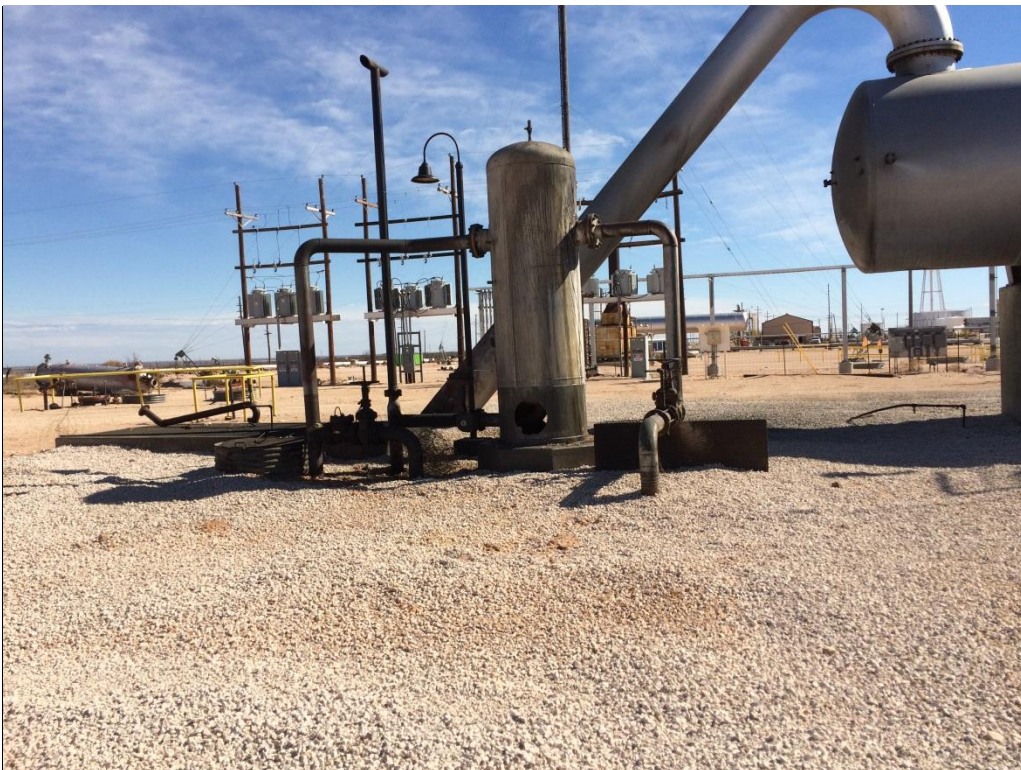
Photo 6: View of the release site after remediation activities, facing south. (32.17595, -103.17288)
