# CONOCOPHILLIPS

SEMU 95 SWD  
(1RP-3485)

## Termination Request

**RE: Termination Request  
ConocoPhillips SEMU 95 SWD (1RP-3485)  
UL/J sec. 23 T20S R37E  
API No. 30-025-06239**

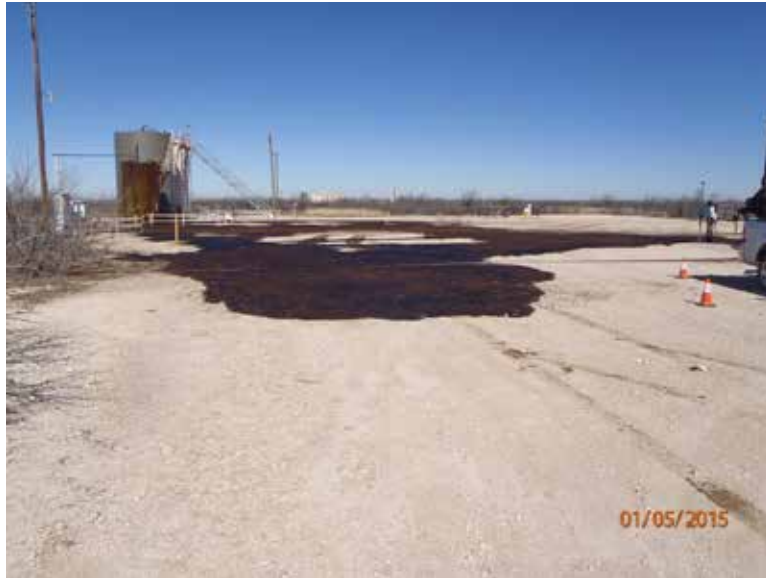
Initial release area, facing north

1/5/15

Basin personnel were on site to assess the release January 5<sup>th</sup>, 2015. The release was mapped and photographed and CoP scraped the release area to 6 inches bgs (Appendix B). On August 18<sup>th</sup>, 2015, three samples were collected at 6 inches bgs and sent to a commercial laboratory for analysis. Laboratory analysis of Point 1 returned a chloride value of non-detect, a Gasoline Range Organics (GRO) value of 15.7 mg/kg, a Diesel Range Organics (DRO) value of 244 mg/kg and BTEX values of non-detect except for Total Xylenes, which returned a value of 0.254 mg/kg. Laboratory analysis of Point 2 returned a chloride value of non-detect, a GRO value of 20.1 mg/kg, a DRO value of 439 mg/kg and BTEX values of non-detect except for Ethylbenzene which returned a value of 0.05 mg/kg and a Total Xylenes value of 0.217 mg/kg. Laboratory

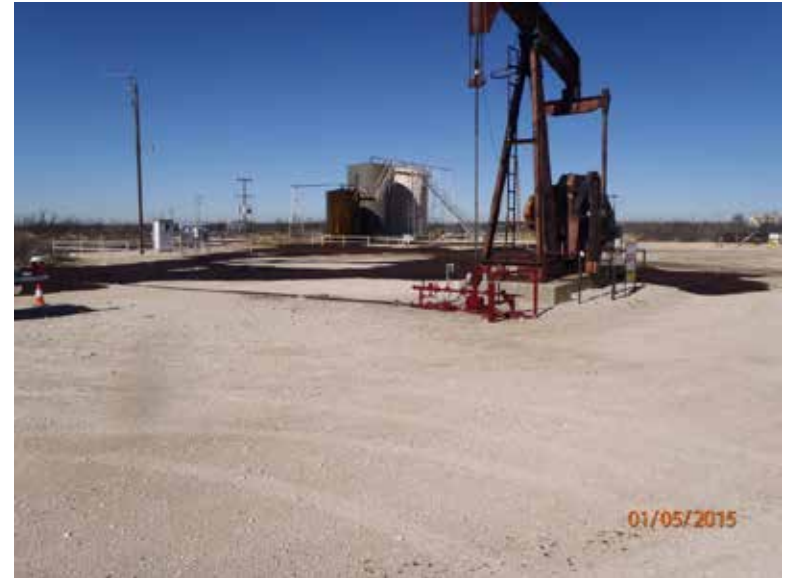
Initial release area, facing northwest

1/5/15

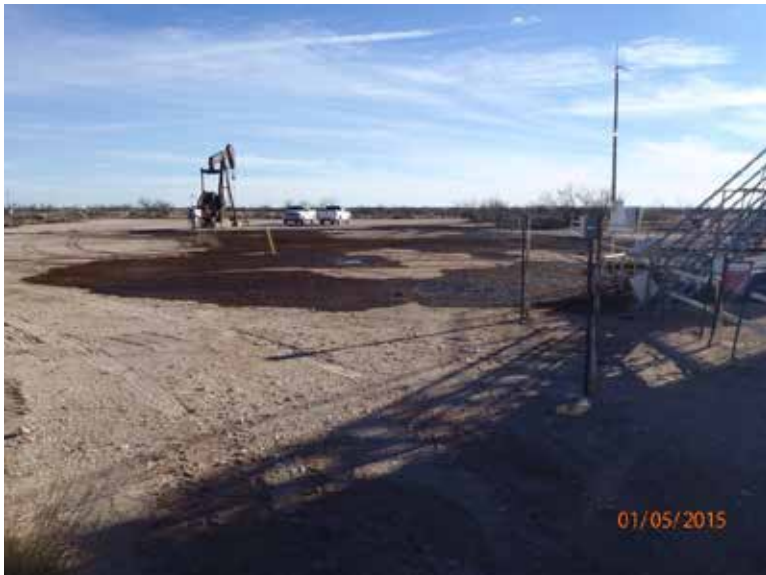
Initial release area, facing south

1/5/15

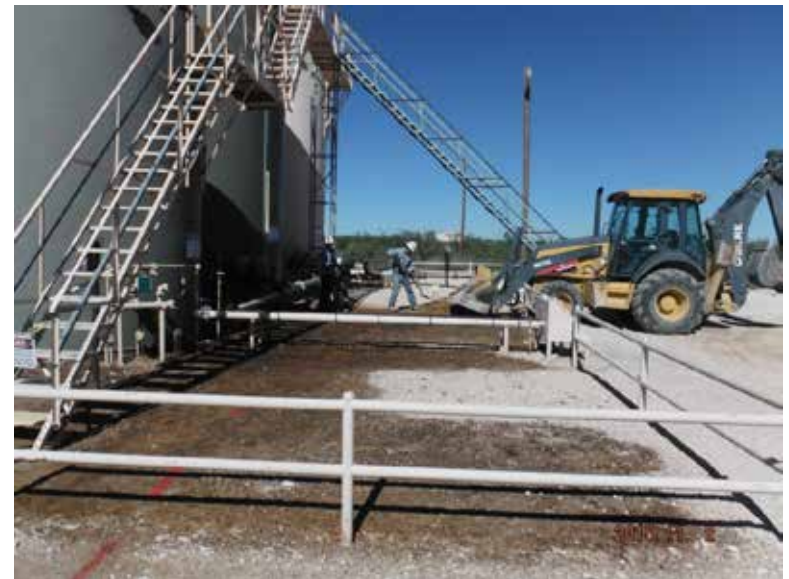
Hand digging, facing north

11/2/15

CAP activities began on November 2<sup>nd</sup>, 2015 and the area around Point 3 was scraped to a depth of 1 ft bgs and approximately 100 yards was exported to an NMOCD approved facility for disposal. Once the scrape was complete 3 discrete samples were obtained from the base of the scrape and sent to a commercial laboratory for analysis (Appendix B). Pt.1 returned a chloride result of 32 mg/kg, GRO/DRO of <10 mg/kg and BTEX of <0.3 mg/kg. Pt.2 returned a chloride result of 32 mg/kg, GRO/DRO of <10 mg/kg and BTEX of <0.3 mg/kg. Pt.3 returned a chloride result of 32 mg/kg, GRO/DRO of <10 mg/kg and BTEX of <0.3 mg/kg. Basin requested backfill approval from NMOCD and BLM on November, 9th 2015 and received approval from NMOCD and BLM on the same day. Approximately 100 yards caliche was imported on site, a sample was obtained from the imported caliche and sent to a commercial laboratory for analysis (Appendix B). The imported sample returned a chloride result of 160 mg/kg. Site was then backfilled with imported material.

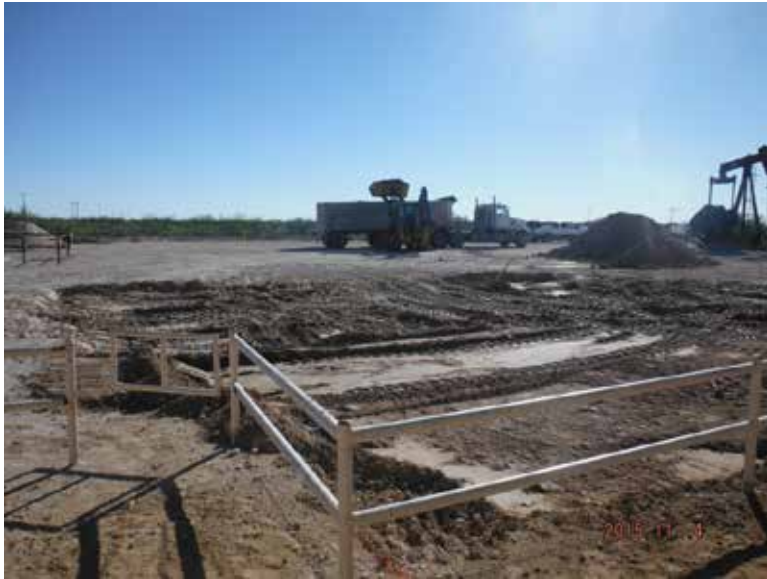
Exporting soil, facing south east

11/4/15

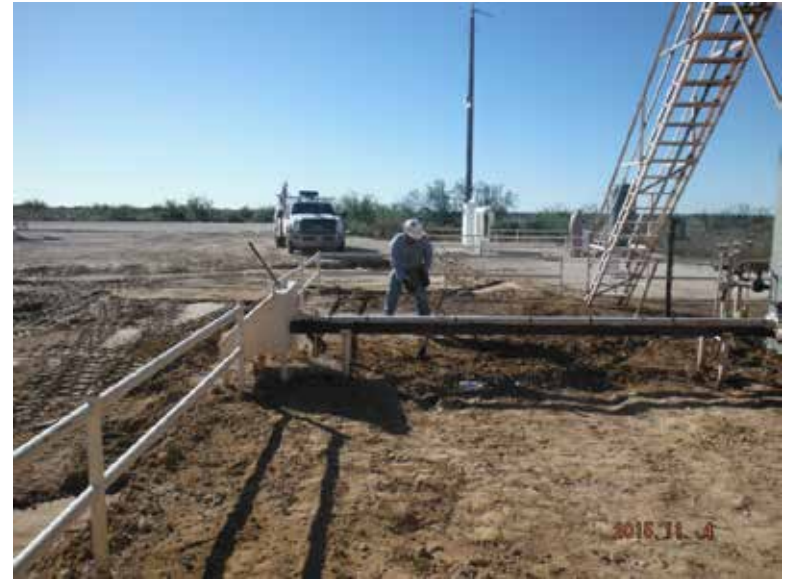
Hand digging, facing south

11/4/15

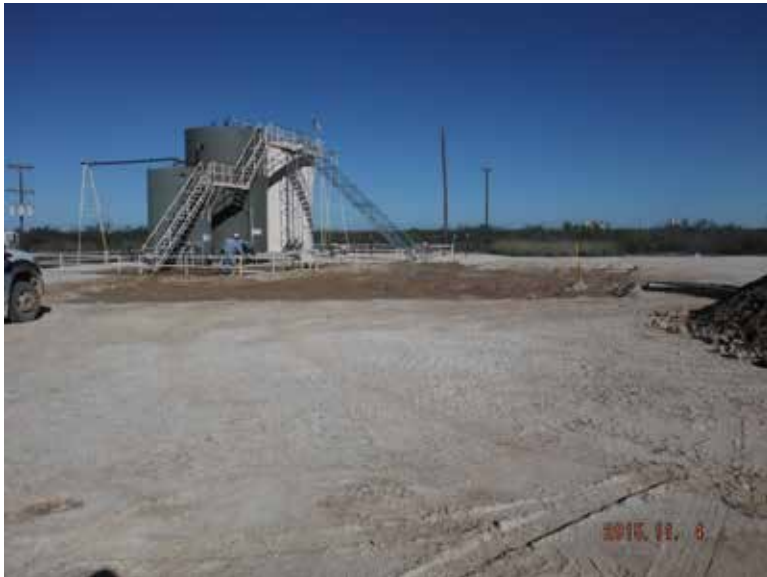
Excavation, facing north west

11/4/15

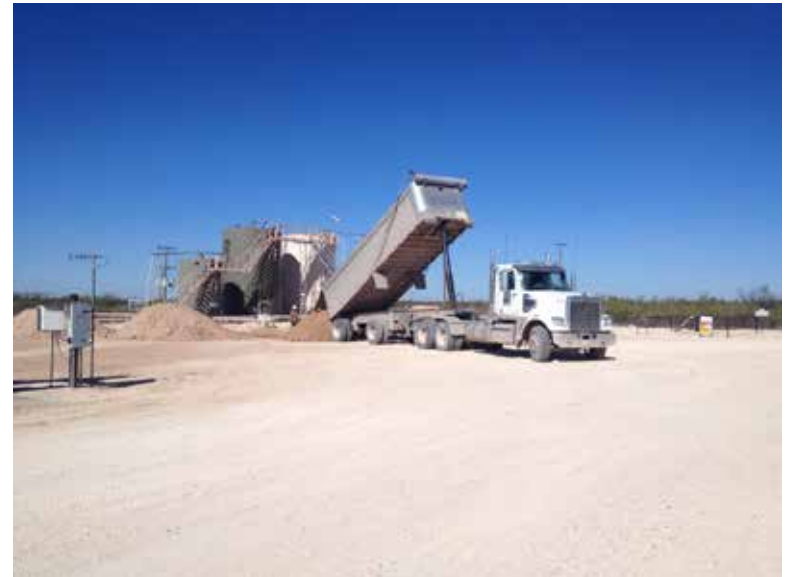
Importing soil, facing north west

11/9/15

All excavated soils will be taken to a NMOCD approved facility for disposal. Clean caliche will be imported to the site to serve as backfill. A sample of the imported caliche will be taken to a commercial laboratory to confirm that the chloride reading is below regulatory standards. The scrape will be backfilled with clean, imported caliche and contoured to the surrounding location.

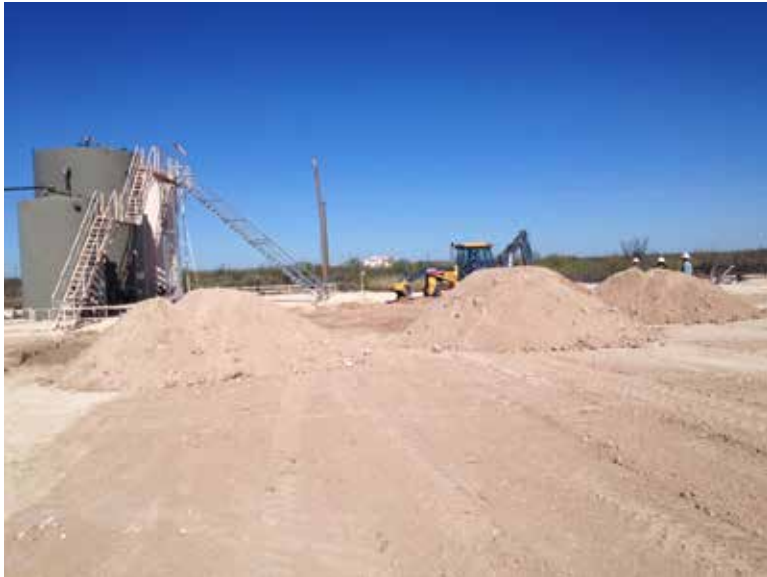
Backfilling site, facing north

11/9/15

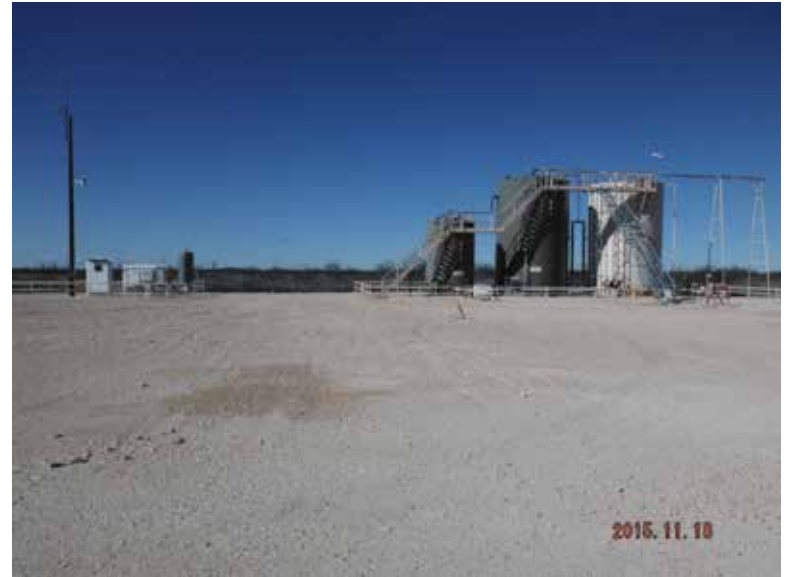
Site complete, facing west

11/18/15

Given that the CAP activities have been completed as approved by NMOCD and BLM, Conoco Phillips respectfully request 'remediation termination' and site closure. The final C-141 can be found in Appendix D.
