RE: Final Closure Report
Vanguard – Elliott B Federal
UL-I, Section 6, Township 22 South, Range 37 East
Lea County, New Mexico
NMOCD Reference # 1RP 4177

The following *Final Closure Report* serves as a condensed update on closure activities for the above referenced Site.

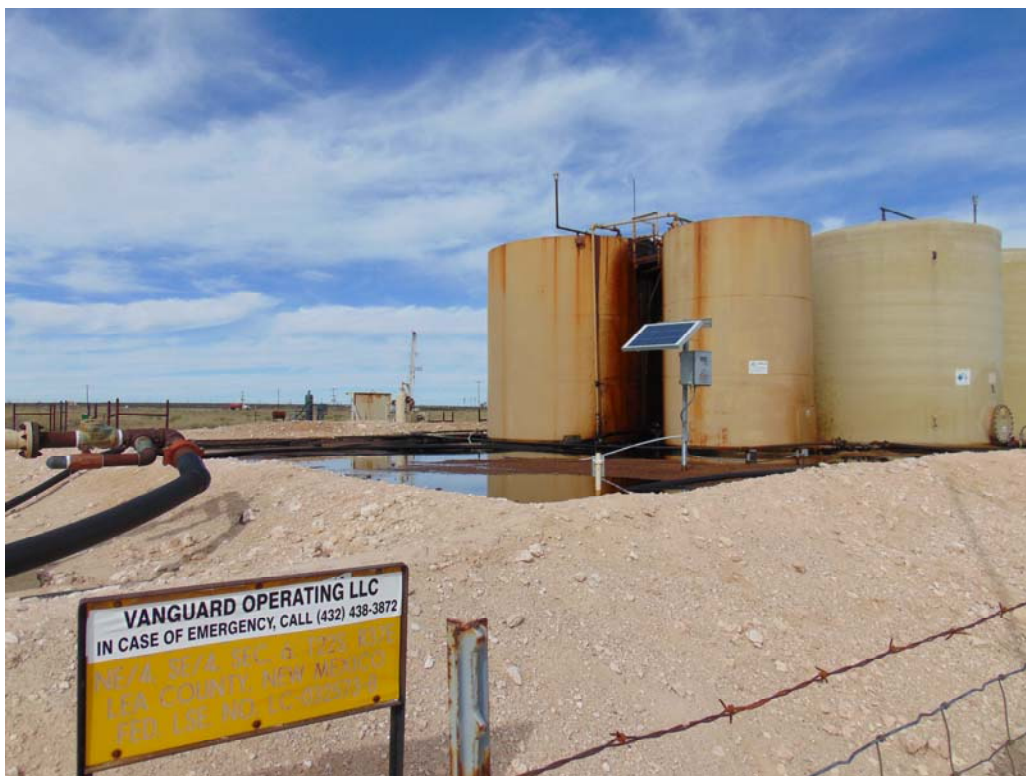
Photograph #1 – Release with in containment berm.

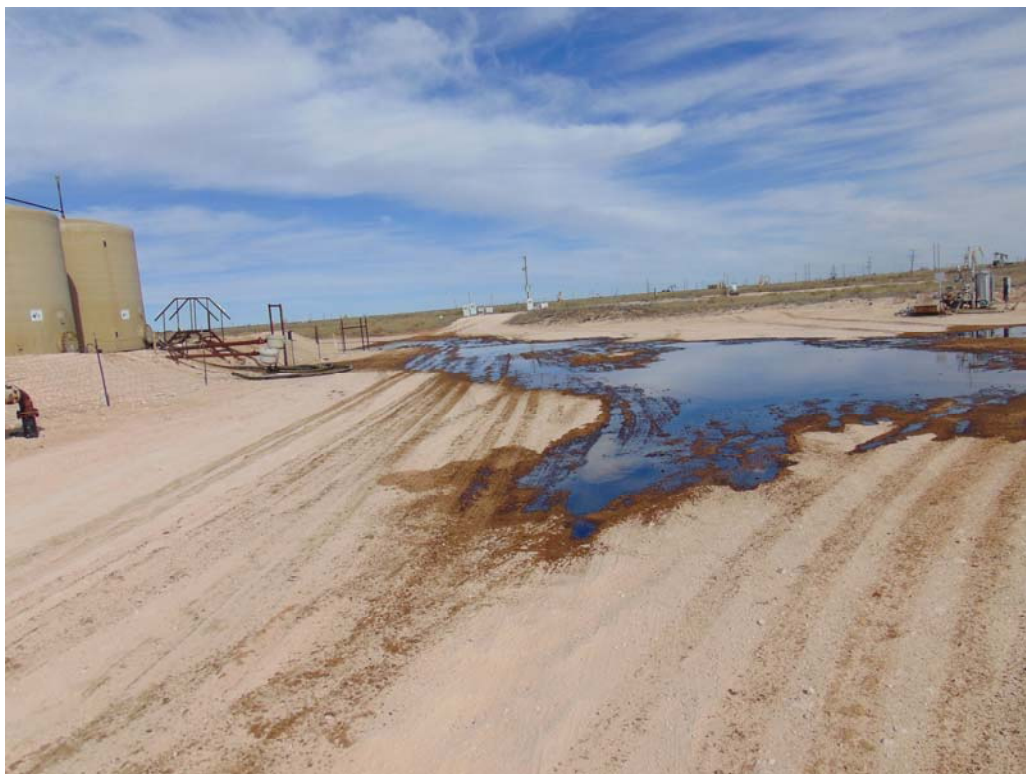
Photograph #2 – Northerly view over release area.

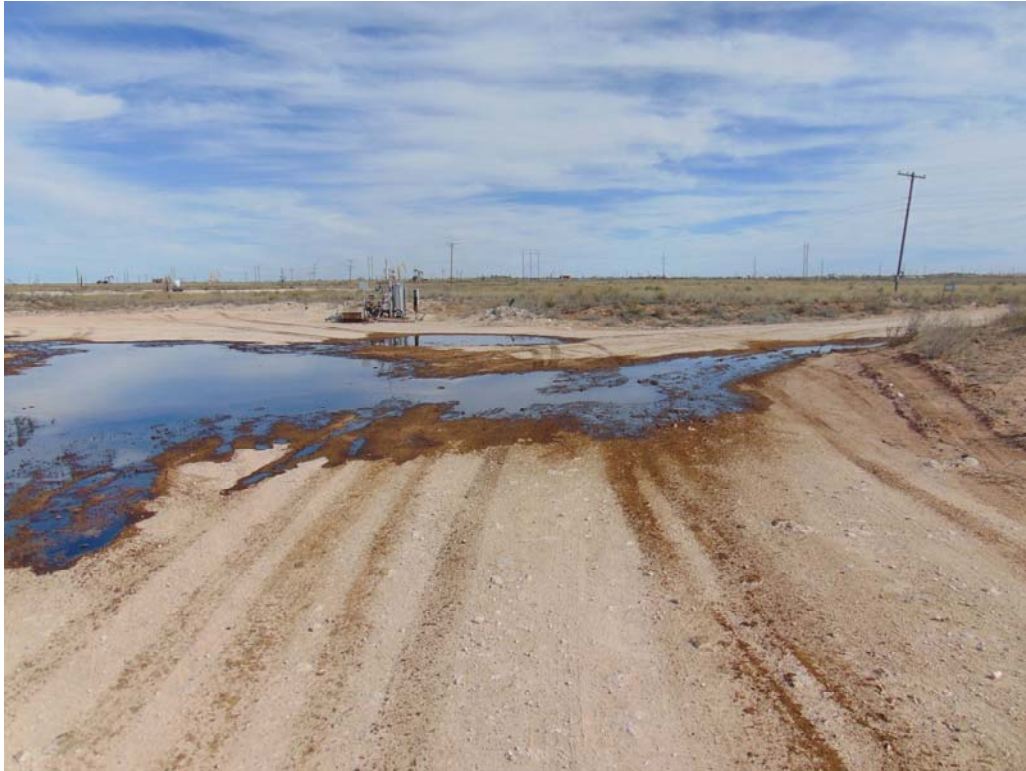
Photograph #3 – Looking north across release area.

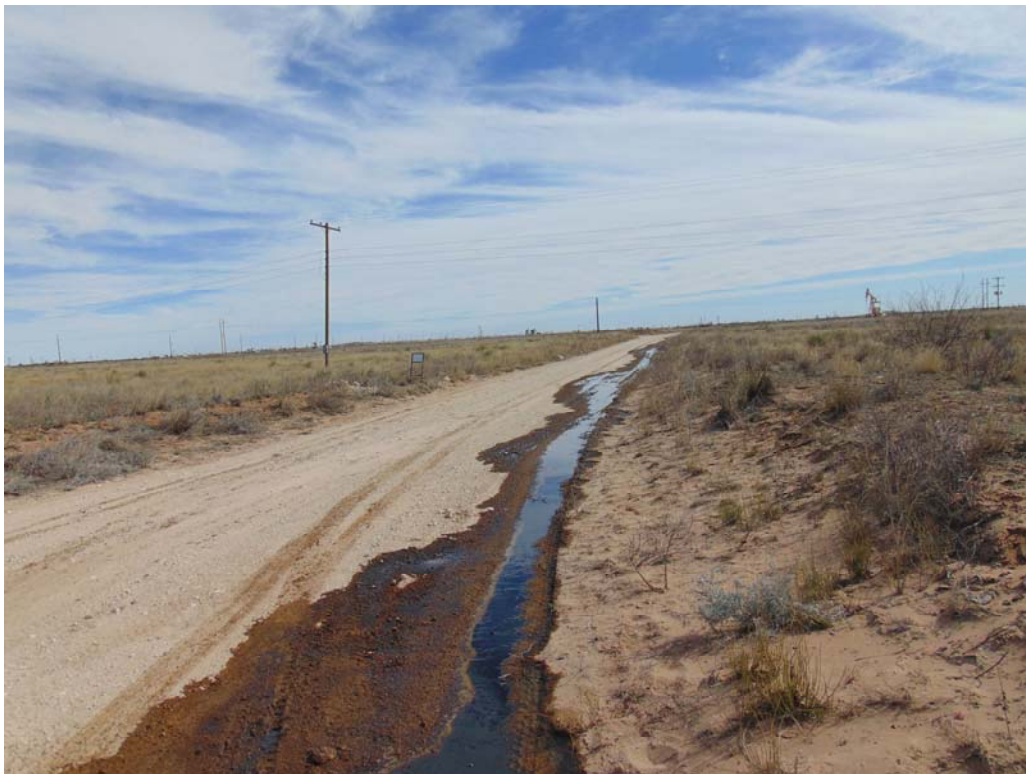
Photograph #4 – Looking east across release area.

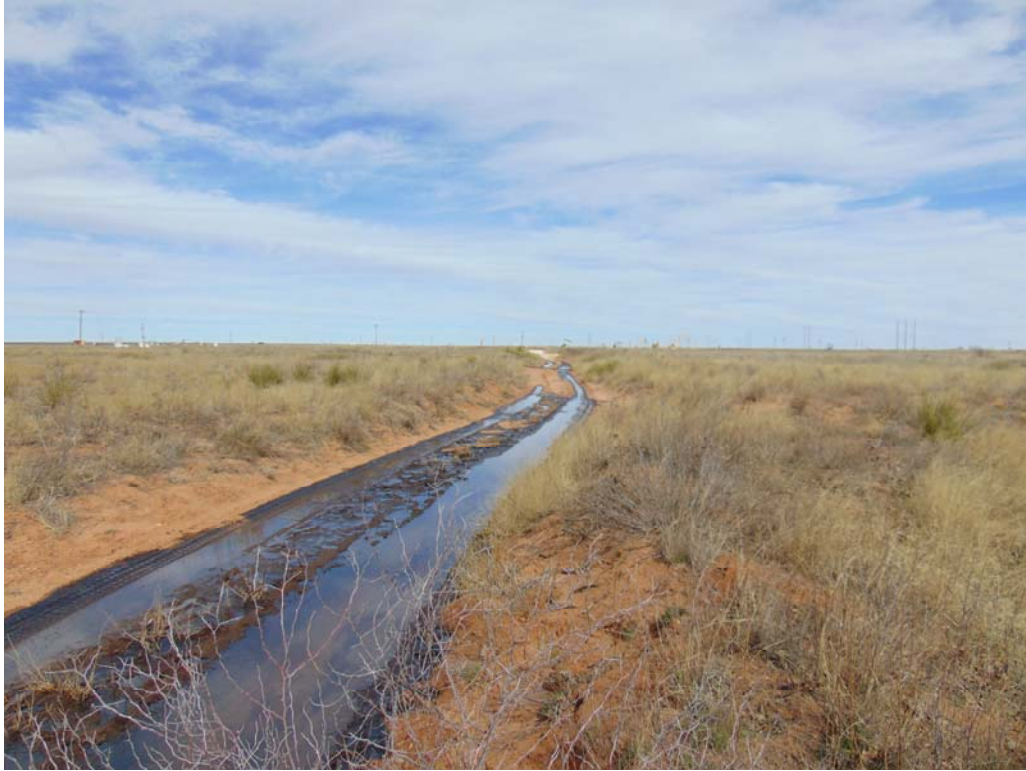
Photograph #5 – Looking south across release area.

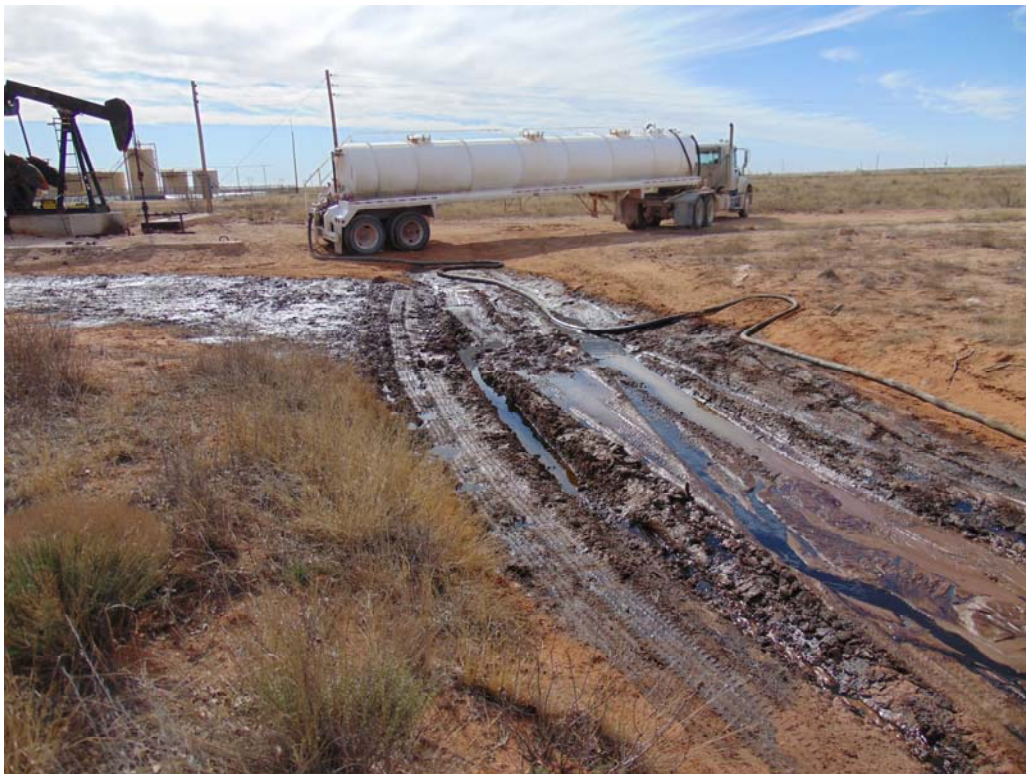
Photograph #6 – Looking south across release area.

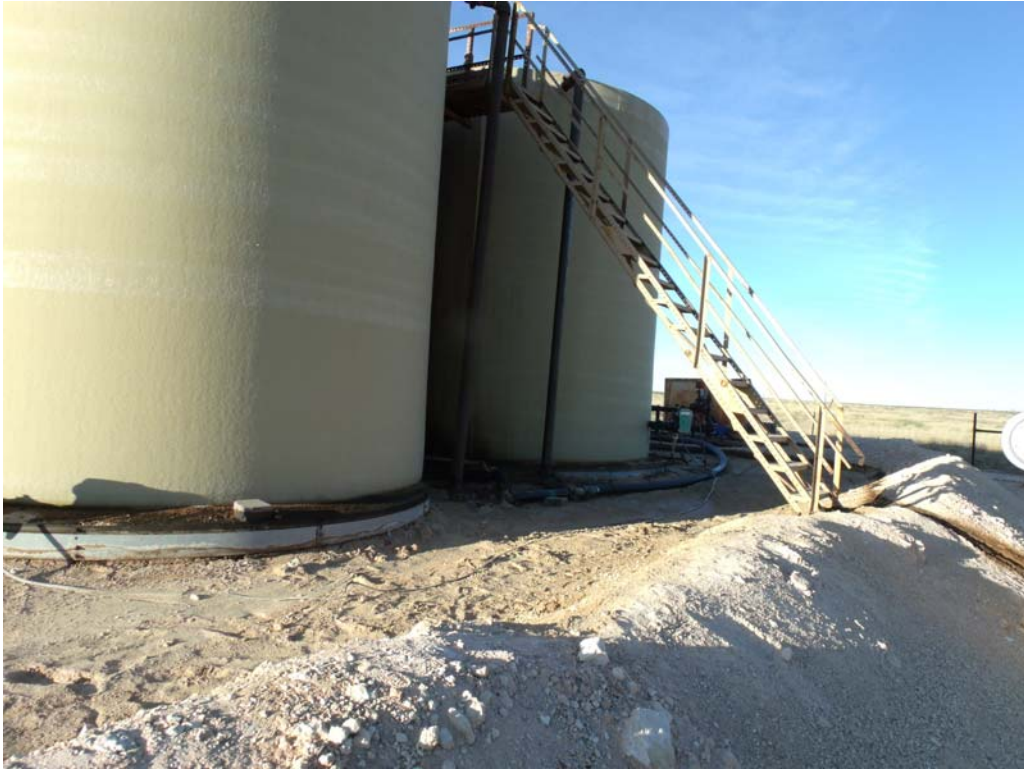
Photograph #7 – Excavated

From February 8 – 18, 2016 the release area was excavated. The area within the berm and on the pad was scraped up. The release area on the lease road was excavated to a depth of approximately one (1) foot bgs, where samples SP1 – SP3 were collected. The southern end of the lease road release area was excavated to a depth of approximately three (3) feet bgs, where sample SP4 was collected. All excavated soil has been placed on plastic and will be hauled to a state approved facility for disposal.

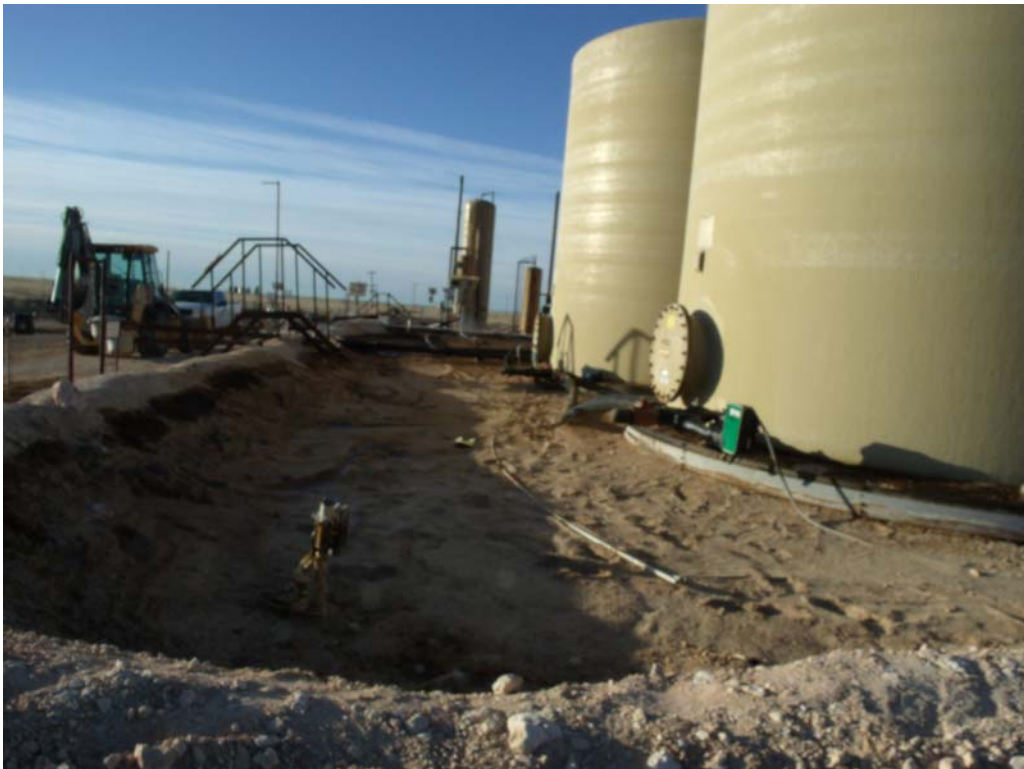
Photograph #8 – Excavated

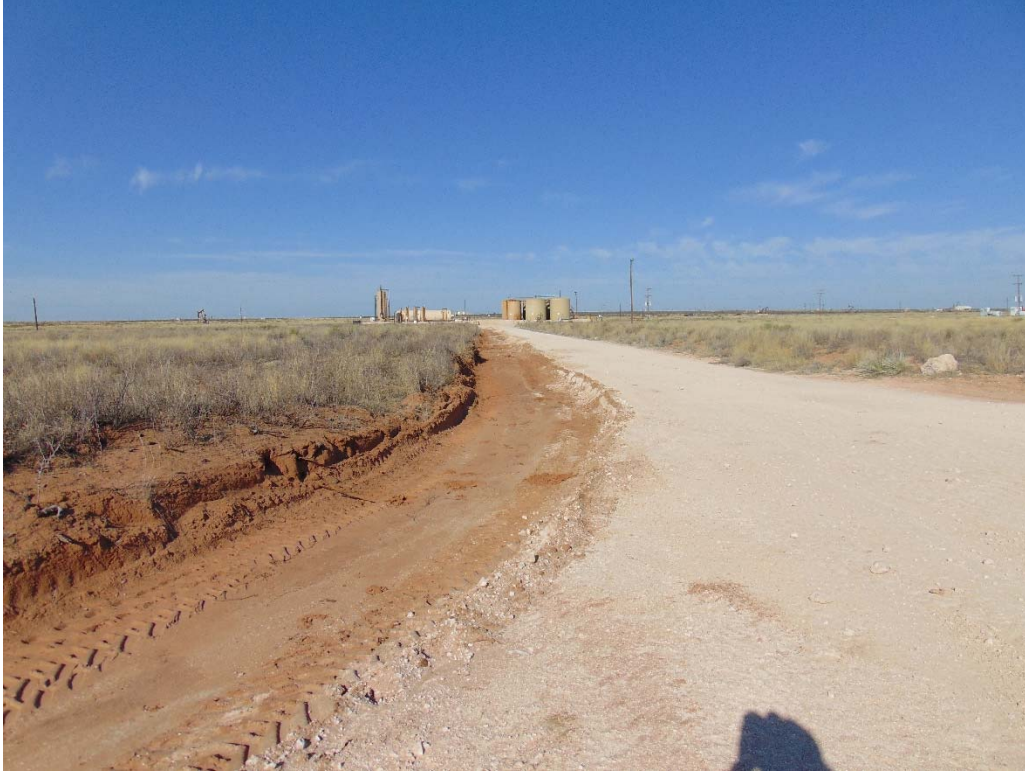
Photograph #9 – Excavated

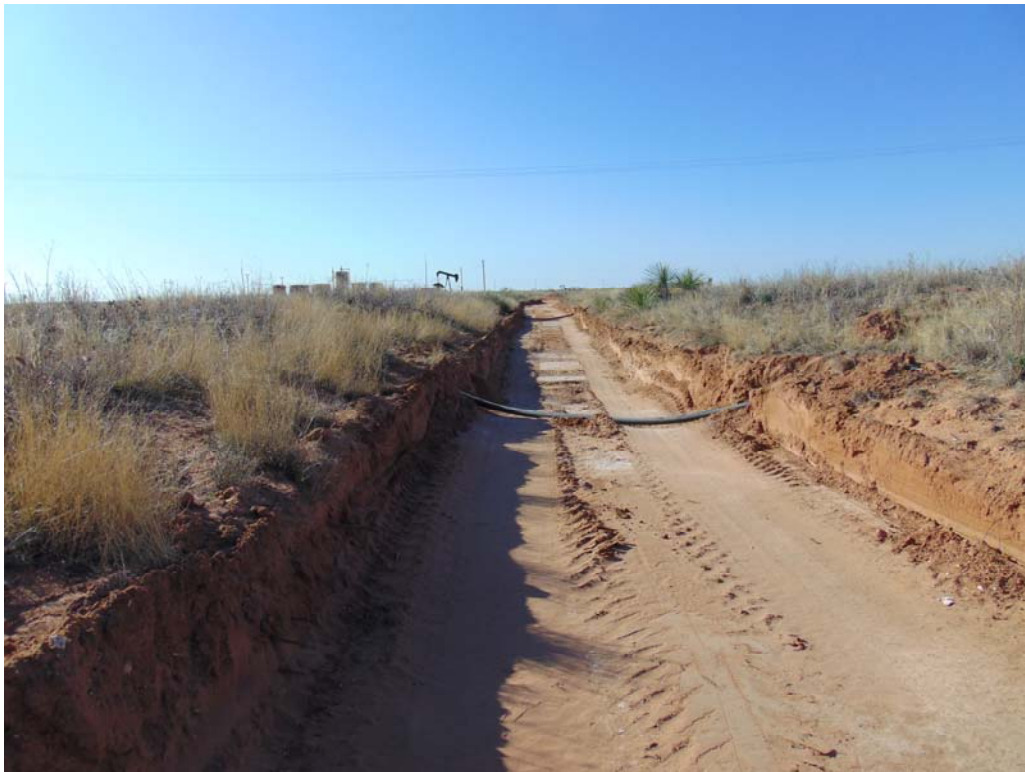
Photograph #10 – Excavated

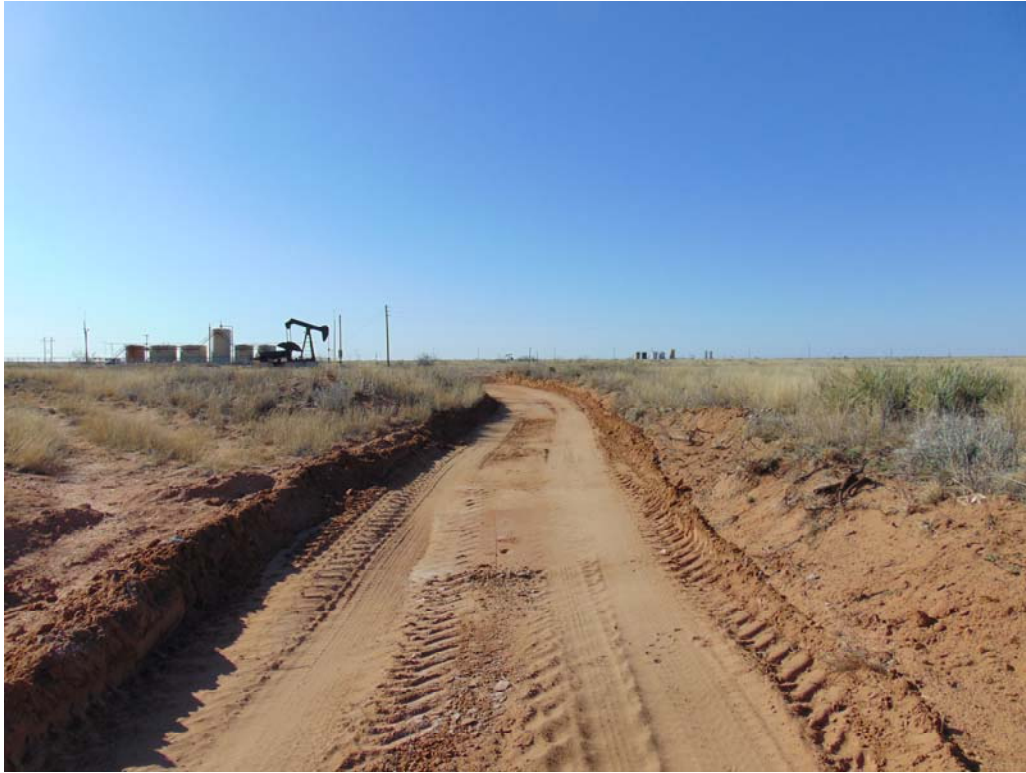
Photograph #11 – Excavated

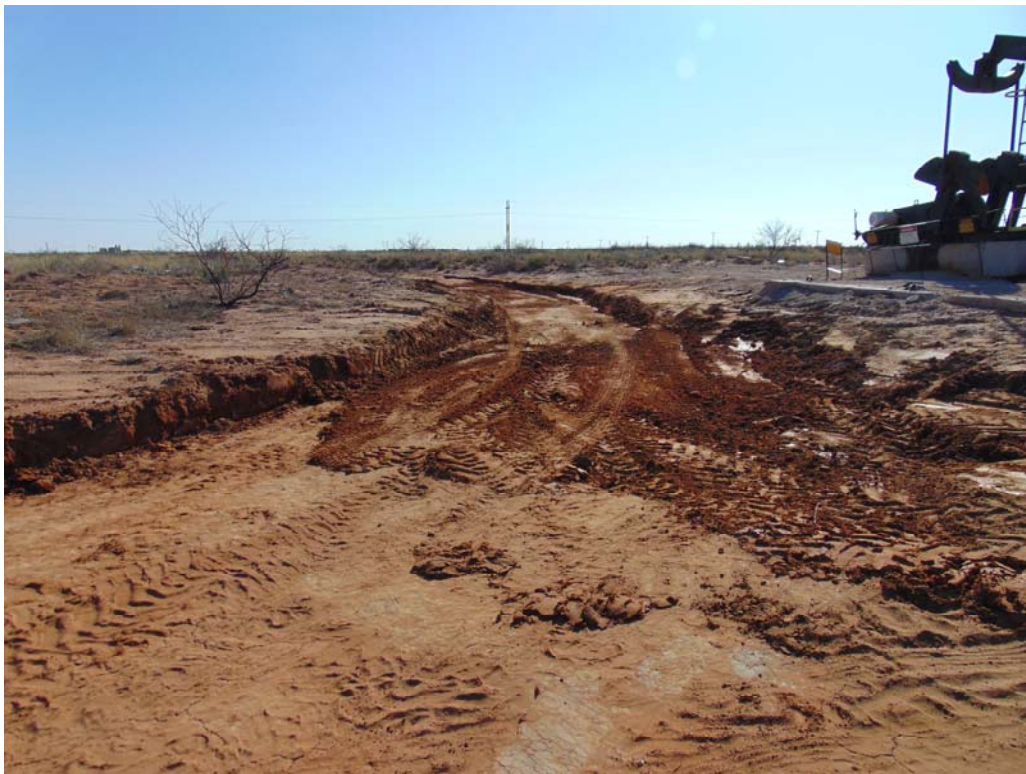
Photograph #12 – Excavated

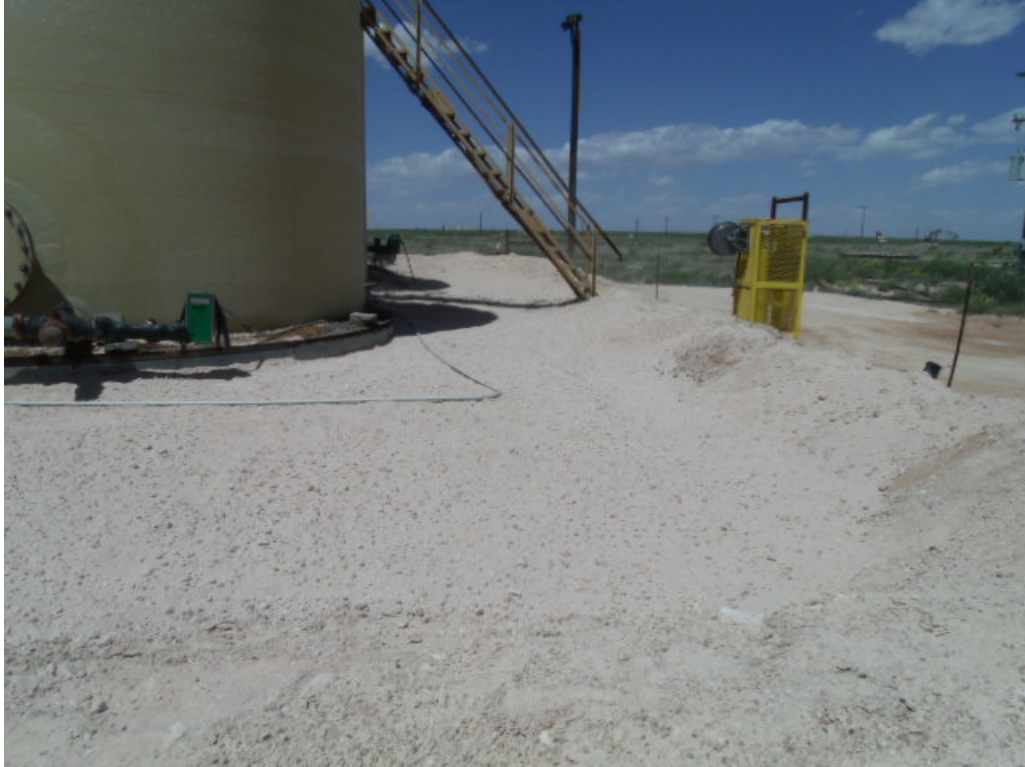
Photograph #13 – Backfilled

Based on laboratory analytical data, and with NMOCD approval, the excavation has been backfilled with clean soil. All soil is free of rocks, clumps, or deleterious material.

Backfilling continued until the entire excavation was closed. Upon completion of backfill activities, the entire disturbed area was contoured to blend with existing pad and lease road area and protected against wind/water erosion.

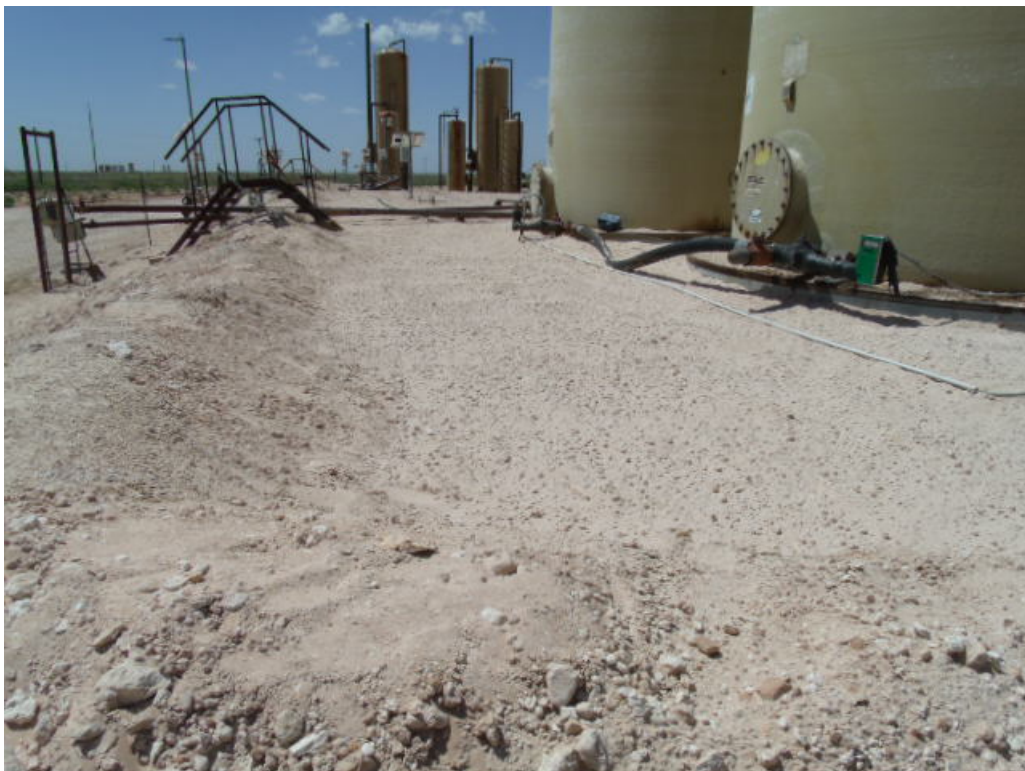
Photograph #14 – Backfilled

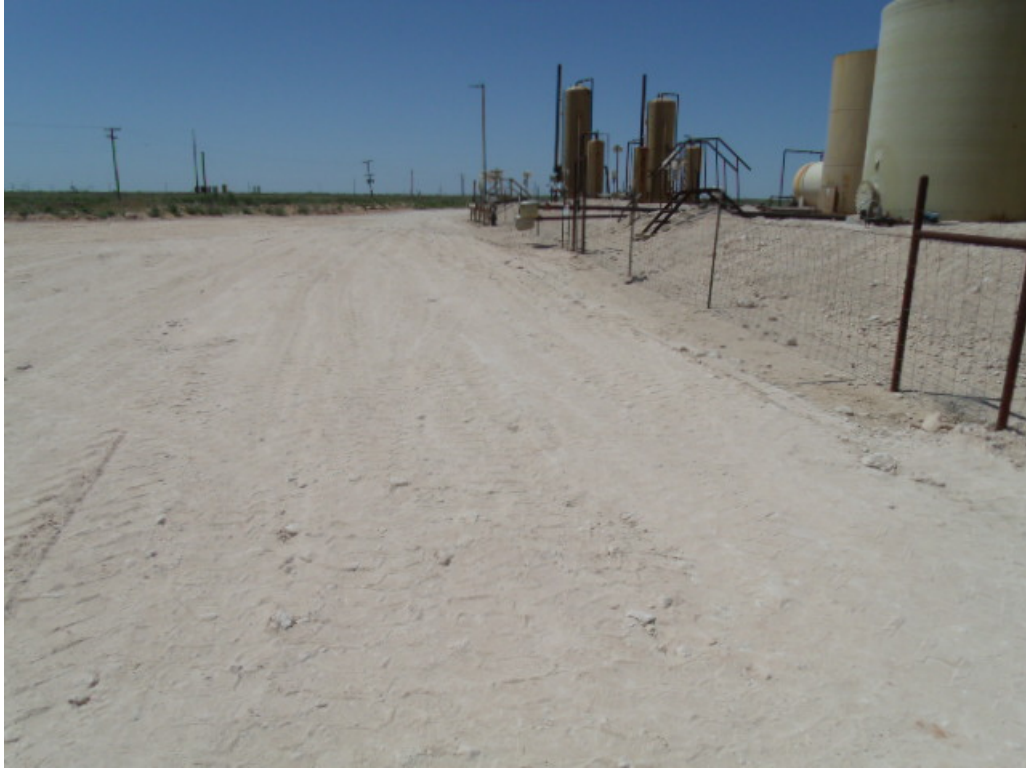
Photograph #15 – Backfilled

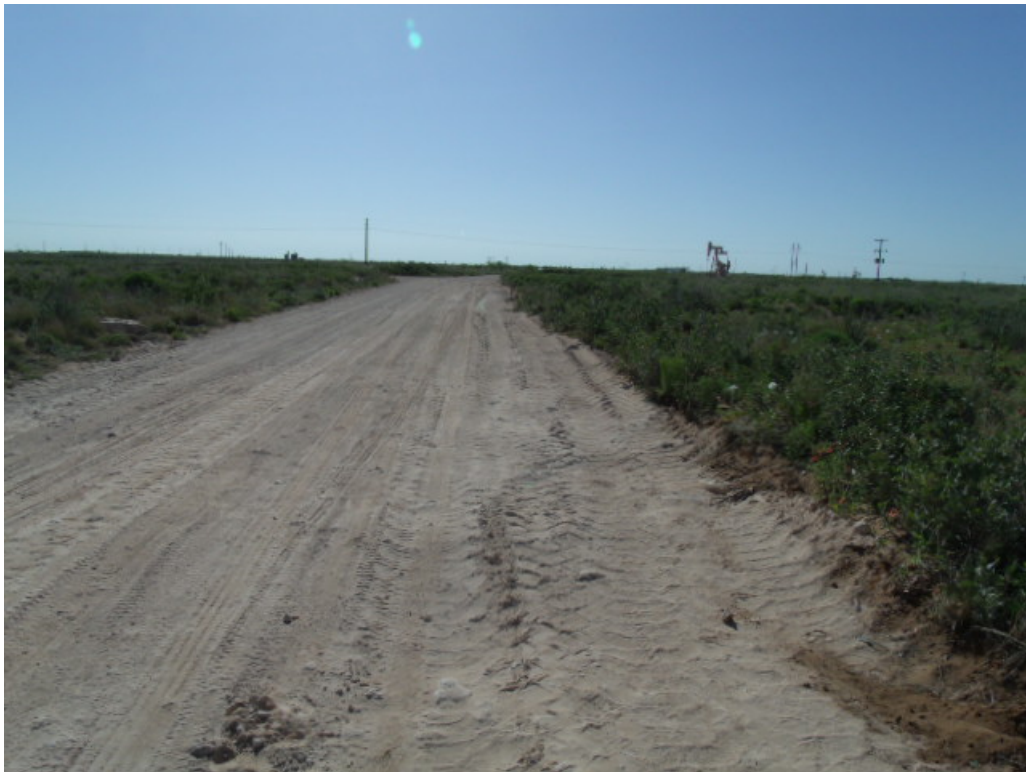
Photograph #16 – Backfilled

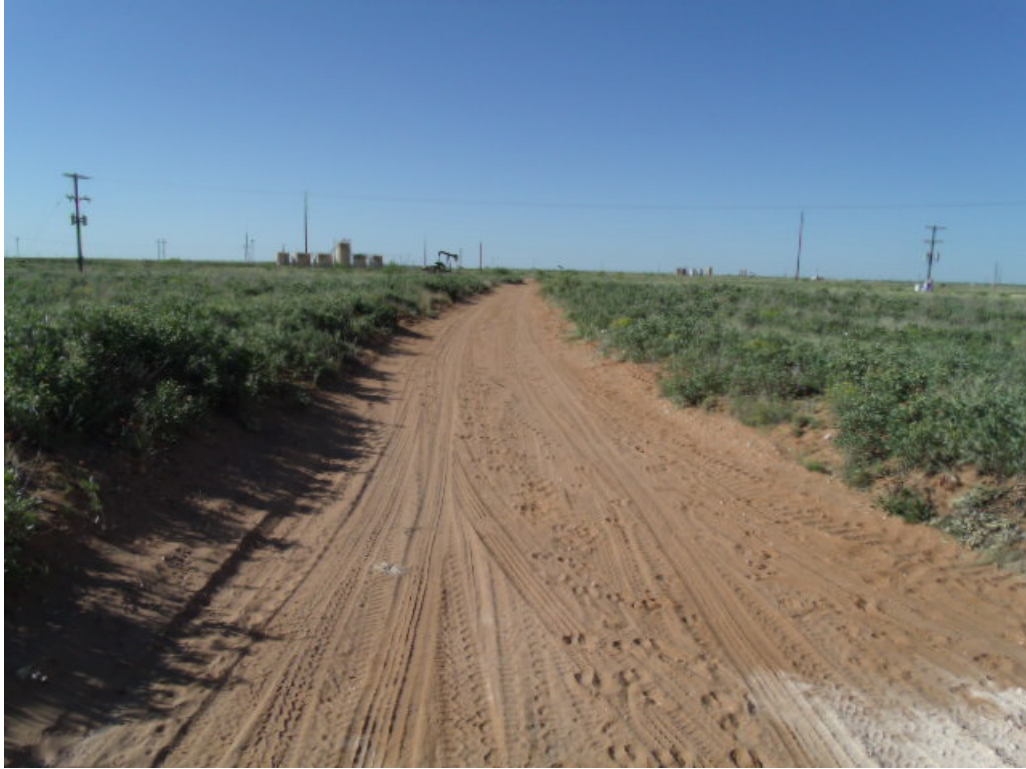
Photograph #17 – Backfilled

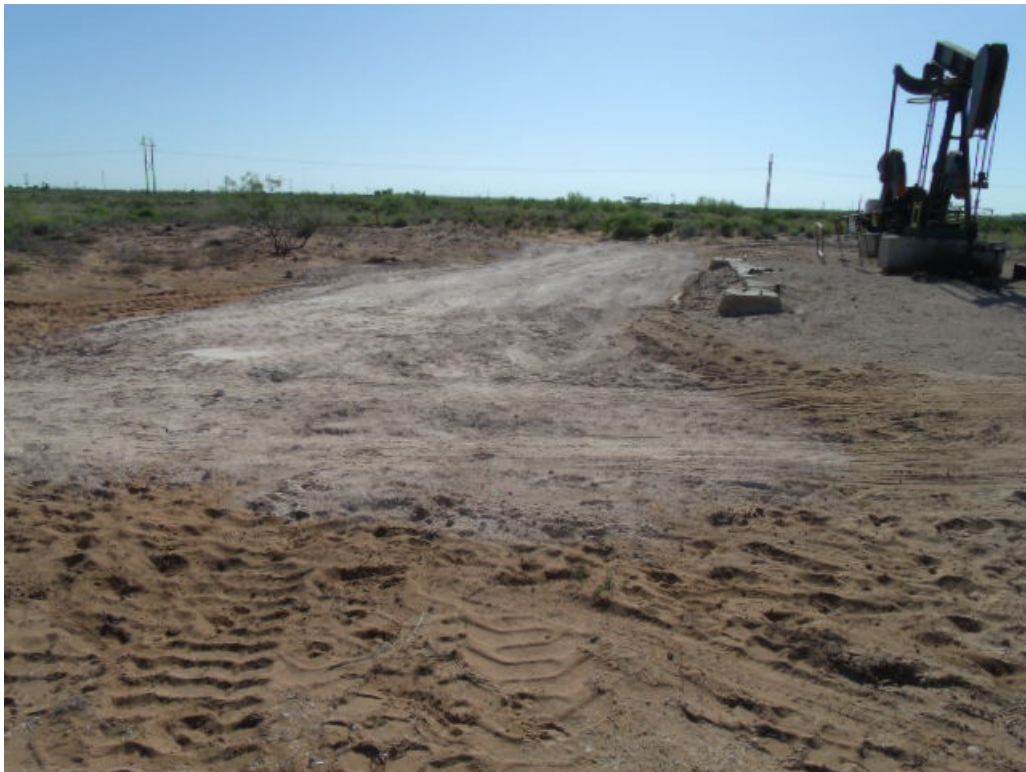
Photograph #18 – Backfilled
