RE: Final Closure Report
Vanguard – Elliott B Federal
UL-I, Section 6, Township 22 South, Range 37 East
Lea County, New Mexico
NMOCD Reference # 1RP 4177

The following *Final Closure Report* serves as a condensed update on closure activities for the above referenced Site.

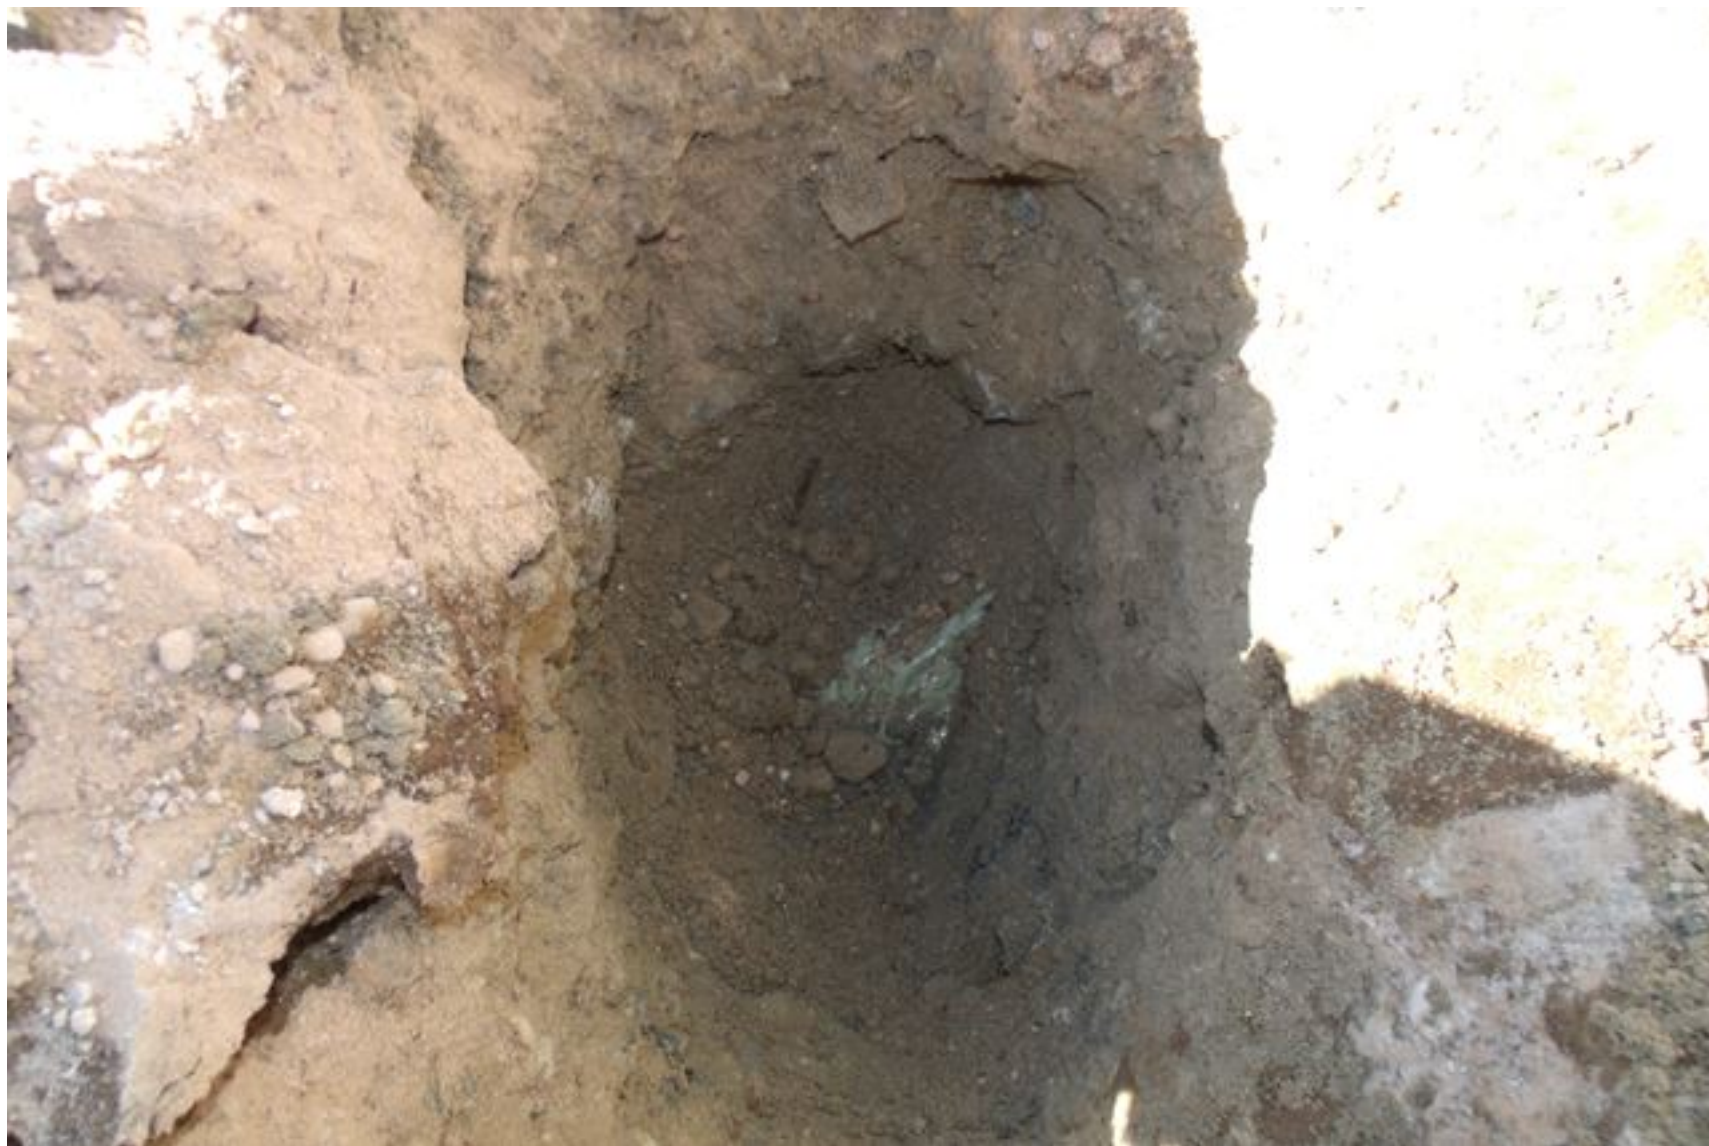
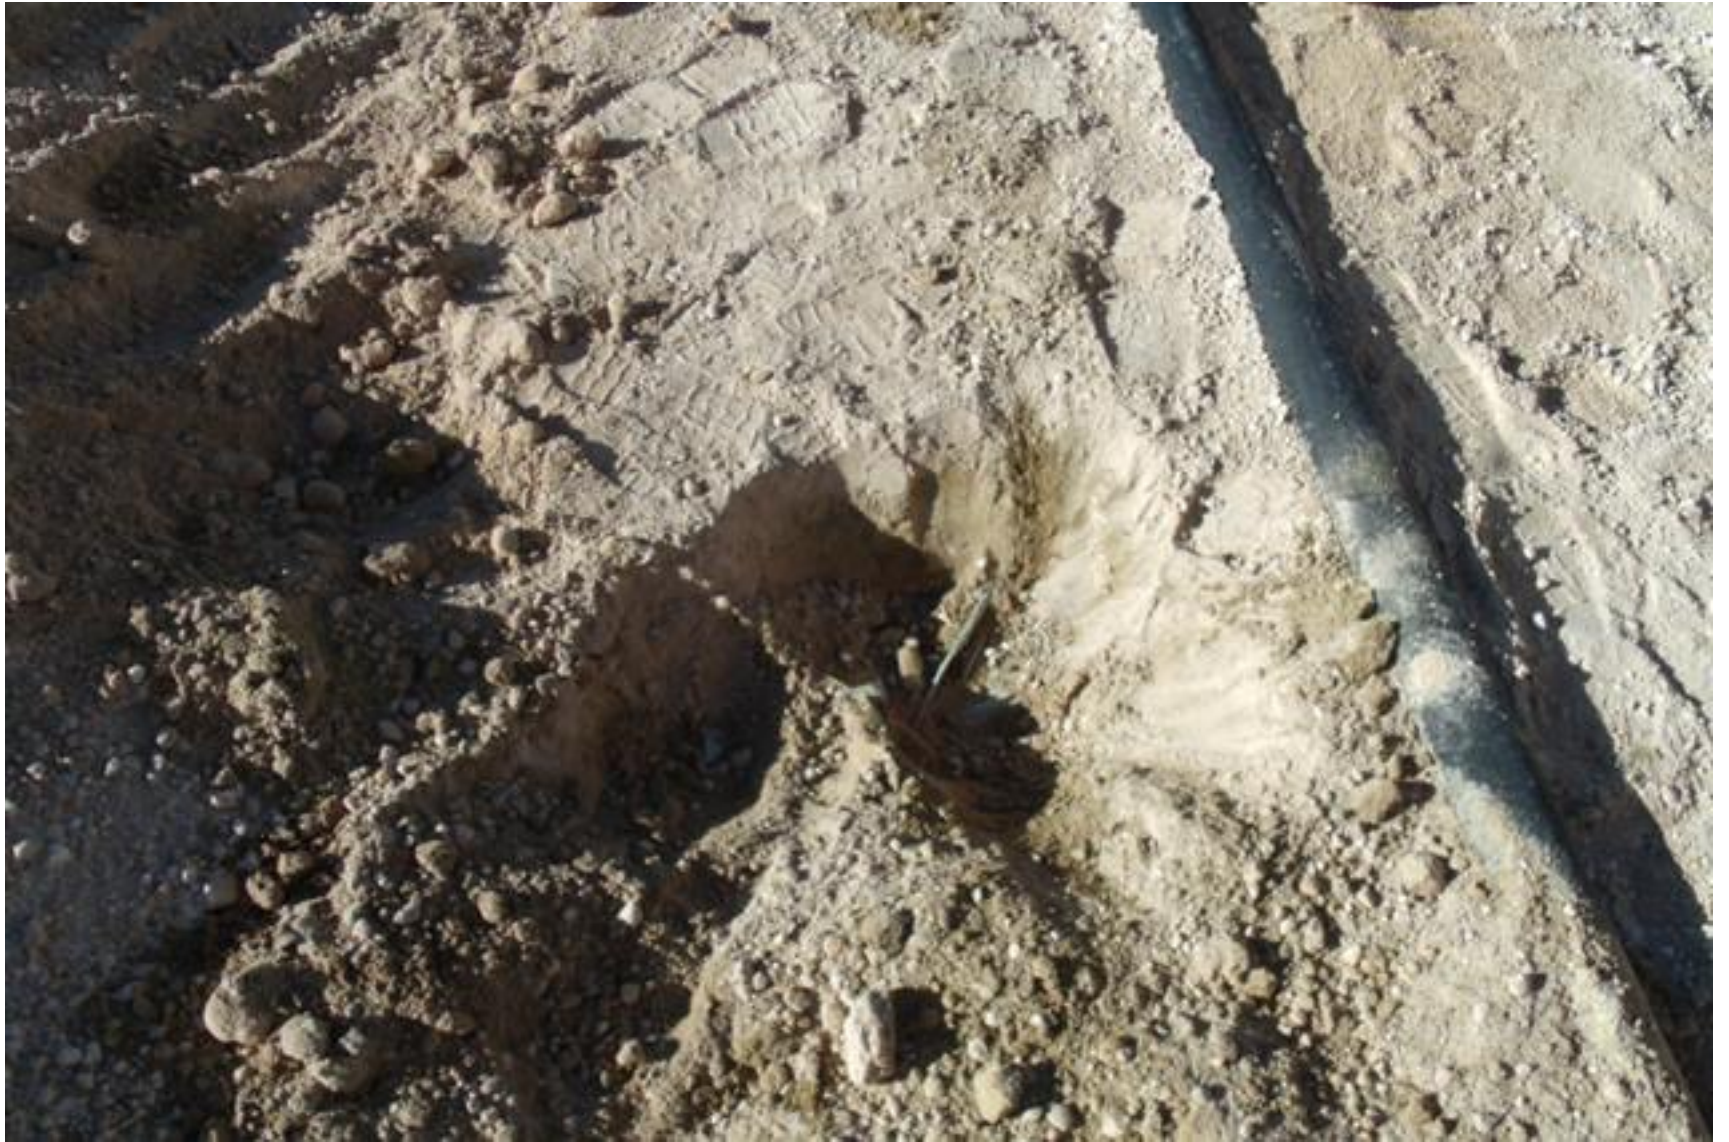
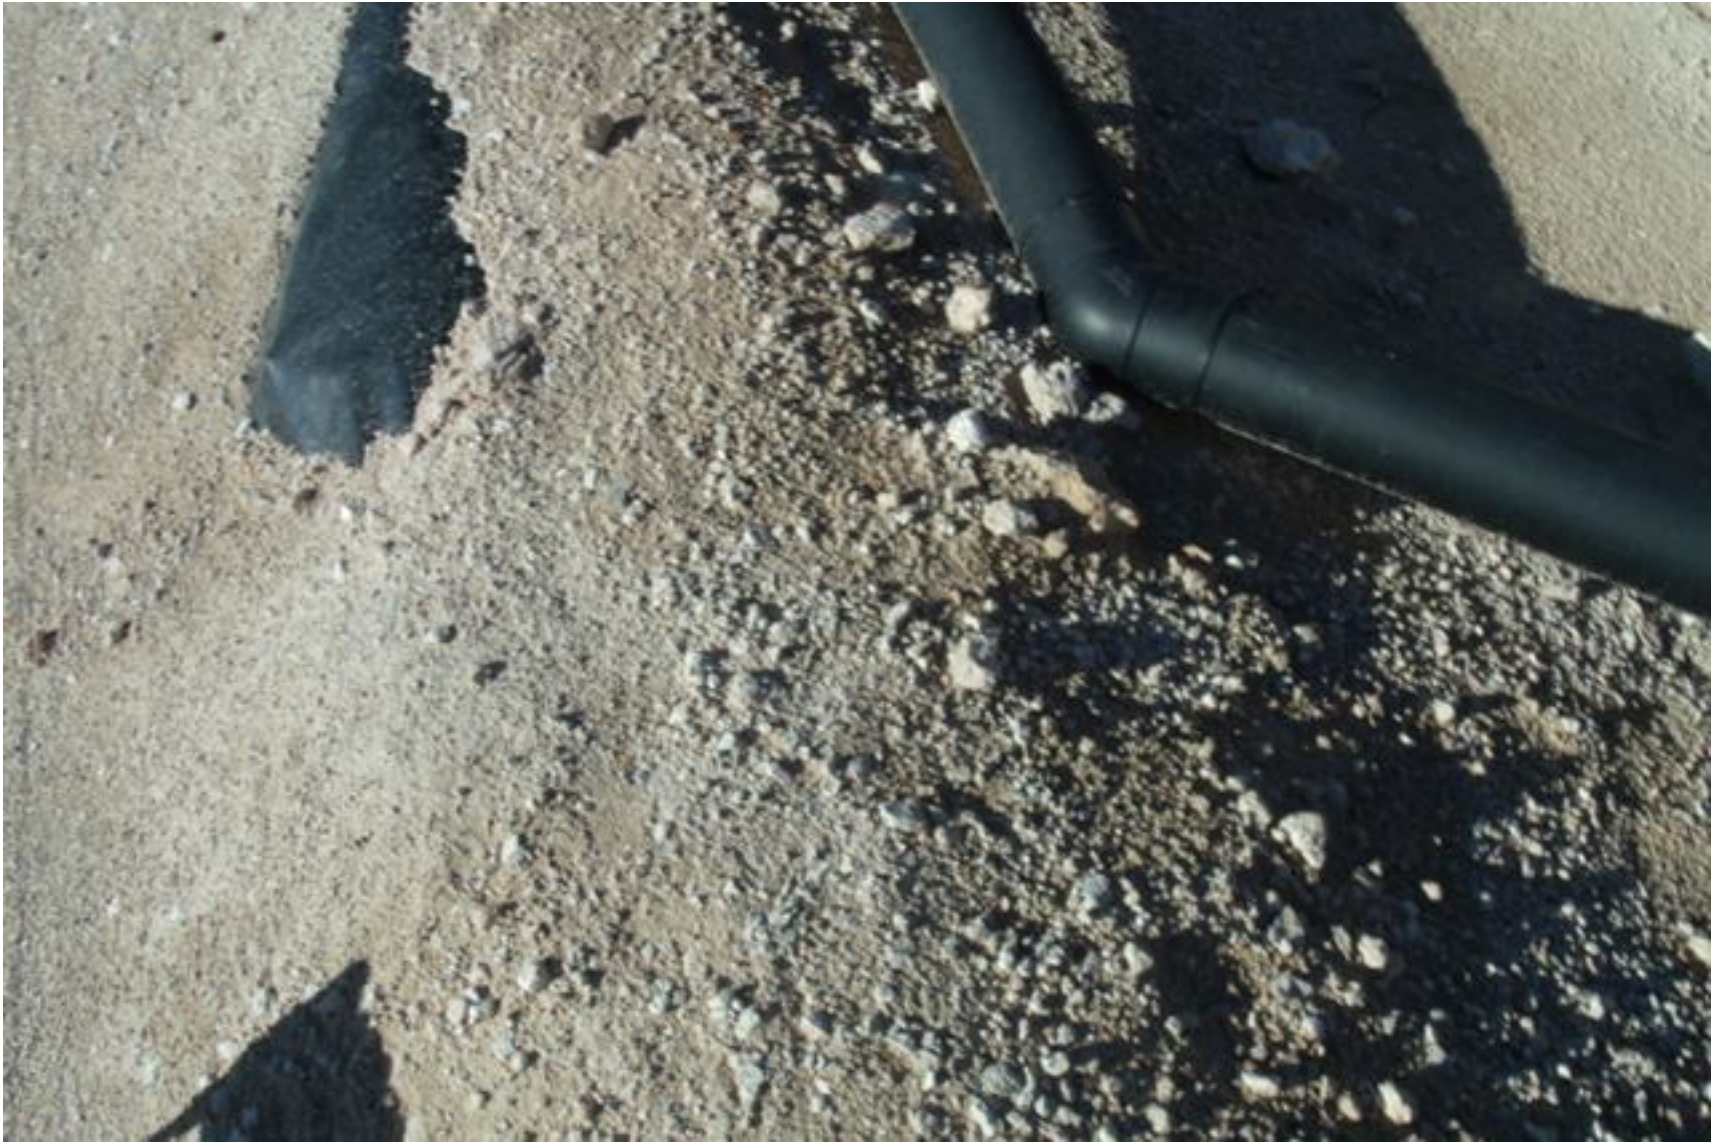
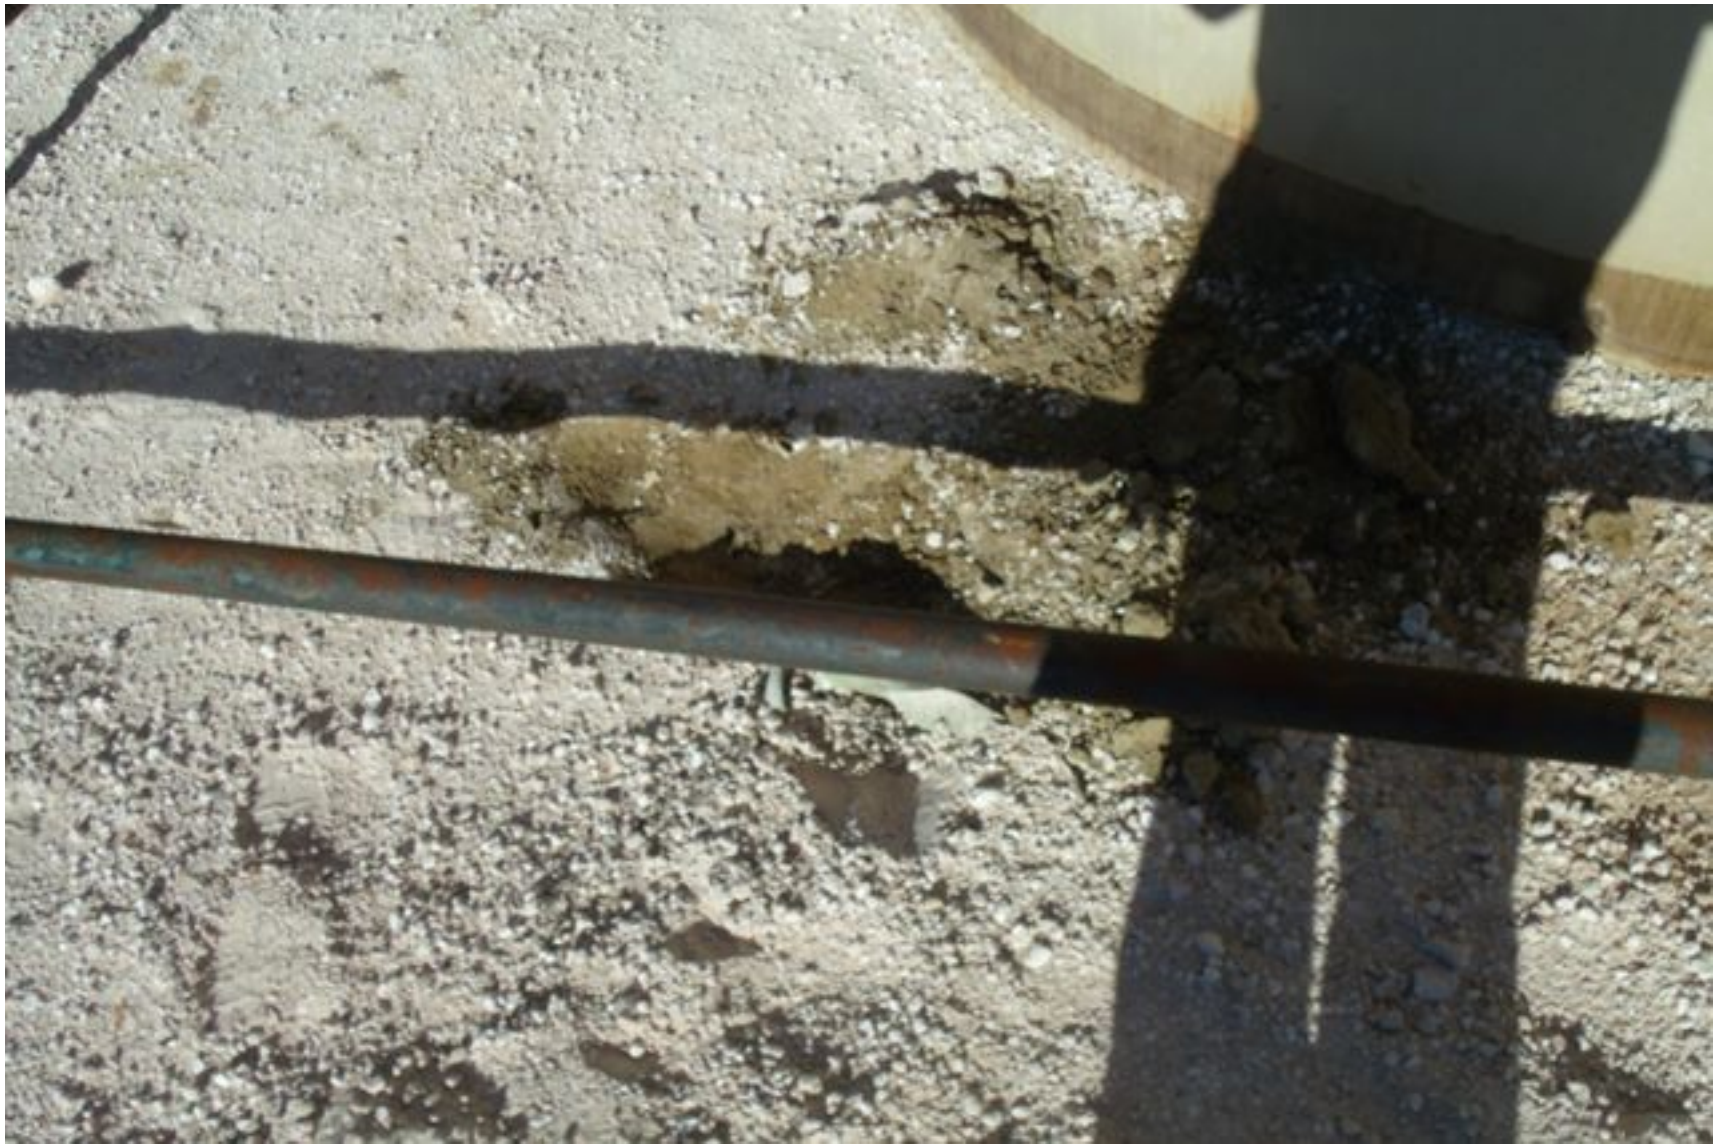
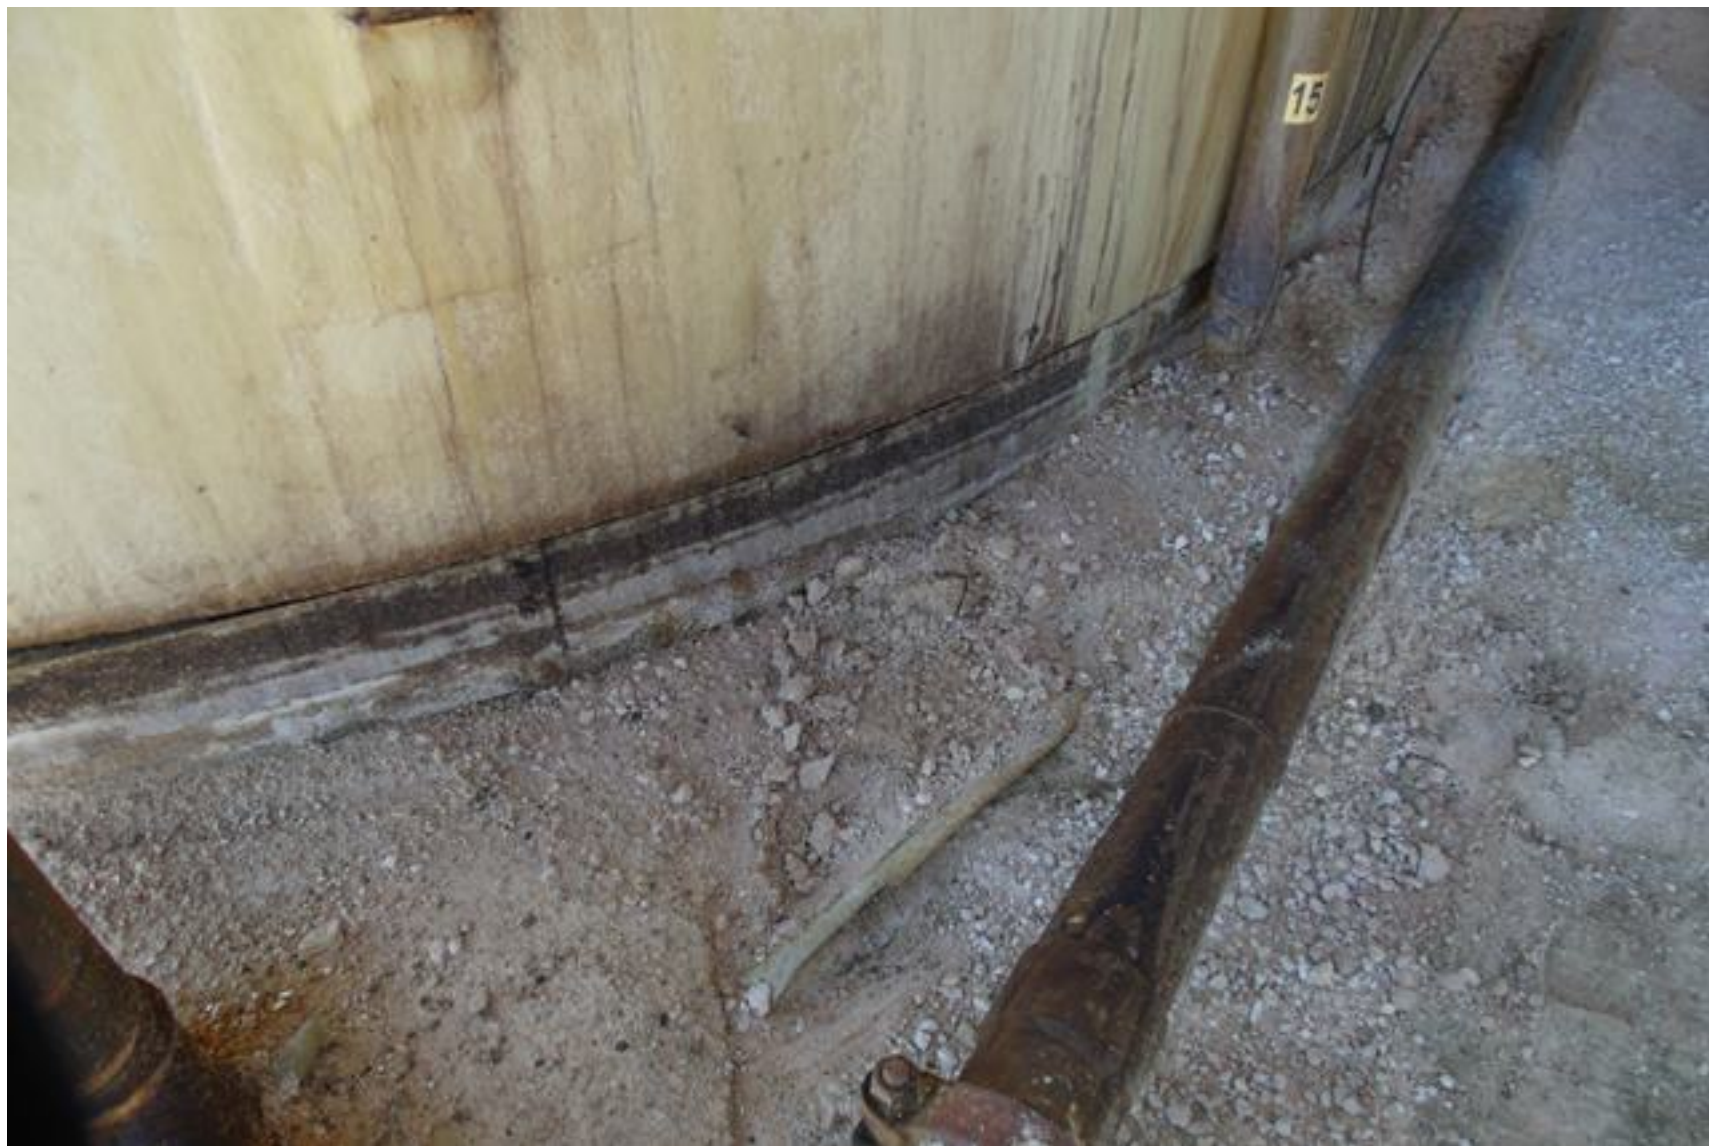
Elliott B Federal Tank Battery Liner
