Hale State Battery

CLOSURE REPORT

API No. 30-025-02154

NMOCD Case #: 1R-3700

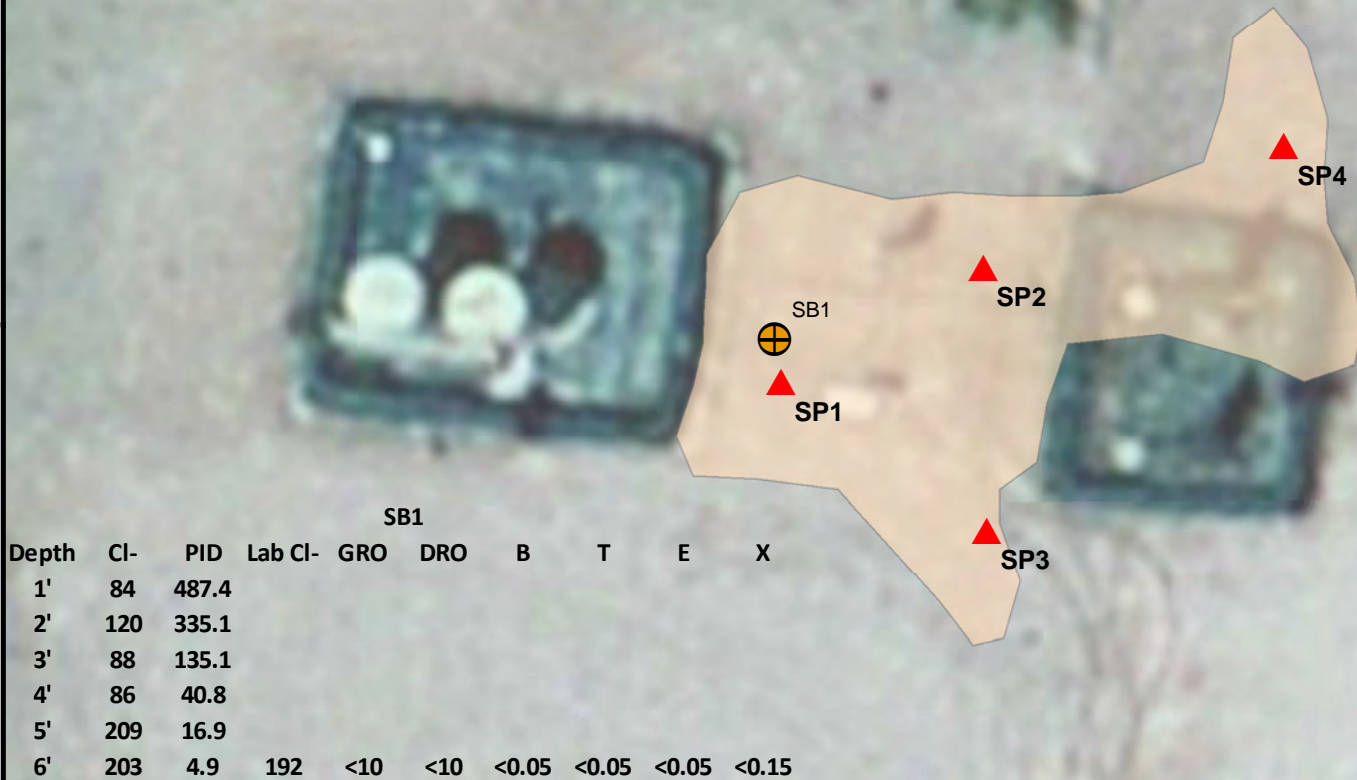
Site Diagram

SP1			
Depth	CI-	PID	
SS	146	1.1	
1'	169	399.7

SP2									
Depth	CI-	PID	Lab CI-	GRO	DRO	B	T	E	X
SS	117	1.9	48	<10	<10	<0.05	<0.05	<0.05	<0.15
1'	90	13.9	64	<10	13.4	<0.05	<0.05	<0.05	<0.15

SP3									
Depth	CI-	PID	Lab CI-	GRO	DRO	B	T	E	X
SS	503	1.7	464	<10	13.8	<0.05	<0.05	<0.05	<0.15
1'	220	3	288	<10	<10	<0.05	<0.05	<0.05	<0.15

SP4									
Depth	CI-	PID	Lab CI-	GRO	DRO	B	T	E	X
SS	926	1	1090	<10	246	<0.05	<0.05	<0.05	<0.15
1'	341	0.9	320	<10	<10	<0.05	<0.05	<0.05	<0.15

SB1									
Depth	CI-	PID	Lab CI-	GRO	DRO	B	T	E	X
1'	84	487.4							
2'	120	335.1							
3'	88	135.1							
4'	86	40.8							
5'	209	16.9							
6'	203	4.9	192	<10	<10	<0.05	<0.05	<0.05	<0.15

Oil and Produced Water (4,363 sq ft)

On June 30, 2015, DFSI personnel were onsite to obtain samples within the release area (Figure 1). Field samples were collected at four sample points, with each sample tested for chloride levels as well as BTEX. The BTEX samples were performed using a Mini Rae Photoionization Detector (PID). All clean field samples under NMOCD and BLM regulatory guidelines were submitted for laboratory analysis at Cardinal Laboratories of Hobbs, NM to obtain confirmation (Appendix II).

A work plan was submitted to NMOCD and BLM on March 23, 2016. On April 25, 2016, DFSI personnel were on site to excavate the area around SP1 and SB1 to 4' bgs. The remainder of the release area was scraped to 6" bgs. The site was then backfill with clean caliche (Appendix IV). Seeding of the site was not warranted.

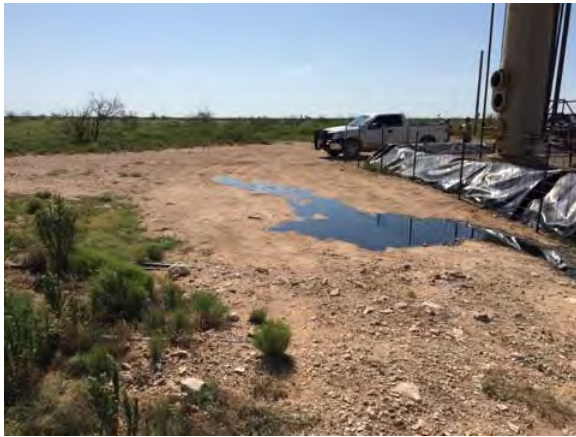
Site prior, facing north

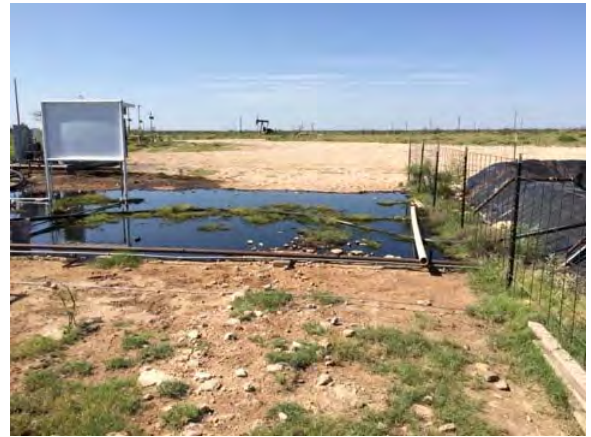
Site prior, facing northeast

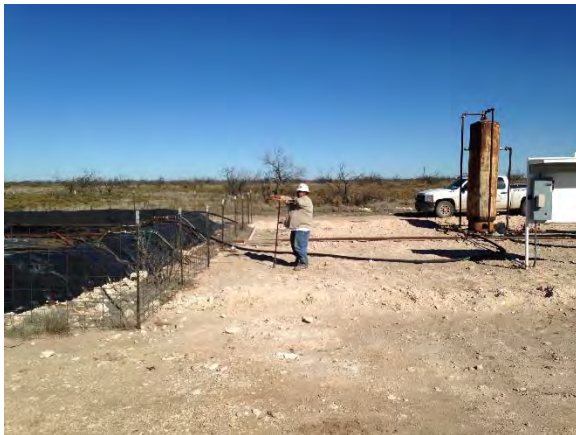
Collecting sample, facing north

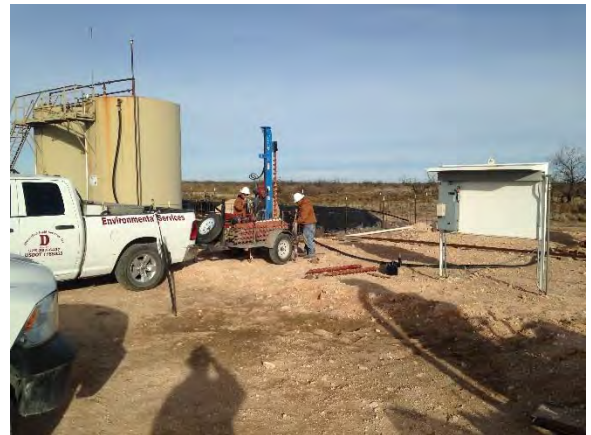
Installing soil bore, facing northwest

On November 20, 2015, to further delineate the site, a soil bore was installed, which each sample tested for chloride levels as well as BTEX. A clean field sample under NMOCD and BLM regulatory guidelines were submitted for laboratory analysis at Cardinal Laboratories of Hobbs, NM to obtain confirmation (Appendix III).

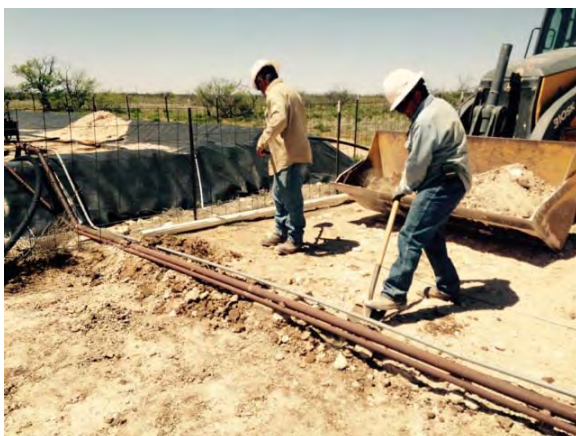
Scraping site, facing northwest

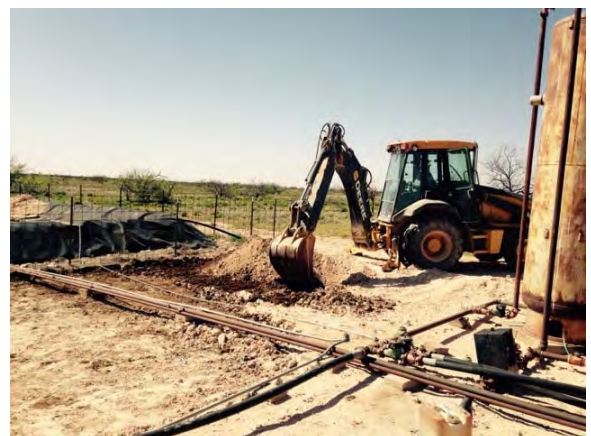
Excavating site, facing northwest

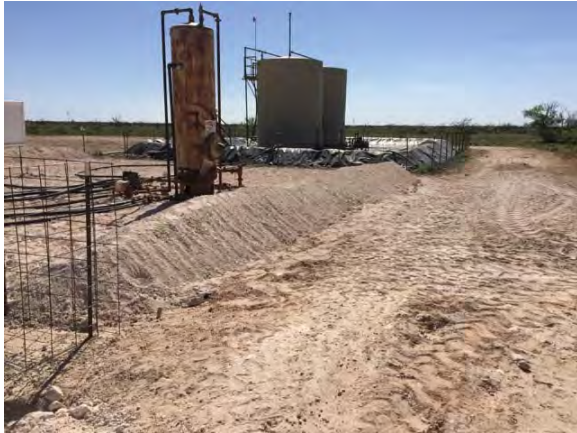
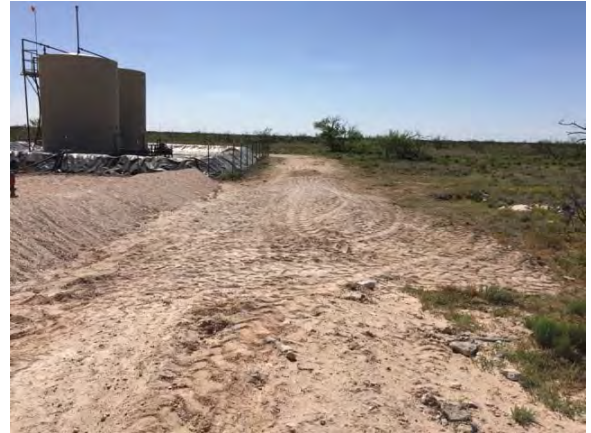
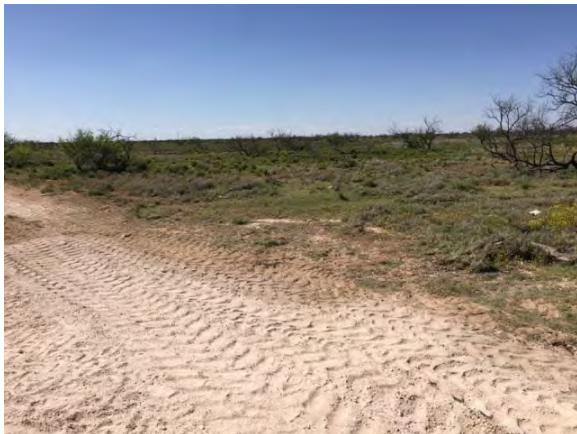
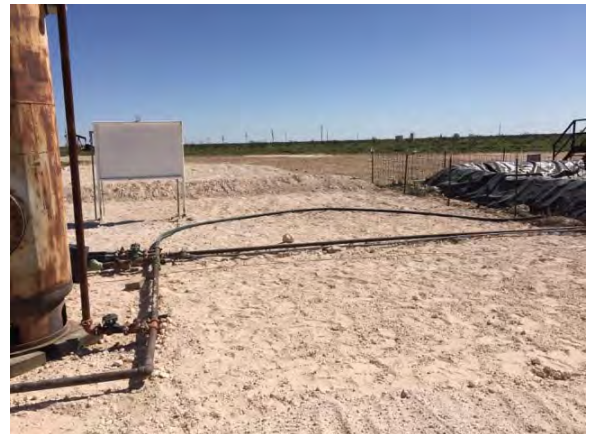
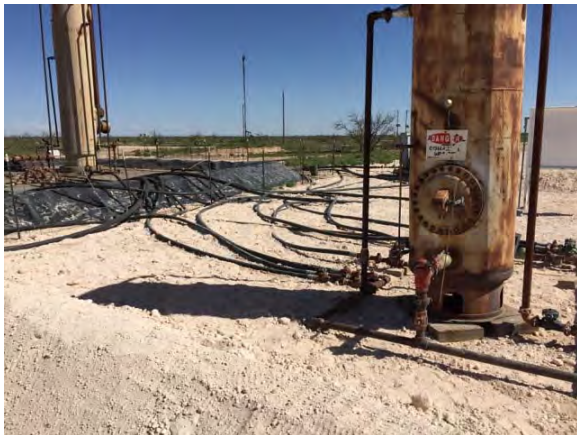
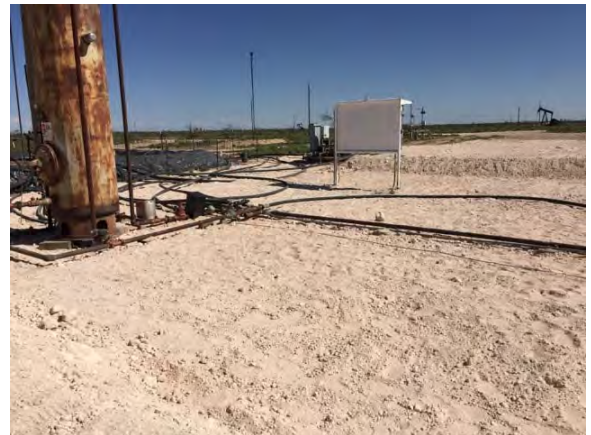
Site completed, facing northwest 5/2/2016

Site completed, facing west 5/2/2016

Site completed, facing north 5/2/2016
