# MGU Battery Flare

## REMEDIATION WORK PLAN

RP# 1RP-4082

RE: **Linn MGU Flare Battery – Remediation Work Plan**  
UL/F, Section 4, T17S, R32E  
API No. 30-025-33208  
NMOCD Case #: 1R-4082

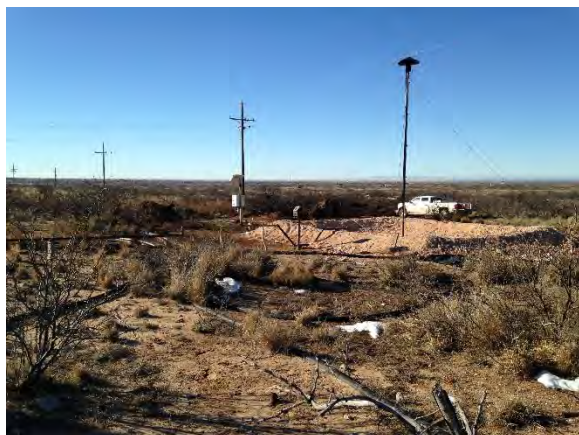
Site prior, facing southwest

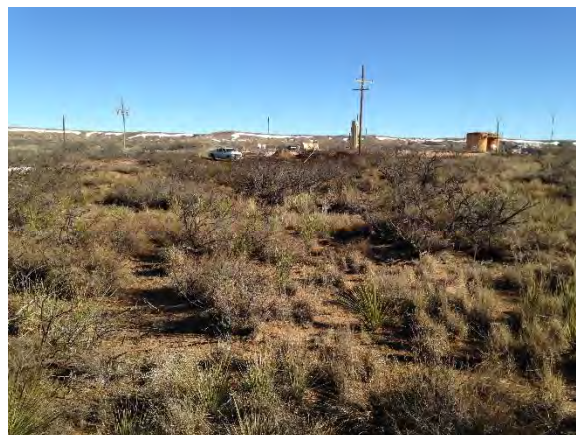
Site prior, facing northeast

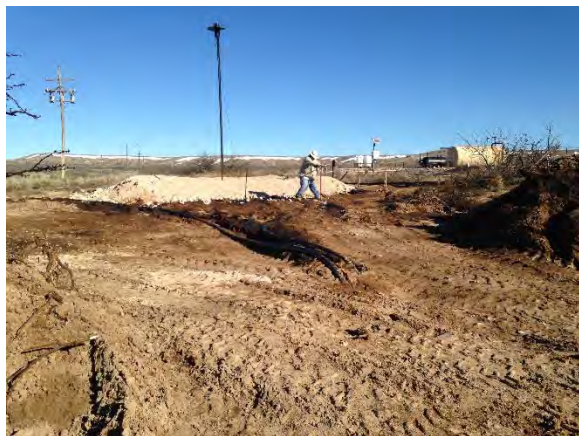
Collecting sample, facing northeast

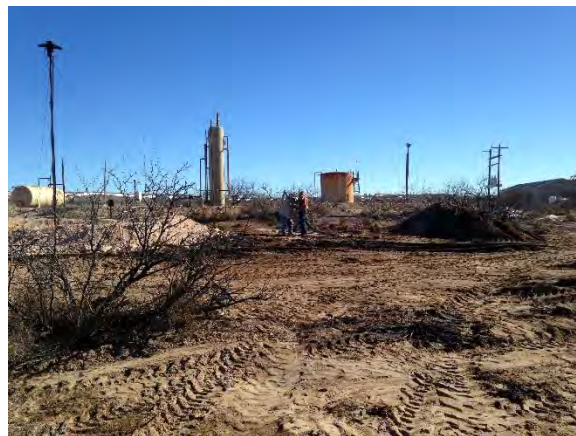
Collecting sample, facing east
