Devon Energy Production Co LP

Checkers 24 Federal 5

1RP-3991

Closure

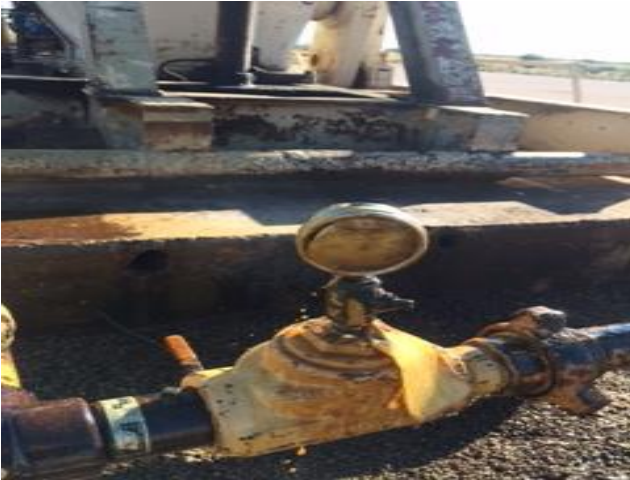
Leak source

The top of the gauge on the tubing line at the well head blew out resulting in a release. Upon discovery the tubing was closed and the well was shut in immediately to prevent further release. The gauge has been replaced.

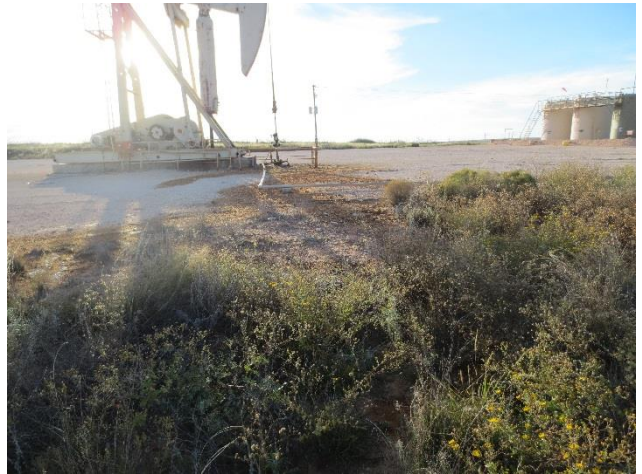
View from west to leak source

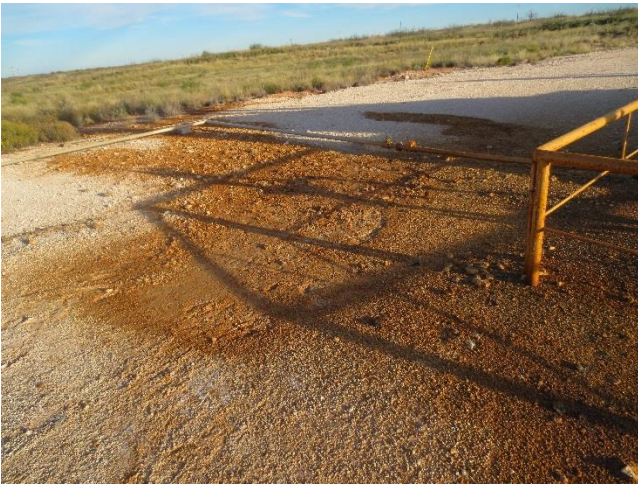
Spill exiting pad to pasture (west)

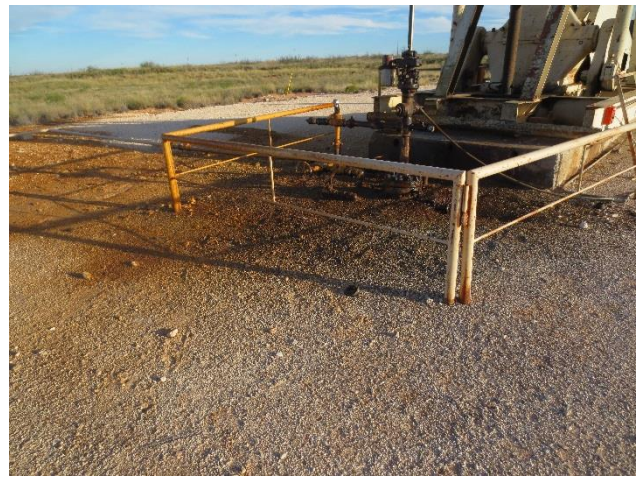
Source of leak

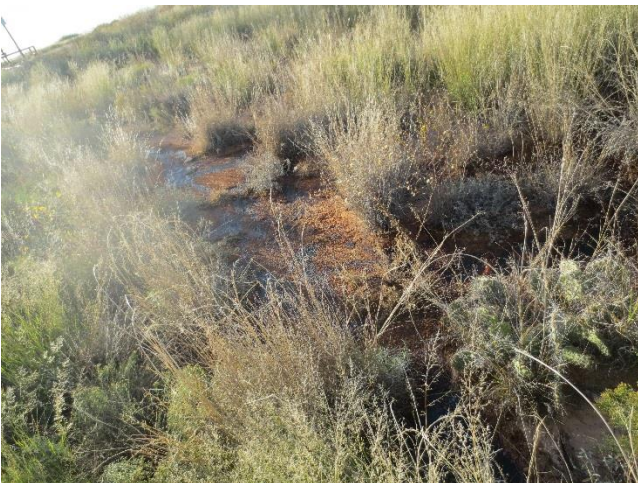
West of location pasture impact

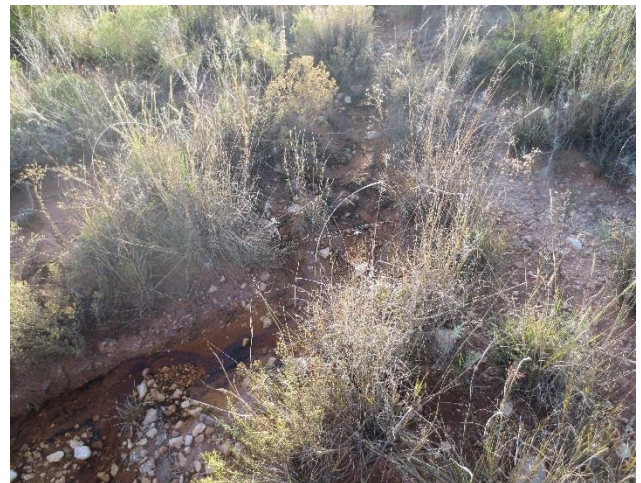
Pasture Impact

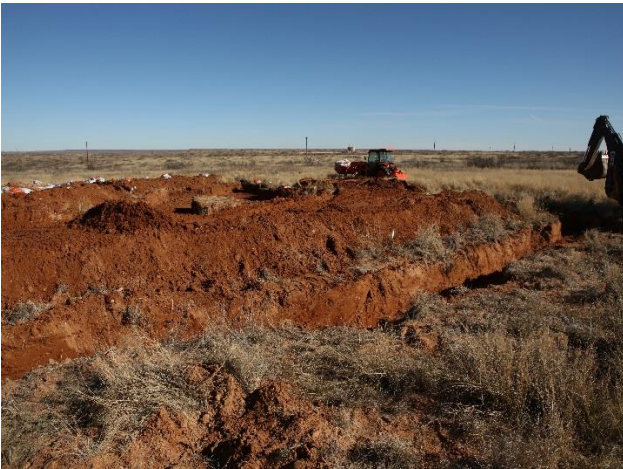
1-21-16 Excavation of Impact

On January 21, 2016, soil samples were retrieved from the sidewalls and bottom of the excavation created by the removal of the contaminated soil. Ms. Shelley Tucker of the BLM, Ms. Kelly Jones and Mr. Jamie Keyes of the NMOCD, and Ms. Amber Groves of the NM State Land Office were touring the location after the excavation was complete, during the side and bottom sampling being performed. Mr. Bob Allen of SESI reported to the regulatory representatives that the sampling was complete and field testing confirmed removal of the contaminated soil. The samples were properly preserved, packaged, and transported to Cardinal Laboratories and analyzed for Chloride (Cl⁻) (Method SM 4500 Cl-B). The results are presented in the table below:

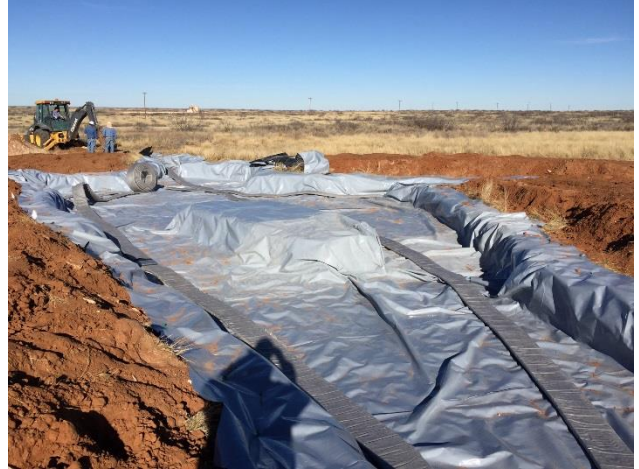
1-22-16 Liner Installation

The site was prepared for remediation activities with the installation of the lined infrastructure for soil treatment, see photo documentation (Appendix D). RX Soil procedure was applied to the impacted soil inside the lined infrastructure.

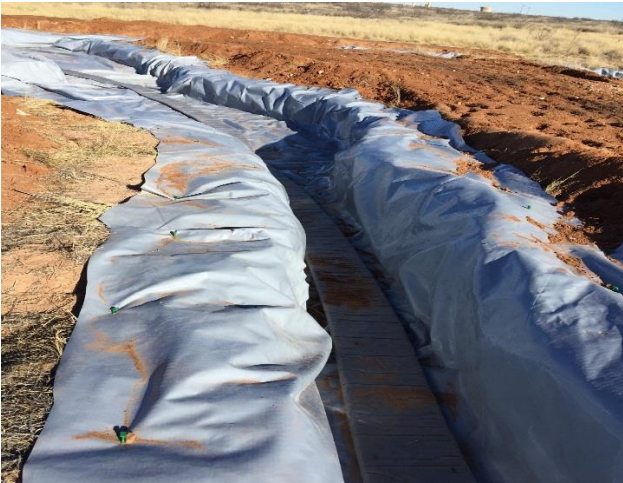
1-22-16 Installation of drain infrastructure

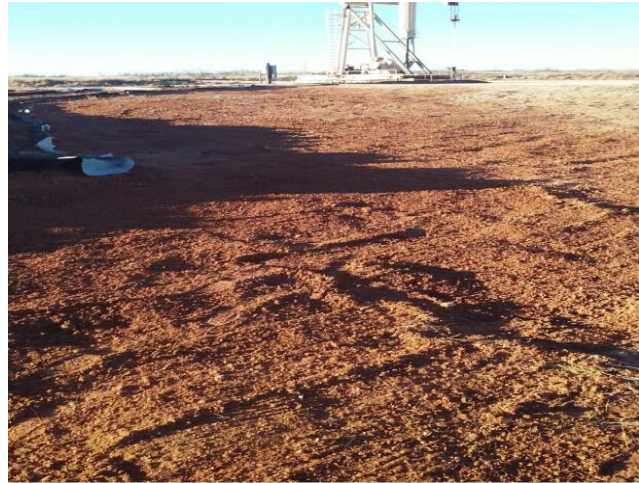
Surface Gradient

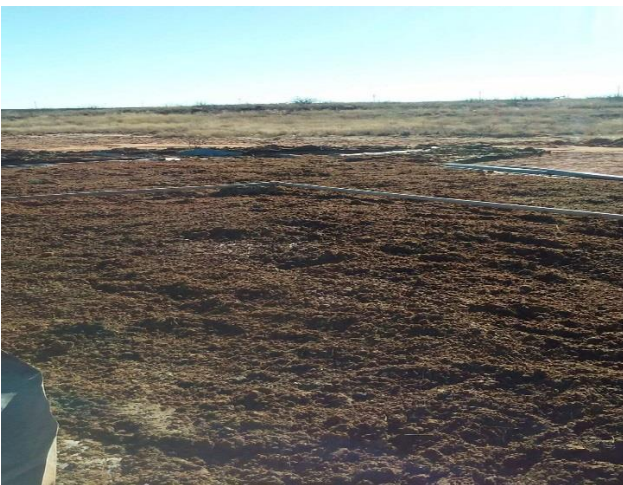
Surface drain infrastructure

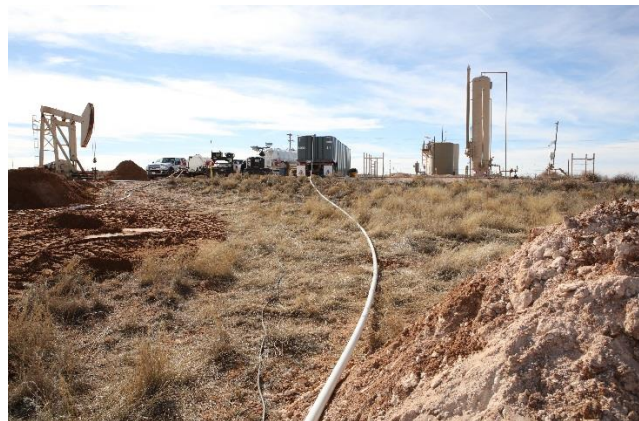
Leachate line to Frac Tank for recycling

On January 25, 2016 SESI personnel returned to the site in order to supervise the blending of the treated soil and obtain samples from the leachate from random areas. The soil was field tested for Chlorides and the results ranged from 380 mg/kg to 1267 mg/kg. The effluent concentrated for Chlorides at 11,000 mg/kg.
