Report Type: Work Plan 1RP-4214

**Re: Work Plan for the COG Operating LLC., Lusk Deep Unit A #023H,
Unit P, Section 19, Township 19 South, Range 32 East, Lea County,
New Mexico. 1 RP-4214**

Tetra Tech, Inc. (Tetra Tech) was contacted by COG Operating LLC., (COG) to review the assessment data and prepare a work plan for a spill that occurred at the Lusk Deep Unit A #023H, Unit P, Section 19, Township 19 South, Range 32 East, Lea County, New Mexico (Site). The spill site coordinates are N 32.6396141°, W 103.7981644°. The site location is shown on Figures 1 and 2.

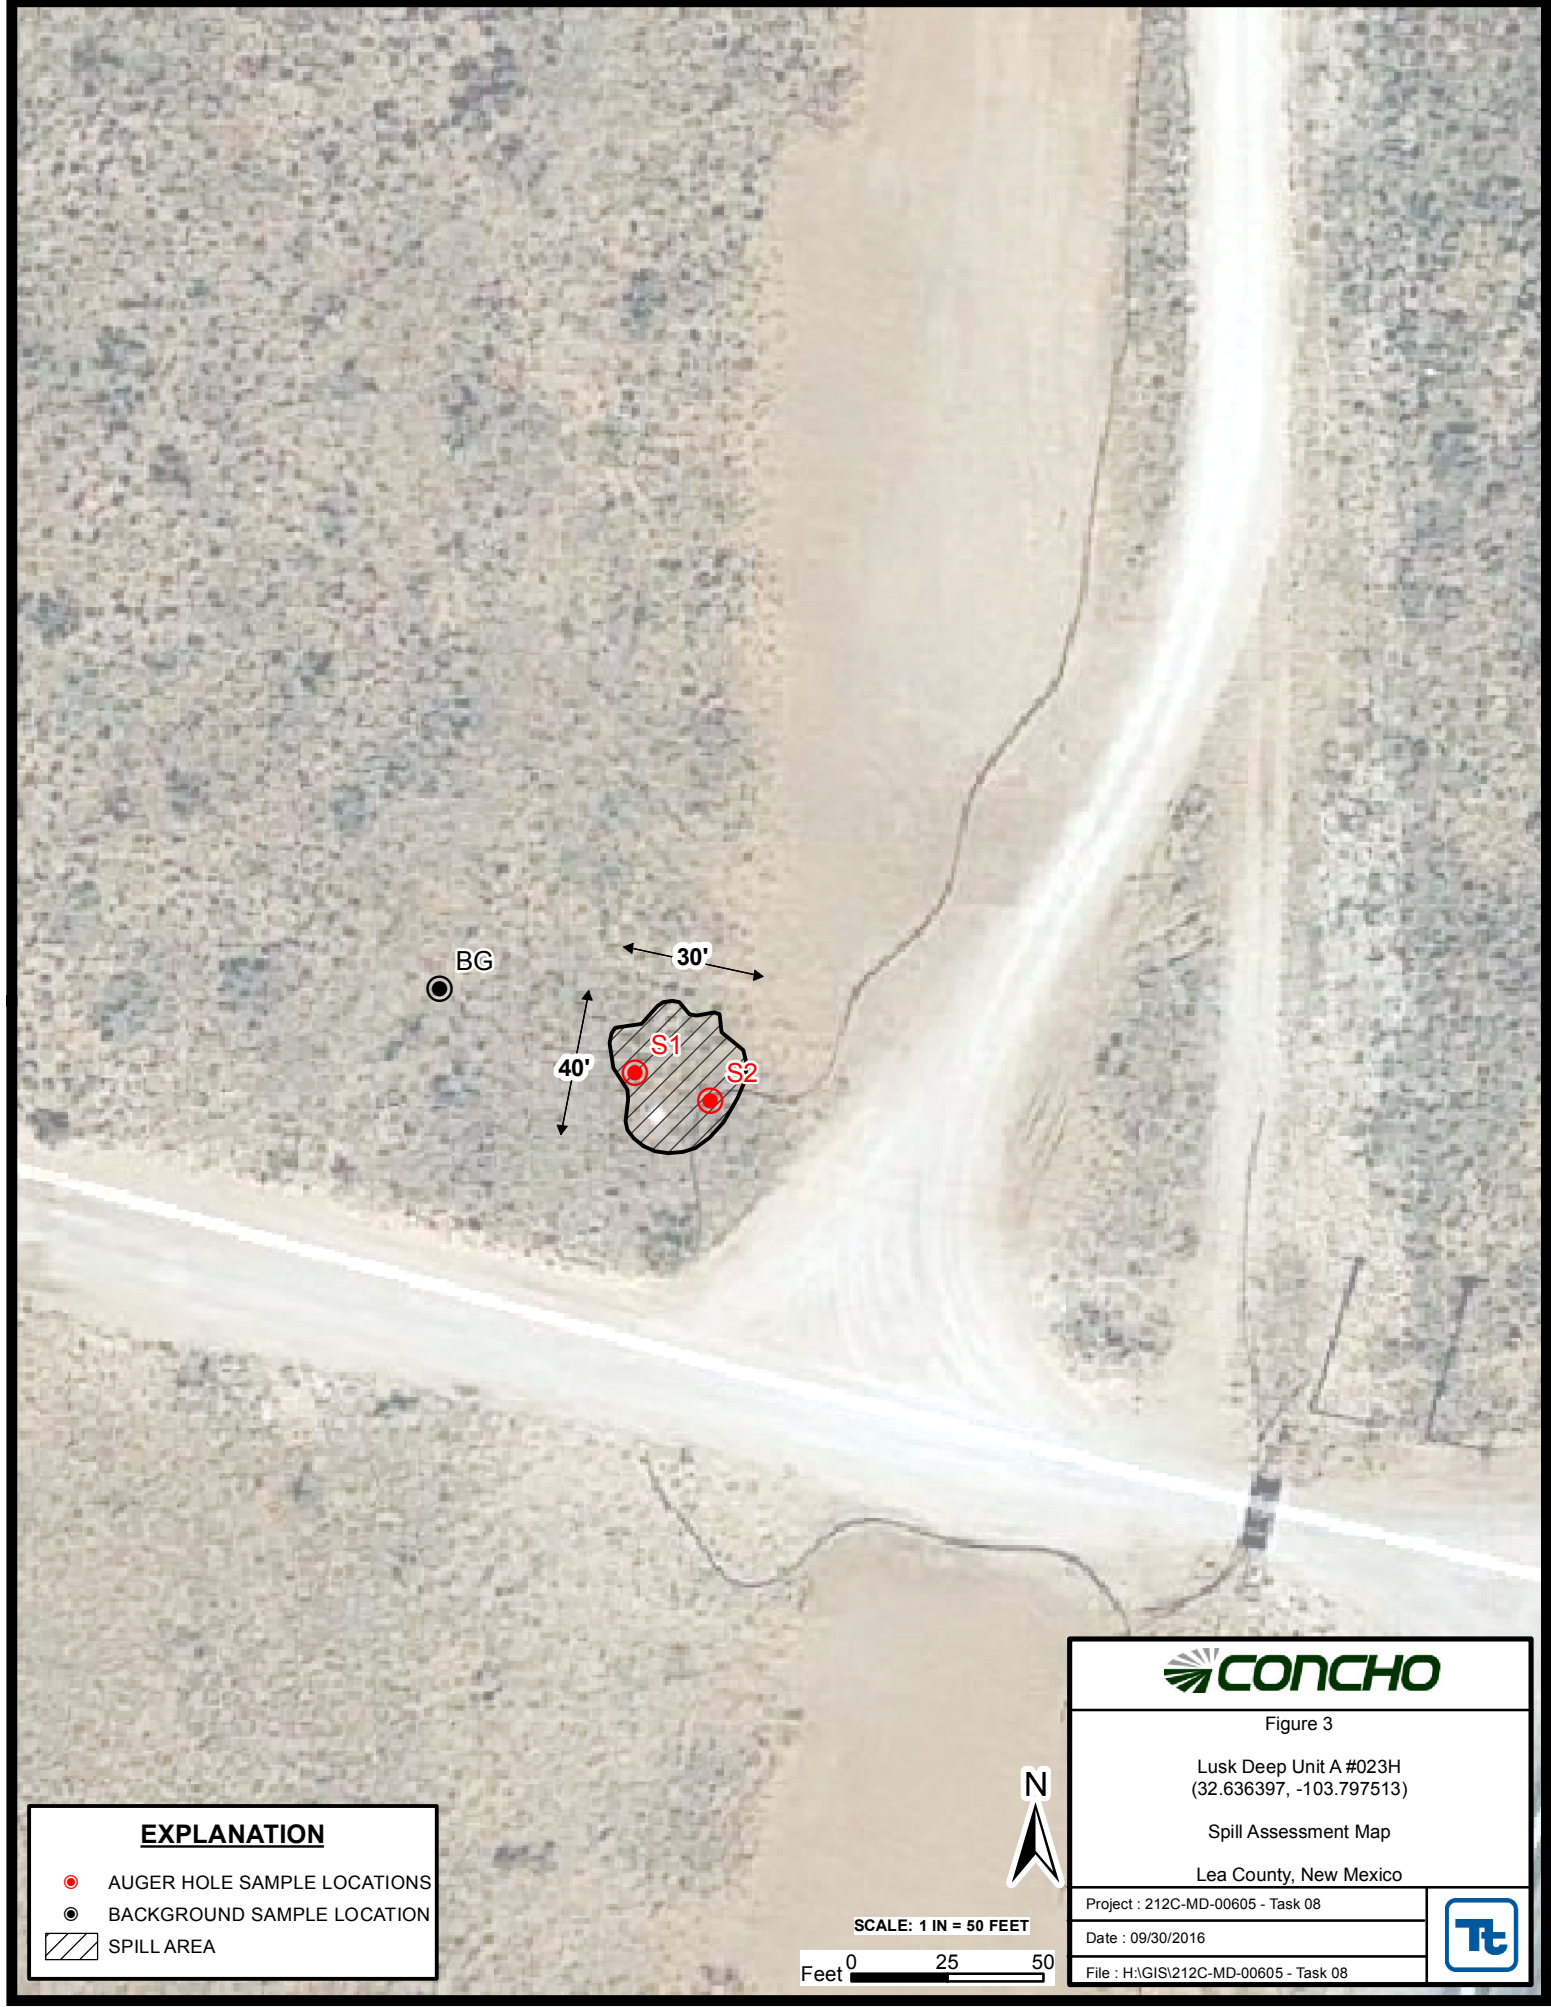
Figure 3

- AUGER HOLE SAMPLE LOCATIONS
- BACKGROUND SAMPLE LOCATION
- ▨ SPILL AREA

Spill Assessment Map

On August 8, 2016, COG personnel were onsite to evaluate and sample the release area. A total of two (2) boreholes (S1 and S2) were installed to depths of 45' and 80' below surface using an air rotary rig to assess the impacted soils. Additionally, a background borehole (BG) was installed to evaluate the native soils. Selected samples were analyzed for TPH analysis by EPA method 8015 modified, BTEX by EPA Method 8021B and chloride by EPA method 300.0. Copies of laboratory analysis and chain-of-custody documentation are included in Appendix C. The sampling results are summarized in Table 1. The borehole locations are shown on Figure 3.

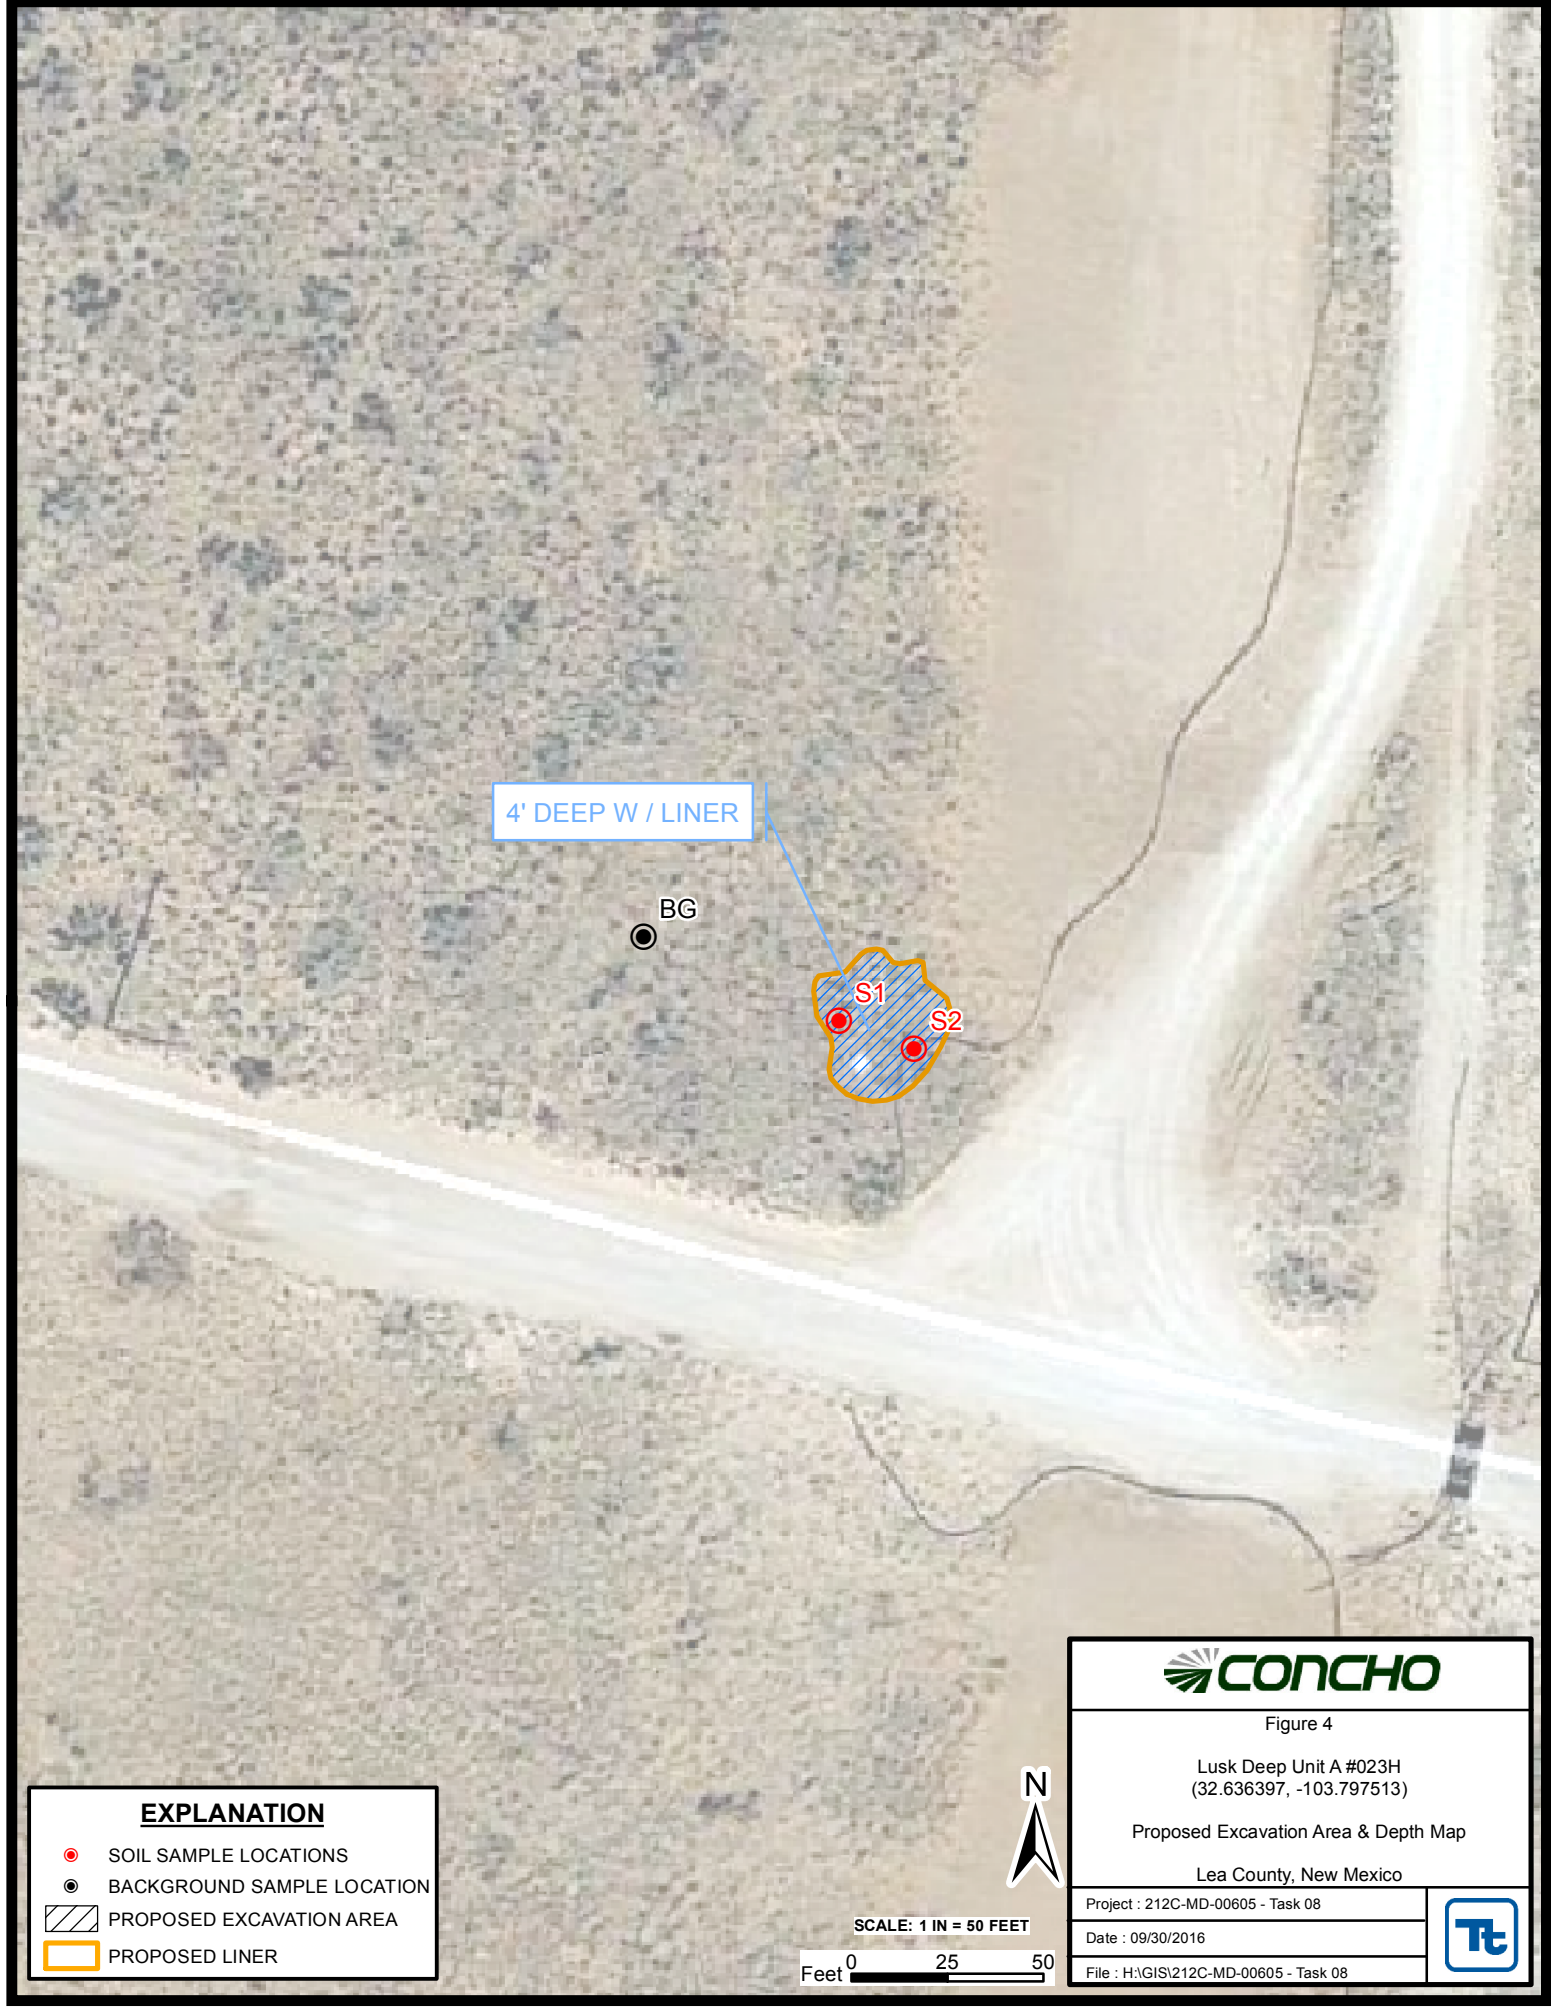
Figure 4

4' DEEP W / LINER

- SOIL SAMPLE LOCATIONS
- BACKGROUND SAMPLE LOCATION
- ▨ PROPOSED EXCAVATION AREA
- ▭ PROPOSED LINER

Proposed Excavation Area & Depth Map

Based on the results, COG proposes to remove impacted material as highlighted (green) in Table 1 and shown on Figure 4. The areas of S1 and S2 will be excavated to a depth of 4.0' below surface and propose to cap the

excavation bottoms with a 20 mil liner to prevent vertical migration of the chloride impacted soils. All of the excavated material from these areas will be transported offsite for proper disposal. The excavations will be backfilled with clean soil to grade. After the site remediation is performed, COG will reseed the remediated area in the pasture in June of 2017 to coincide with the rainy season in southeast New Mexico.
