Coogan Federal Battery #1 & #3

CLOSURE REPORT

NMOCD Case #: 1R-4385

October 19, 2016

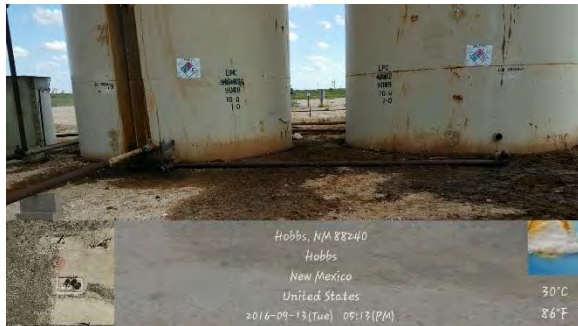
Site prior, facing south

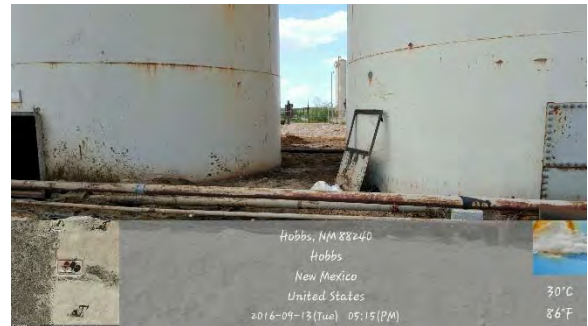
Site prior, facing north

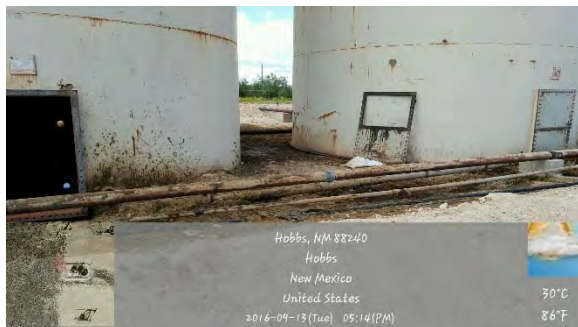
Site prior, facing east

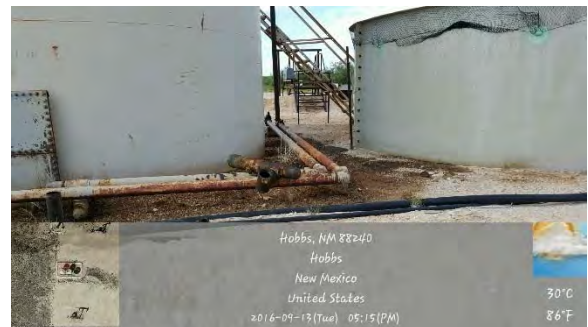
Site prior, facing north

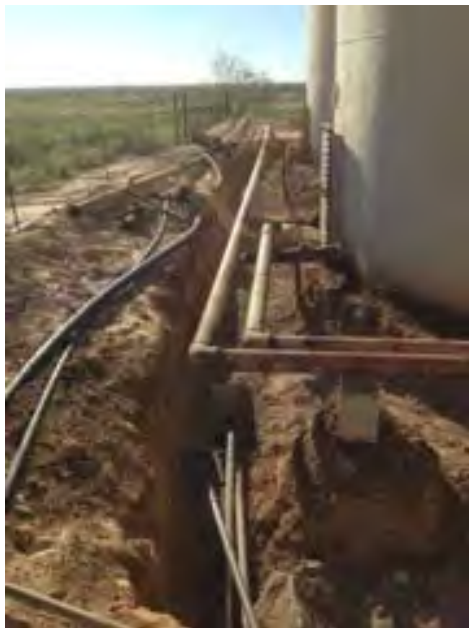
Handshoveling site

Beginning October 6, 2016, the area around SP3 was excavated to a depth of 2' bgs. The areas around SP1 and SP2 were excavated to a depth of 1.5' bgs. The excavation and scraped areas were backfilled with clean, imported soil to ground surface and contoured to the surrounding area. Seeding of the site was not warranted (Appendix III).

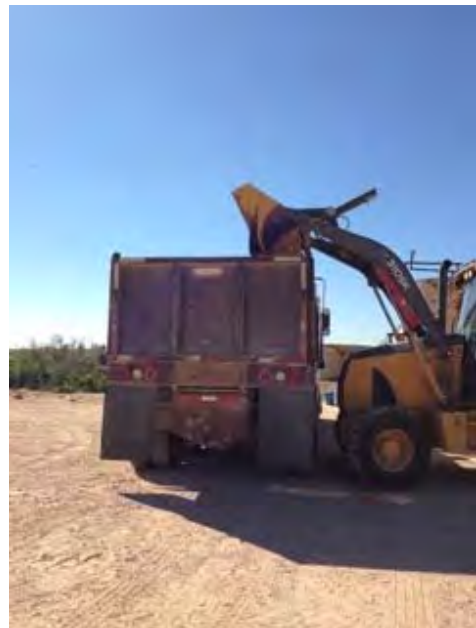
Exporting contaminated soil

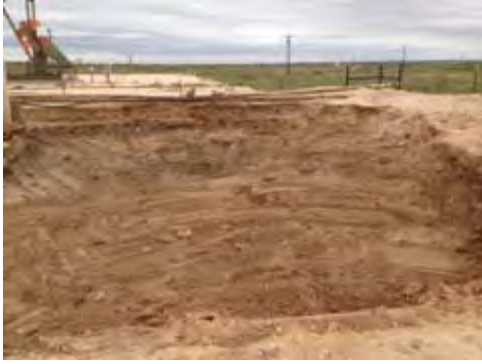
Excavation completed

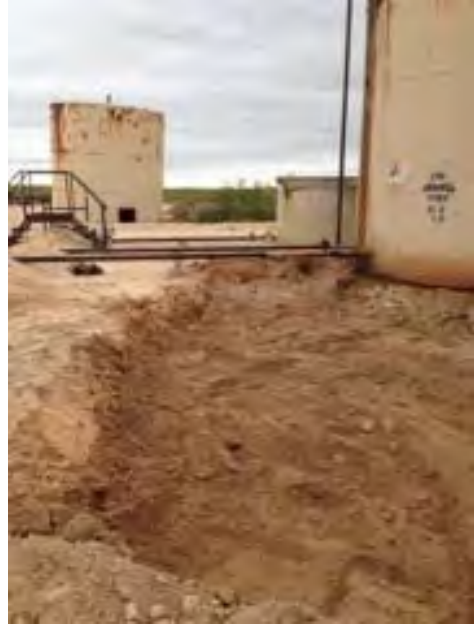
Excavation completed

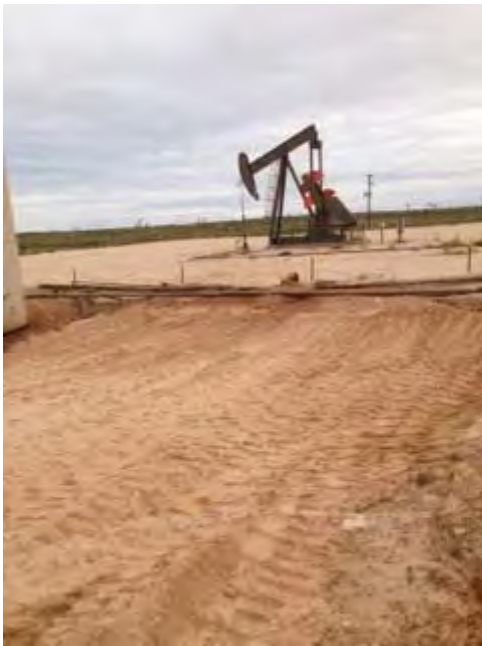
Site backfilled

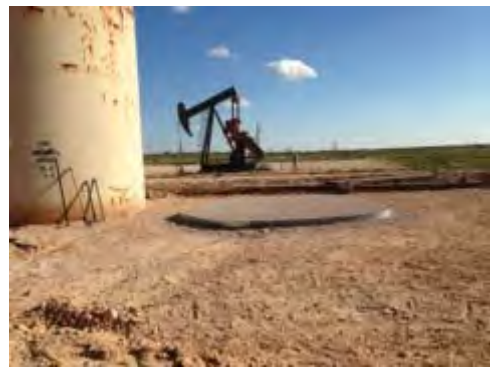
Site completed

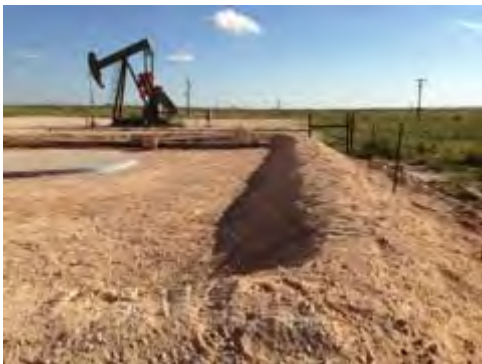
Site completed

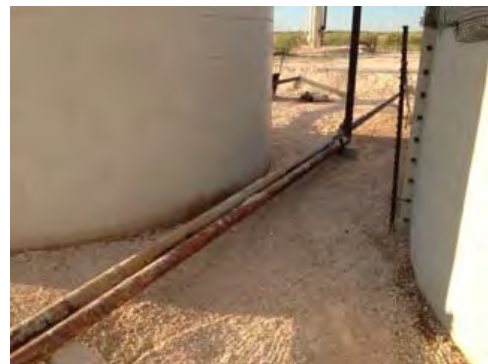
Site completed
