Remediation Summary and Closure Report

Lynch Station Tank Line 1459
Plains SRS No. 2016-135
NMOCD Ref. No. 1RP-4406
Lea County, New Mexico
Unit Letter "G", Section 34, Township 20 South, Range 34 East
Latitude 32.533014° / Longitude -103.545923°

January 19, 2017 Terracon Project No. AR167190

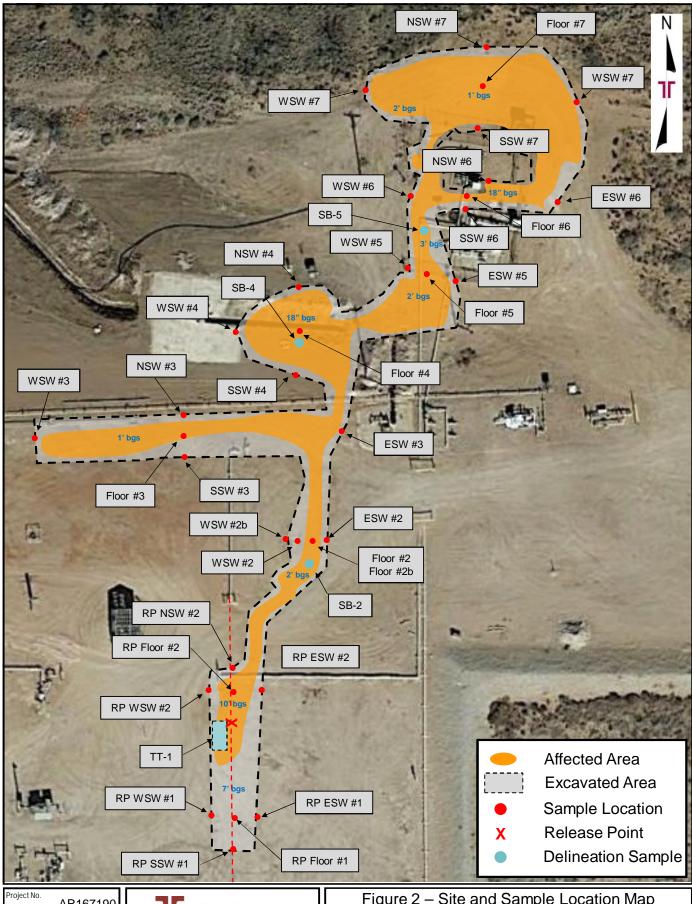
Figure 1 – Site Location Map
Figure 2 – Site and Sample Location Map

Following notification of a crude oil release that occurred on August 8, 2016 at the Lynch Station facility, Terracon visited the site with a Plains representative. The release was attributed to the failure of a 12-inch pipeline. It is estimated that approximately 250 bbls of crude oil were released, with approximately 200 bbls being recovered. The release affected an area measuring approximately 13,000 sq. ft. within the facility boundaries. During initial response activities, Plains personnel responded to the reported incident, secured the release site, recovered free-standing fluid and replaced the affected pipeline. A "Site and Sample Location Map" is provided as Figure 2 in Appendix A.

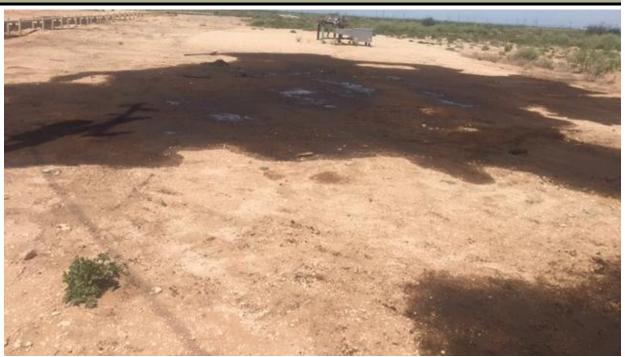
PHOTO 1: View of surface staining from the initial release, facing west.

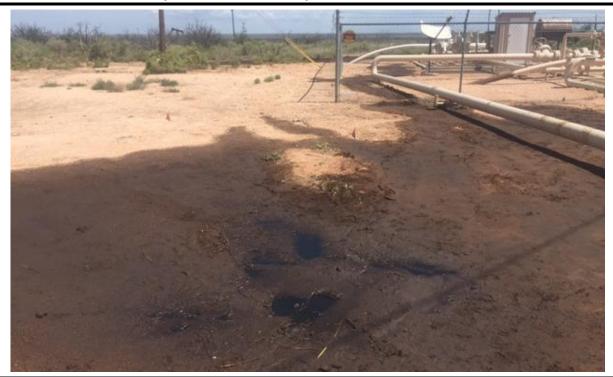
PHOTO 2: View of surface staining from the initial release, facing north.

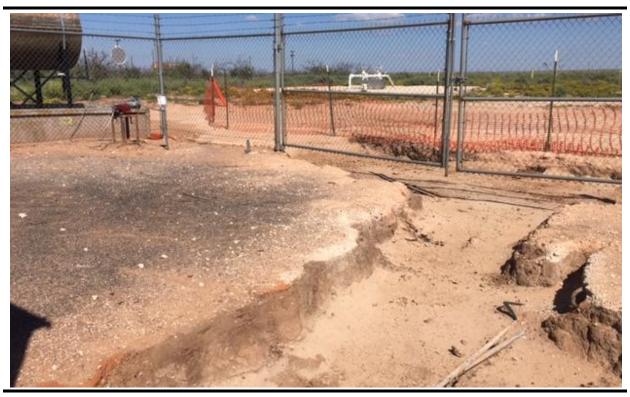
PHOTO 3: View of portion of the excavated area, facing northeast.

Remediation activities commenced at the release site. Basin Environmental Services (Basin) excavated impacted soil from within the release margins. The floor and sidewalls of the excavation were advanced until field observations suggested concentrations of TPH and BTEX were less than the NMOCD Recommended Remediation Action Levels. Excavated soil was stockpiled onsite, atop a poly-urethane liner, pending final disposition.

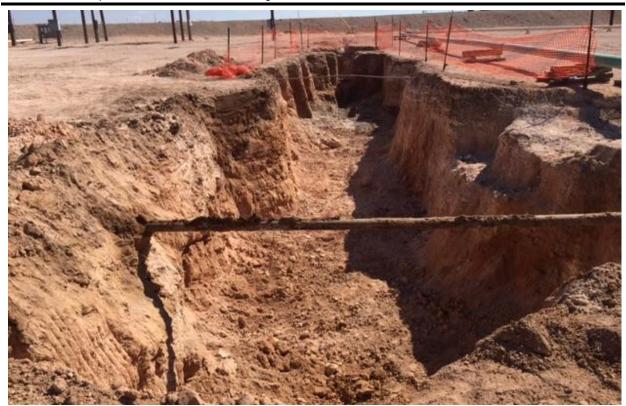
PHOTO 4: View of portion of the excavated area, facing south.

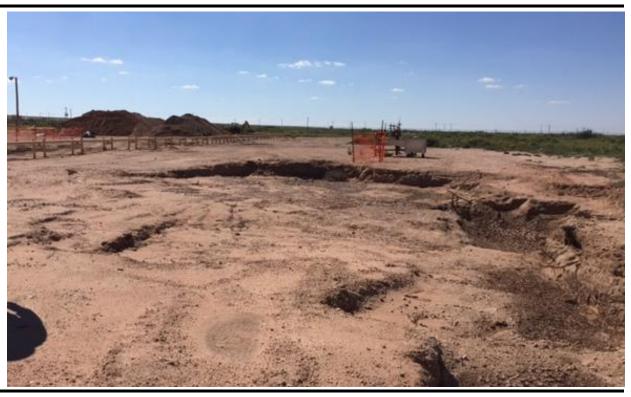
PHOTO 5: View of portion of the excavated area, facing southwest.

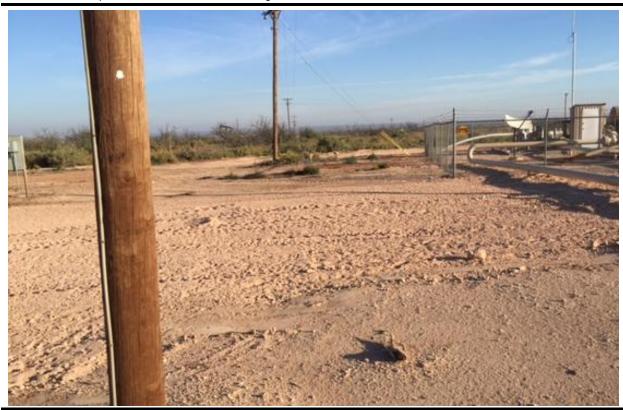
PHOTO 6: View of the release site after remediation activities, facing north.

Remediation activities conducted at the Lynch Station Tank Line 1459 site met the objectives set forth by the NMOCD. Based on the completion of field activities and review of laboratory analytical results from confirmation soil samples, Terracon recommends no further action be taken in regards to the documented release at the site at this time.

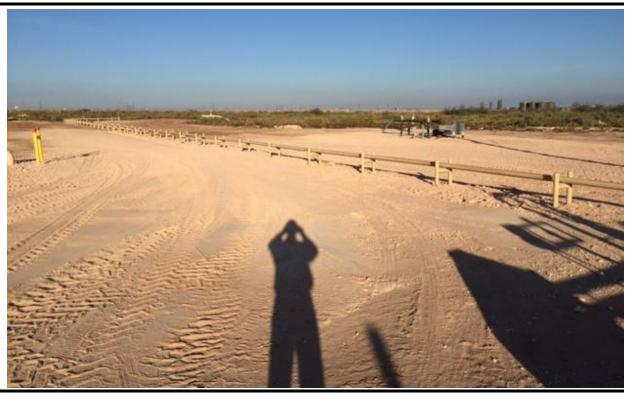
PHOTO 7: View of the release site after remediation activities, facing northeast.

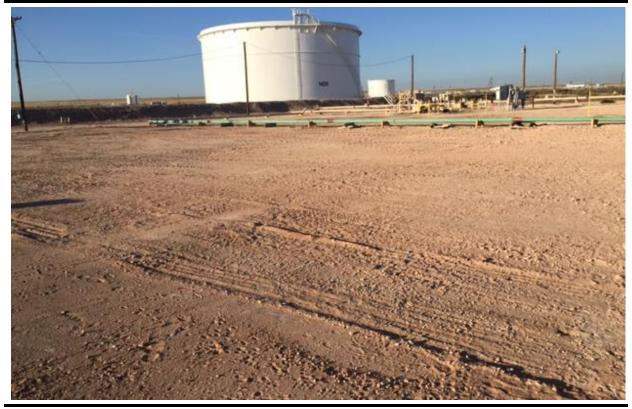
PHOTO 8: View of the release site after remediation activities, facing southwest.
