CLOSURE REPORT

STATE C-20 #1 FLOW LINE

1RP-1434

MAY 2008

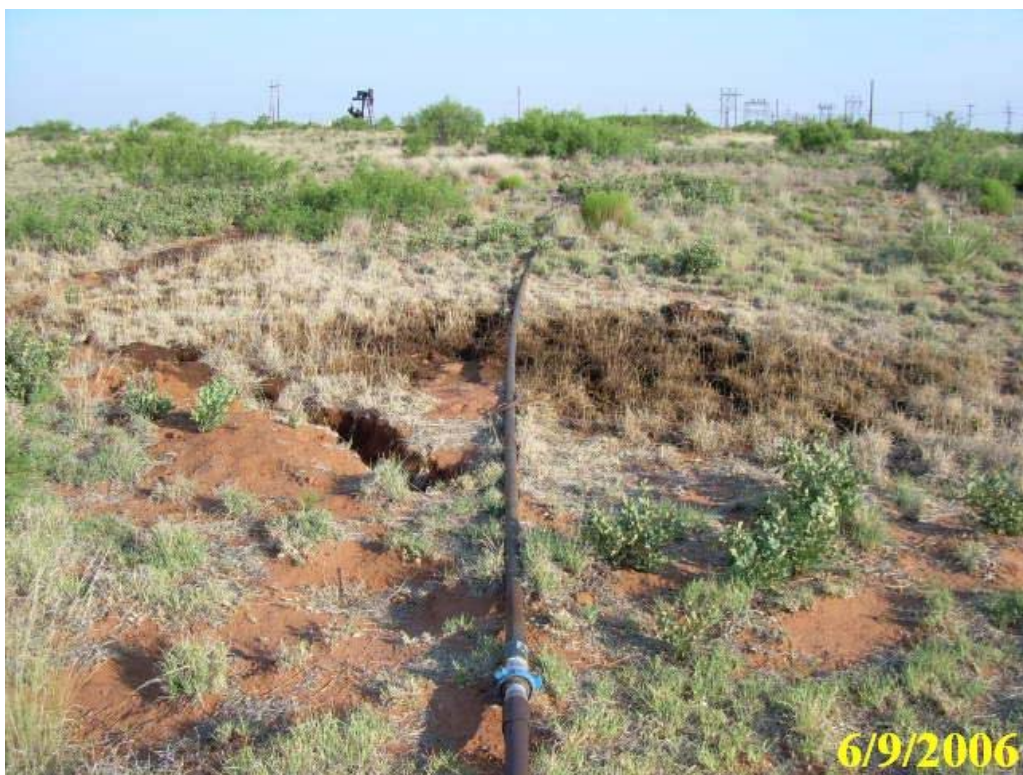
Photo #1 – Looking northeasterly across point of release and overspray area

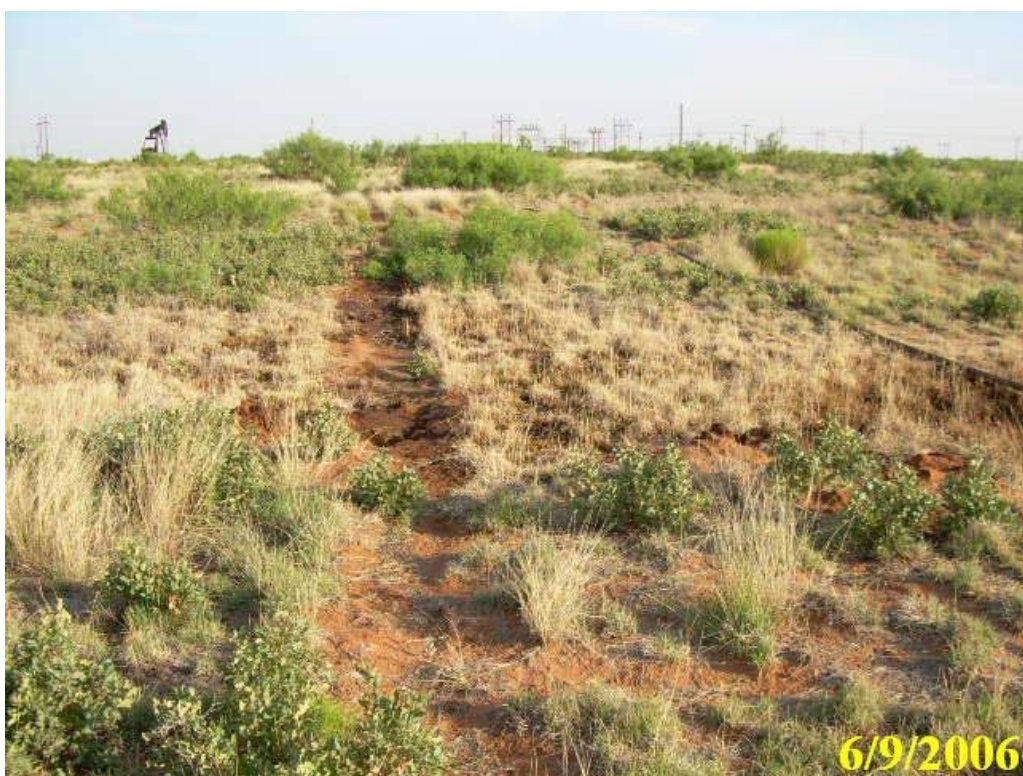
Photo #2 – Looking northeasterly across release area

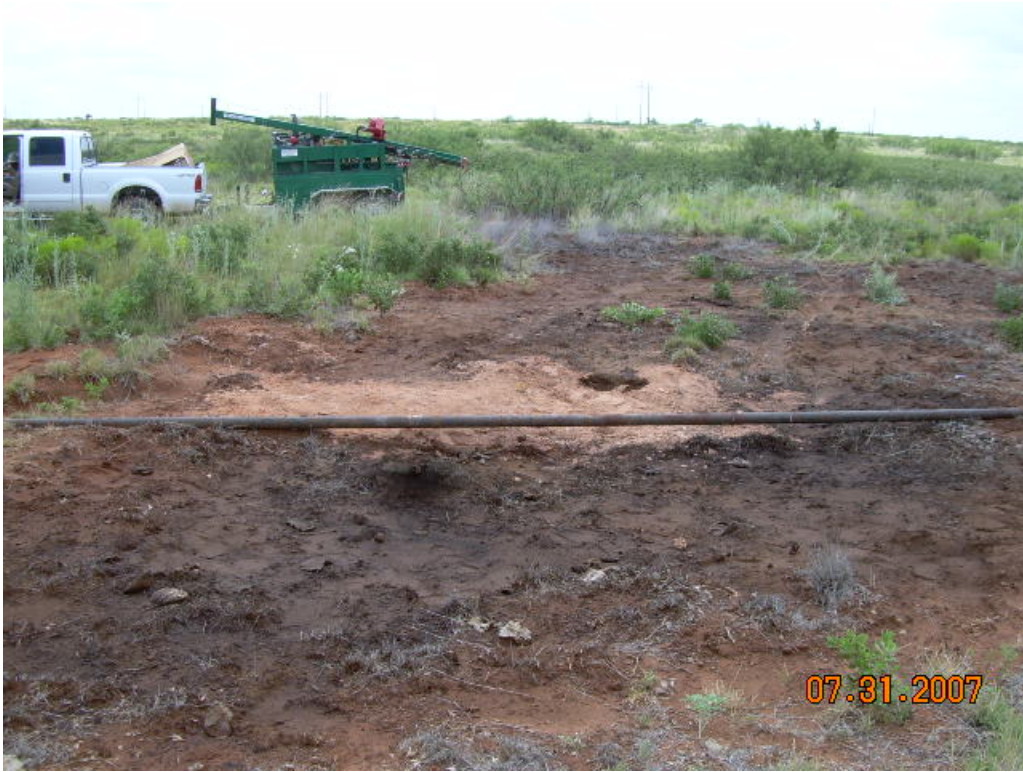
Photo #3 – Soil boring #1

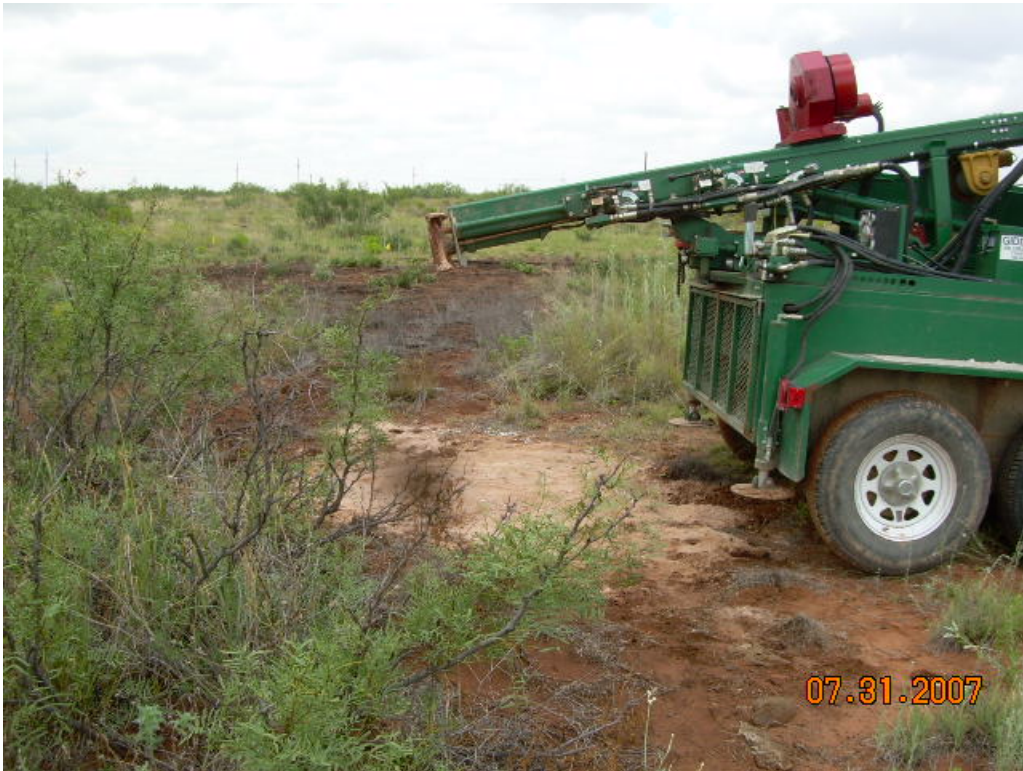
Photo #4 – Soil boring #2

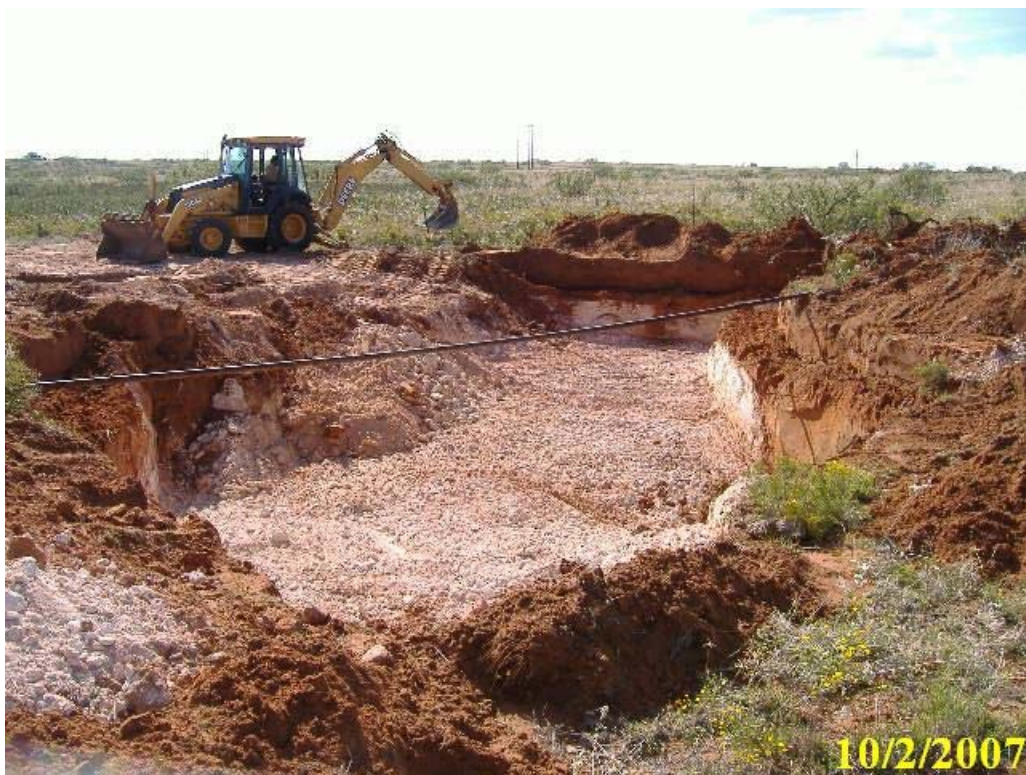
Photo #5 – Excavating contaminated soil

From October 2 through 25, 2007 approximately 1,152 yds³ of contaminated soil were excavated and transported to J & L Landfarm with an additional 182 yds³ to Sundance Services, Inc. for disposal. Upon laboratory confirmation hydrocarbon impacts were below NMOCD remedial threshold goals, the excavation was backfilled with caliche (~392 yds³) and clean topsoil (~840 yds³). Following completion of backfill operations, the entire remedial area was graded to allow natural drainage and will be seeded with a grass blend preferred by the BLM.

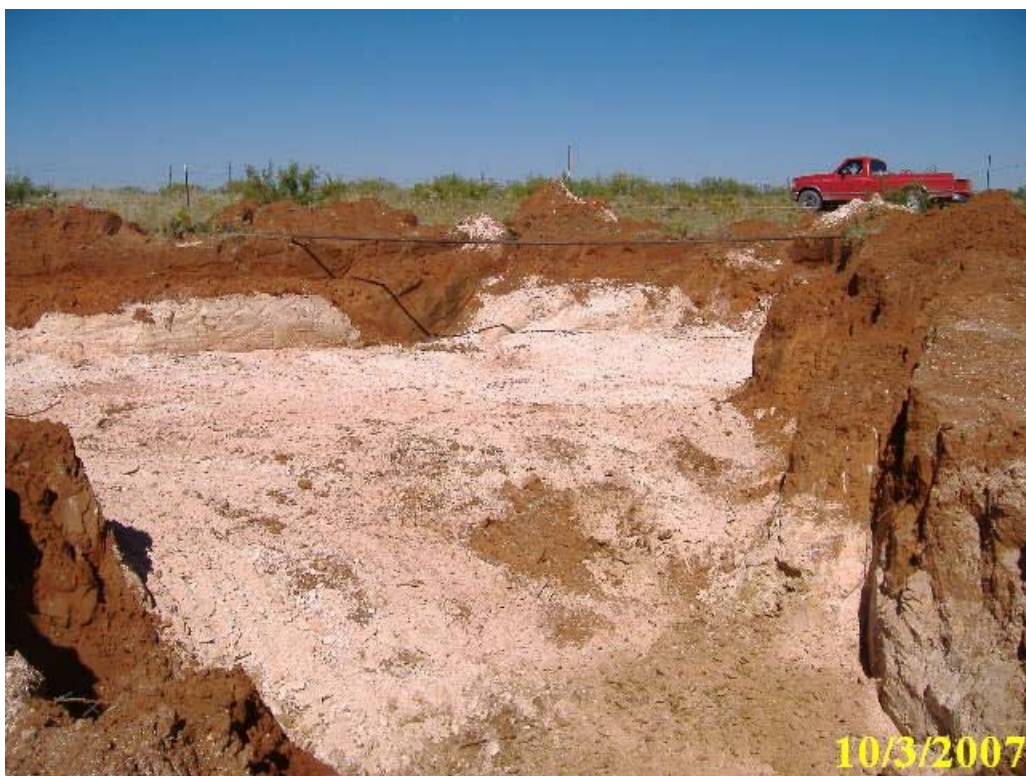
Photo #6 – Looking northerly across excavation

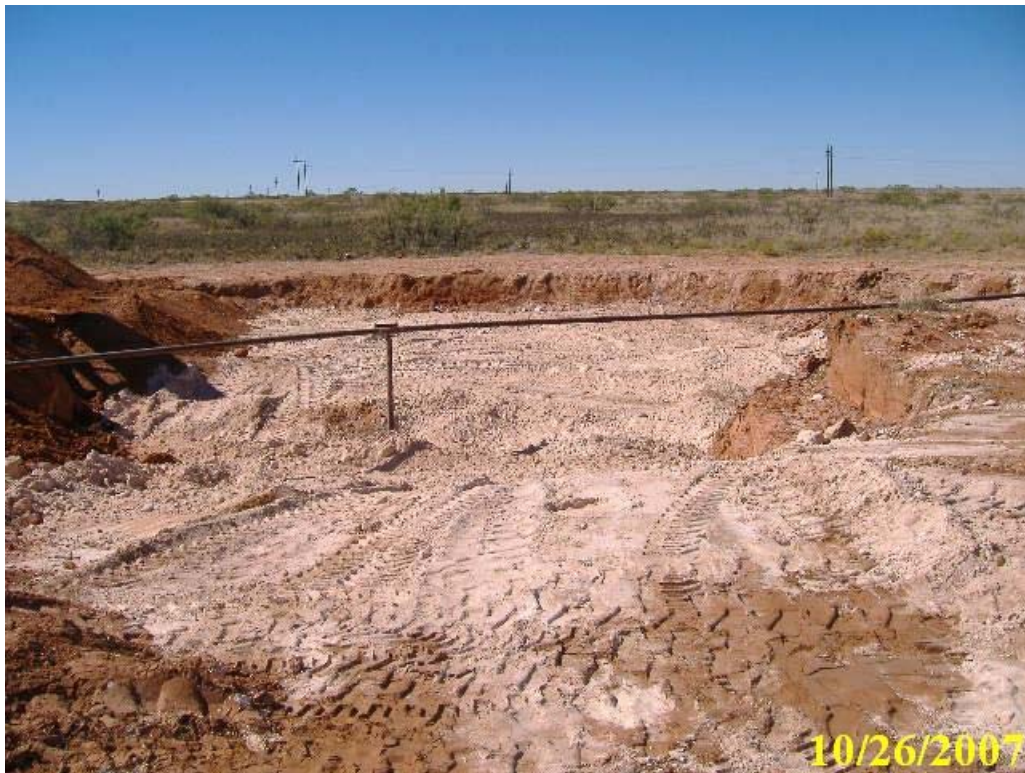
Photo #7 – Looking southerly across excavation

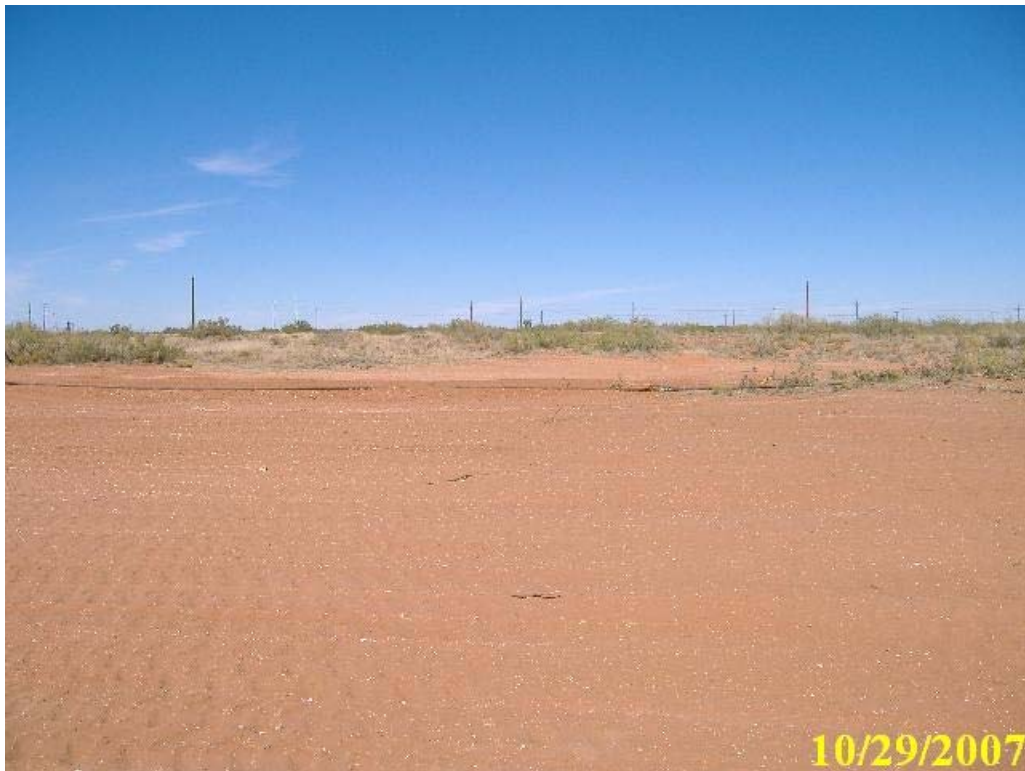
Photo #8 – Remediated site
